## REPORT 6600 Miller Creek

January 30, 2019

Regarding: Quick visit to Miller Creek (Martell Ranch) on 1/28/2019

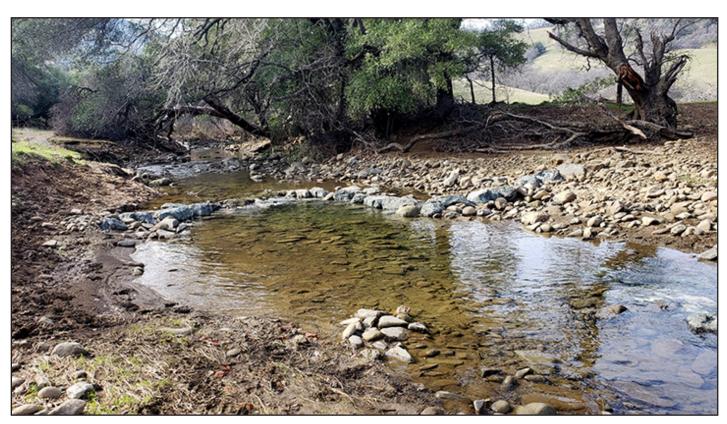
Looking upstream from the large oak. 1/28/2019

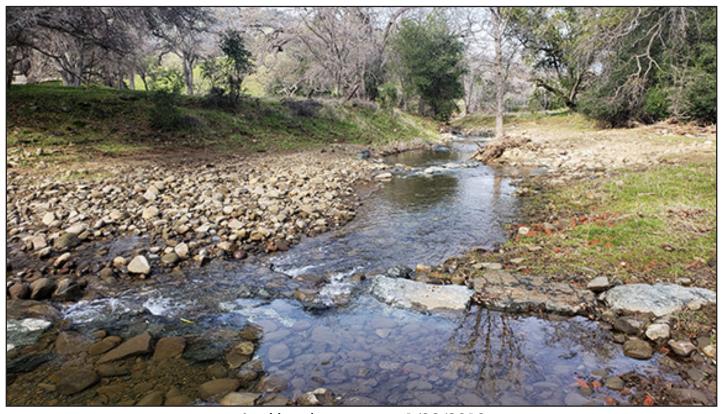
Looking downstream. 1/28/2019

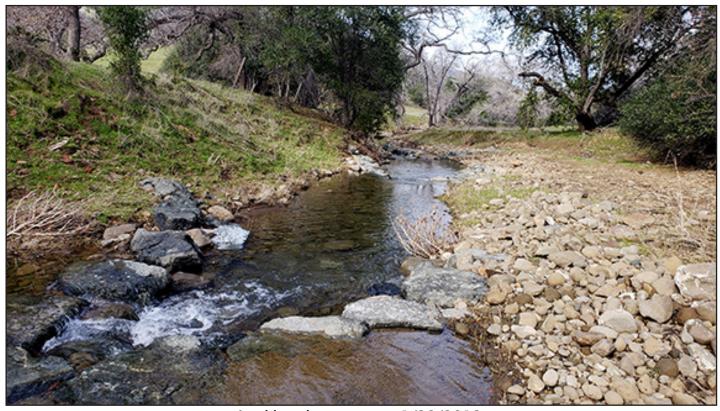
Looking downstream. 1/28/2019

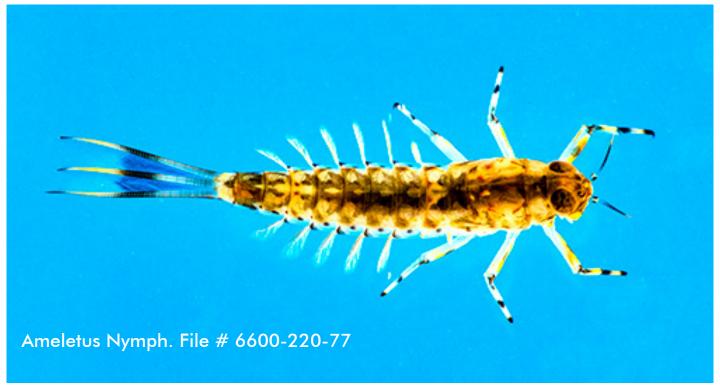
Early Instar Ameletus sp. Nymph 5/8 inch total length. The Martell Weir area has a decent population of these sensitive mayflies.

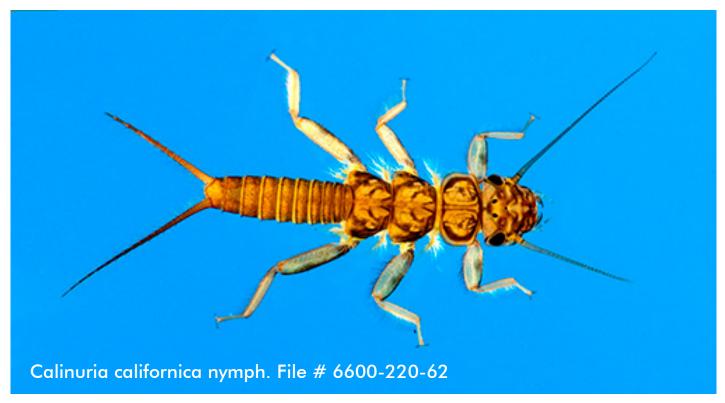
Calinuria californica nymph. 1/28/2019

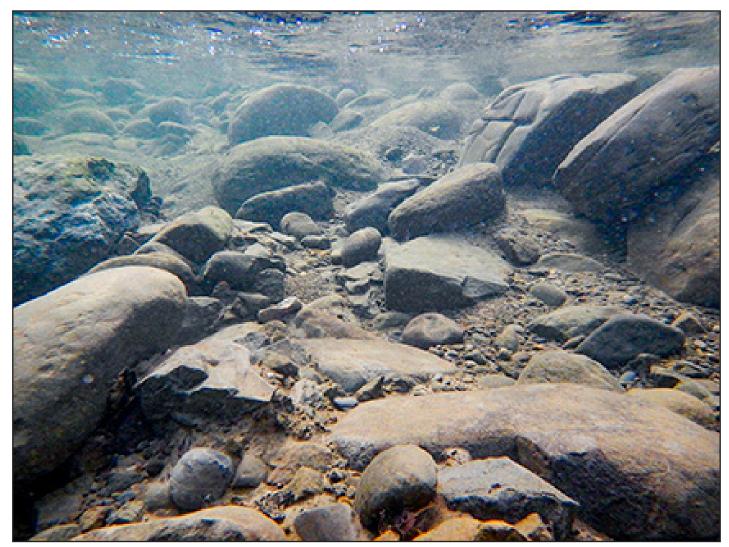
- 1. The weirs appear to be functioning as planned.
- 2. Cal Fire used the Weir Area as a crossing (October 2018). Some damage is evident.
- 3. The benthic cobble is already embedded. See image on page 4.

- 5. The water has just recently started flowing. Note the lack of algae on the subsurface image on page 4.
- 6. The benthic invertebrate population is lower than I expected, but considering the recent water flow, it is at a reasonable level. I took a complete collection of the BMI community.

Subsurface image in Martell Ranch weir area. The vast majority (85%) of the cobble are embedded which prevents benthic macroinvertebrates from feeding and seeking refuge in the interstitial spaces. 1/28/2019.
