Re: **Mertz Dam and Potential “New” Spawning Sections in Lower Putah Creek**

## REPORT 5478

### Lower Putah Creek

Mertz Dam & Exposed Gravelbeds

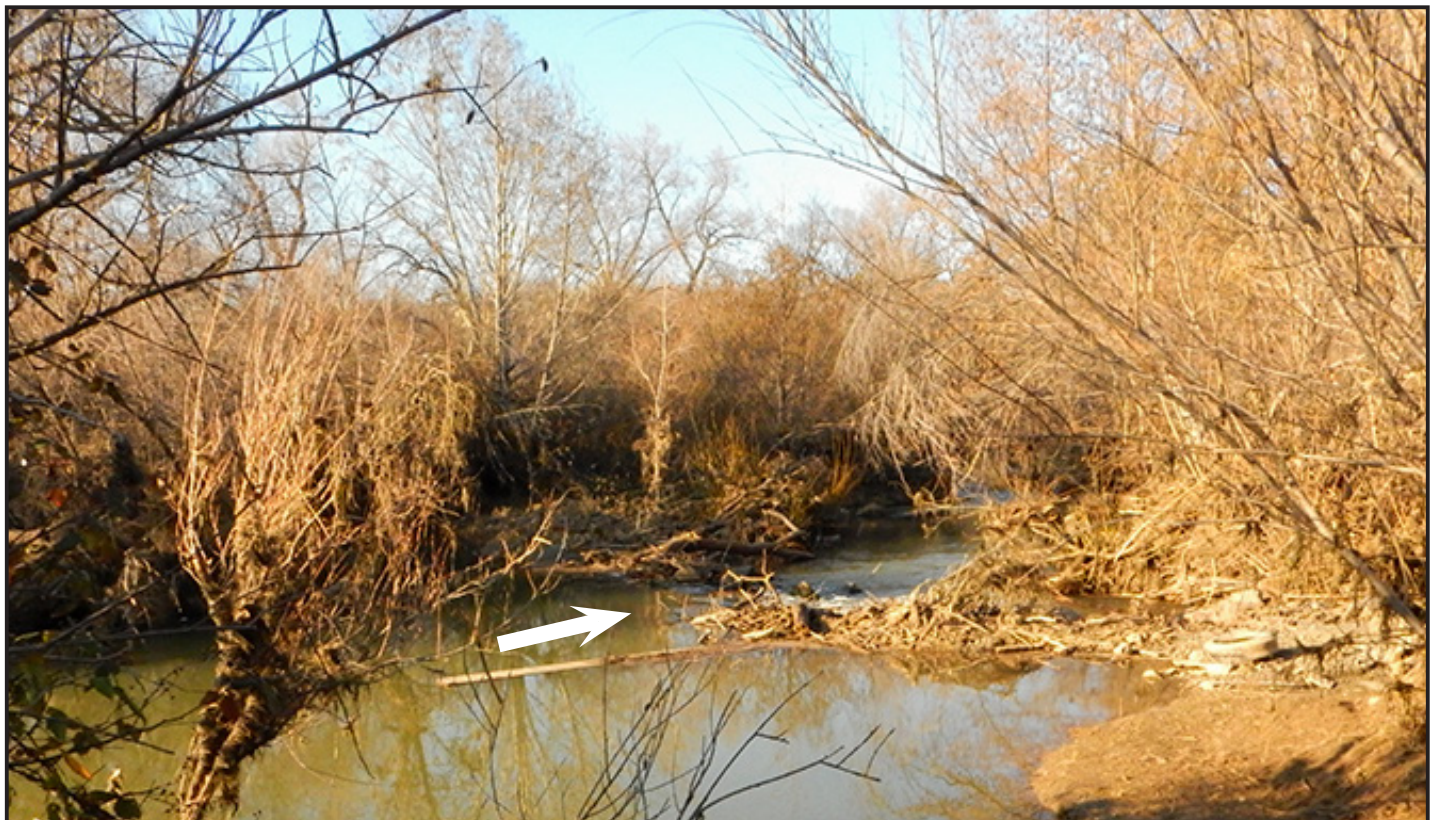
From a distance, the Mertz Dam appears to have been breached or “dismantled” by flood waters. The photos below (enlarged on Page 3) show that the Mertz Dam appears to be a collection of rip rap or other materials rather than one unified structure. A close examination by the CDFW might be warranted to document what appears to be a haphazard and degrading structure.

**Mertz Dam:** January 16, 2017 after a significant flood event. Arrow shows breached area of Mertz Dam

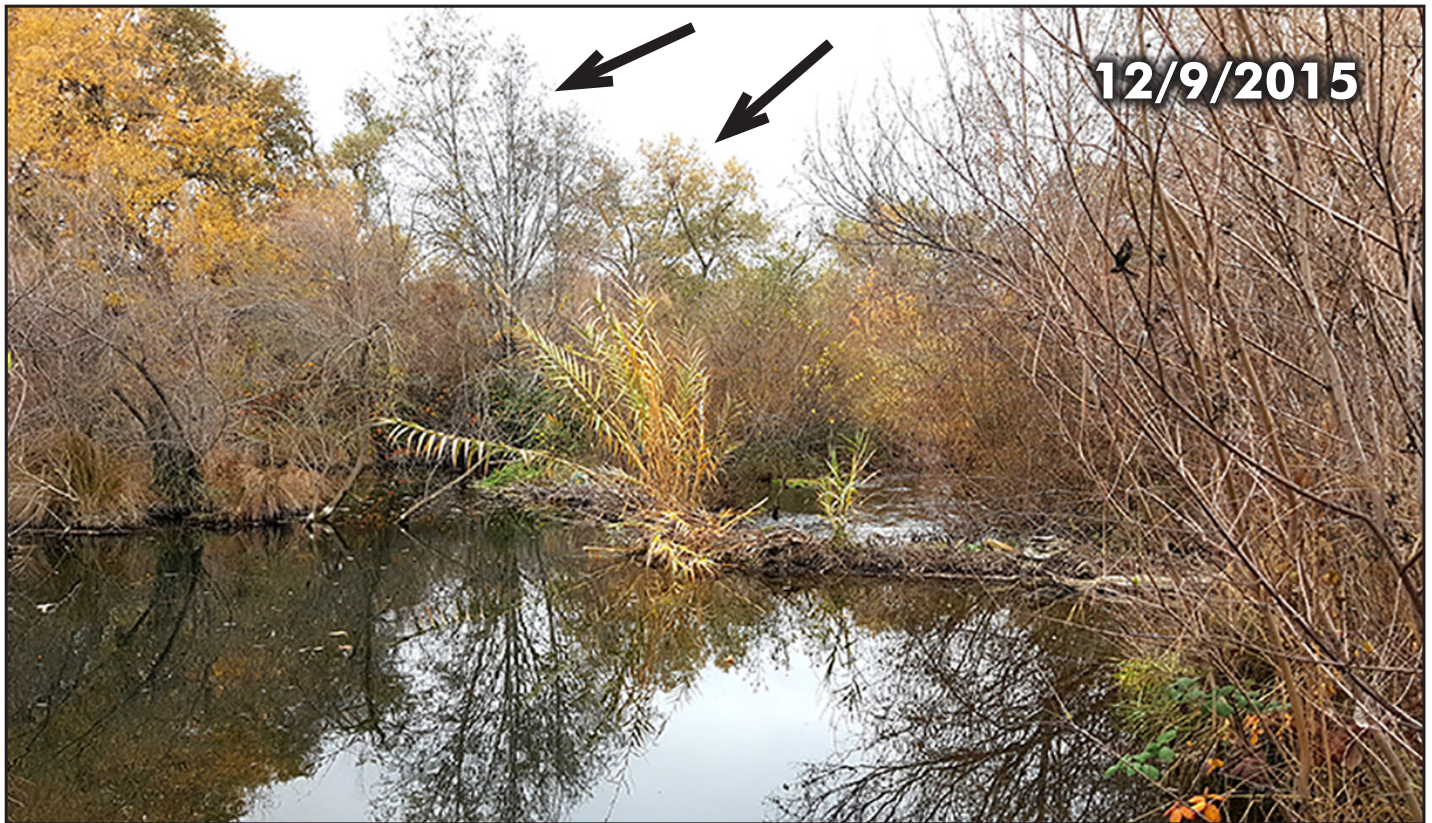
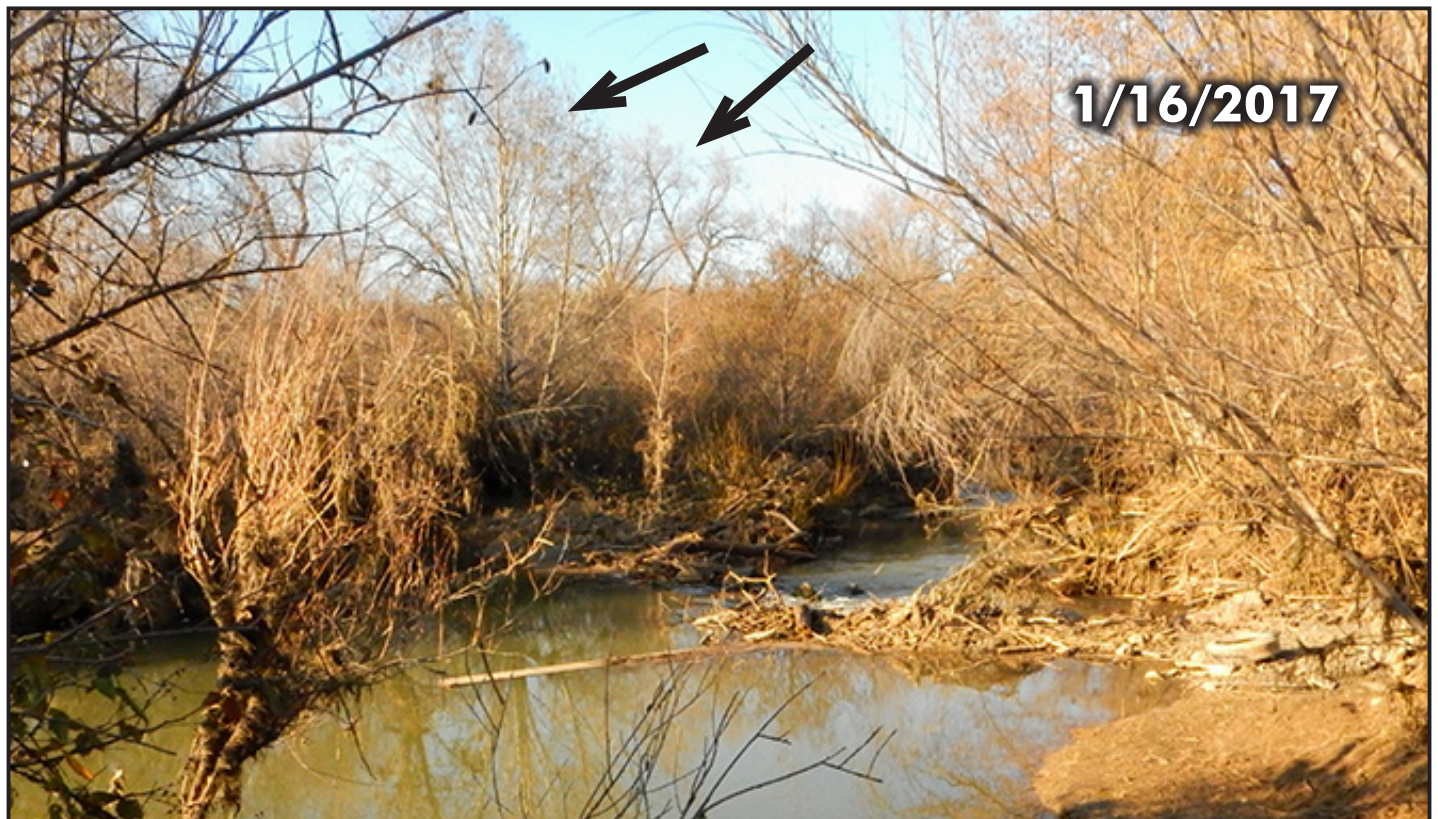
Mertz Dam: Additional images for scale and site identification. Top image was taken on 12/9/2015, the bottom image was taken on 1/16/2017. Use the trees in the background for site reference and location.

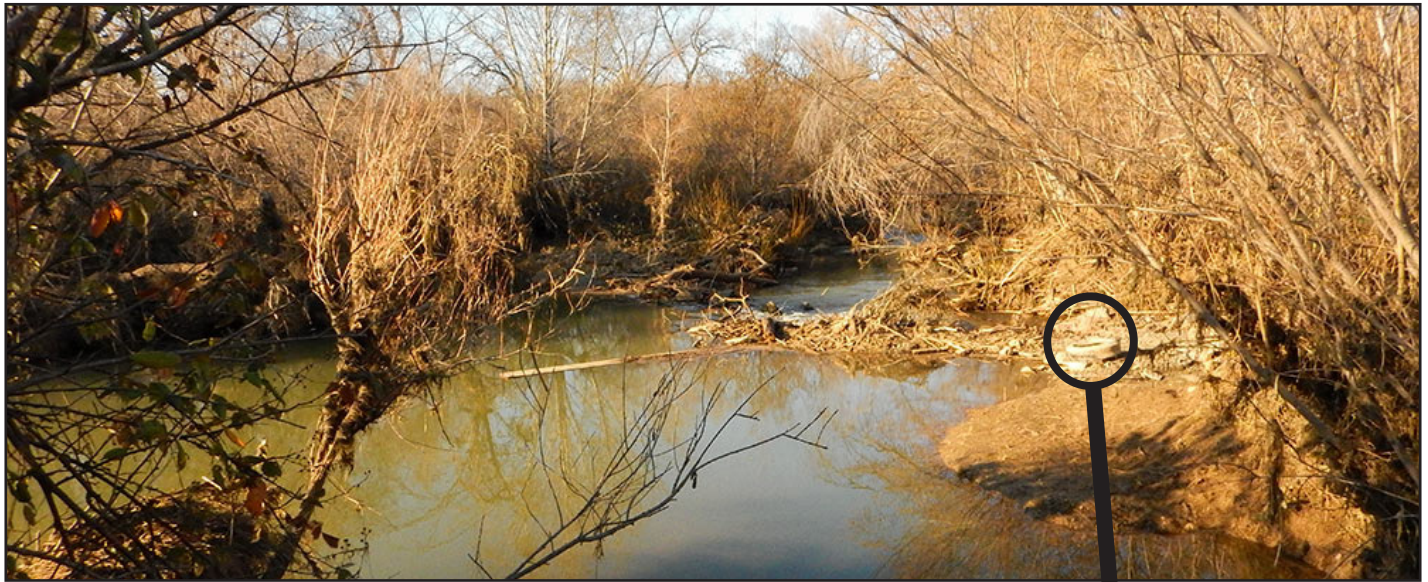
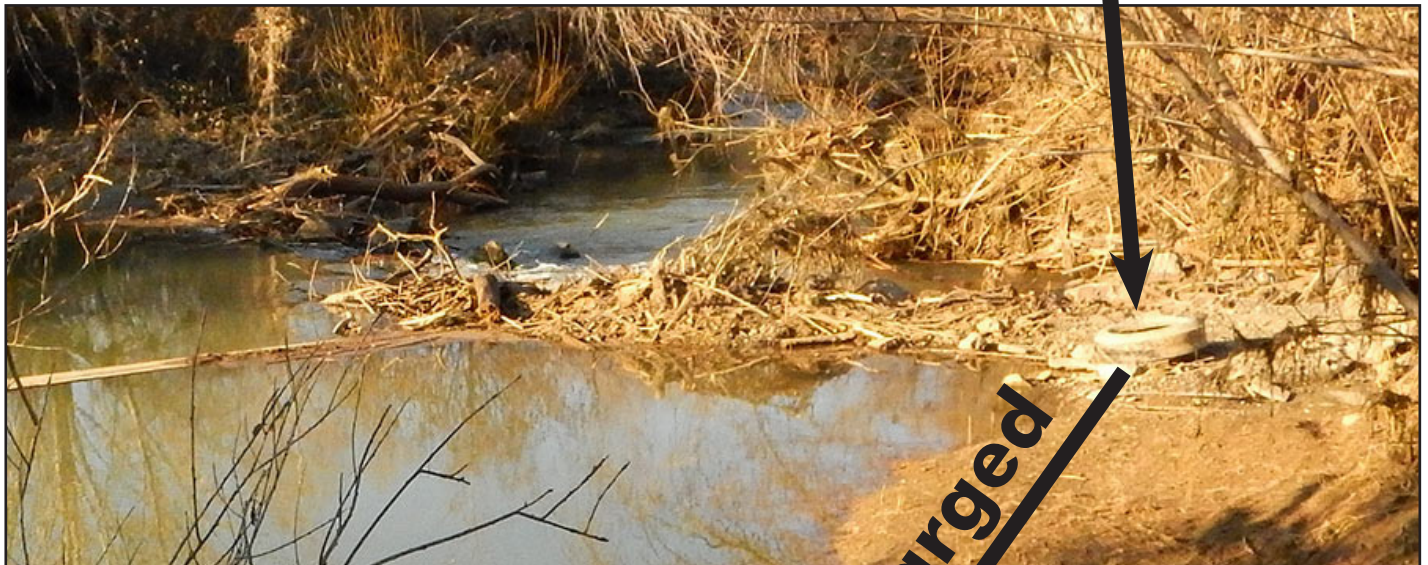
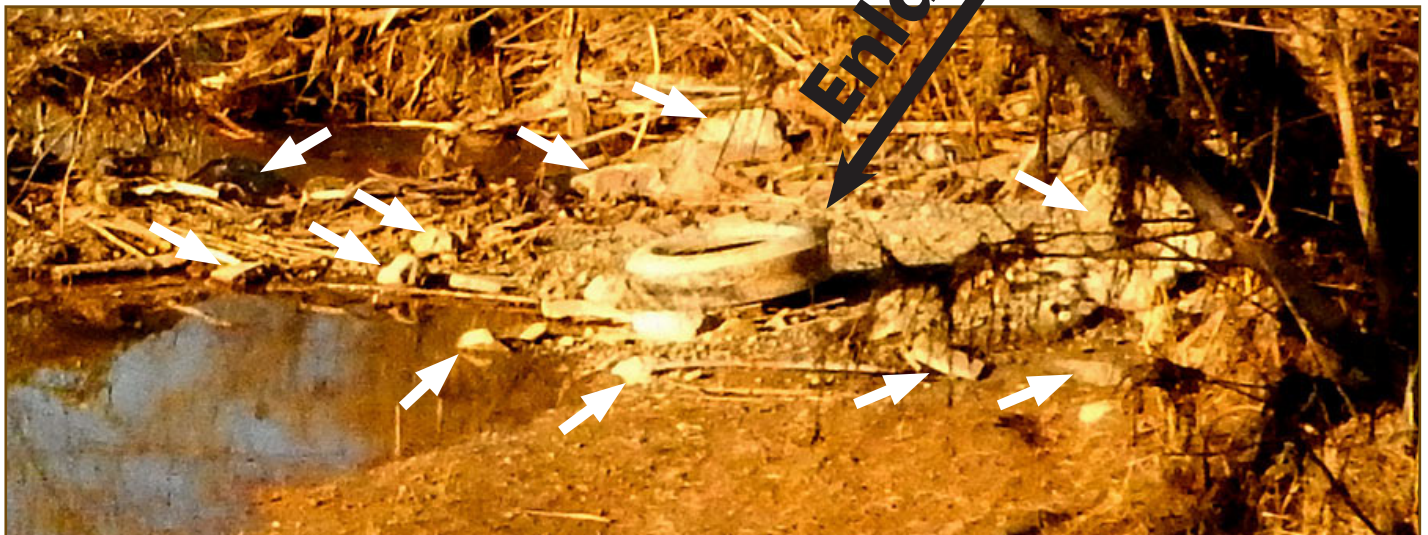
Close Up: Arrows point to a few of what appear to be Rip Rap or some sort of masonry rubble that form the dam. Closer examination must be completed to confirm identity of the materials.

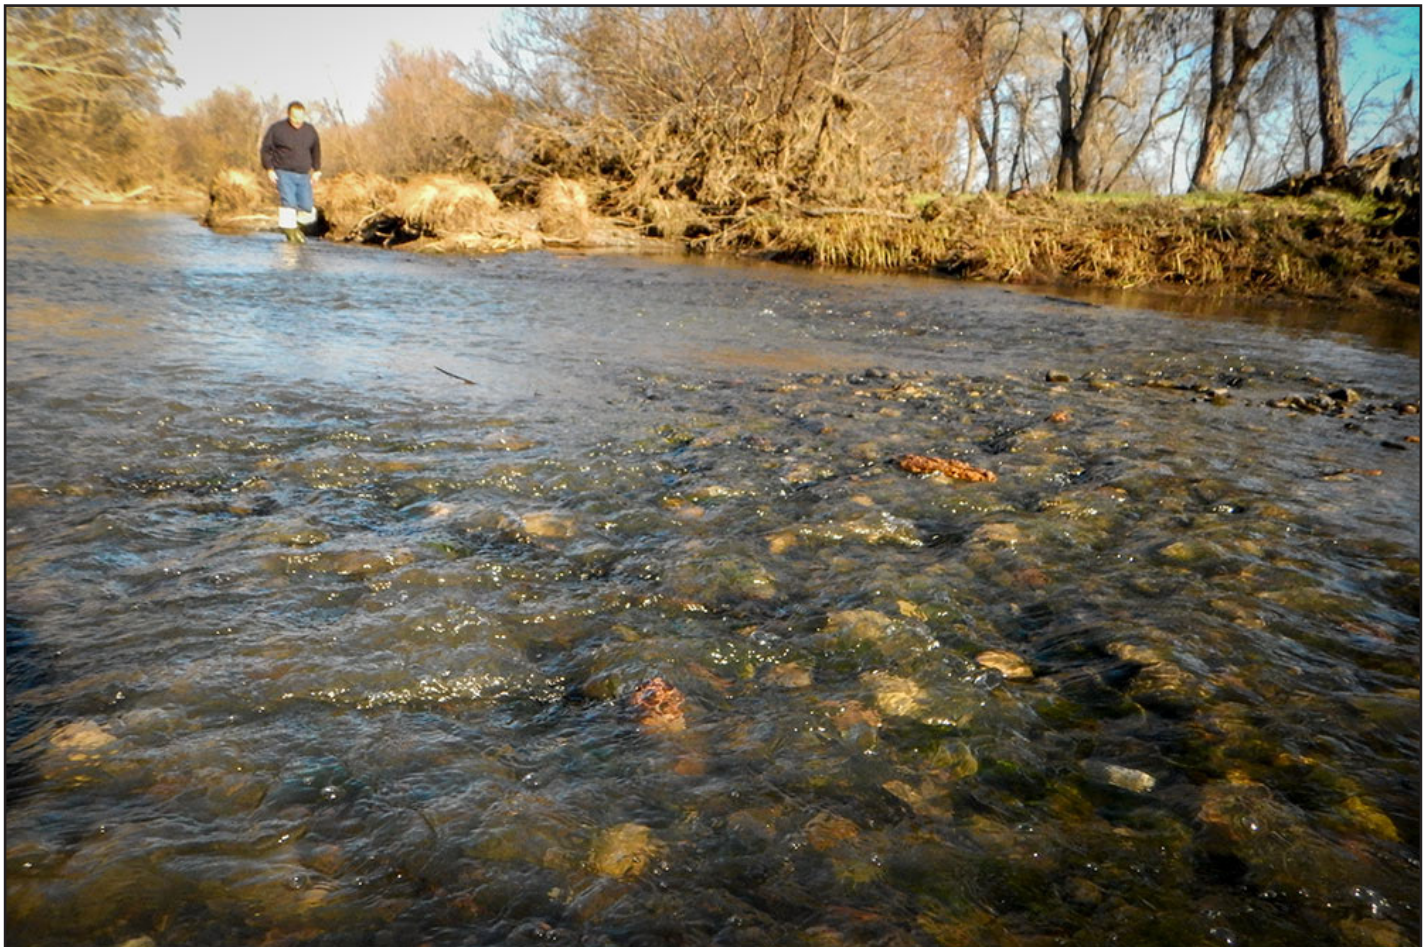
The lower water level in the Parker area - possibly due to the breach of the Mertz Dam - revealed gravelbeds that appear to be ideal for scarification and salmonid spawning. We examined two exposed gravel sections, each with an estimated 200-300 feet of creek length.

January 16, 2017 - Rick Fowler examining the upstream gravelbed (Parker #1). See map on Page 5.

**Conclusion:** It appears that if the water in the Parker section of Lower Putah Creek remains at this level, it would be prudent to consider the two Parker sites for scarification. Scarifying these gravelbeds has the potential to add 400 - 600 feet of prime spawning beds within the main salmonid spawning reach below Putah Diversion Dam.
