# MONTICELLO FIRE

## WATERSHED EROSION POTENTIAL ANALYSIS

**Prepared by Michael Hogan**  
**Integrated Environmental Restoration Services**  
**For the Solano County Water Agency**  
**May 27<sup>th</sup>, 2015**

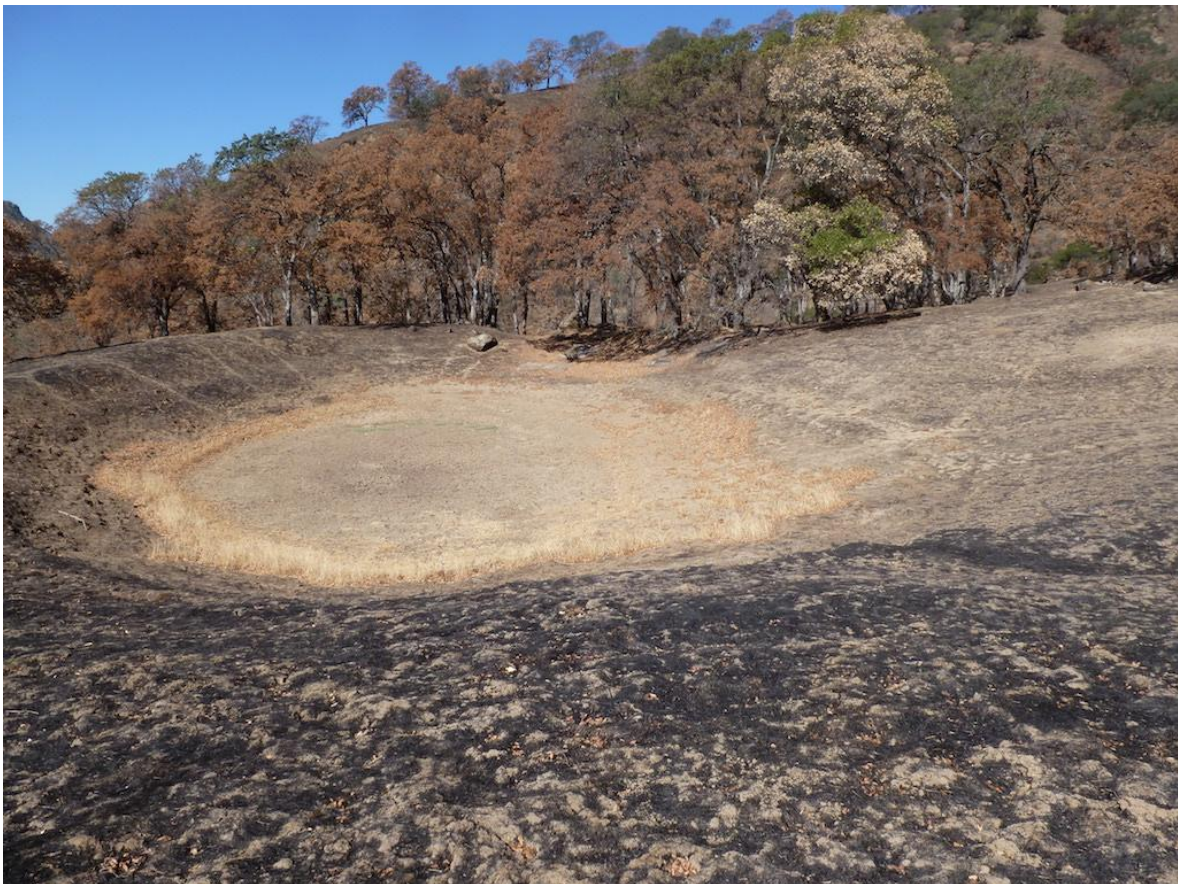
**FIGURE : THIS PHOTO CAPTURES A NUMBER OF ELEMENTS DESCRIBED IN THIS REPORT: 1) THE BLACK RESIDUE IS LIGHTLY BURNED SURFACE MULCH AND PLANT MATERIAL, SUGGESTING A LOW INTENSITY BURN; 2) THE VERY ROUGH SURFACE CAN BE SEEN THROUGHOUT THE PHOTO; 3) THE TREES IN THE BACKGROUND ARE ALL ALIVE, SOME RETAINING MOST OF THEIR GREEN LEAVES AND THE OTHERS CONTAINING RE-SPROUTING; 4) THE POND ITSELF WAS NOT BURNED AS IS INDICATED BY THE VEGETATION RING AROUND THE POND BOTTOM; 5) THERE ARE SEVERAL AREAS OF SURFACE VEGETATION RESPROUTING AND 6) THE POND ITSELF PROVIDES A CATCHMENT AREA IF HIGH AMOUNTS OF OVERLAND FLOW DO OCCUR IN THIS AREA.**

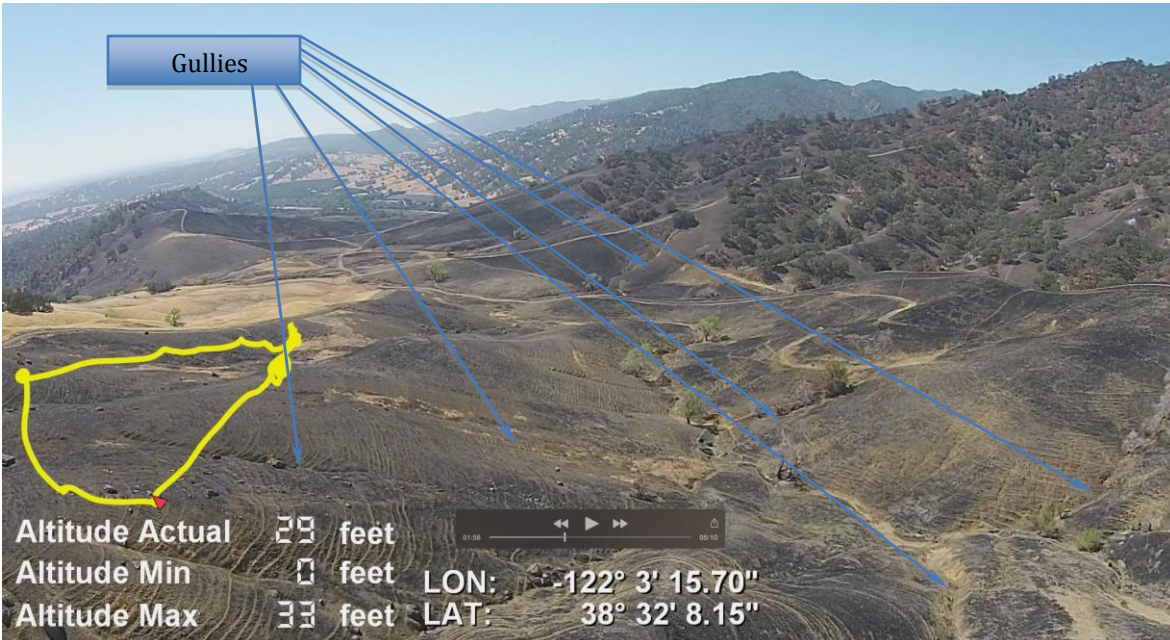
**FIGURE : THIS AERIAL VIEW OF THE FIRE AREA DEMONSTRATES A NUMBER OF FINDINGS FROM THE ASSESSMENT: A GREAT MANY EROSION SIGNATURES EXIST THAT WERE PRESENT PRE-FIRE (MANY RILLS AND GULLIES VISIBLE IN PHOTO); CATTLE TRACKS ARE CLEARLY PRESENT, INDICATING THE EXTENT OF CATTLE INFLUENCE; MOST OF THE TREES IN THIS PHOTO ARE SHOWING ROBUST RE-GROWTH AND THE DRAINAGE ITSELF UNDULATES SUCH THAT WATER TENDS TO BE SLOWED AND SEDIMENT DROPPED FROM THE WATER COLUMN BEFORE IT REACHES PUTAH CREEK. THE AERIAL SURVEY PROVIDES EXACT GPS COORDINATES, ELEVATION OF THE QUADRICOPTER AND A YELLOW TRACK SHOWING THE RELATIVE FLIGHT PATH DURING THIS PARTICULAR FLIGHT.**

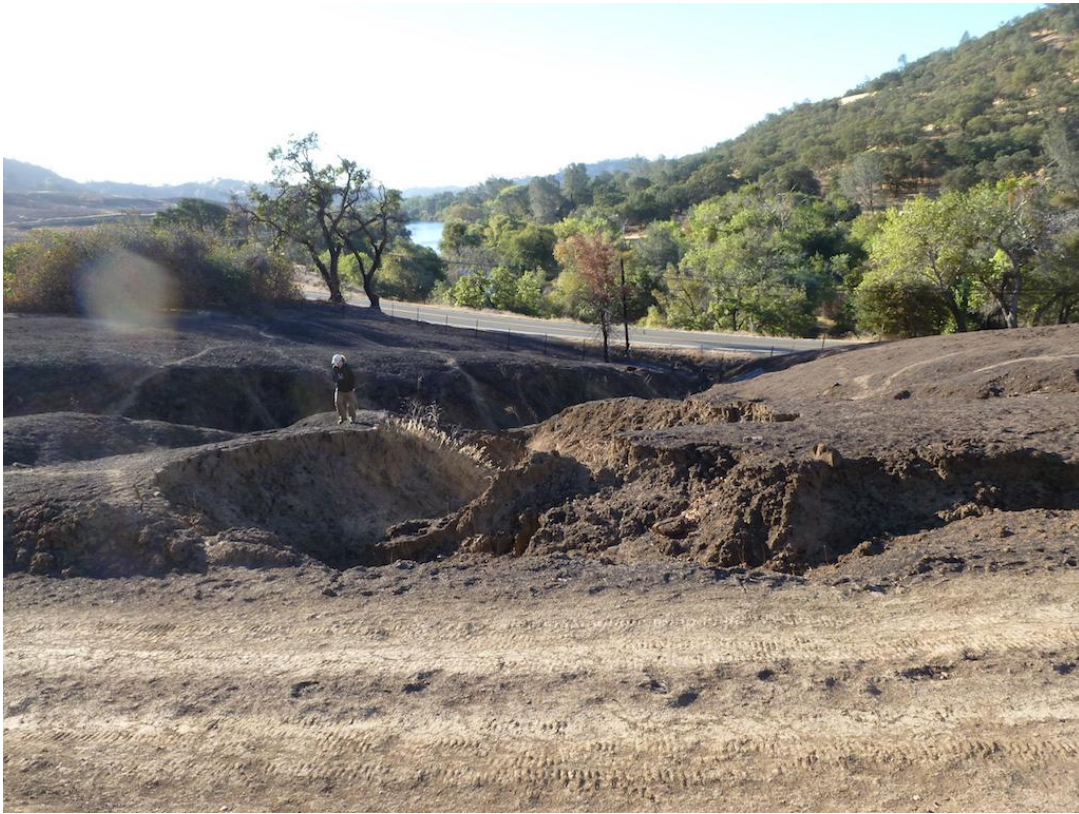
**FIGURE : EROSION HOT SPOT. THIS PHOTO SHOWS TWO CONTRIBUTING ELEMENTS: 1) THE ROAD IN THE FOREGROUND WHICH CONCENTRATES WATER IN LOW SPOTS AND 2) HIGHWAY 128 IN THE BACKGROUND WHICH CUTS INTO THE UPSLOPE AREA CREATING A STEEP GRADIENT AND RESULTING HEADCUT WHICH HAS MIGRATED UPSLOPE TO THE DIRT ROAD.**

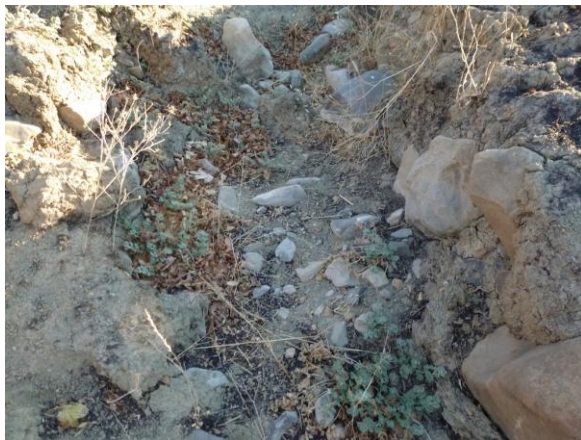
**FIGURE : BURNED AREAS SHOWING RESPROUTING**

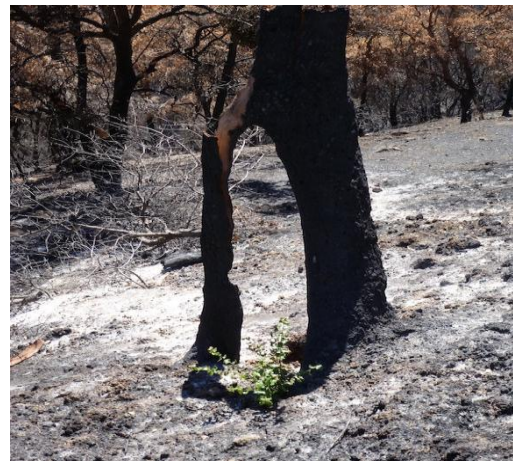
**FIGURE : EVEN WHERE AN OAK WAS COMPLETELY KILLED, A RE-SPROUT WAS PRESENT.**

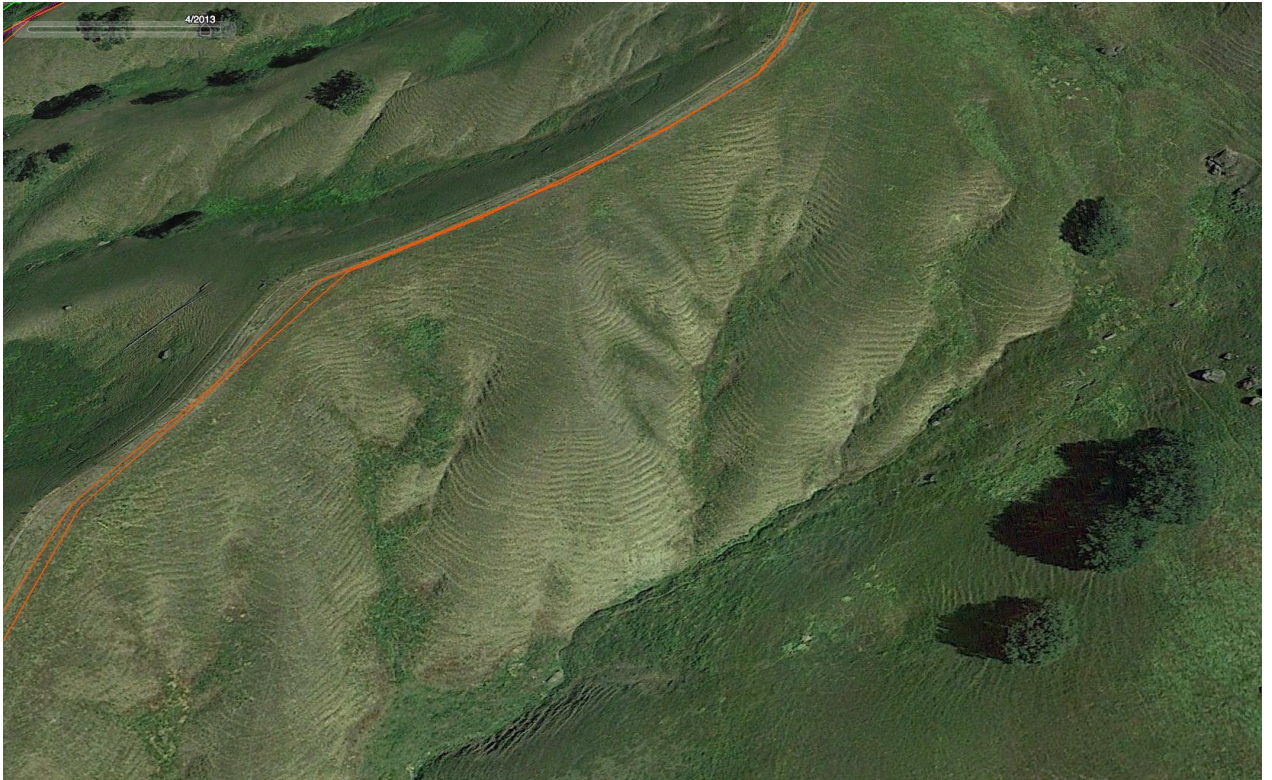
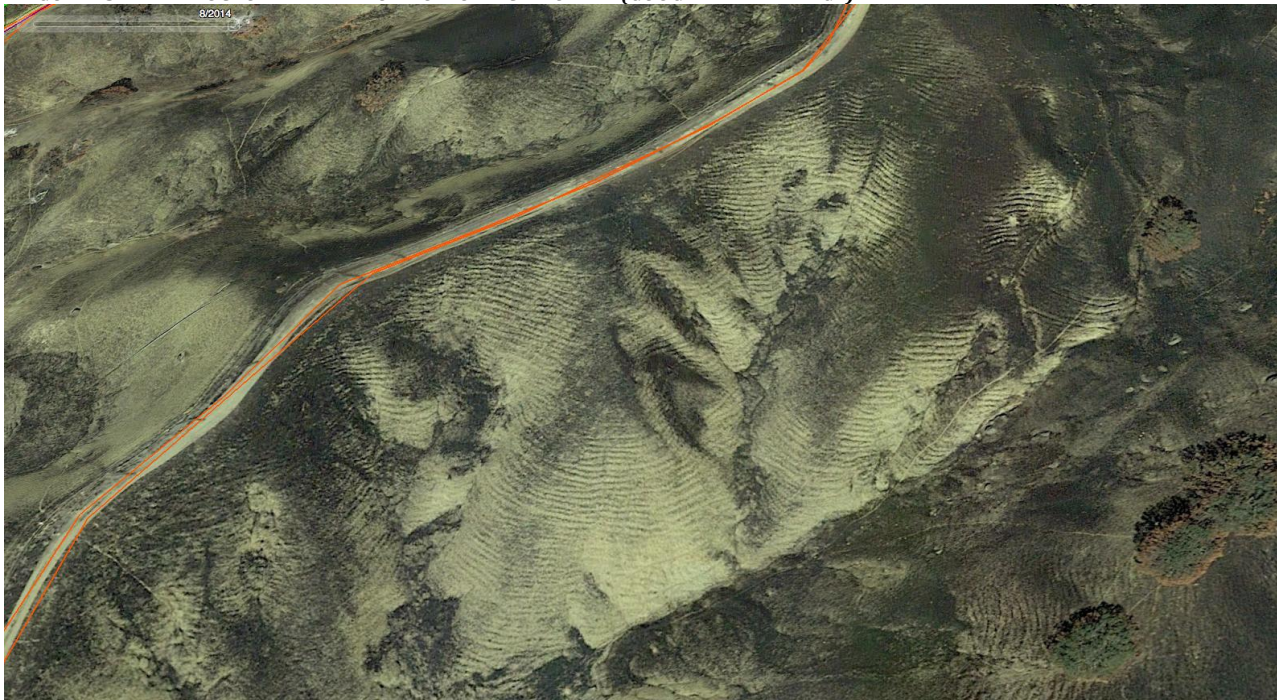
**FIGURE : SITE IN PROCTOR DRAW PRIOR TO MONTICELLO FIRE (GOOGLE EARTH IMAGE)**

**FIGURE : SAME SITE IN PROCTOR DRAW FOLLOWING MONTICELLO FIRE (GOOGLE EARTH IMAGE)**  
 THESE IMAGES SHOW HOW AREAS THAT WERE LIGHTLY VEGETATED BEFORE THE FIRE SHOWED LITTLE IMPACT FROM THE FIRE. AREAS THAT WERE MORE DENSELY VEGETATED SHOWED MORE CHARRED MATERIAL. NOTE THE LIGHTLY SINGED TREES IN THE BOTTOM RIGHT OF THE IMAGE AS WELL AS THE GREENING OF SOME AREAS.

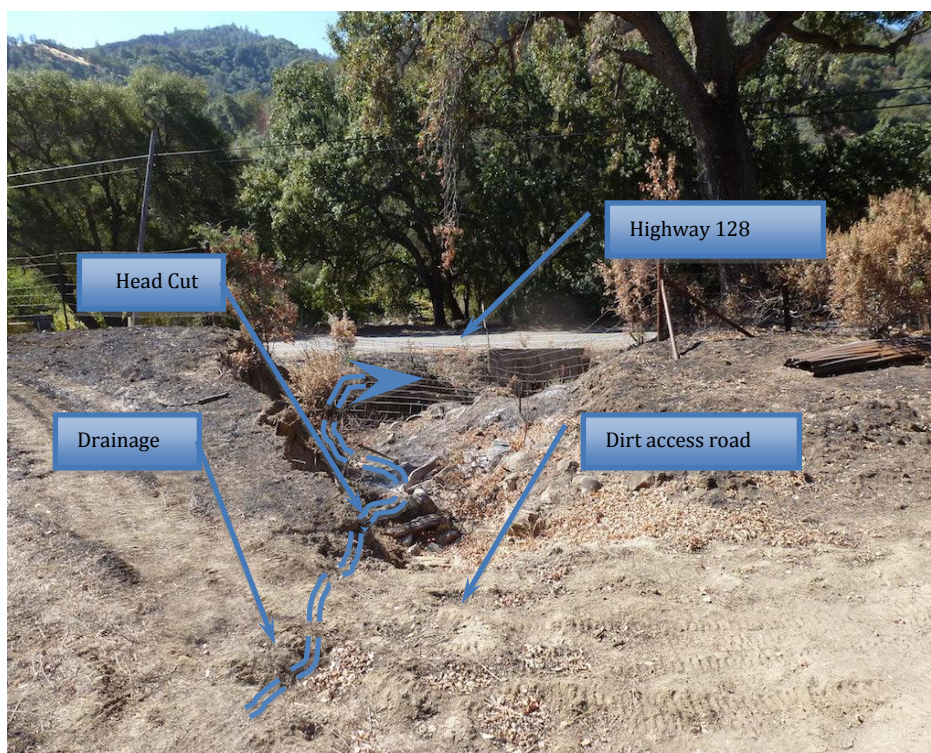
Figure 16 below, shows a typical hot spot that is partially the result of a lack of a road management strategy. That is, roads are bulldozed throughout the Bobcat Ranch and in Thompson Canyon with little to no regard for impact on water quality. With a small amount of effort and an effective management plan, this situation can be addressed and vastly improved. However, Bobcat Ranch and Thompson Canyon are used and impacted by a number of users beyond the landowners and managers including PG&E and fire crews who are likely creating the bulk of the issues. Thus, any solution will require cooperation by the various impacting entities.

**FIGURE : HEADCUT DUE TO THE GRADIENT DIFFERENTIAL CAUSED BY THE HIGHWAY 128 ROADCUT. THIS CONDITION, AS WITH THE MAJORITY OF EROSION ISSUES, EXISTED PRE-FIRE. THESE AREAS POSE A VERY HIGH RISK OF WATER QUALITY DEGRADATION IN PUTAH CREEK DUE TO THE INSTABILITY OF THE SITE AND ITS PROXIMITY TO PUTAH CREEK. WHICH IS JUST BEYOND THE OAKS IN THE MIDDLE OF THE PHOTO.**

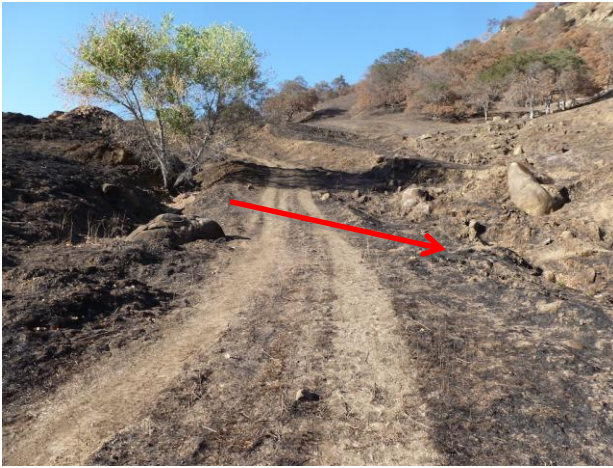
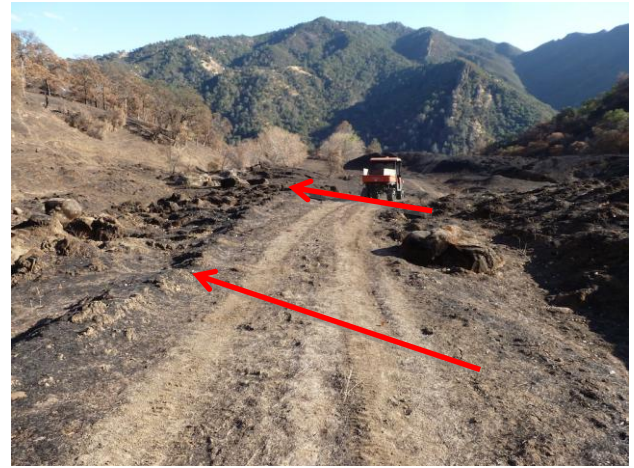
### PRIORITY SITE 130

*Figure T-130.1 looking upslope*

*Figure T-130.2 looking downslope*

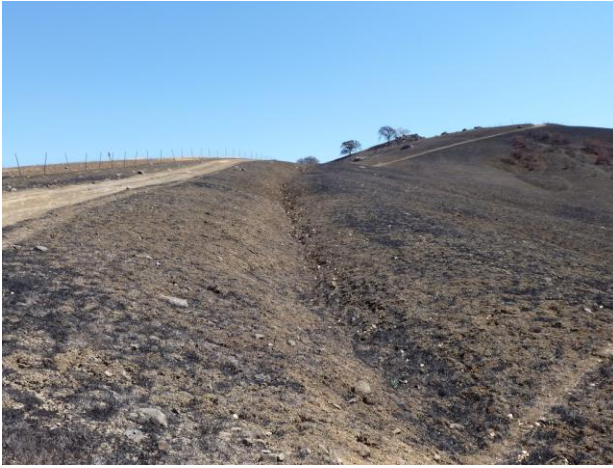
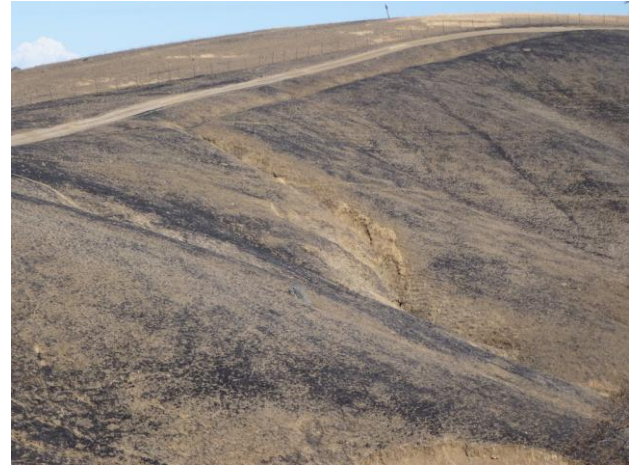
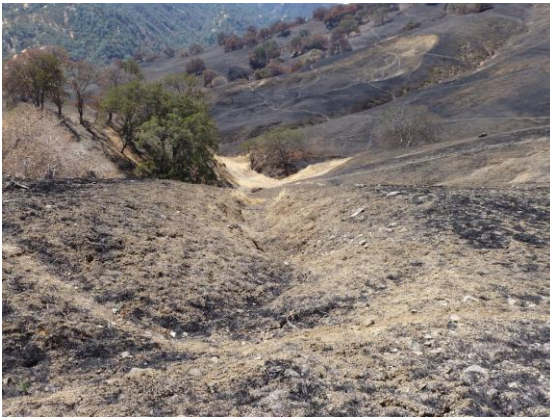
## PRIORITY SITE 140

*Figure T-140.1: looking upslope along roadside ditch*

*Figure T-140.2: roadside ditch into drainage diversion.*

*Figure T-140.3: downslope ditch*

- Rock for downslope ditch (20 yds. 18-24" angular)

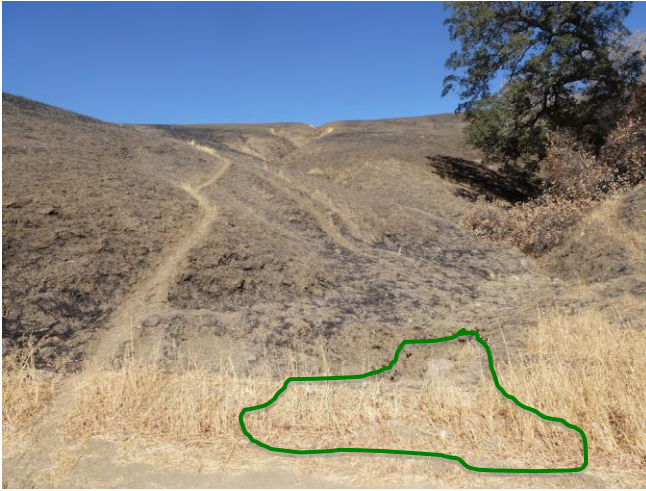
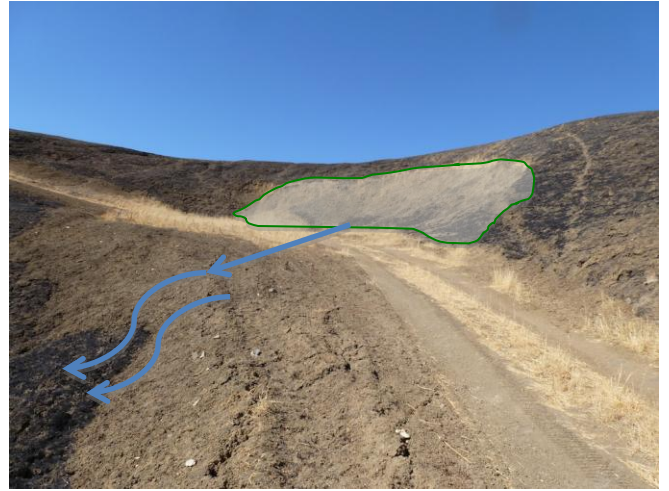
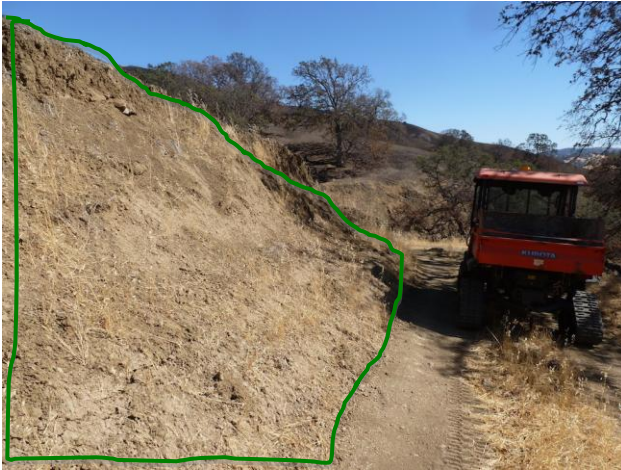
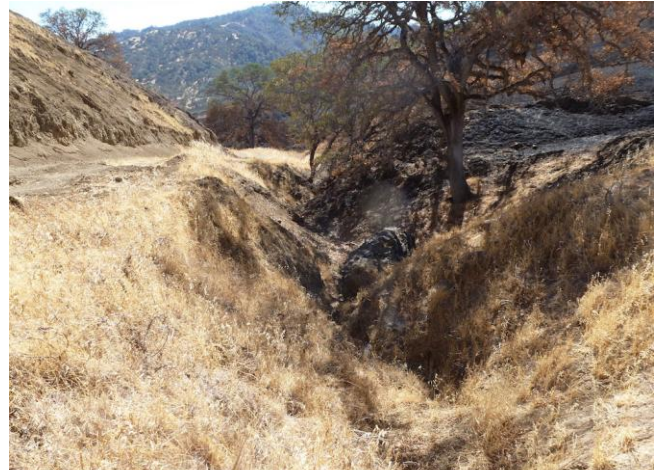
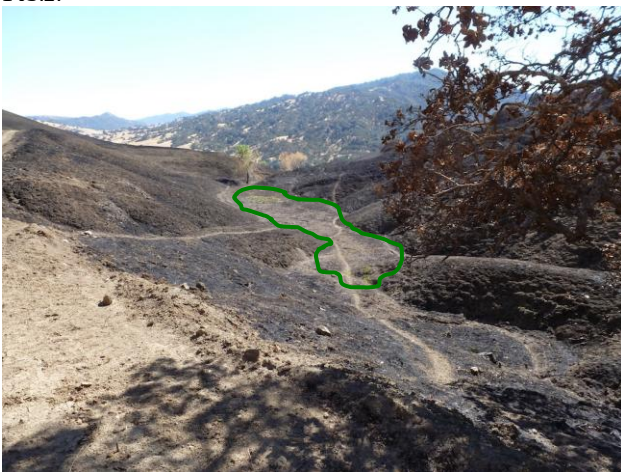
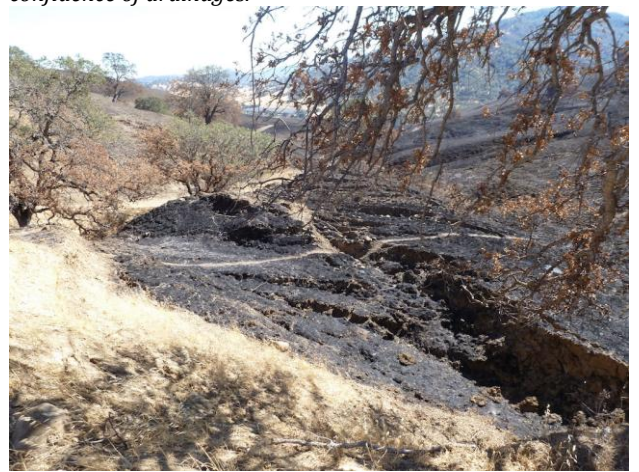
### PRIORITY SITE 143

Figure T-143.1: downslope side of site 140.

Figure T-143.2: ongoing erosion area.

Figure T-143.3: eroding cutslope just downslope from Figure T-143.2.

Figure T-143.4: deep cut just to west of Figure T-143.3 caused by confluence of drainages.

Figure T-143.5: area downslope from previous photos showing sediment accumulation in low area.

Figure T-143.6: photo taken downslope from Figure T-143-3 showing gullies from road, just out of sight on left, leading into highly eroding drainageway.

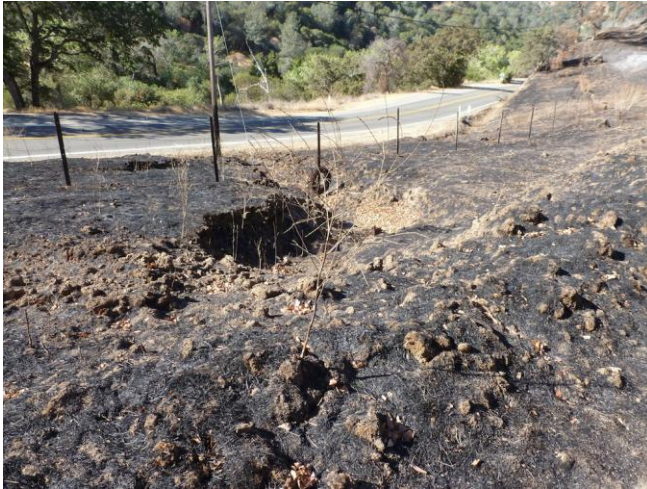
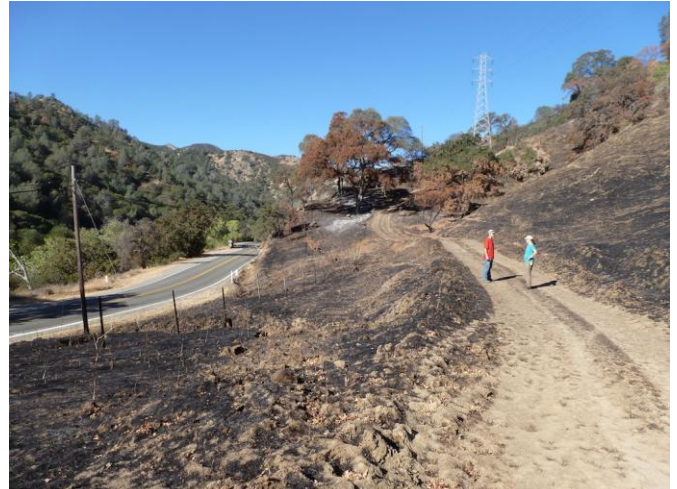
## PRIORITY SITE 149

*Figure T-149.1: Site 149 typical of headcutting between Bobcat Ranch and Highway 128. Putah Creek is just beyond the trees in the background.*

*Figure T-149.2: This access road is typical of access roads that are adjacent to Highway 128 that capture and focus water onto the slope between the dirt road and Highway 128. Eventually contributing to the issue seen in Figure T-149.1.*

- 8 hours
- Mini or midi ex
- Soil amendment (20 yds. aged wood chips)
- Seed (20#)
- Mulch (10 yds. wood chip or pine needle mulch)

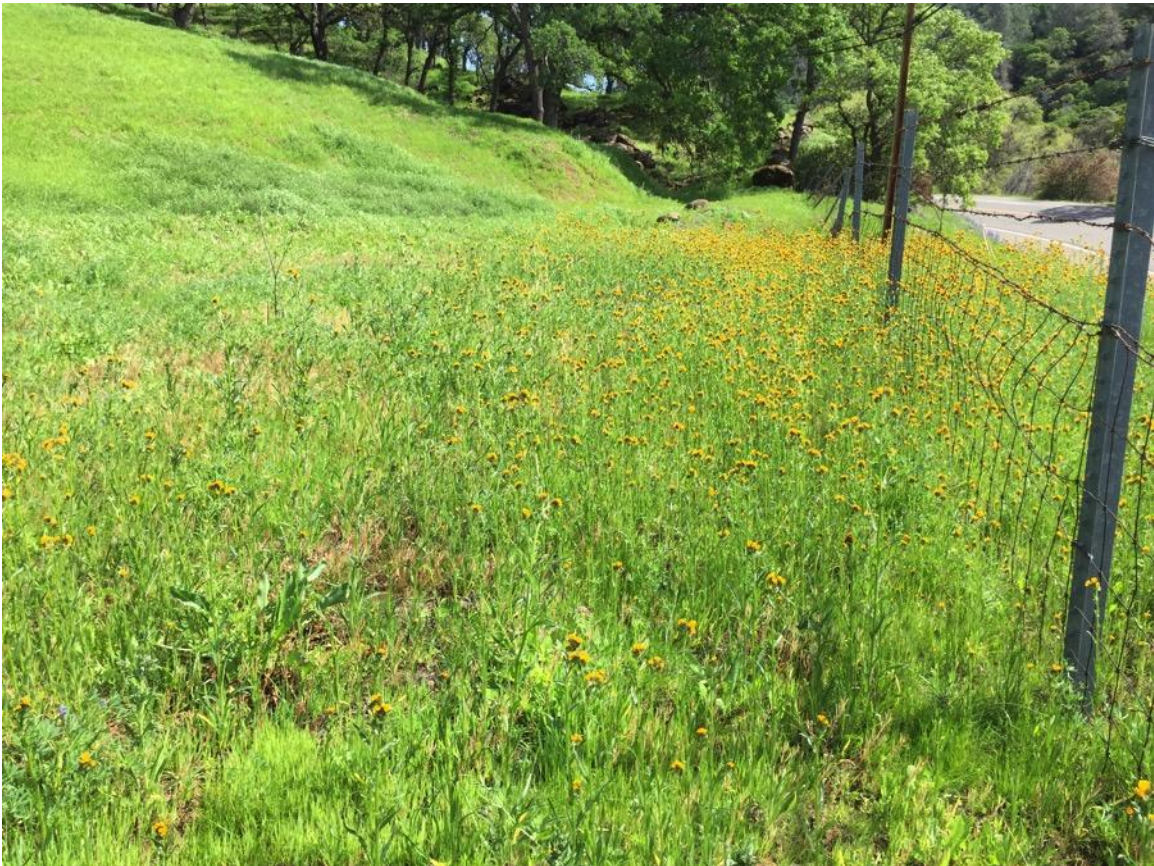
***FIGURE D-4. WILDFLOWERS, FORBS AND GRASSES COVERING AN ABANDONED ROAD NEAR HIGHWAY 128.***

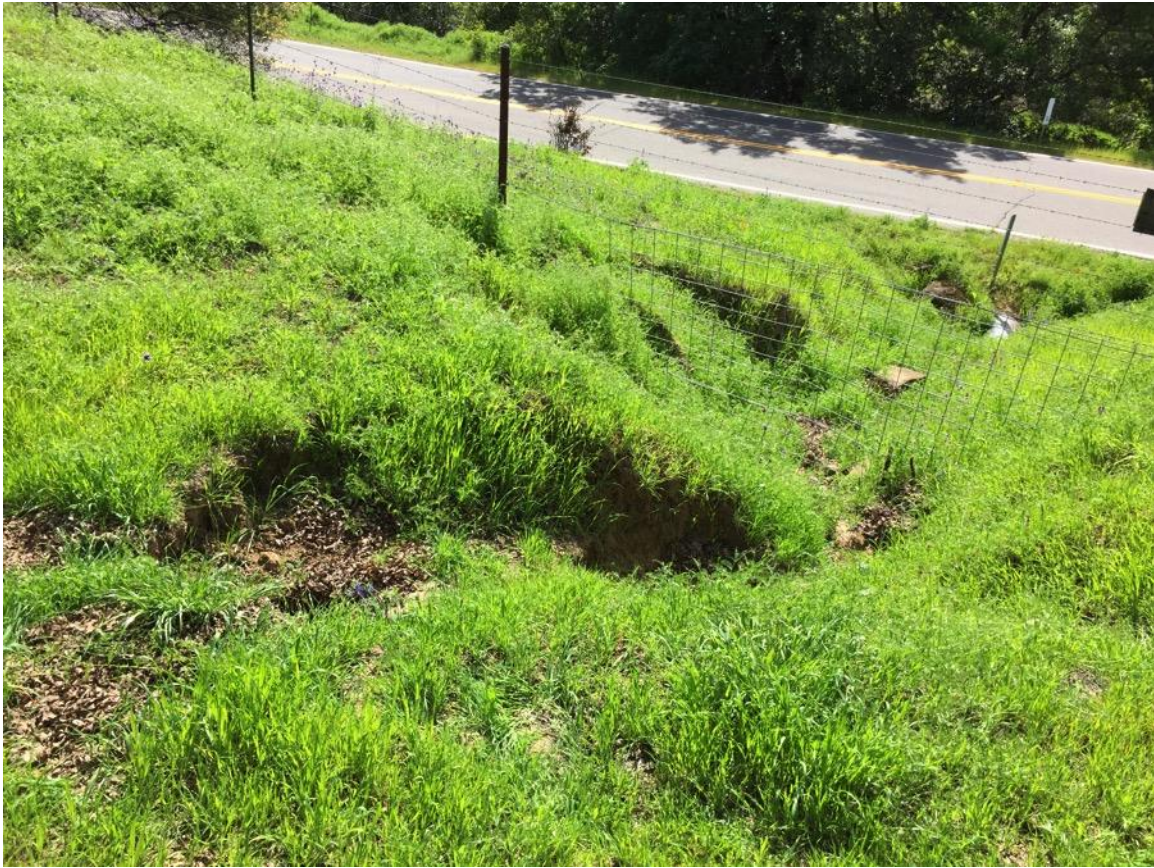
**FIGURE D-5 GRASSES ALMOST COMPLETELY COVER AN ERODING DRAINAGEWAY, ONE OF THE WATCH/PRIORITY SITES ABOVE HIGHWAY 128.**
