Watershed Emergency Response Team Evaluation
LNU LIGHTNING COMPLEX
HENNESSEY FIRE

CA-LNU-013407

October 8, 2020

LNU LIGHTNING COMPLEX (HENNESSEY FIRE)
Watershed Emergency Response Team EVALUATION
October 8, 2020

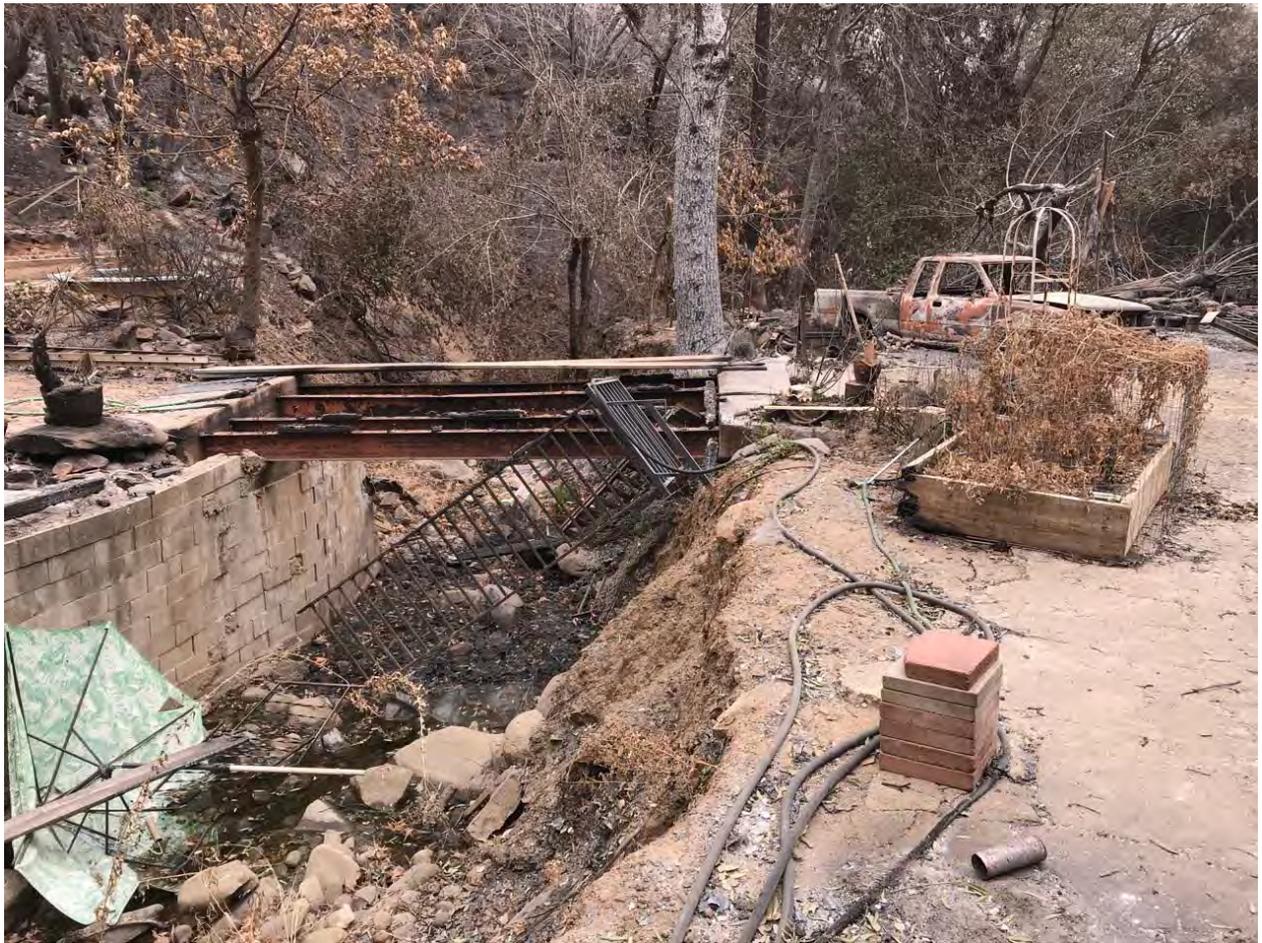
Photograph E01: Burned residence and pad across Gates Canyon (VAR 24).

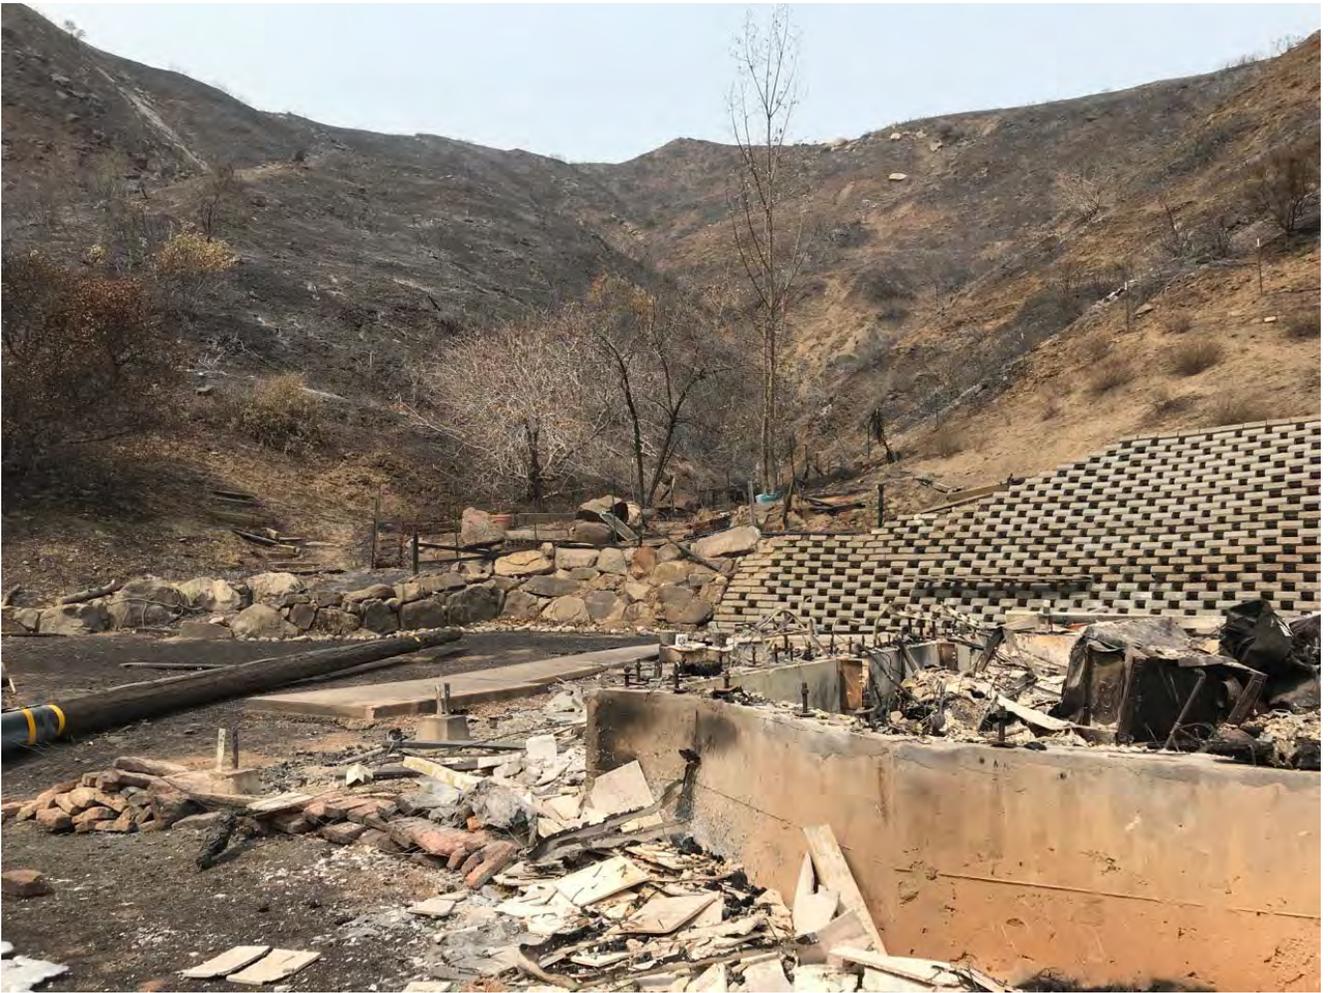
Photograph E02: Burned residence at the mouth of a steep channel (VAR 15).

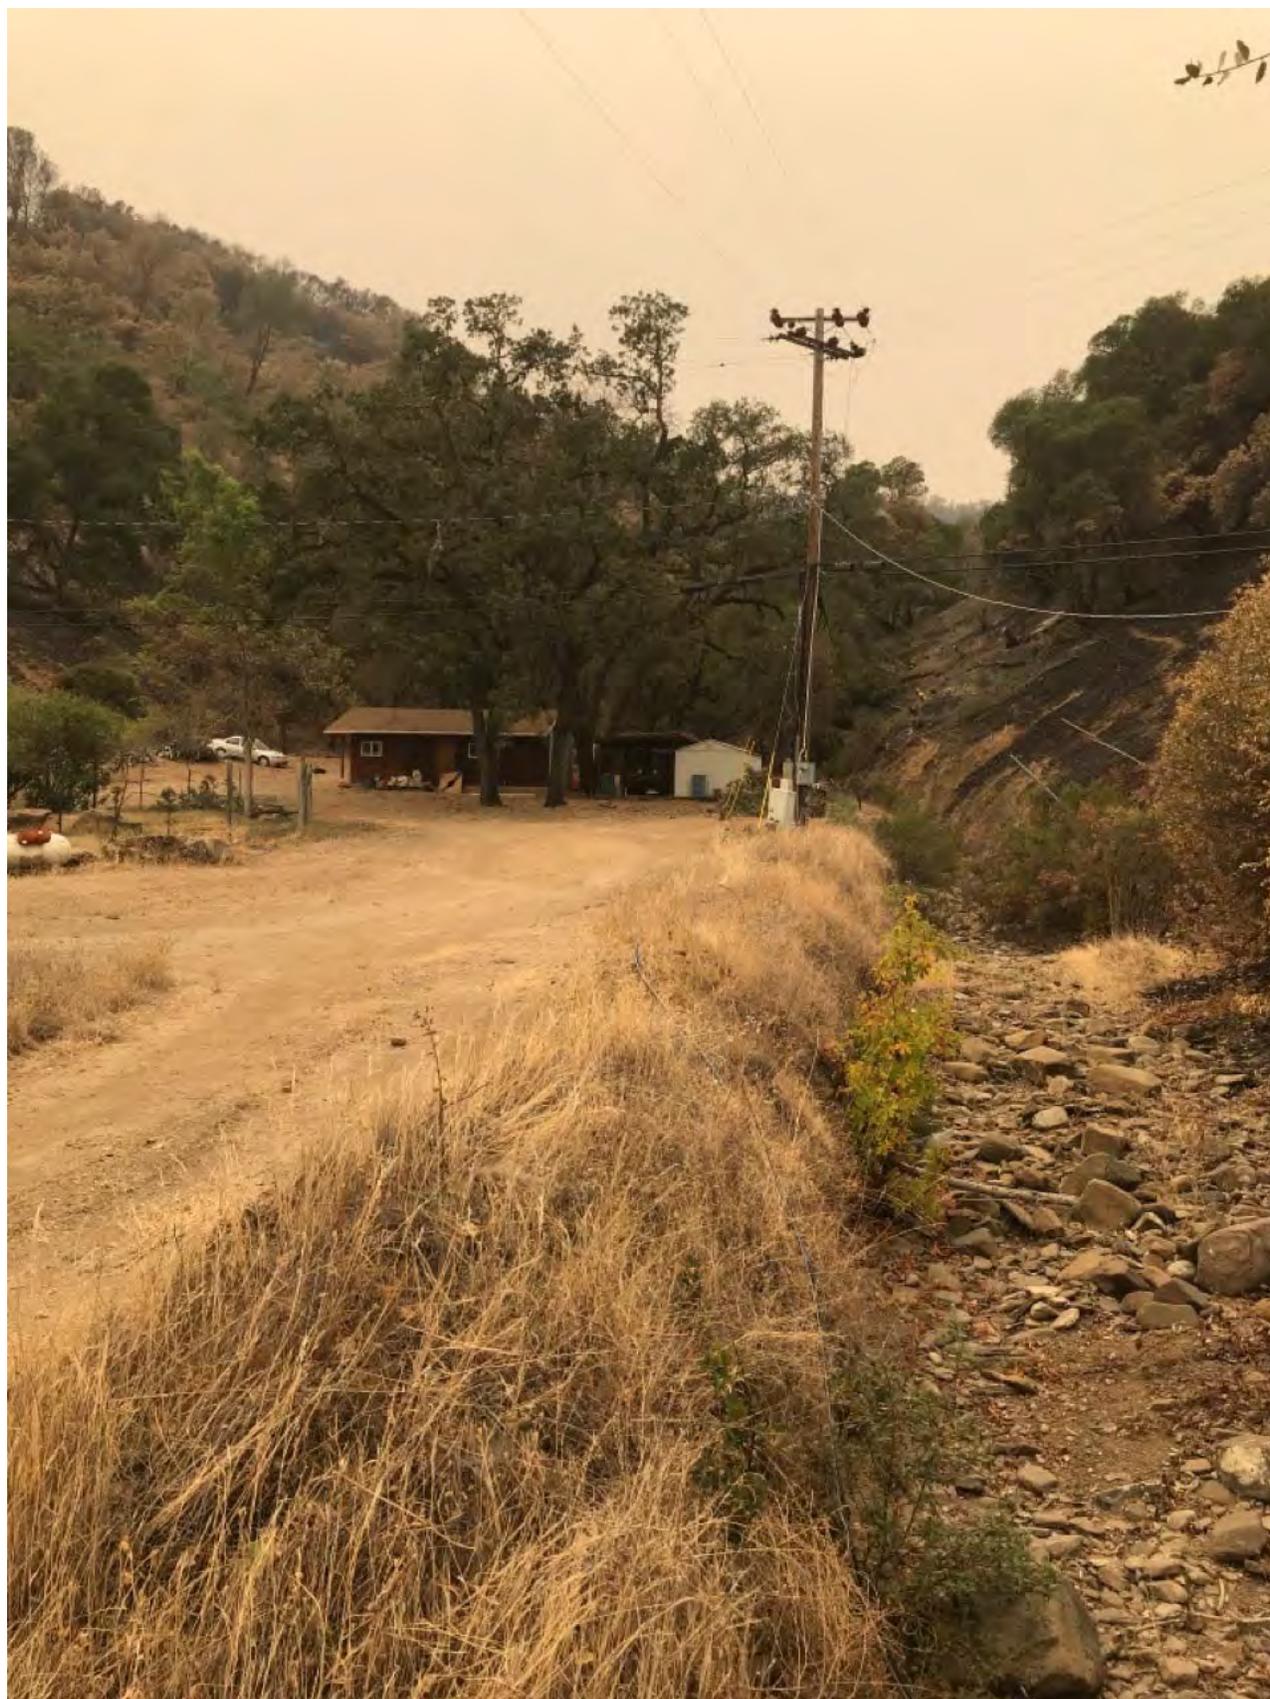
Photograph E03: Unburned residence at mouth of a steep channel (VAR 62).

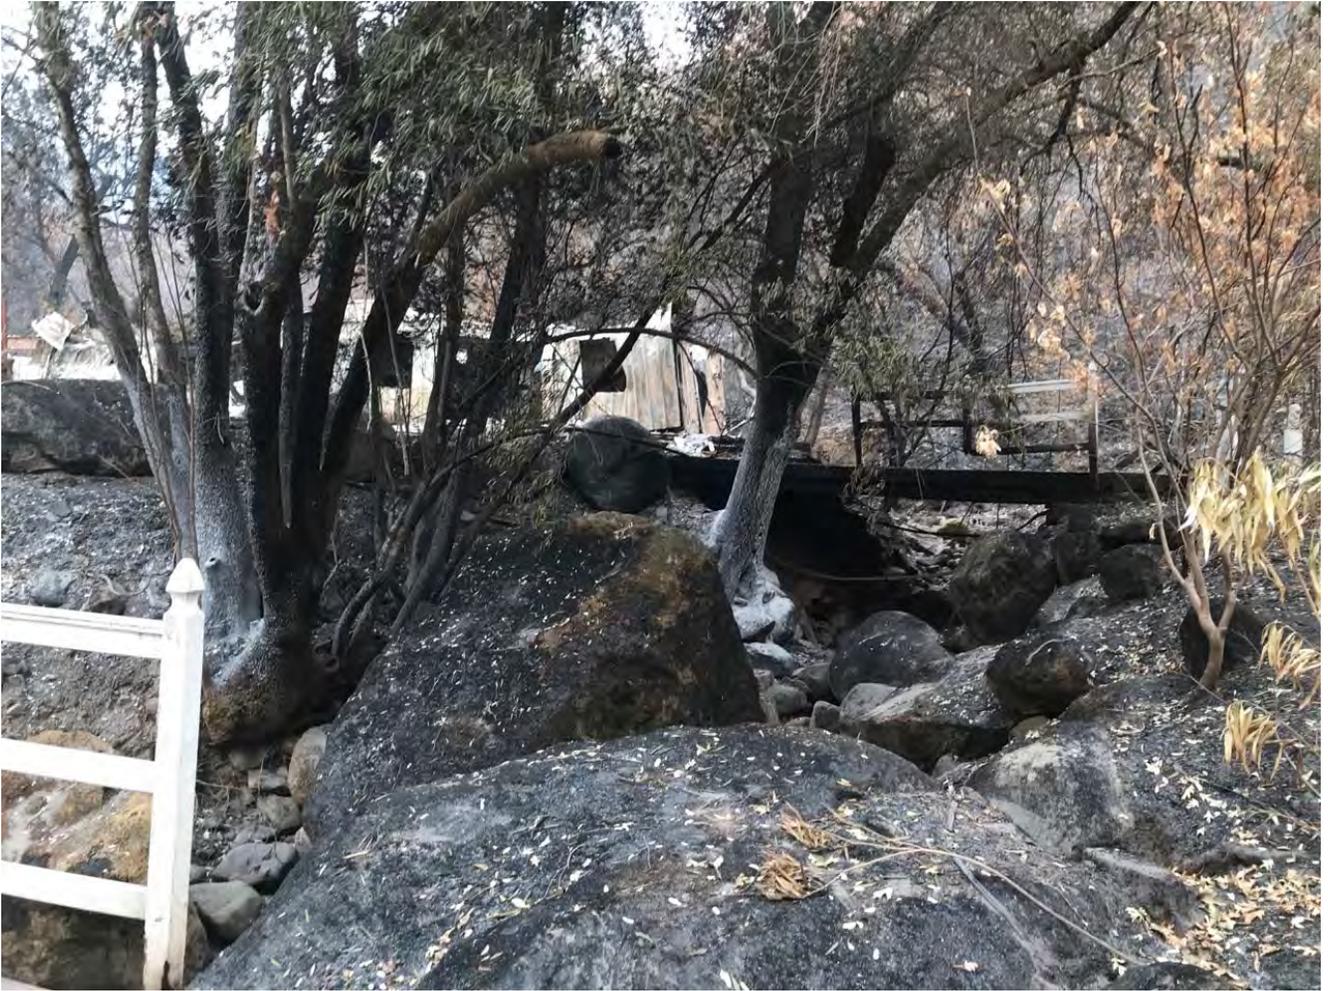
Photograph E04: Burned residence within a steep channel (VAR 59). The channel is diverted around the house.

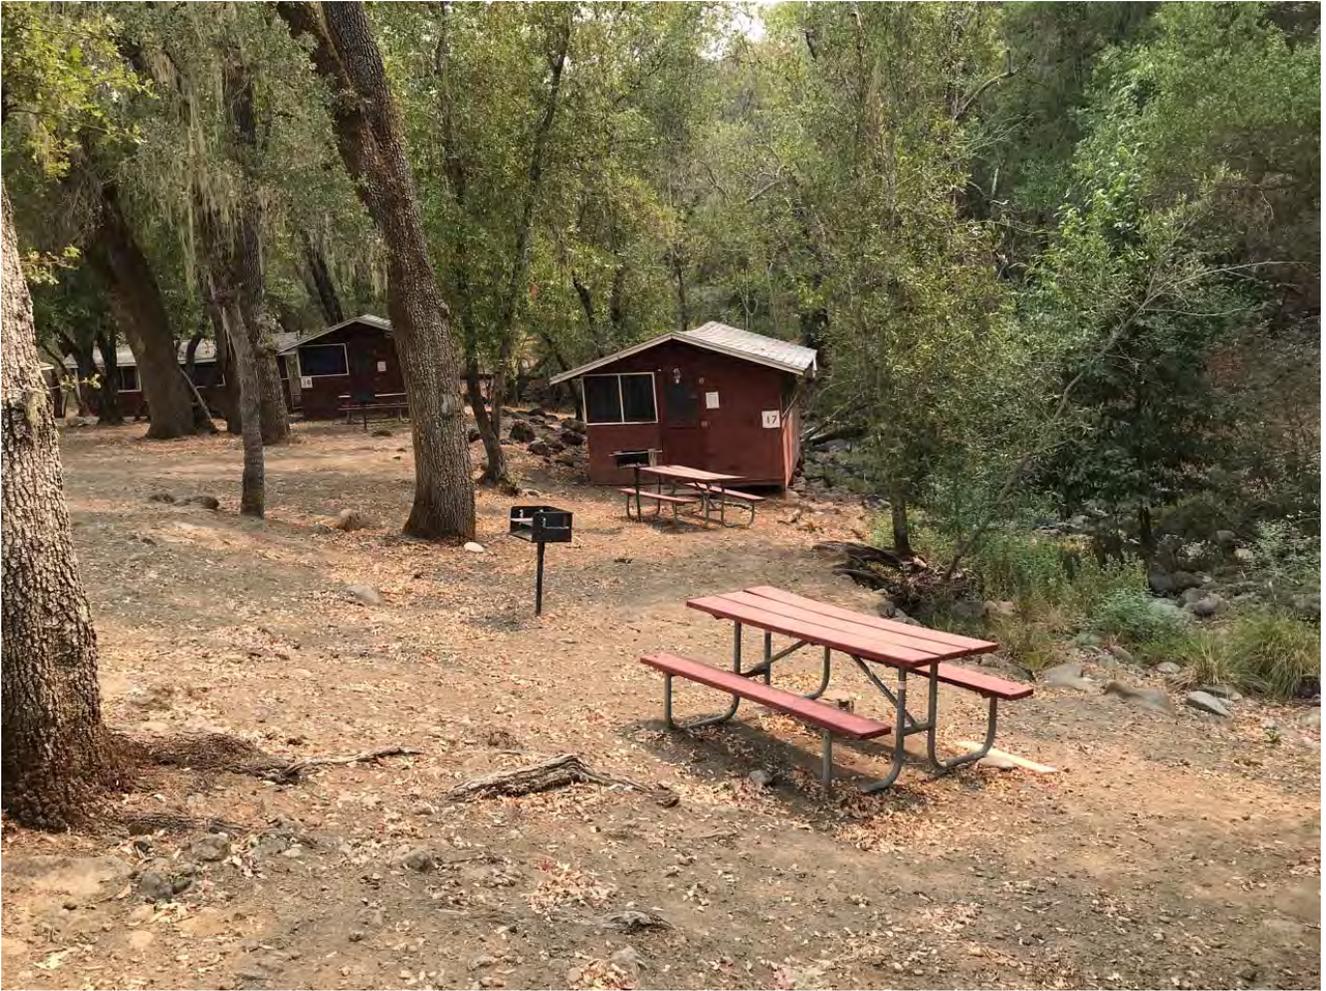
Photograph E05: Teen center cabin protruding into the channel (VAR 71).
