December 16, 2014

From: Ken W. Davis, Aquatic biologist

Re: Lower Putah Creek Scarification - Observations and Images

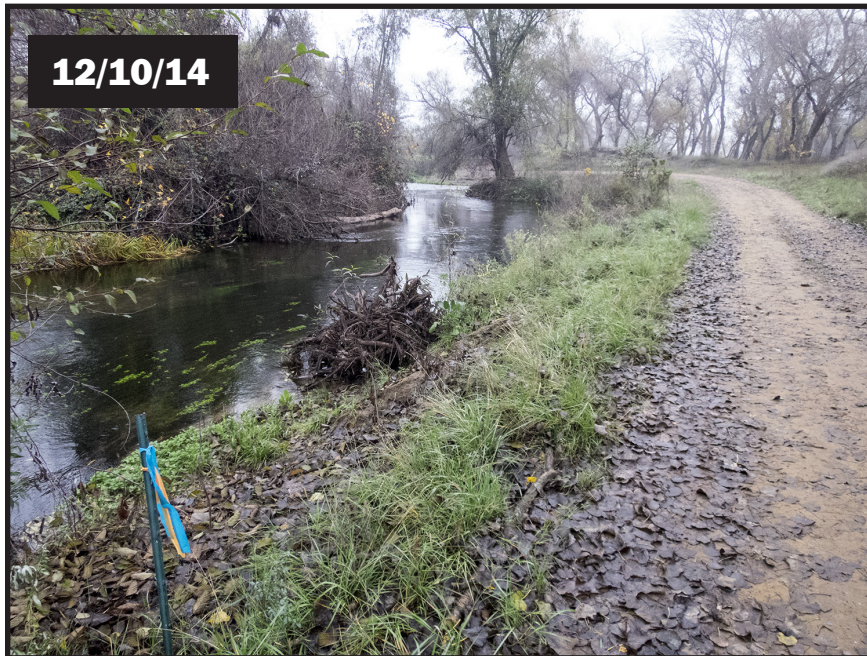
SECTION NUMBER 1: This section was not scarified and remains as a control site as an area with copious gravel resources. Salmon did spawn in this area after it appeared that available gravel sites were occupied by other salmon. The depth of the redds was significantly less than those redds in the scarified areas.

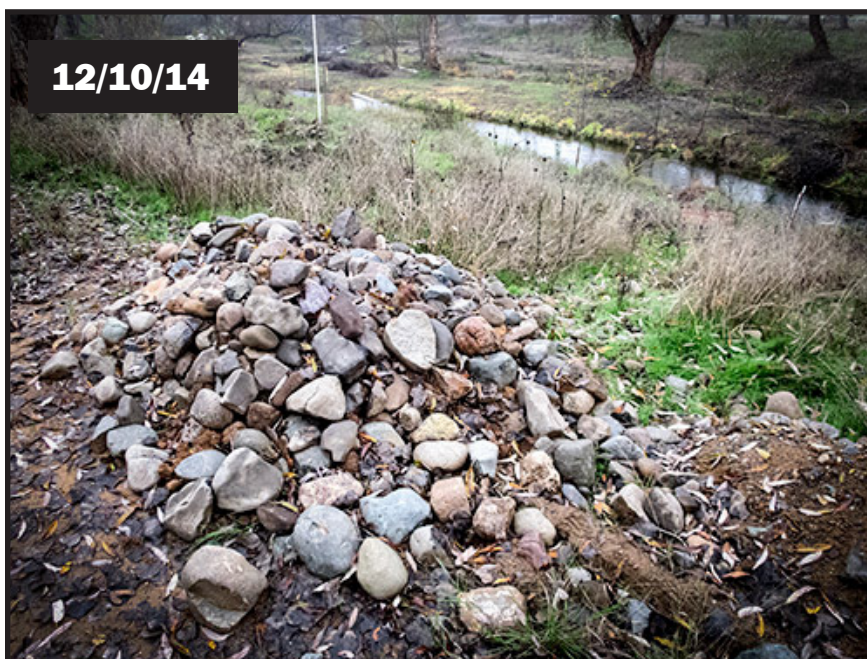
Gravel added: To my knowledge and observations, there was NO gravel or cobble added to Lower Putah Creek. See image on Page 3 of cobble staged for possible placement in Lower Putah Creek upon approval by DFW. That cobble remains in place.

All cobble staged near the creek remains in place. To my knowledge, no cobble or gravel was added to the creek during the recent scarification action.

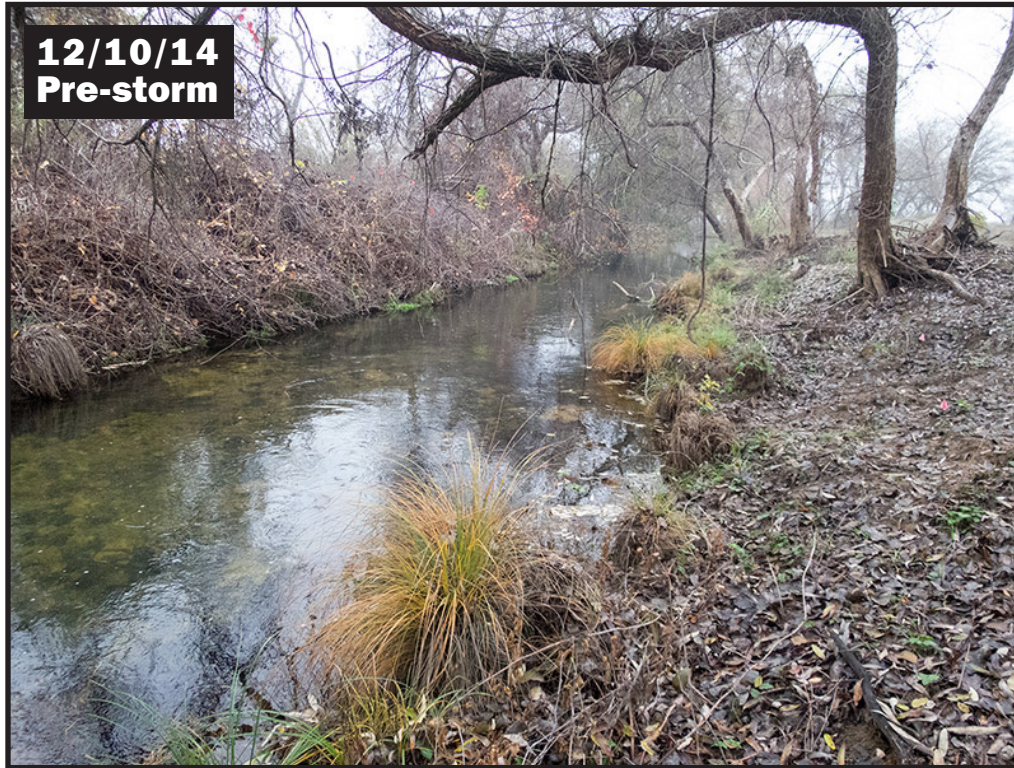
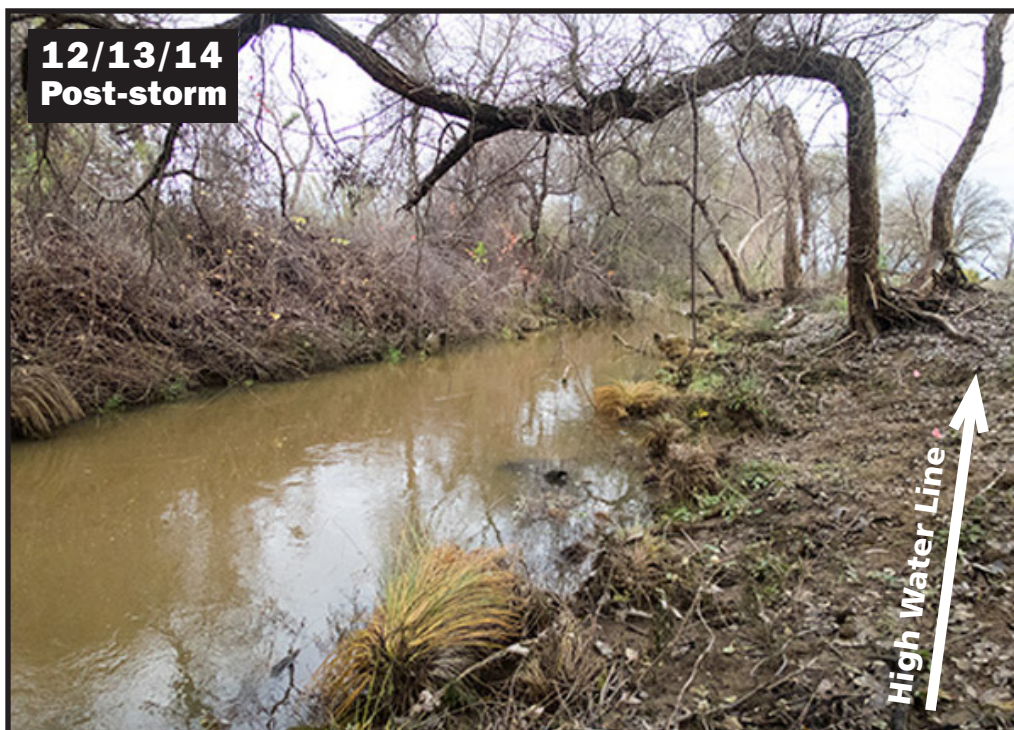
SECTION NUMBER 2: This section was partially scarified but was abandoned due to the lack of gravel. No gravel or cobble was added. Salmon did not use the site for spawning.

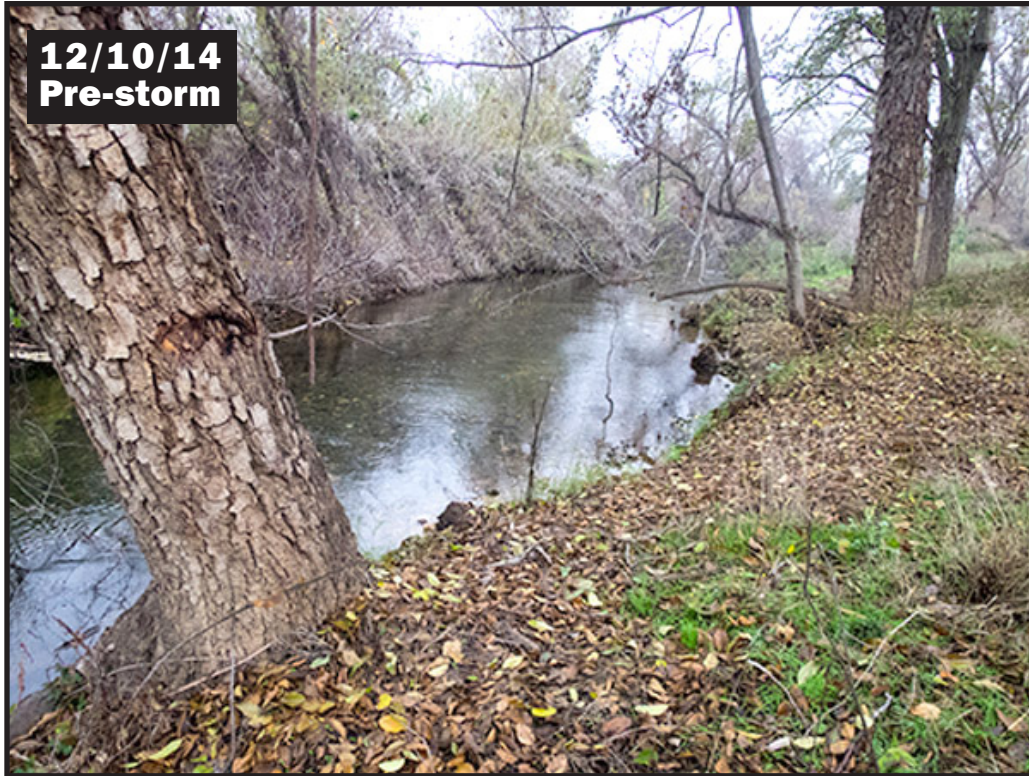
**12/10/14
Pre-storm**

SECTION NUMBER 3: Site was scarified. At least four pairs of salmon and two pairs of trout spawned on this section

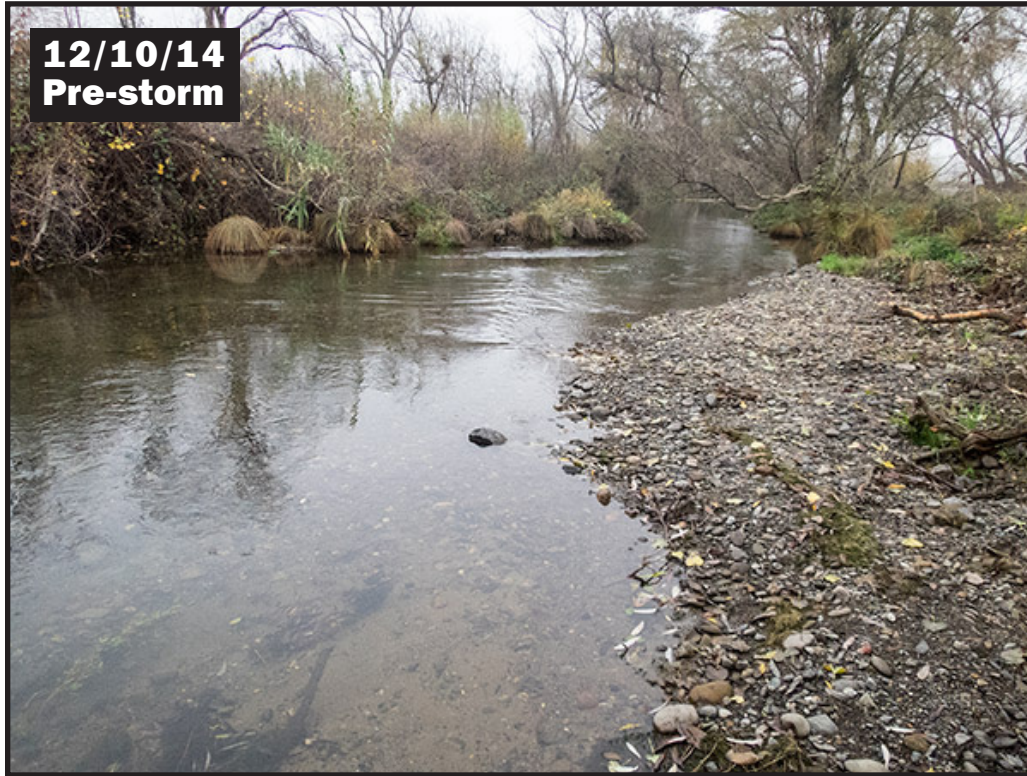
**12/10/14
Pre-storm**

SECTION NUMBER 4: Section 4 was not scarified in the recent action. This is the original test site that was visited by Lorie Hammerli and Ryan Watanabe on 8/5/14. At least four pairs of salmon and one pair of trout spawned on this scarified site.

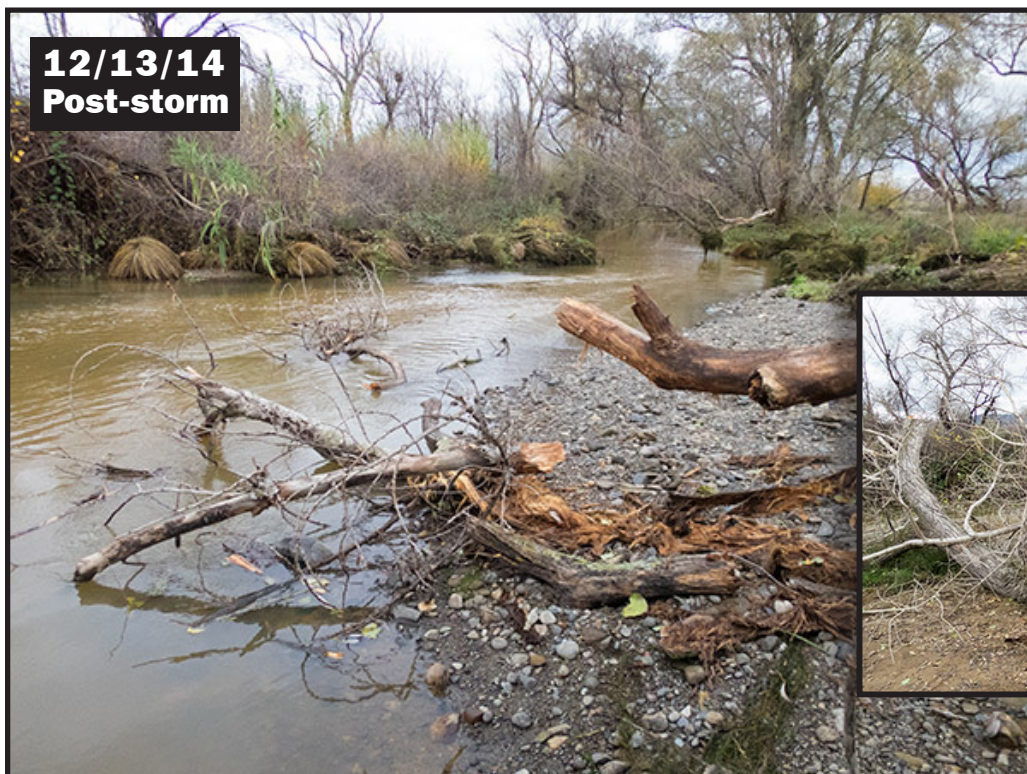
**12/13/14
Post-storm**

8. It appears that the scarification action in some areas facilitated the storm water to narrow the creekbed. Note comparison images for Scarification Sections 4 and 5.

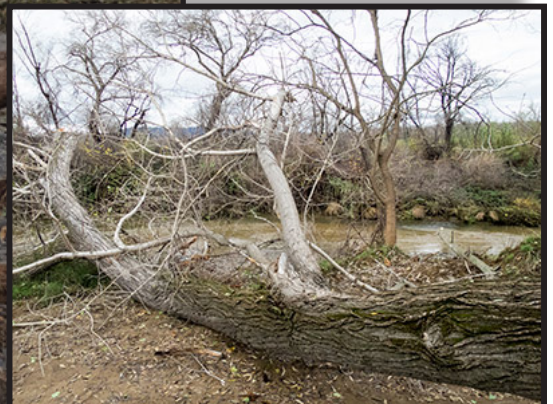
Tree that fell on Scarification
Section 4. Image 12/13/14

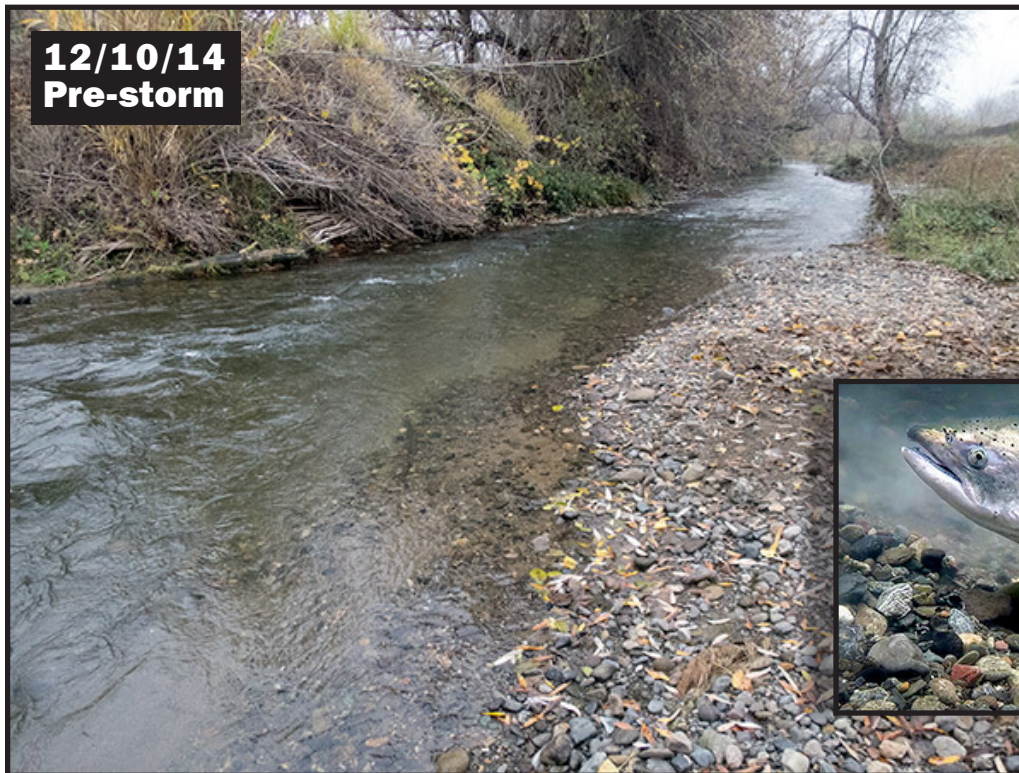
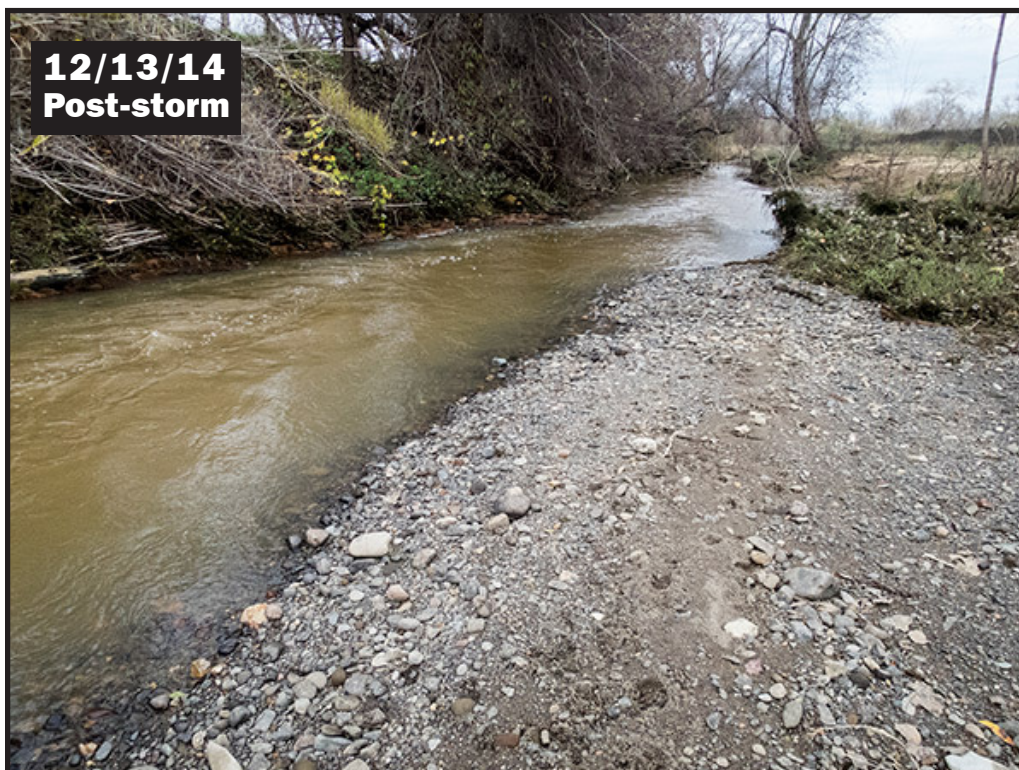
SECTION NUMBER 5: Site scarified and was used by two pairs of salmon. Image below shows female salmon that spawning at this site.

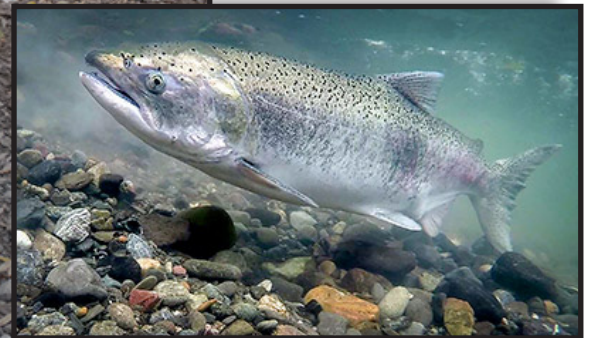
Salmon spawning in Scarification Section 5.

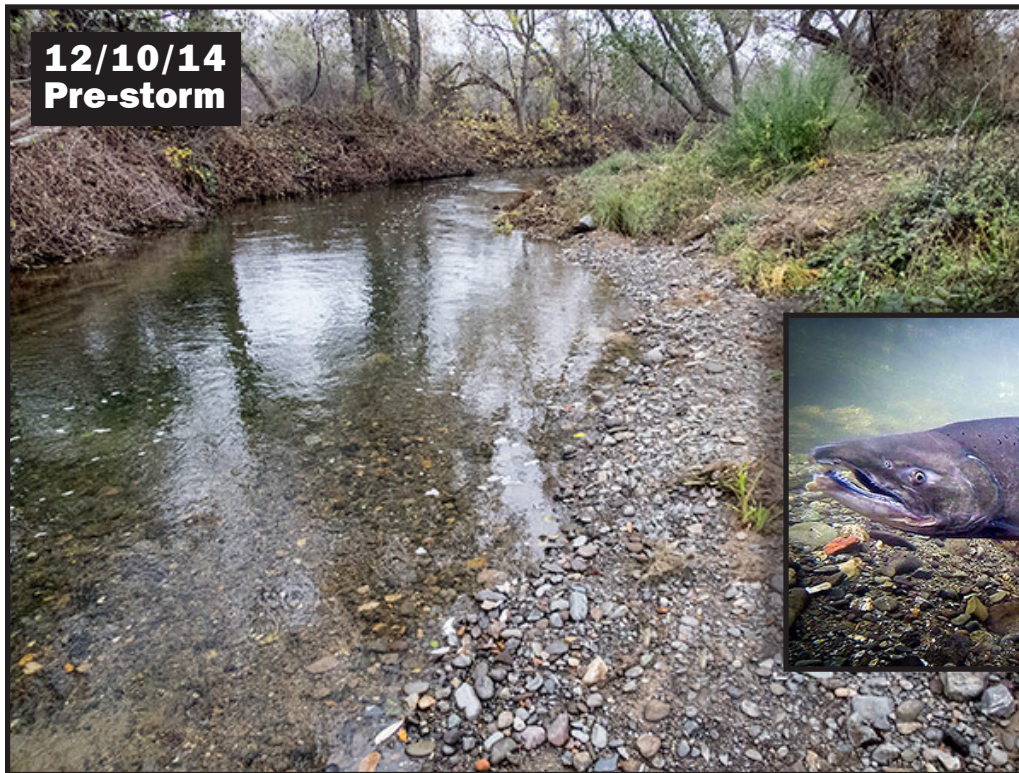
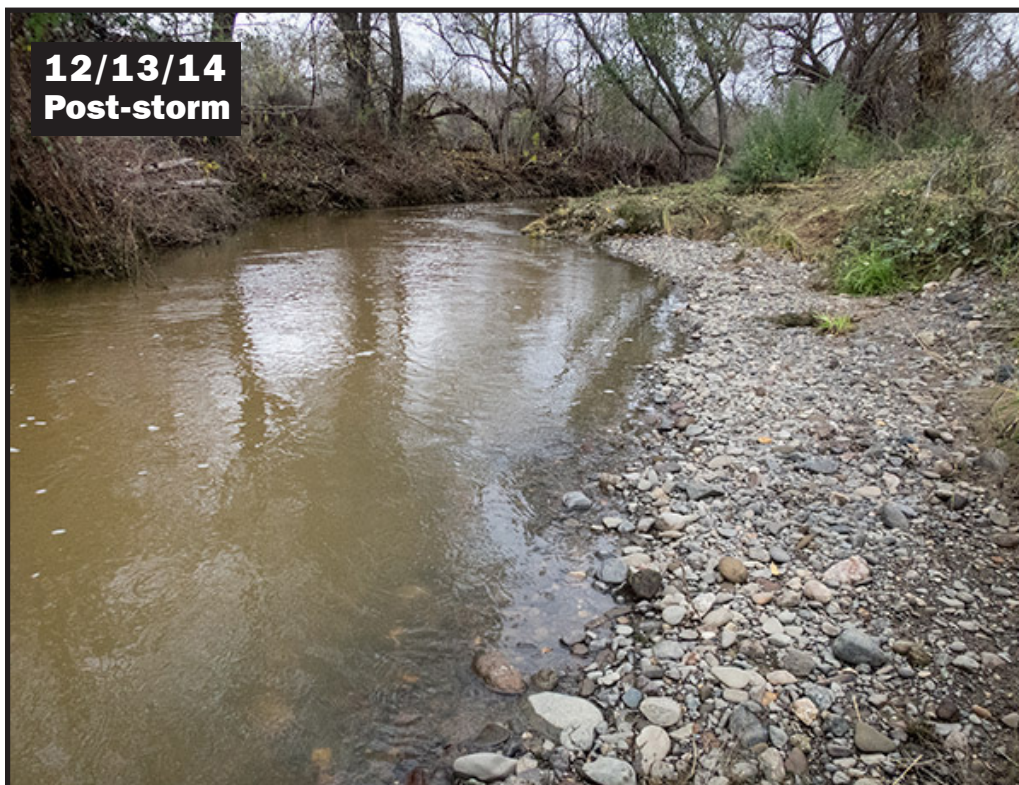
SECTION NUMBER 6: Site scarified and used by 2-3 pairs of salmon for spawning. One pair is shown in image below.

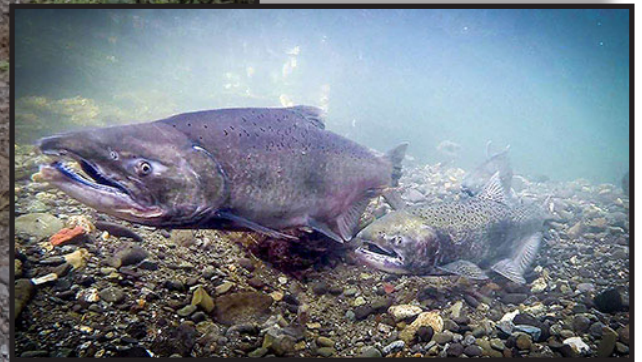
Salmon spawning in Scarification Section 6.
