REPORT 4539

Lake Berryessa Mussel Surveys

Regarding: *Eurasian Mussel Surveys - Lake Berryessa - January - July 2013*

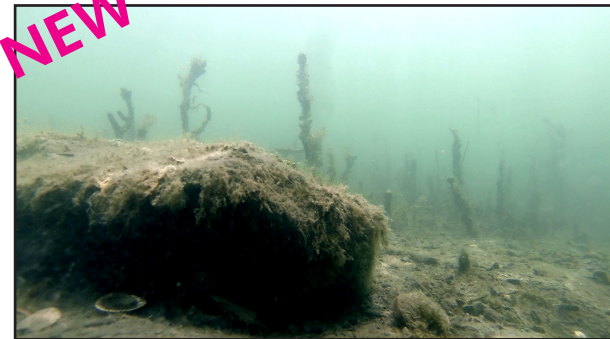
Subsurface Image clipped from video examination of bottom of Capell Cove.

I've added subsurface video inspections of high risk sites - such as the Capell Public Launch Ramp because it is relatively inexpensive, quick, and highly effective. The two-foot boulder on the left was recorded at a depth of 7.5 feet below the Capell Boat ramp. I've examined a wide variety of subsurface video taken in Lake Mead and in the Great Lakes and believe that the technique is effective at locating a mussel infestation.

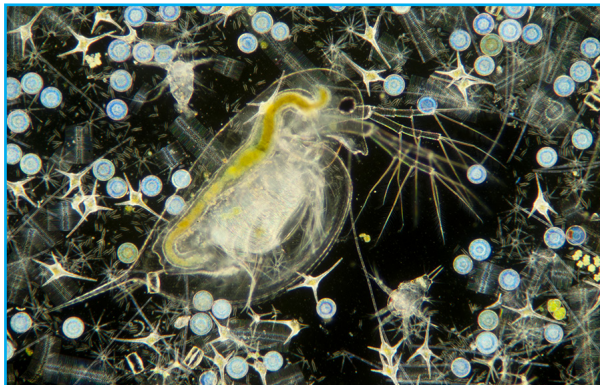
Plankton image from specimen collected in Lake Berryessa. Shows water flea (*Daphnia*) and several species of algae.

Plankton is collected using standardized collection protocols under the auspices of my DFW Scientific Collection Permit. All samples are preserved and examined using standardized laboratory techniques within 12 hours of the collection. Suspect samples are compared to Plankton Image Library developed for the Lake Berryessa Sector of the Solano Project.

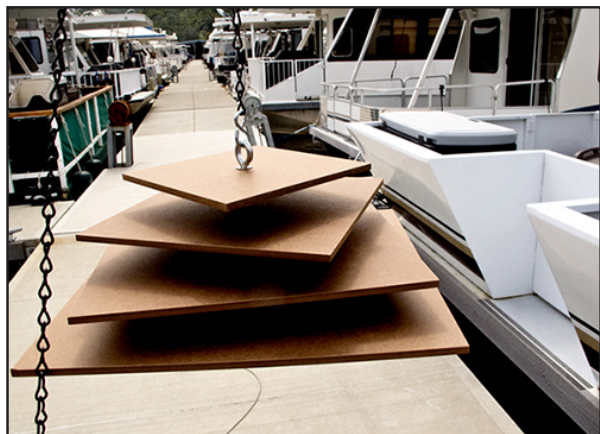
Section of colonization tree that was deployed on the houseboat dock at Markley Cove Marina. The devices are locked to avoid theft and vandalism.

Colonization plates - also called colonization trees - have been placed (hung) from strategic sites at Lake Berryessa marina docks. The colonization trees are typically a mix of materials that are strung on aircraft cable, rope, or chain to extend the selection of materials to 30 - 50 feet depth. All plates are placed with the knowledge and cooperation of the Marina management and the USBR.

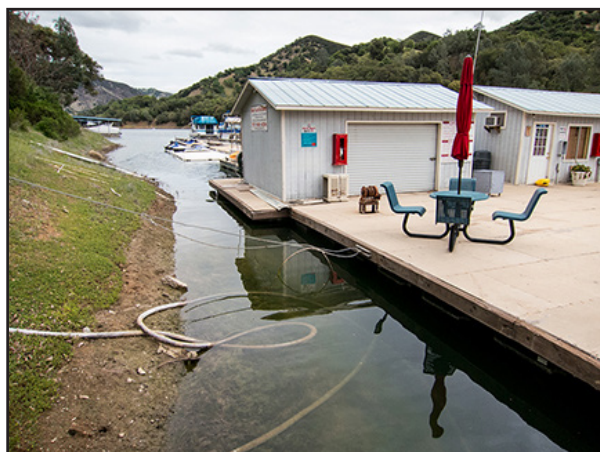
Gas dock, cables, and banks at Markley Marina.

On a regular basis, the existing infrastructure, such as banks, docks, cables, cobble etc., are checked for the presence of adult Eurasian mussels.
