February 24, 2015

Subject: Putah Creek Fish Video Project - 2014 Salmon Run

REPORT 4963 2014 Putah Salmon Run

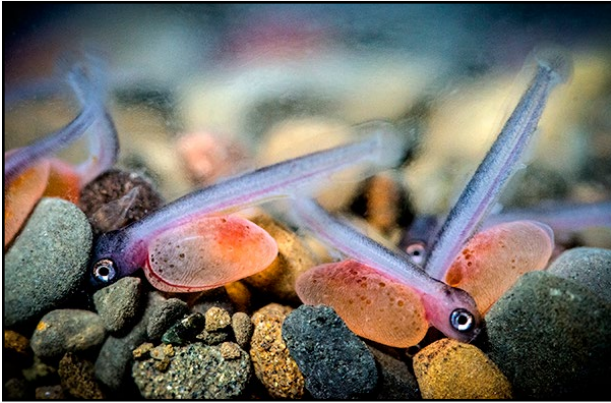
Steelhead alevin (Sac Fry) attempting to seek harbor in gravel. Gravel is too small to allow entry.

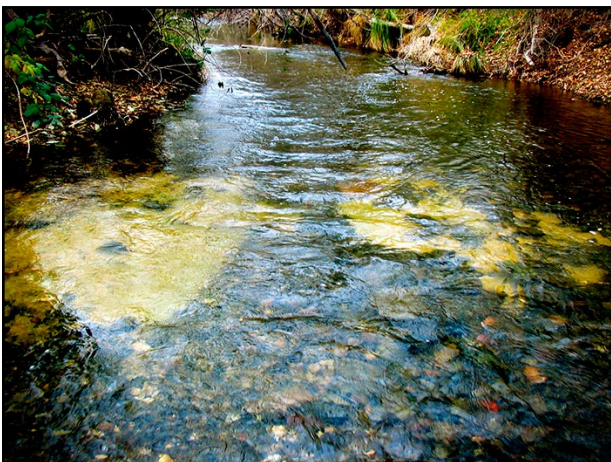
Salmon attempted to dig redds near I-505 (2005). Exposed claypan and marginal gravel was not sufficient for spawning.

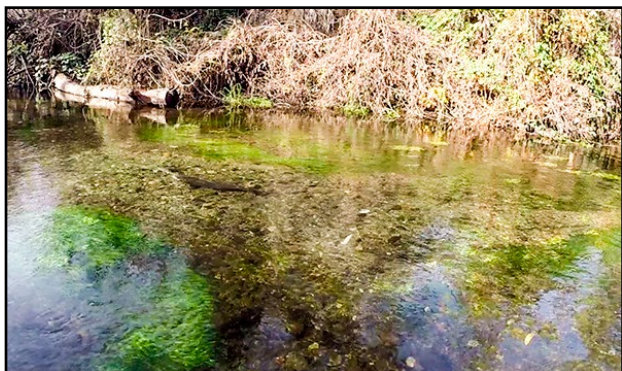
Female Chinook on shallow redd located in the Scarification Control Section Number 1.

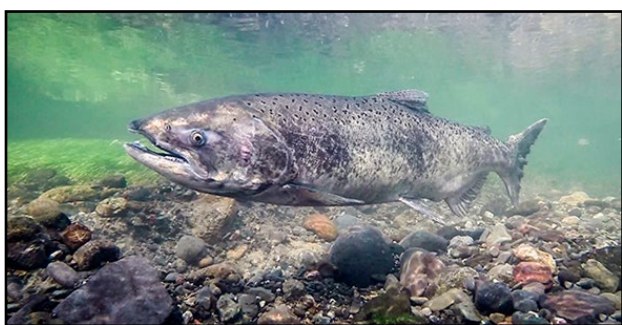
Female Chinook above shallow redd on Scarification Control Section Number 1. The redd was approximately 7 cm. in depth.

There appeared to be a significant difference in the depth and condition of the salmon redds when comparing the scarified and non-scarification sections.

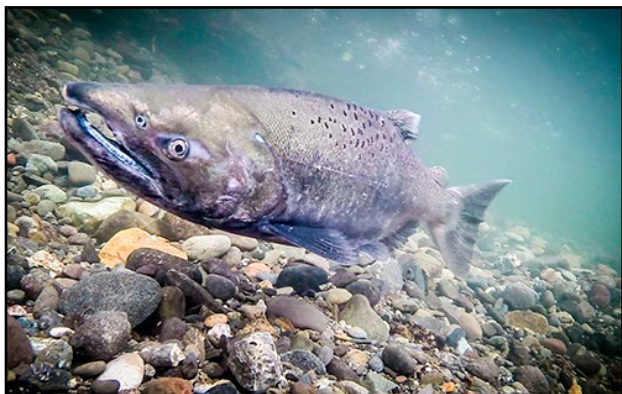
Male Chinook above a deep redd on Scarification Section No. 5.

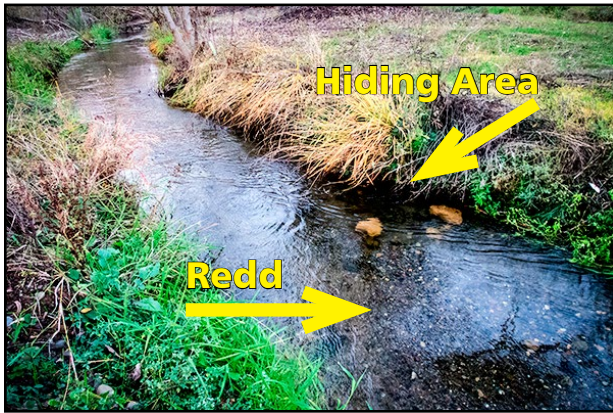
Salmon redd and hiding area. Pickerel North Side Channel. 12/10/14

2014 Salmon Run: In the 2014 salmon run, at least three (3) pairs of salmon spawned in the North Pickerel side channel. At least two female salmon used the overhanging vegetation for aerial cover and appeared to dig deeper into the bank to develop hiding areas. Video is available of this action.

2. Encourage the development of side channels whenever possible. The North Side Channel was used again this year by several pairs of salmon and a group of rainbow trout.

3. Suggest the coordinated planting of sedges along all side channels. Documented this year with video that salmon and trout use the overhanging vegetation as cover.

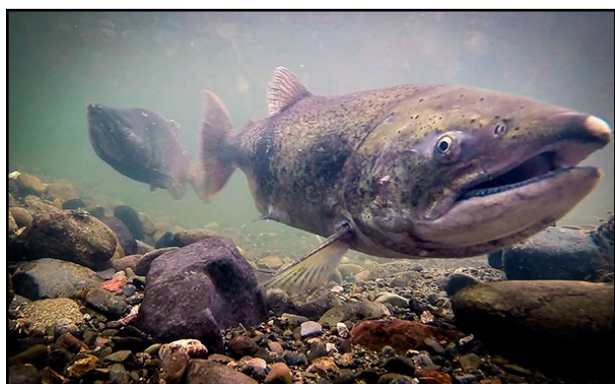
Salmon with larger cobble exposed by scarification.

The Scarification process exposed larger cobble in some areas such as at Section Number 3 (Image left). The larger cobble provides additional harbor for developing salmon, fish such as sculpin already in the creek, and larger aquatic invertebrates which can recruit from Miller Creek if sediment conditions allow their survival.

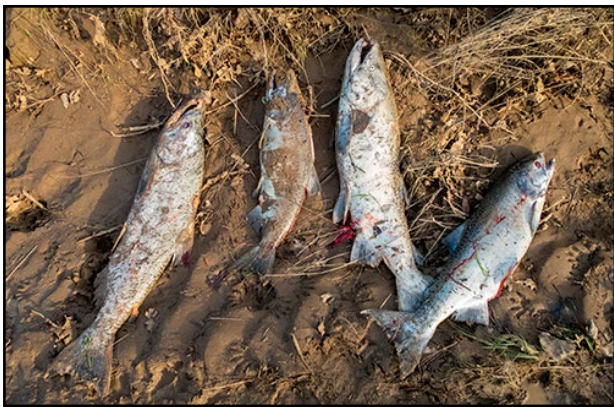
Five salmon were stranded in Mc Cune Creek. They entered the creek during the last storm event.
