Wildlife Survey & Photo Service

July 1, 2004

RE: Putah Creek NZMS Monitoring Project

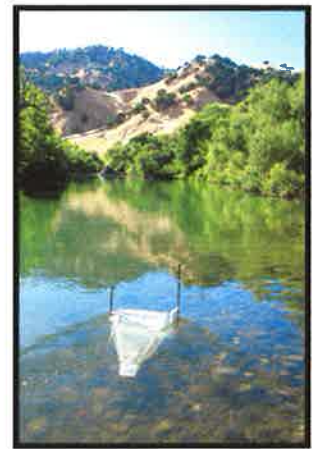
Interdam Reach. Site JA: Note that this site is approximately 0.5 Kilometer below Fishing Access #3. During the December 2003 Emergency Delineation, NZMS were rare at this site. Although no formal population density was recorded in December 2003, we only found three (3) NZMS at the site. Currently, NZMS at this site are visible on the surface of the rocks. Water depth and velocity were also recorded. Partial data in the table below.

Putah Creek - Riffles at Site JA - 6/28/04		
Site Sample	Collection #	NZMS (#/m ²)
1	893-22JA	1145
2	894-22JA	4450
3	895-22JA	1005
4	896-22JA	2992
5	897-22JA	691
6	898-22JA	1316
7	899-22JA	1240
8	900-22JA	3995

Putah Creek, riffles at Site JA

1. Interdam Reach: Work will continue to determine the NZMS population density.

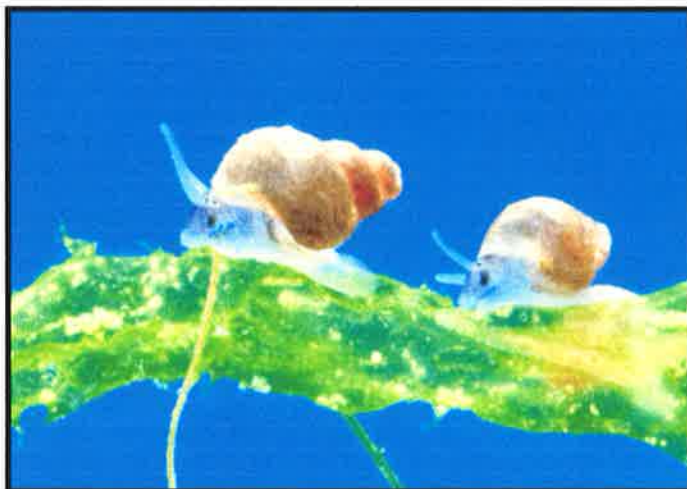
My concerns about the movement of NZMS in the invertebrate drift (normal daily movement of non-mollusk invertebrates in the water column) were heightened by two six-hour invertebrate drift samples taken at the site shown above. All samples contained NZMS that were ≤ 1 mm in length. Half of the NZMS were approximately equal to .5mm length (see image on left).

NZMS measuring approximately 0.5mm long move on a strand of floating algae.

- 1. Downstream surveys will continue to track the movement of NZMS.**
- 2. Downstream surveys will determine the NZMS density at selected riffles using accepted protocols.**
- 3. Downstream surveys will determine the movement of NZMS via the invertebrate drift.**

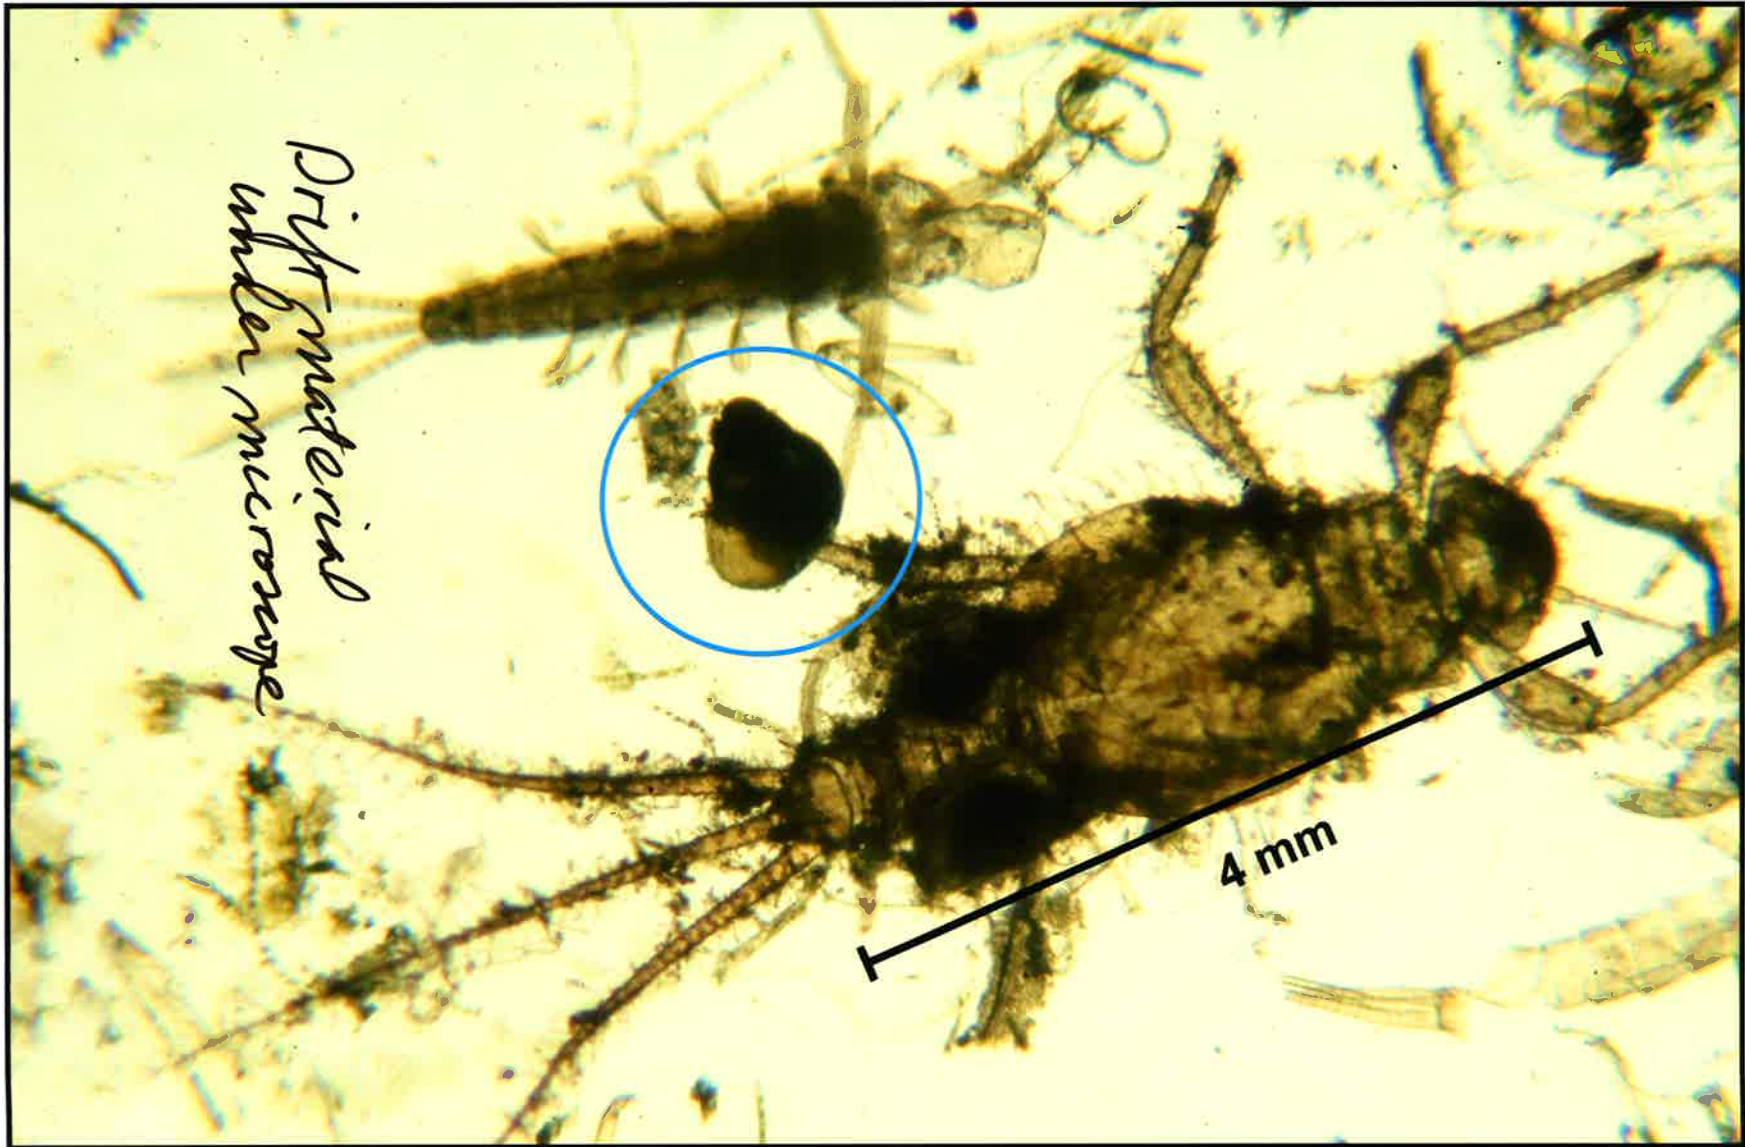
Image / Collection #: 865-22H-41-M5

Date collected: May 27, 2004
Waterway: Putah Creek
County: Yolo
State: California

Species: *Potamopyrgus antipodarum*

Common Name: New Zealand Mudsnail

Potamopyrgus antipodarum
