January 6, 2011

To: Chris Lee, SCWA
Rich Marovich, LPCCC

Subject: General Update - Solano
System

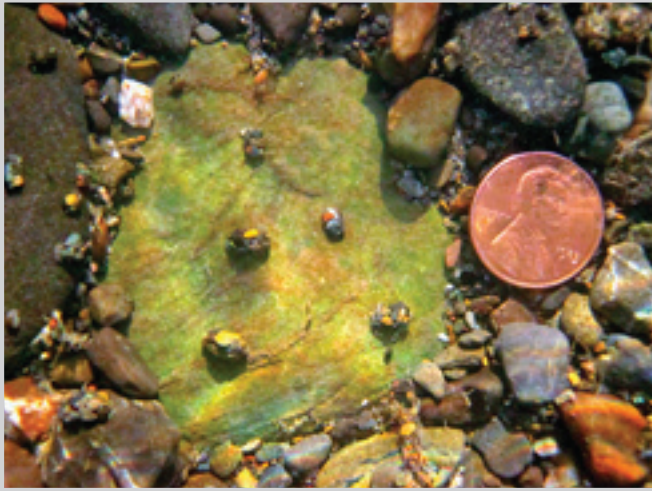
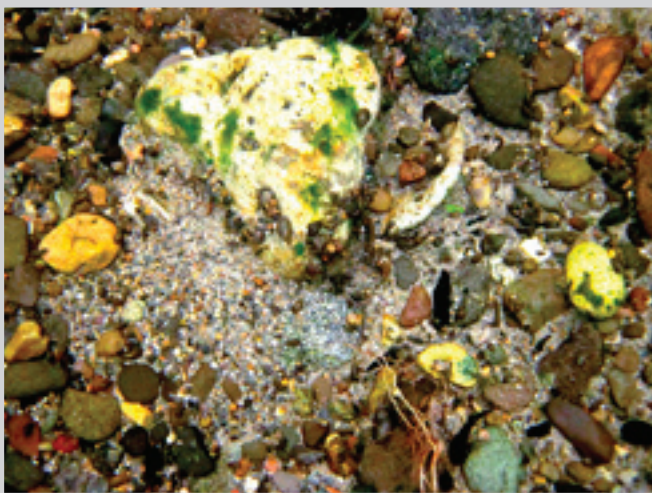
1. Cobble embeddedness: The embeddedness issue in Putah Creek continues and appears to worsen after storm events. Underwater images on the left show the dramatic impact - and loss of interstitial spaces at the Pickerel site - due to the input of fine sediment. The loss of native invertebrate habitat and aquatic invertebrates appears to be significant.

Embedded cobble - Pickerel Riffles (1/5/11)

In the near future, I'll be comparing the embeddedness at Fishing Access # 5, Pickerel Weir, and the Design Channel.

The same species of *Epeorus* was common in the Design Channel for a year after the channel relocation. Embeddedness of the interstitial spaces has eliminated the species from that stretch of Putah Creek. Regular mechanical disturbance of the Design Channel might artificially create a healthy interstitial space habitat.

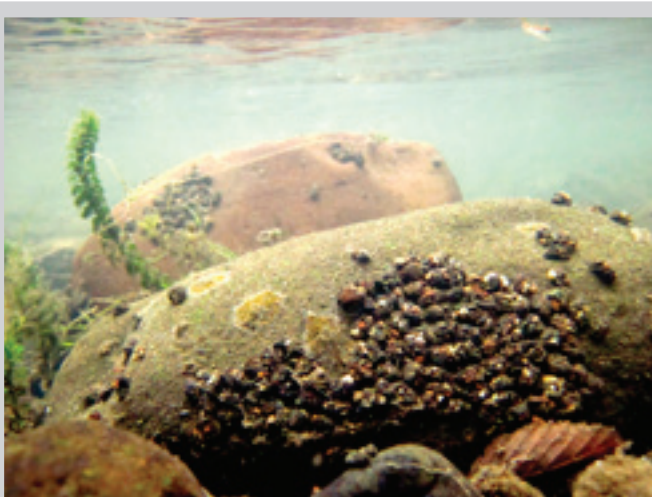
Subsurface Image: Glossosoma pupae

In addition, some anglers express concern about stranded *Glossosoma* pupae in the Interdam Reach.

Studies over the last few years continue to determine that the vast majority (80-90%) of the pupae emerge before the water level is lowered and the subsurface nymph population is rather significant.

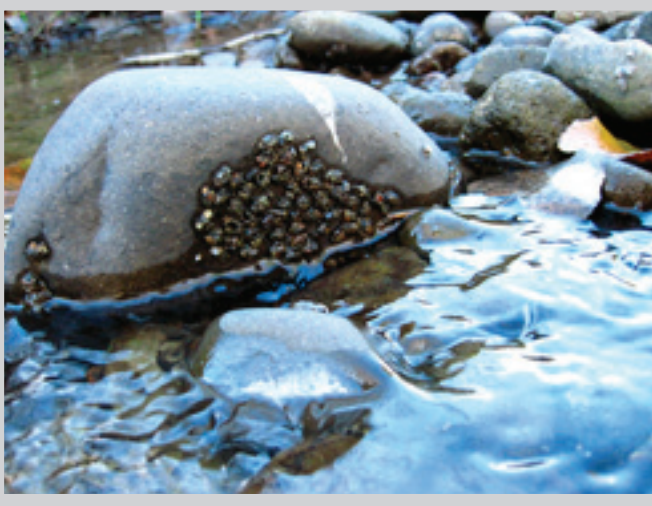
Glossosoma - Stranded (most emerged) pupae

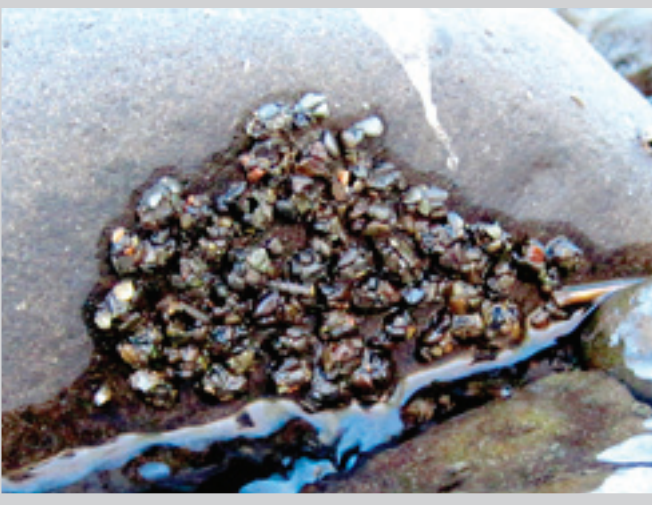
Close-up: Glossosoma pupae showing many with emergence holes

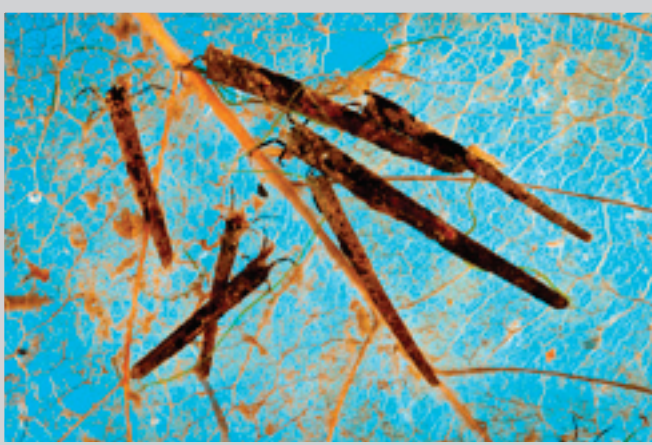
Caddisfly larvae: Nectopsyche sp.

Image on left is a another caddisfly that has become somewhat common in aquatic weedbeds in Lower Putah Creek. Considering some important species, the IBI should give a better measure of the creek than "richness" or "diversity" scores when measure individually.

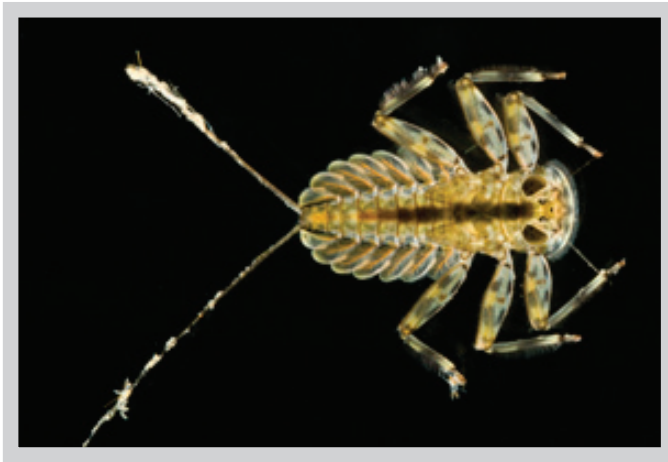
Epeorus albertae: Clean water species - dorsal view

The *Epeorus* mayflies are highly intolerant of organic pollution and are generally considered indicators of clean water. The population of *Epeorus* in the Interdam Reach has increased dramatically over the past few years. I've already found a few small specimens in early 2011. The main population will grow though early spring and hatch by late April.

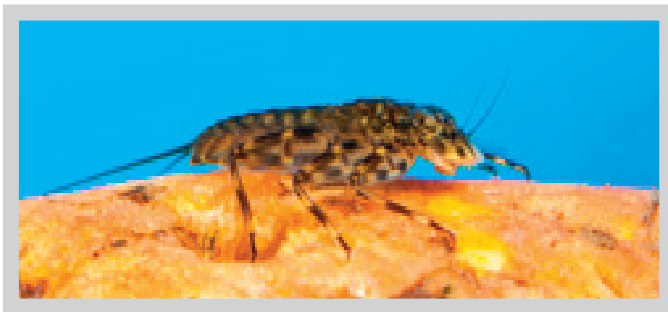
Epeorus albertae: lateral view - shows hydrodynamic structure as nymphs prefer clean, rapid flowing water.

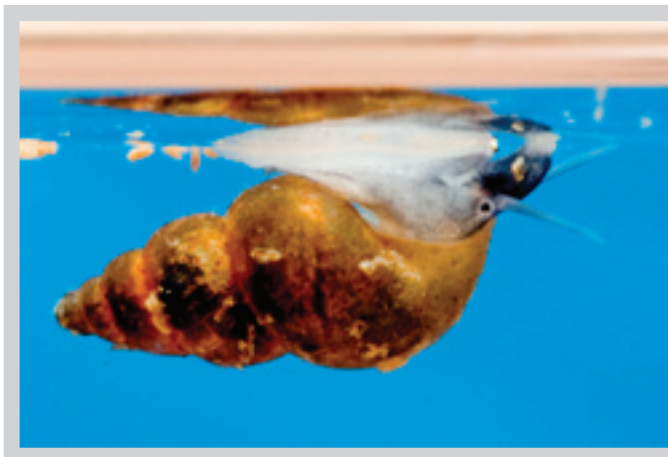
New Zealand Mudsnail translocating under water surface

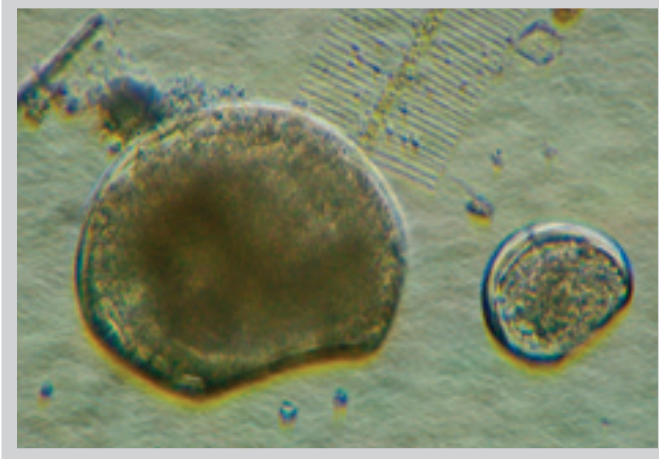
Microscopic Image: Comparison between Asian Clam and Quagga Mussel veligers

Photo comparisons are essential for the identification of Dreissena Mussel veligers. The goal is to prevent false positive mussel determinations within the Solano System.

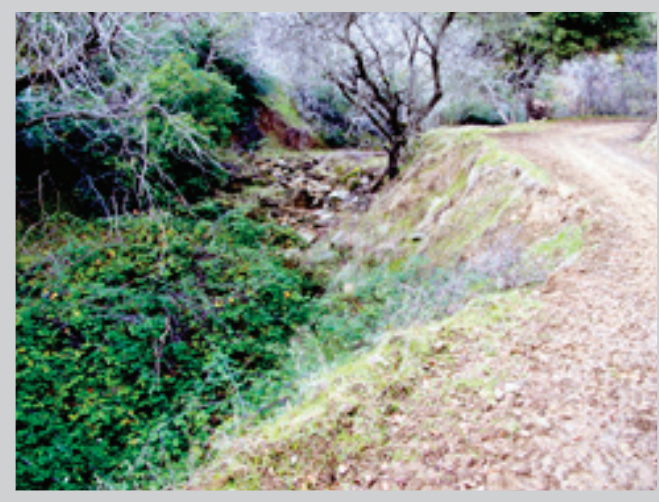
Thompson Creek - Road: Matt Straw property - 1/6/11. Note blackberry cover in creekbed.

Recent discussions with Matt Straw, the owner of a significant section of Thompson Creek, continue to be constructive. He supports my unfunded invertebrate work in Thompson Creek and property access by SCWA staff and consultants to determine potential sediment-reduction ideas.
