Date: May 29, 2017

Subject: Post 2017 Floods - Scarification Still Necessary

Preliminary Report

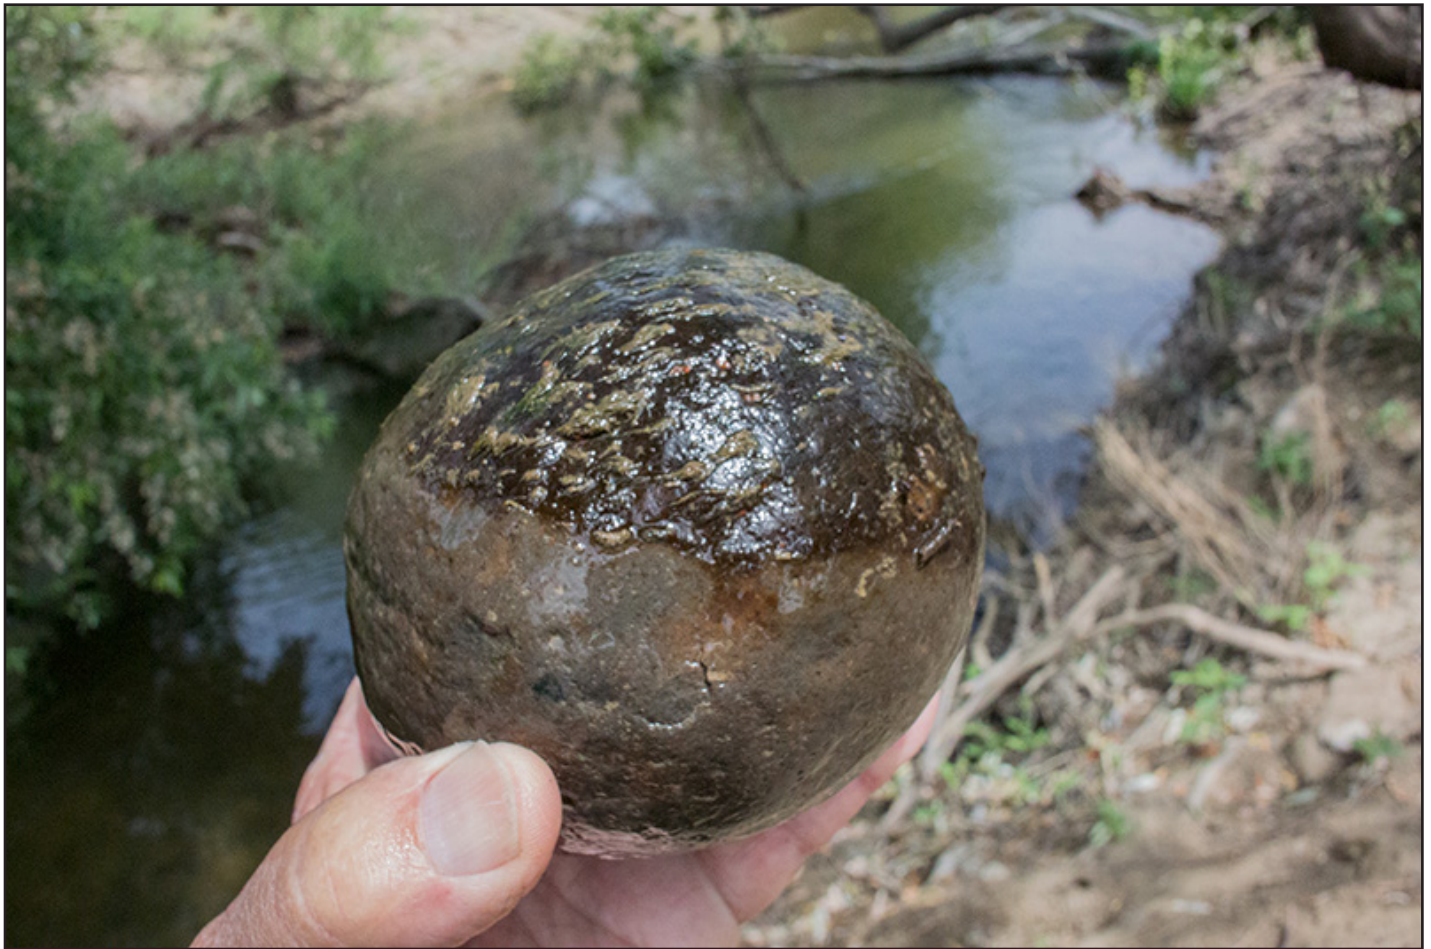
Several 2016 Scarification sites and potential scarification sites (2017) have been checked for invertebrate communities. These surveys are simple measures of Benthic Macroinvertebrate (BMIs) species and density that are retained on embedded cobble. The survey is conducted while measuring cobble cementation. While diversity is limited due to the embeddedness, the BMI density is what I would expect on embedded rocks after a prolonged flood event. The image below of a cobble is characteristic of one that was embedded. The benthic macroinvertebrates are restricted to the non-embedded section and characterized by Chironomids (midges) and several species of caddisflies that are protected from fish in self-constructed cases.

Embedded rock (75%) showing algae and significant numbers of Midge (Chironomid) tubes on the top surface of the cobble. Harris Control Site. Image taken on 5-23-2017

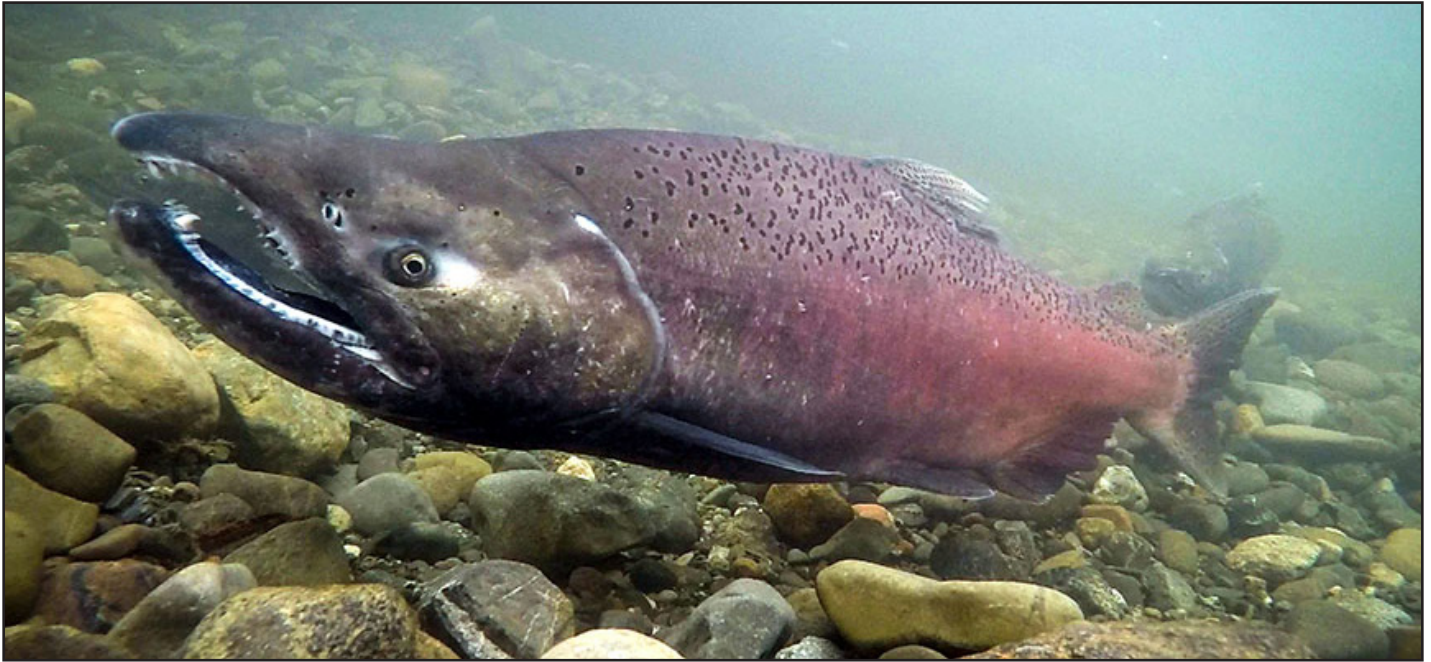
Field experience of observing and filming spawning salmon in Lower Putah Creek and numerous other waterways has convinced me that the recommended size of cobble necessary for successful Chinook salmon spawning in Lower Putah Creek is on the small side. For example, redds that survived flood events in 2014 and 2016 had large cobble (15-25 cm. range) which the female used to armor the upstream edge of the redd. It appeared that the redd was developed to protect the "pot" or interior of the nest where the eggs were deposited. Other redds in areas with smaller gravel (and no larger cobble) were buried by flood-mobilized gravel.

2016 Spawn: Male salmon over a redd dug by the female (in background). The "spawning gravel" in the middle of the redd is consistent with the size of rock recommended for restored sites. The rocks used by the female to armor the redd are more in the 15-25 cm. range. 2016 Scarification Site #12.

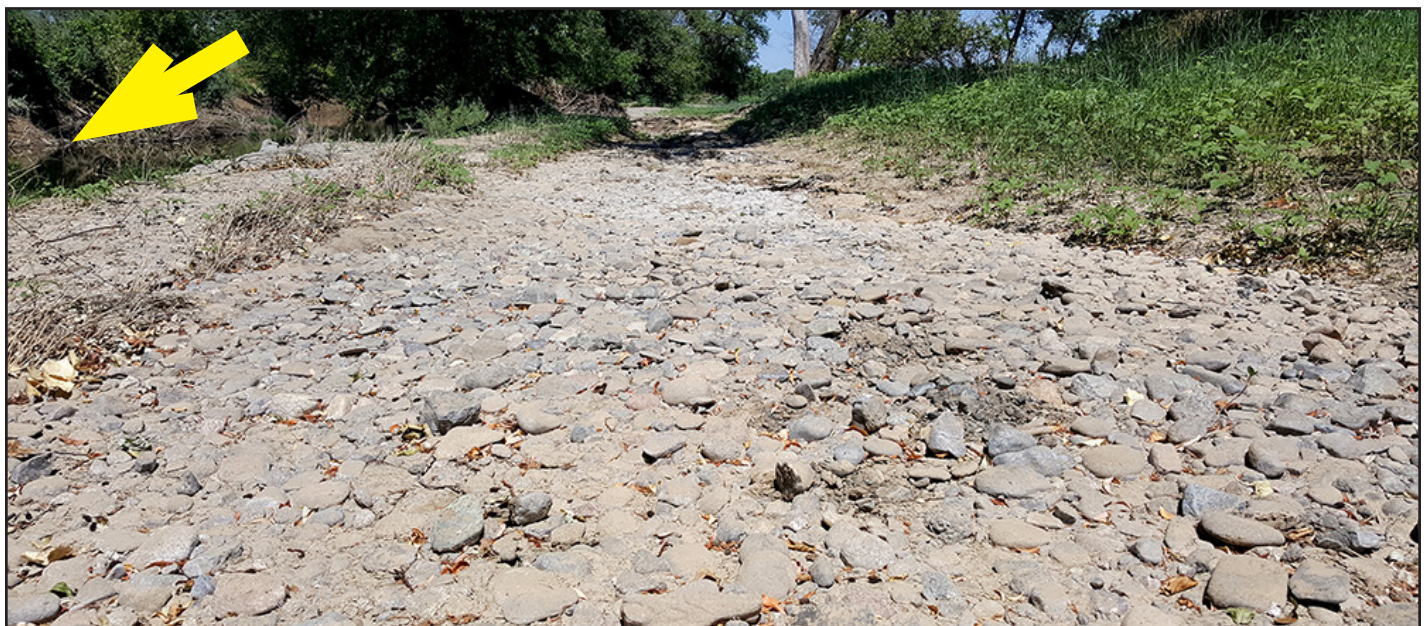
NAWCA access road after 2017 flood. Image shows copious amount of rock that was revealed by the flood waters. Note: My understanding is that this rock is native and was not placed during the NAWCA project. The main channel Lower Putah Creek is on the far left of the image (see arrow). 5/20/2017
