Wildlife Survey & Photo Service

Subject: General Field Update

REPORT 4987

BMI Response - Scarification

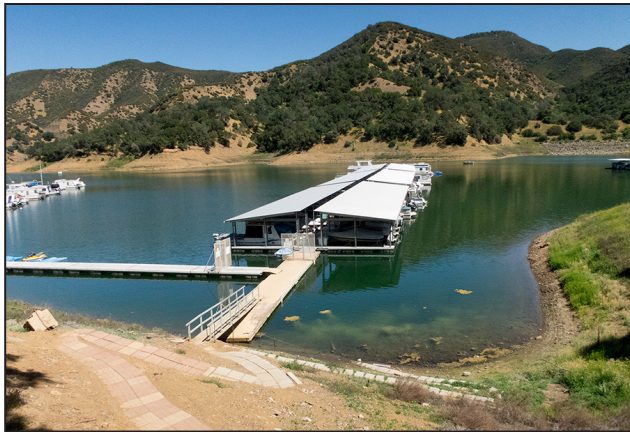
Markey Cove Marina - Mussel Survey Area

Mussel Surveys - Lake Berryessa

Mussel surveys continue per the provisions and techniques described in the ***"Solano Project: Early Detection and Education Plan for Eurasian Mussels."*** To date, all surveys have been negative with zero organisms of concern.

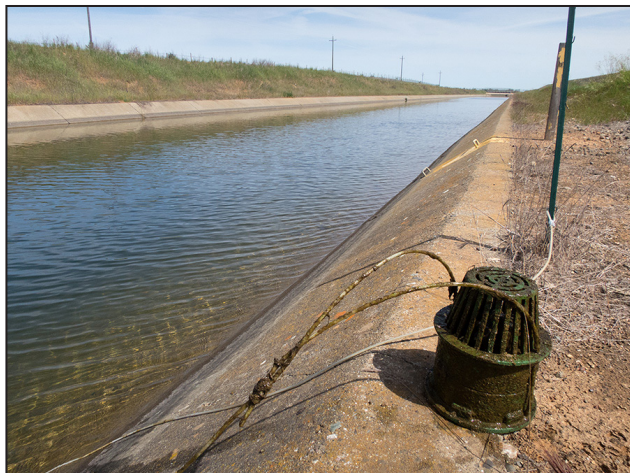
Putah South Canal. Mussel / NZMS Colonizer

Putah South Canal - Invasive Species Surveys:

All areas surveyed negative. Schedule has been affected by construction (road work) along the canal. Will attempt to coordinate more efficiently with SID.

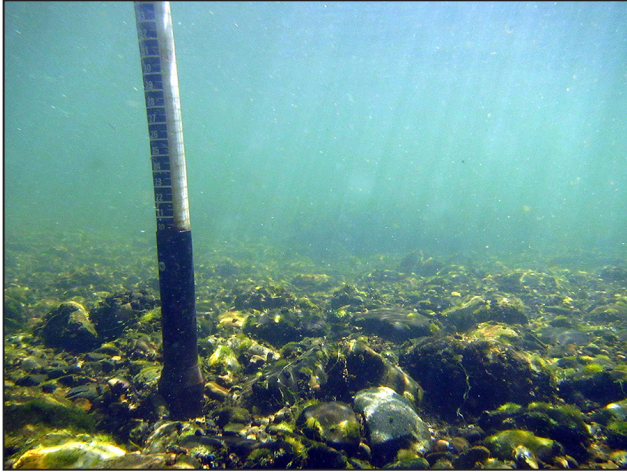
Control Section of Scarification / Salmon Redd

Scarification Project: Benthic Invertebrate Response

It appears that the scarification process (artificial scour) does have a positive effect on the benthic invertebrate population. That condition was expected via experience in other Western waterways.

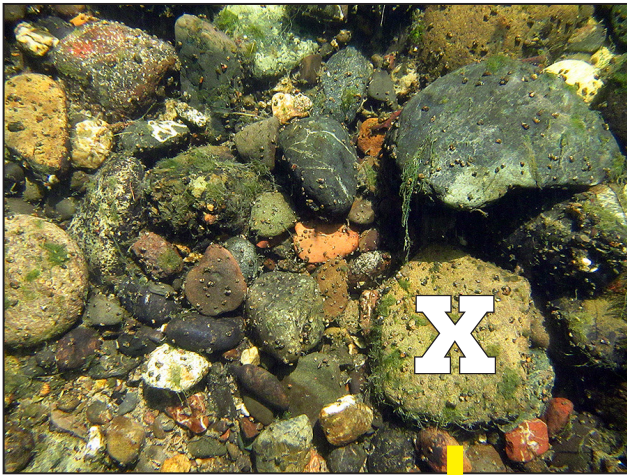
Scarification Section No 3.

Scarification Project: Benthic Invertebrate Response

The additional gravel movement by female salmon in areas where scarification was conducted appears to have an additional positive effect on some aquatic invertebrates. This is being monitored and documented.

When the top layer of cobble is removed (see image on left), gravel resources remain below. Typically in this area, the gravel is not mobilized, it is buried.

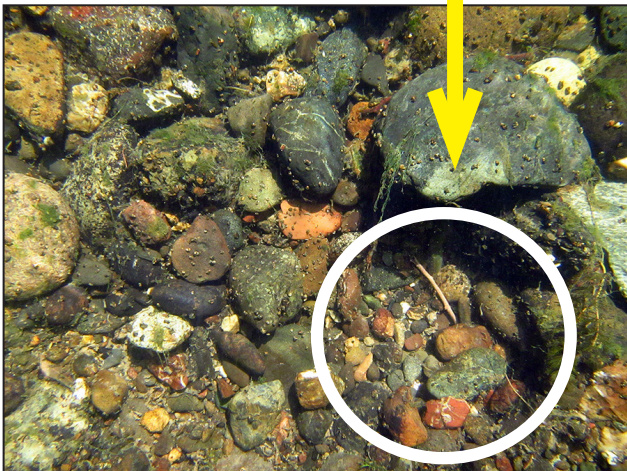
Scarification Section No. 3. After one cobble is removed.

Scarification Project: Benthic Invertebrate Response

Image shows gravel resources when surface cobble is removed. This condition will be measured and documented.

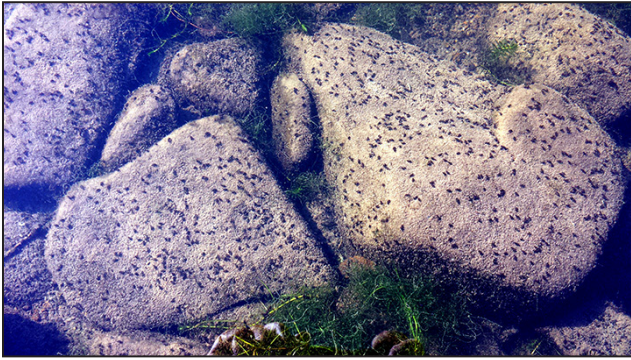
New Zealand Mudsnails - Interdam Reach

New Zealand Mudsnail Density:

The New Zealand Mudsnail density in certain areas of Putah Creek has been reaching 200,000 / sq. meter.
