Report: 3700 Update

Pleasure Cove, Lake Berryessa

Subject: Update - Surveys in Solano System

Dreissena Mussel Project:

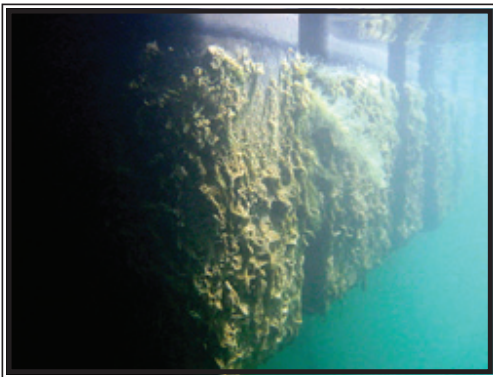
Docks at Pleasure Cove. As part of the *Dreissena* Mussel survey program, docks are checked for adult mussels by running your hand along base.

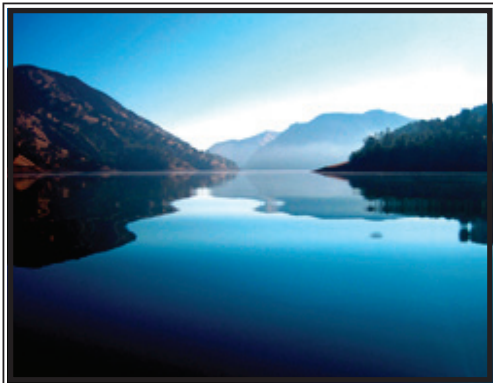
Lake Berryessa: Area near Monticello Dam used for early morning plankton tow.

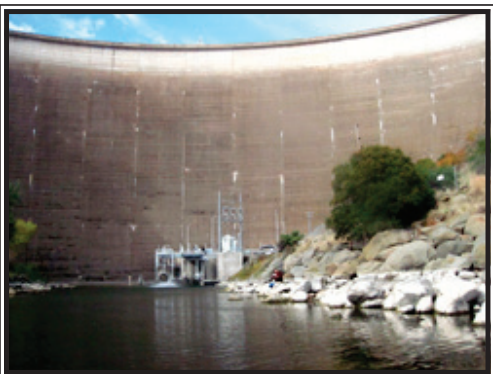
Monticello Dam: Low water allowed the visual survey of the lower face of the dam.

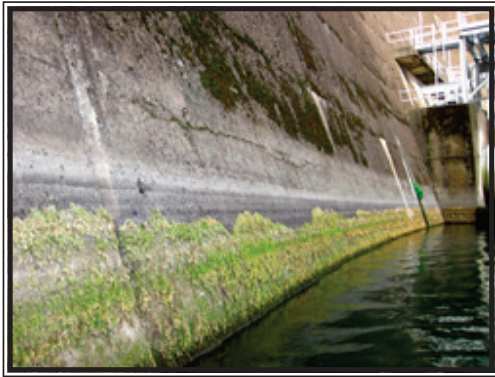
Monticello Dam: Shows algae on dam face.

Mussel infestations typically begin in dark, well protected areas. The lower face of Monticello Dam should be visually surveyed on annual basis.

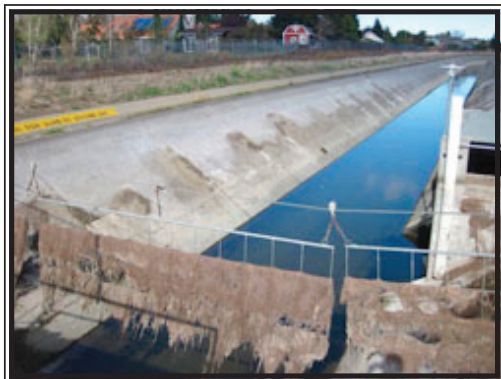
Putah South Canal: Visual inspection of canal infrastructure for adult mussels is accomplished on a regular basis. 11/10/10.

The cleaning of Putah South Canal presents an excellent opportunity to examine infrastructure and the material removed from the canal.

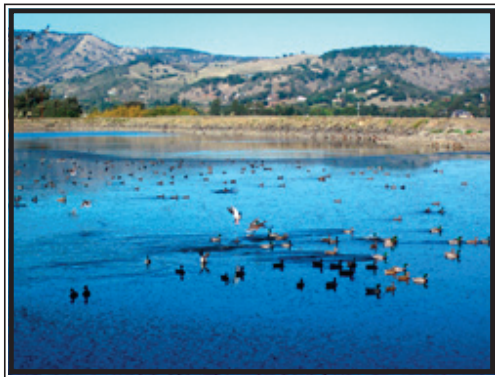
Waterfowl on Terminal Reservoir on 11/1/10.

Terminal Reservoir is a significant resting and feeding area for migrating waterfowl. San Justo Reservoir, the site a major zebra mussel infestation, is also a resting area for waterfowl. San Justo Reservoir is 100 miles due south of Terminal Reservoir. We know that waterfowl move mussels, we just don't know the distance and the survivability.

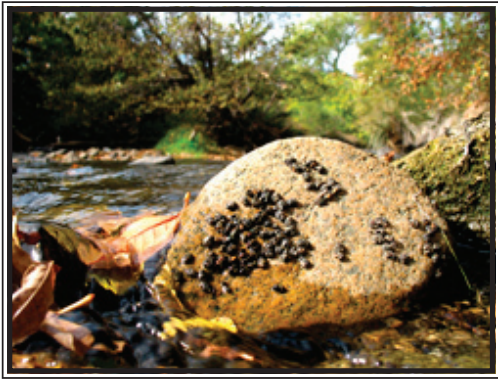
Shows *Glossosoma* pupal cases "stranded" on a rock at Fishing Access # 5.

Glossosoma caddisflies stranded by low water flows:
Anglers routinely complain about the stranding of *Glossosoma* caddisflies. I have several years of data showing that the majority of "tortoise case caddisflies" have emerged prior to the low-water flows. I am continuing that work during routine mudsnail surveys.

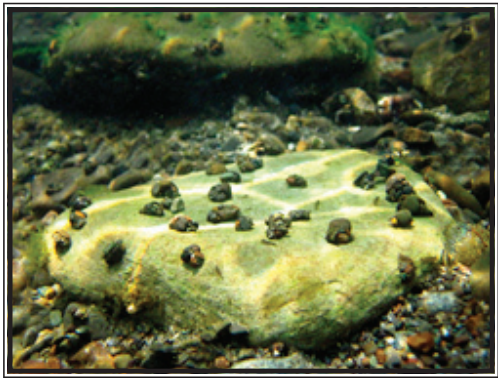
Subsurface image: *Glossosoma* larvae moving across a rock below the Pickerel Weir.

Image on left shows *Glossosoma* caddisfly larvae in Putah Creek below the Pickerel Weir. Weir construction and the realignment of the Design Channel have extended the *Glossosoma* population from the Morales property to an area downstream from I-505.

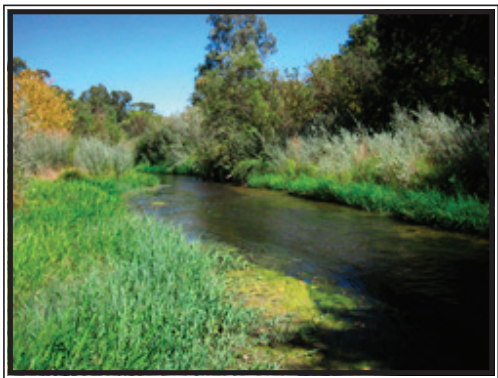
Neil Property: Shows riffle area at the Neil Property access.

Completed baseline community study at the site which is the upstream site for the River Parkway Project.
