**Subject: General Update on Scarification, Salmon and other Assorted Projects**

**REPORT 5753**

General Update

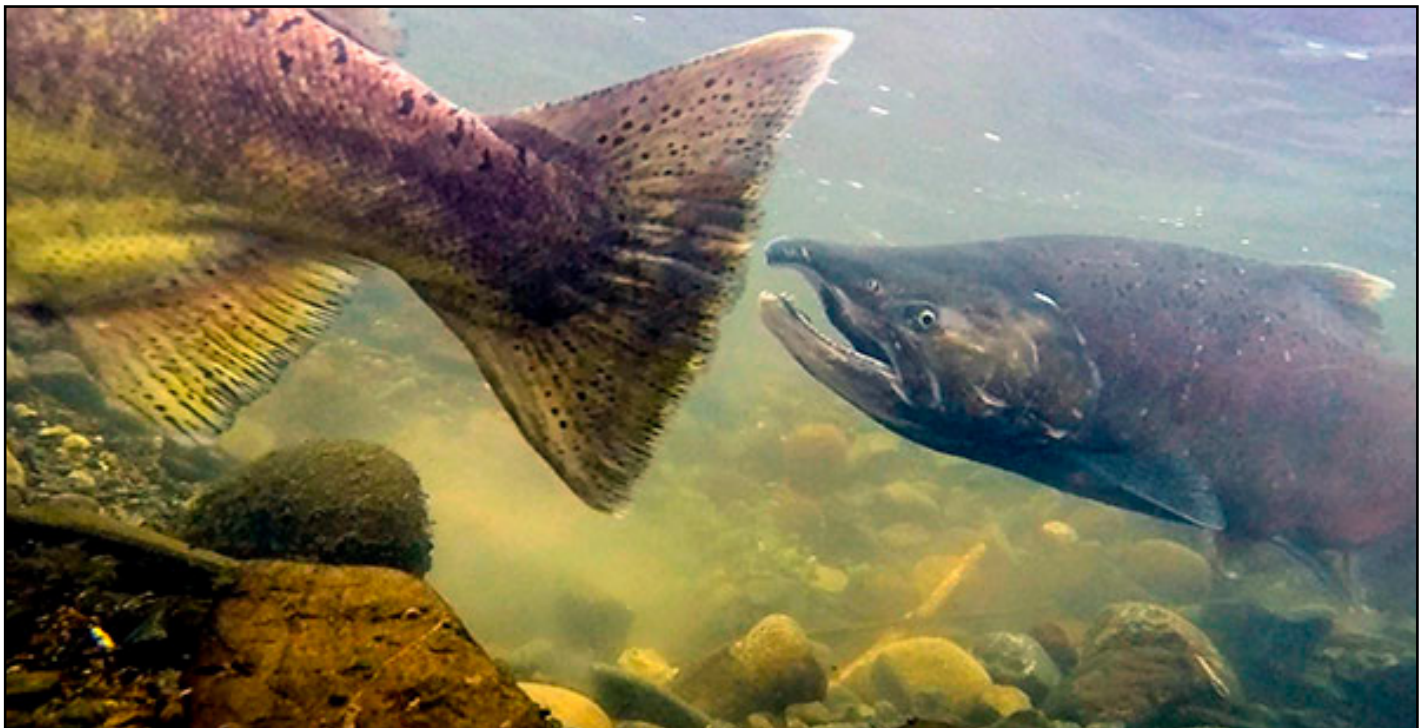
2017 Chinook salmon on edge of 2014 Scarification Ridge.

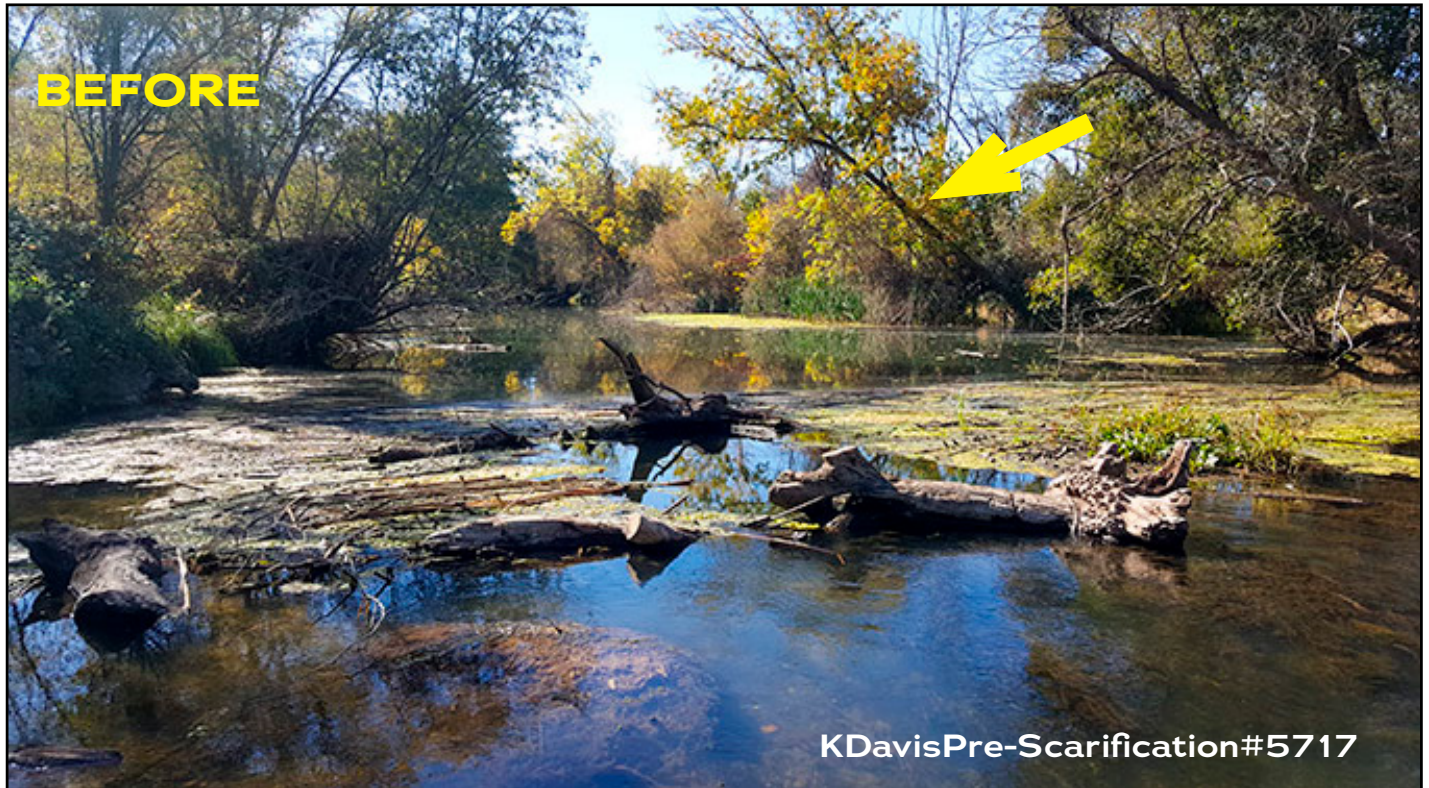
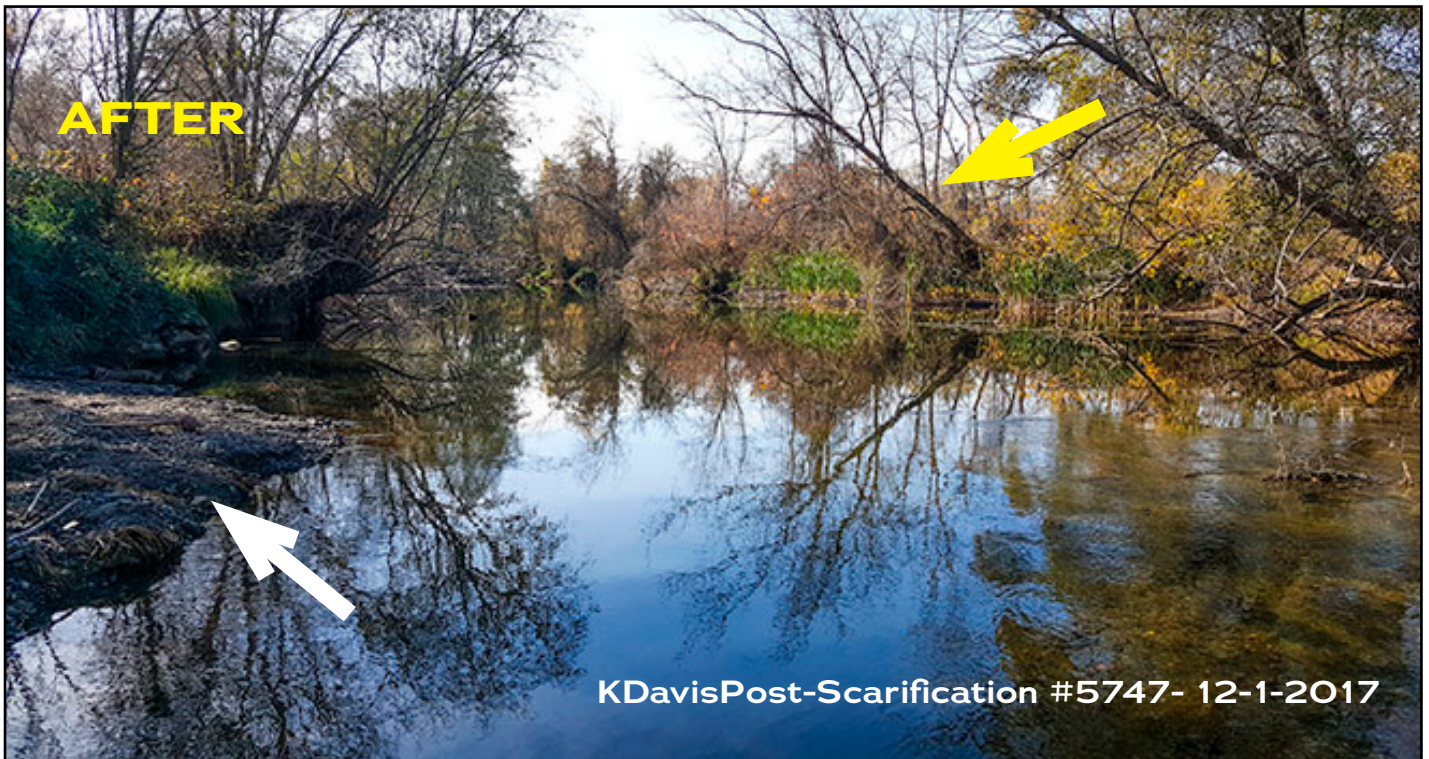
The existing DFW Permit that covers the Scarification Project requires that a biologist be on site before and during the scarification actions. It also requires an effective wildlife survey prior to the scarification and follow up with an array of other surveys including benthic macroinvertebrates, salmon, and quality of salmon redds. All conditions of the permit have been followed. The “matched” images below were taken at the Dry Creek

Confluence. Dry Creek is on the right out of sight. The YELLOW arrows point to trees that provide match for the images. The WHITE arrow points to a gravel bar that was exposed by lower water level created when the flood debris was removed in the area selected for scarification. The scarification area has been used extensively by spawning salmon. NO gravel, cobble or other material was placed or moved into the creek during the scarification process.

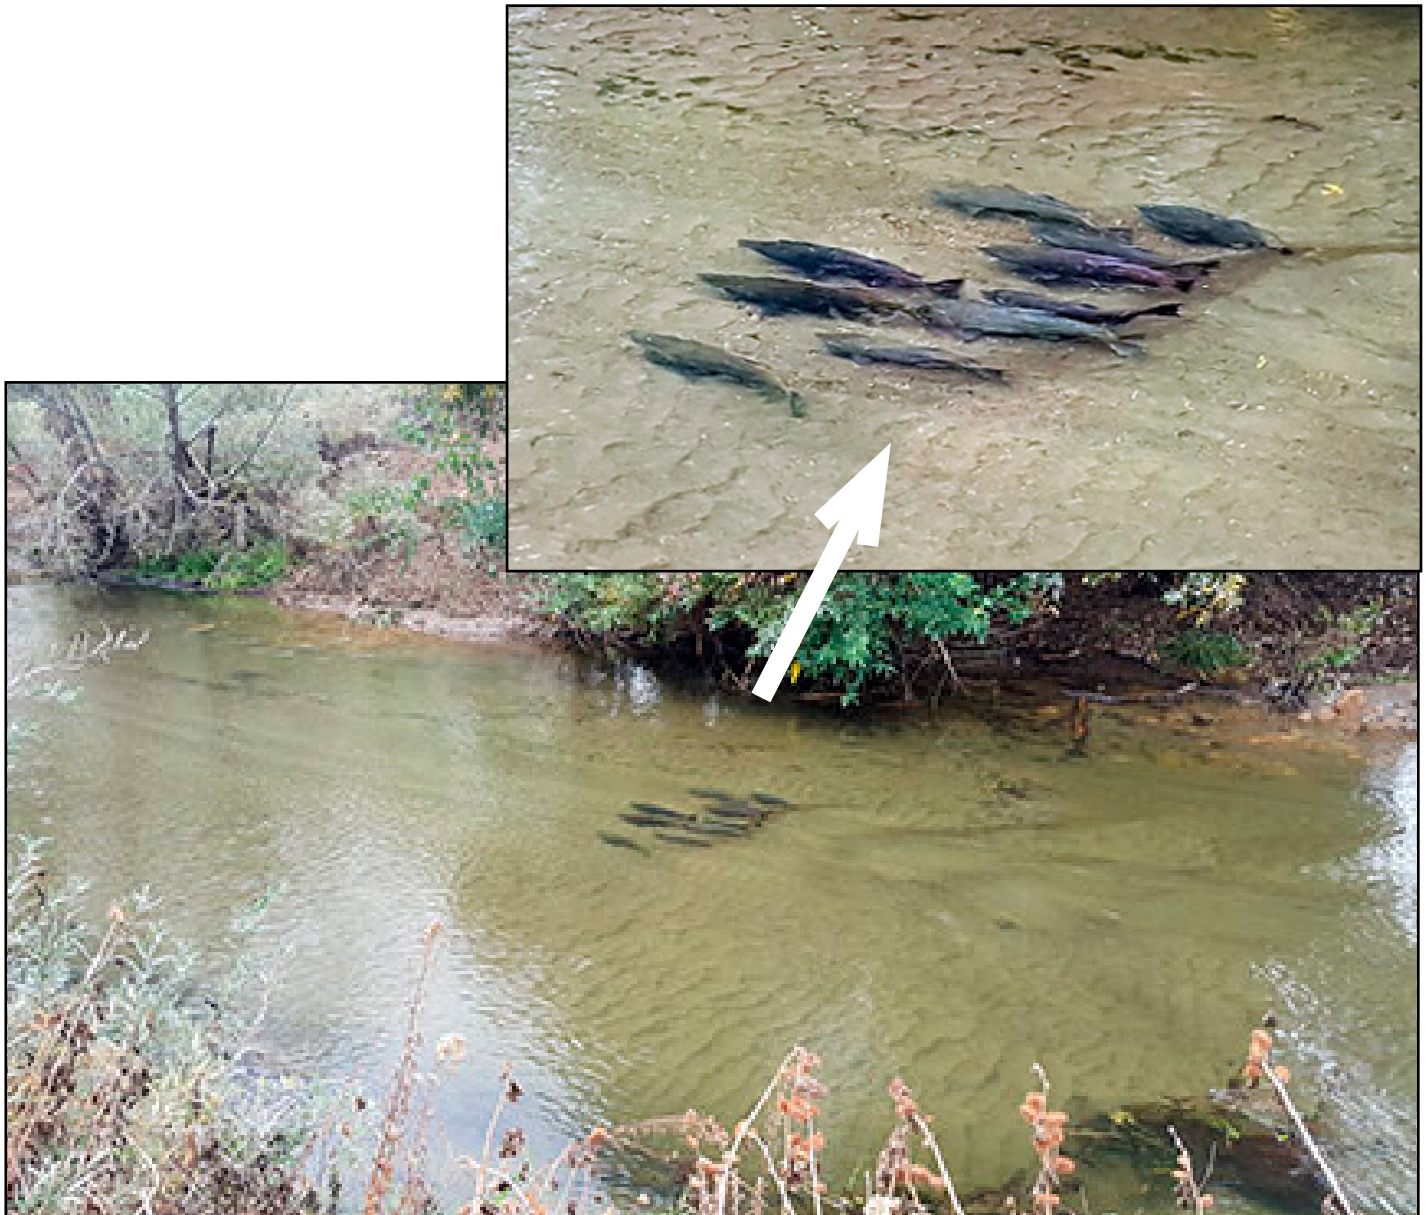
The extensive floods in 2017 deposited several feet (more in some areas) of sand in the main stem of Lower Putah Creek. Example below, shows a school of salmon moving across an area that was a Scarification Control site since 2014. The area now has approximately three feet of sand over the former base of cemented benthic material. The area has proved essentially worthless for use by salmon, benthic macroinvertebrates and probably native mussels which require more plankton than is available below the Putah Diversion Dam.

**Salmon moving across the Harris Scarification Control Site on 11-10-2017.**

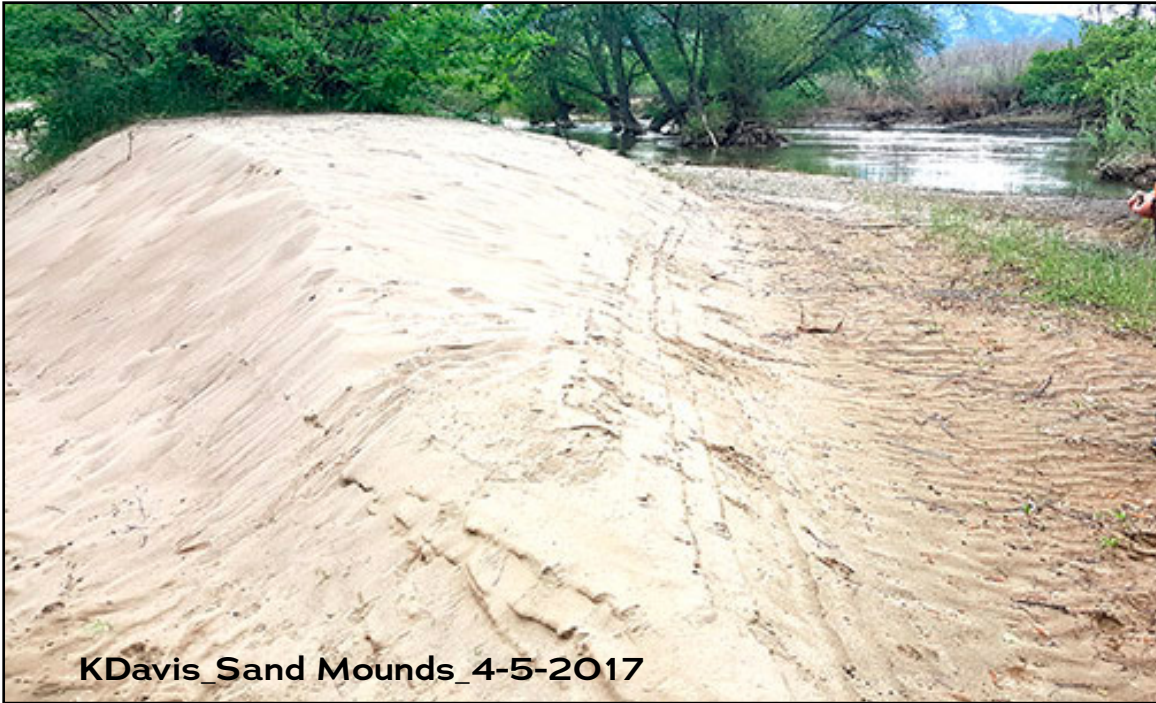
Images below continue to demonstrate the massive amount of sand that was relocated downstream. Images are important to document the reason why benthic macroinvertebrate density and diversity has severely diminished.

Sand mound on the Morales property, approximately 1/4 mile below the Putah Diversion Dam. Mounds such as this one are common in some areas of the lower creek.

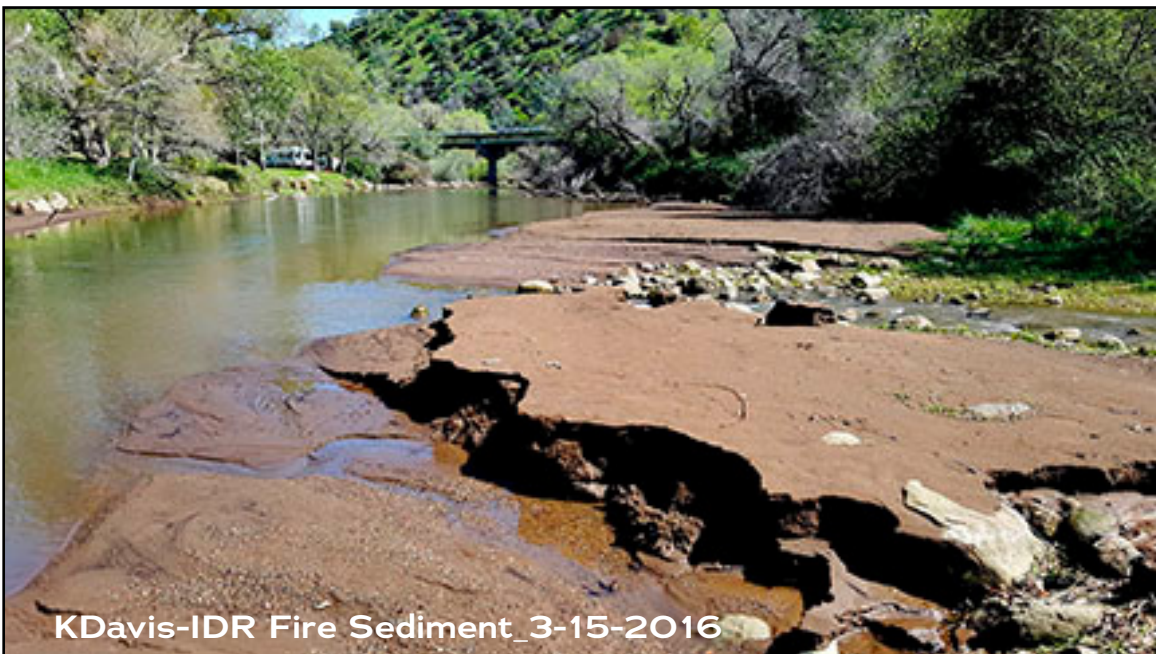
Interdam Reach at Cold Creek confluence. Canyon Creek RV Park on left. 3-15-2016 image shows the massive amount of sediment that was expelled from Cold Creek. The sediment effectively covered the streambed cobble and appeared to carry nutrients responsible for a filamentous algae bloom and increased density of New Zealand mudsnails.

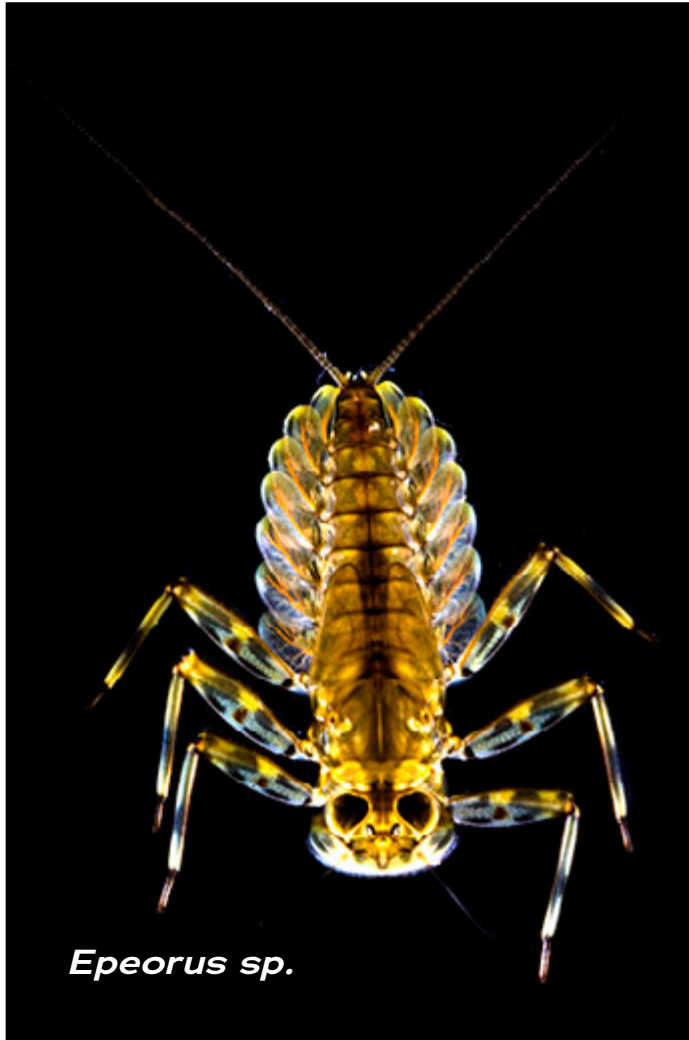
Prior to the wildfires, the IDR has had significant populations of *Epeorus sp.* including the specimen on the top left. The *Ameletus sp.* is common in Miller Creek.

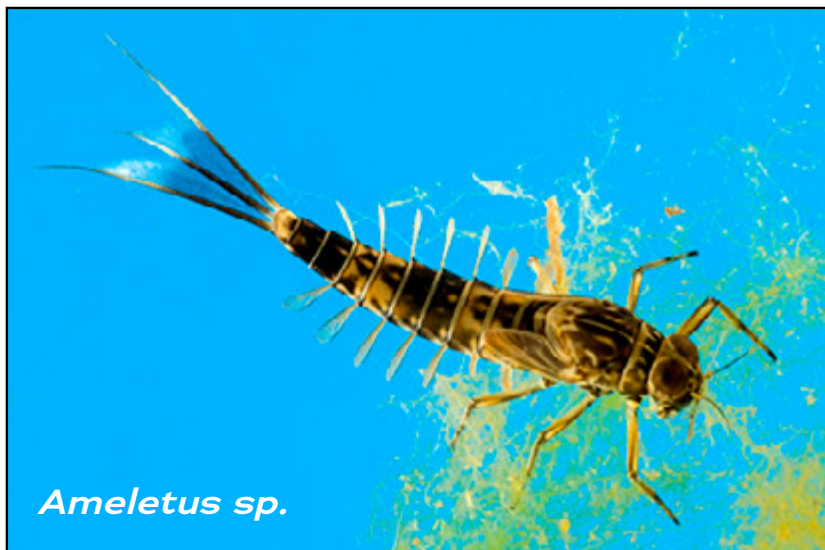
*Ameletus sp.*

The BMI community in Miller Creek is significant and represents possibly the best invertebrate community that can recruit into Lower Putah Creek. Several species have moved down into Pleasant Creek near the Putah Creek road bridge.

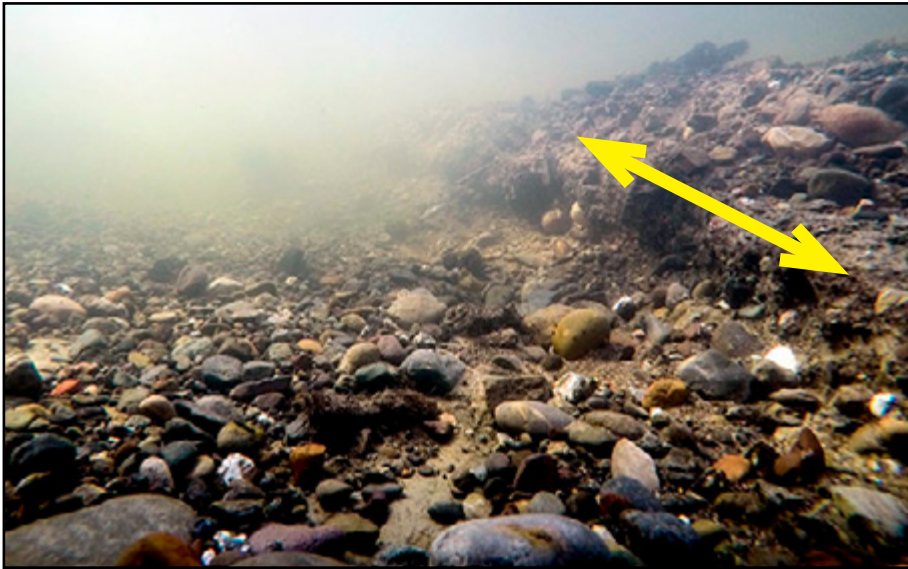
**Superimposition:** Superimposition does not appear to occur at least at the number of salmon estimated to spawning in 2017. The females appear to prefer to open the edges of the scarified areas rather than spawning on existing redds.

**Image on Left:** This site is at the Dry Creek confluence. Note the ridge (yellow arrow) that shows the edge of the scarification project due to the limited reach of the excavator.

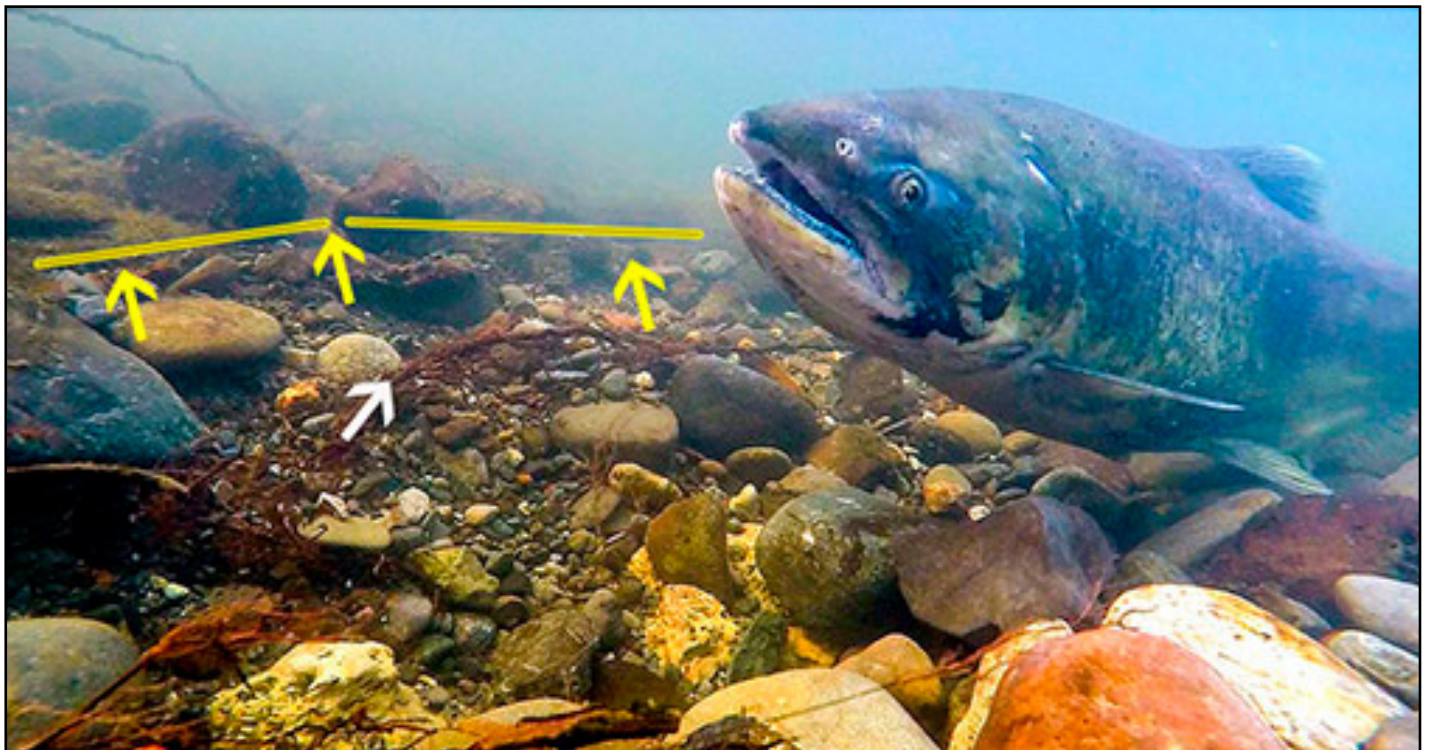
The image below shows a female salmon on 11-11-2017 in the 2014 Scarification Control site. The arrows show the upstream edge of the scarification area that was also enlarged in 2015 and 2016. It appears that the area was enlarged by at least 25 feet (2017) on the upstream side. I will elaborate more on this site in the 2017 Scarification Report.

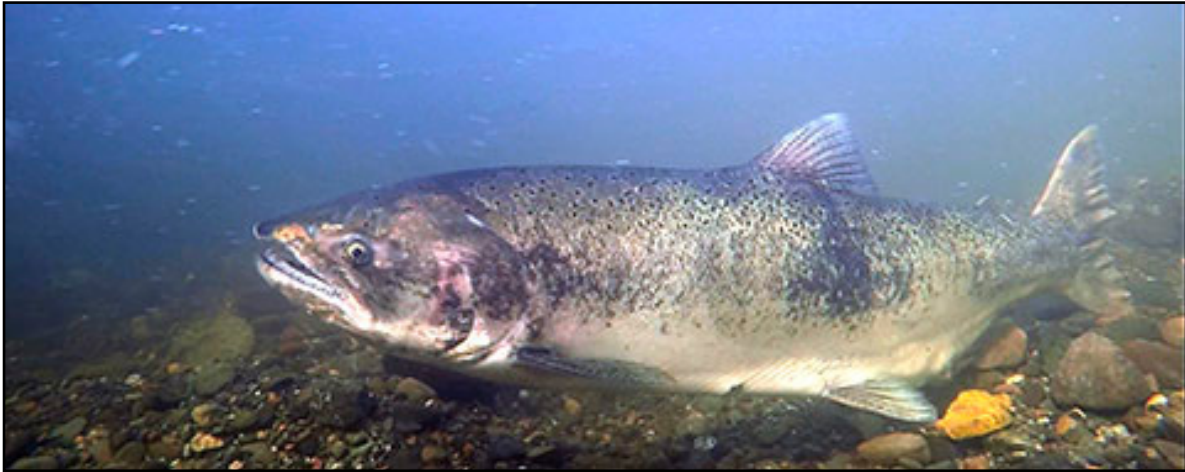
Female salmon in the Pickerel Run Scarification area that was scarified in 2016. The site has some ideal cobble and large amounts of sand.

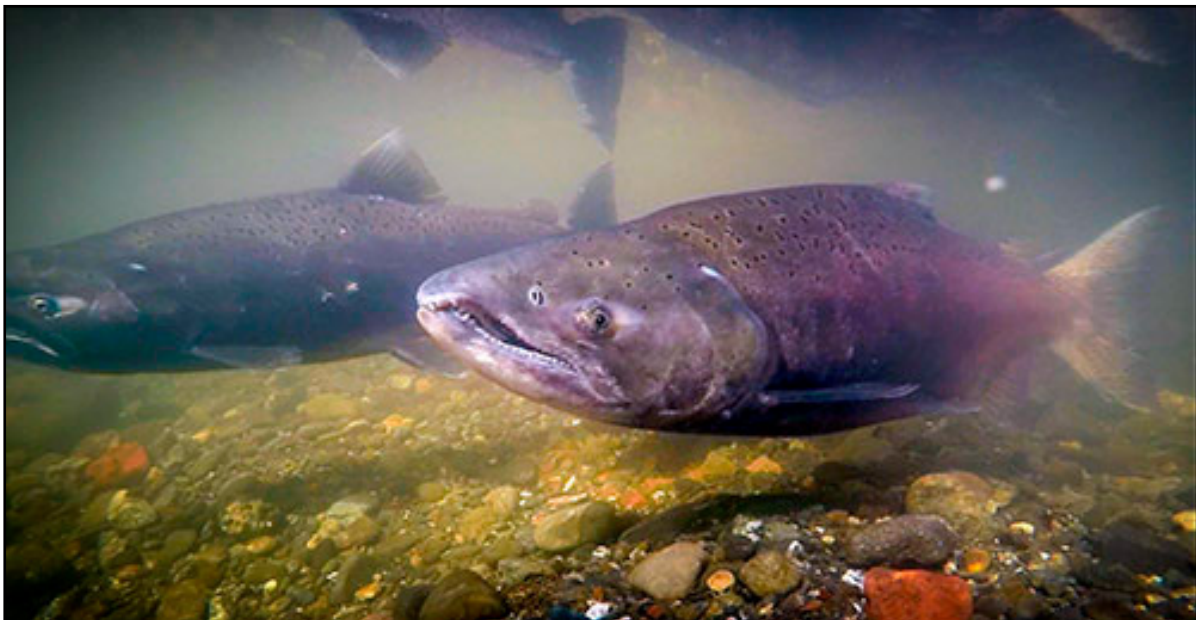
Pair of salmon in a 2016 Scarification site near I-505.

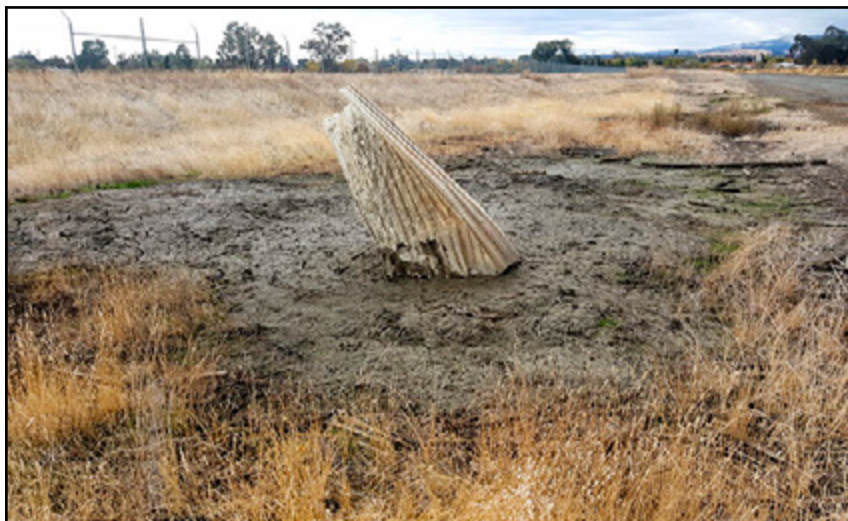
**Putah South Canal:**

Invasive species Surveys continue in the PSC. All sediment and debris removed during the 2017 canal cleaning will be examined. Image shows a debris pool near Allendale.

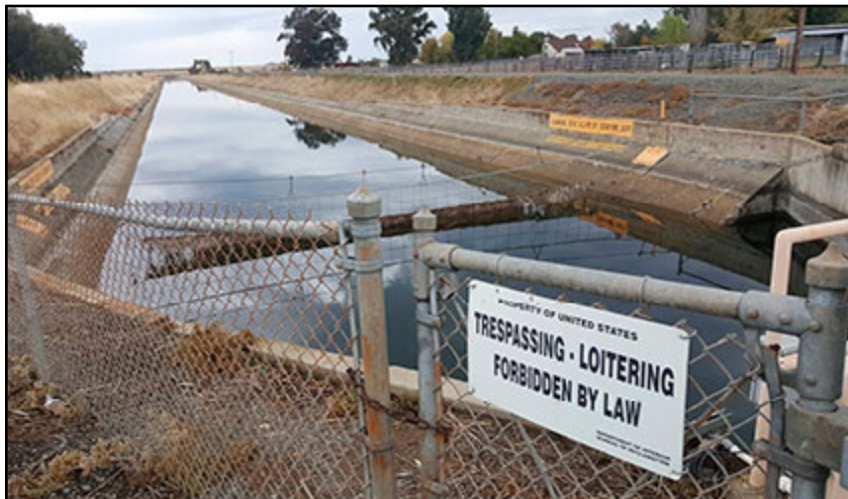
**Putah South Canal:**

Infrastructure is examined from the bank.

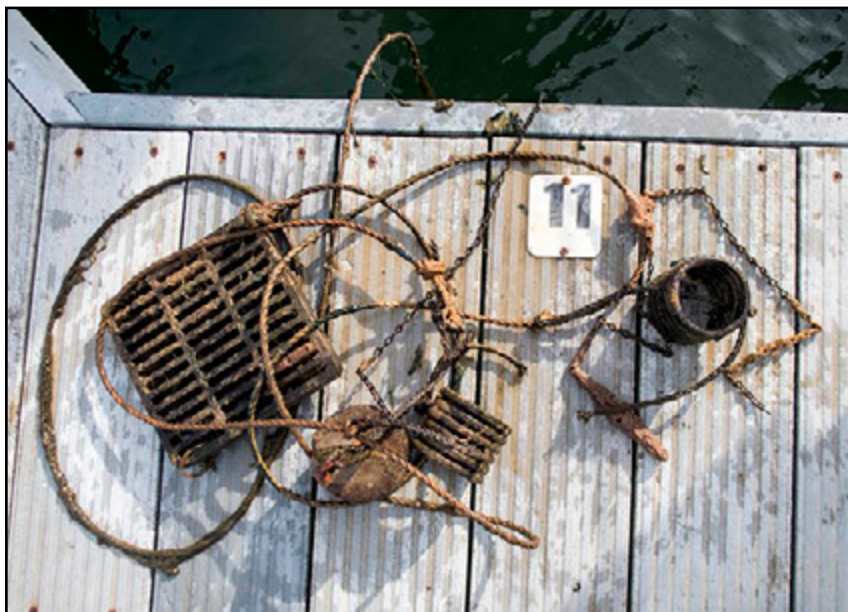
**Lake Berryessa Eurasian Mussel Surveys:**

Mussel Surveys continue in the lake. Surveys include plankton, infrastructure and colonization trees as shown on the left. All colonization devices are examined and cleaned once per month.

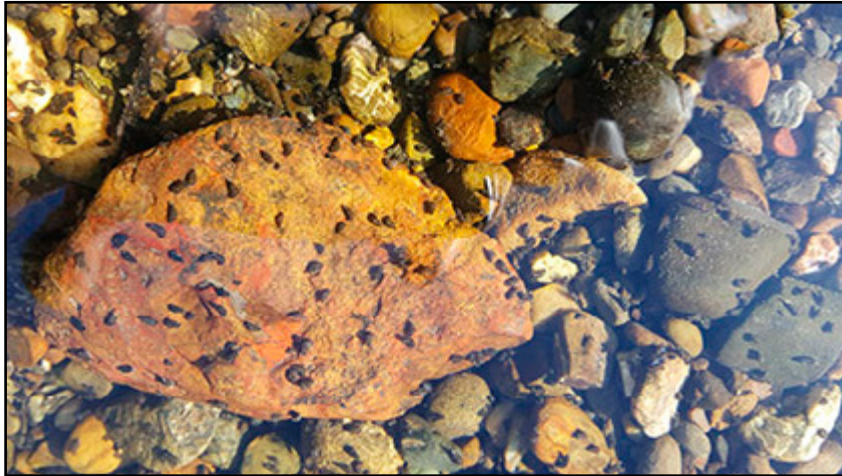
Mudsnail density is increasing in some areas. Like most other aquatic invertebrates, mudsnails were buried by sand mobilized during the 2017 floods.
