REPORT 5890 Scarification Images

Subject: 2017 Scarification Sites- Comparative Images for Project Site 2 (Morales 1 of 3)

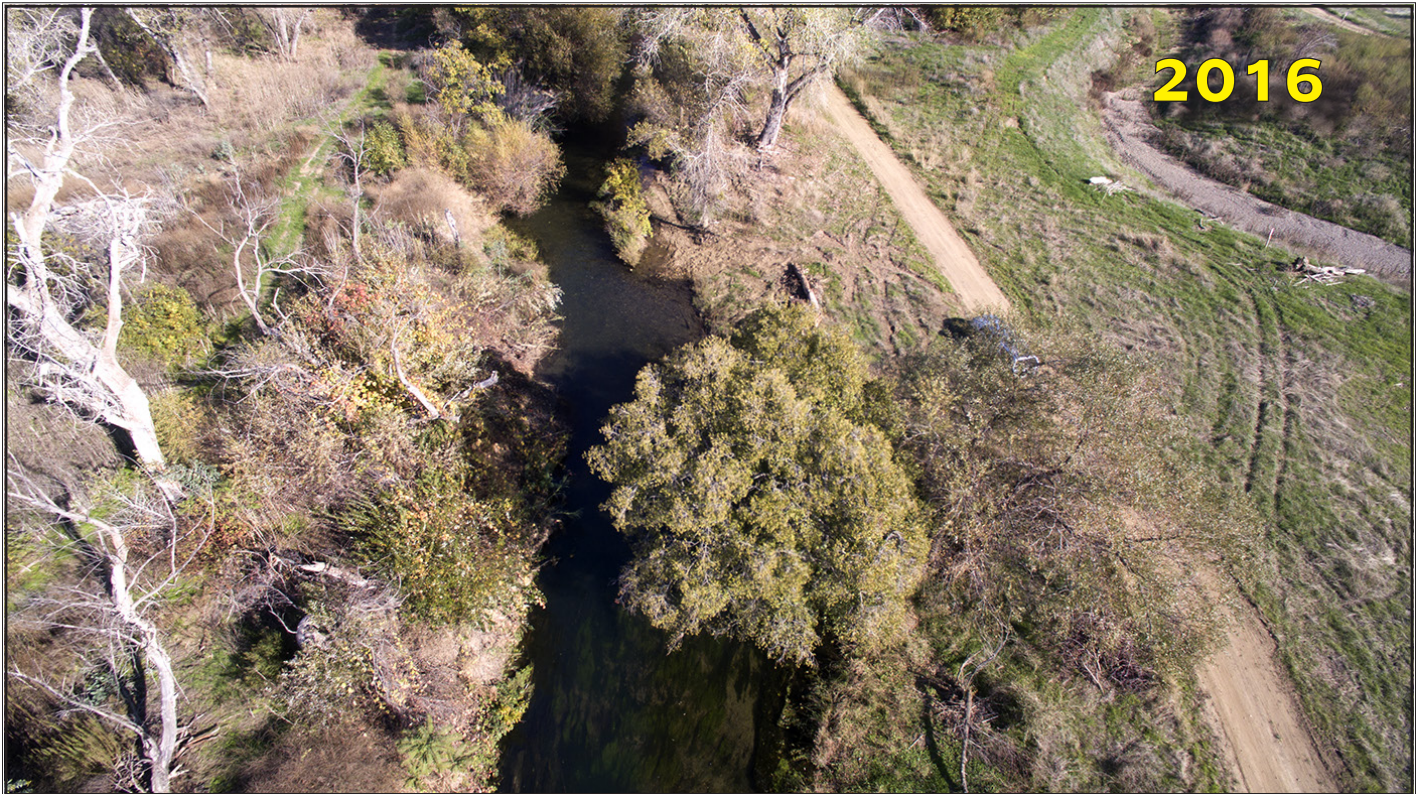
Aerial image of Pre-Scarification site taken on 11-18-2016. Site was not usable by spawning salmon prior to 2017 scarification due to a cemented benthic condition and slow water.

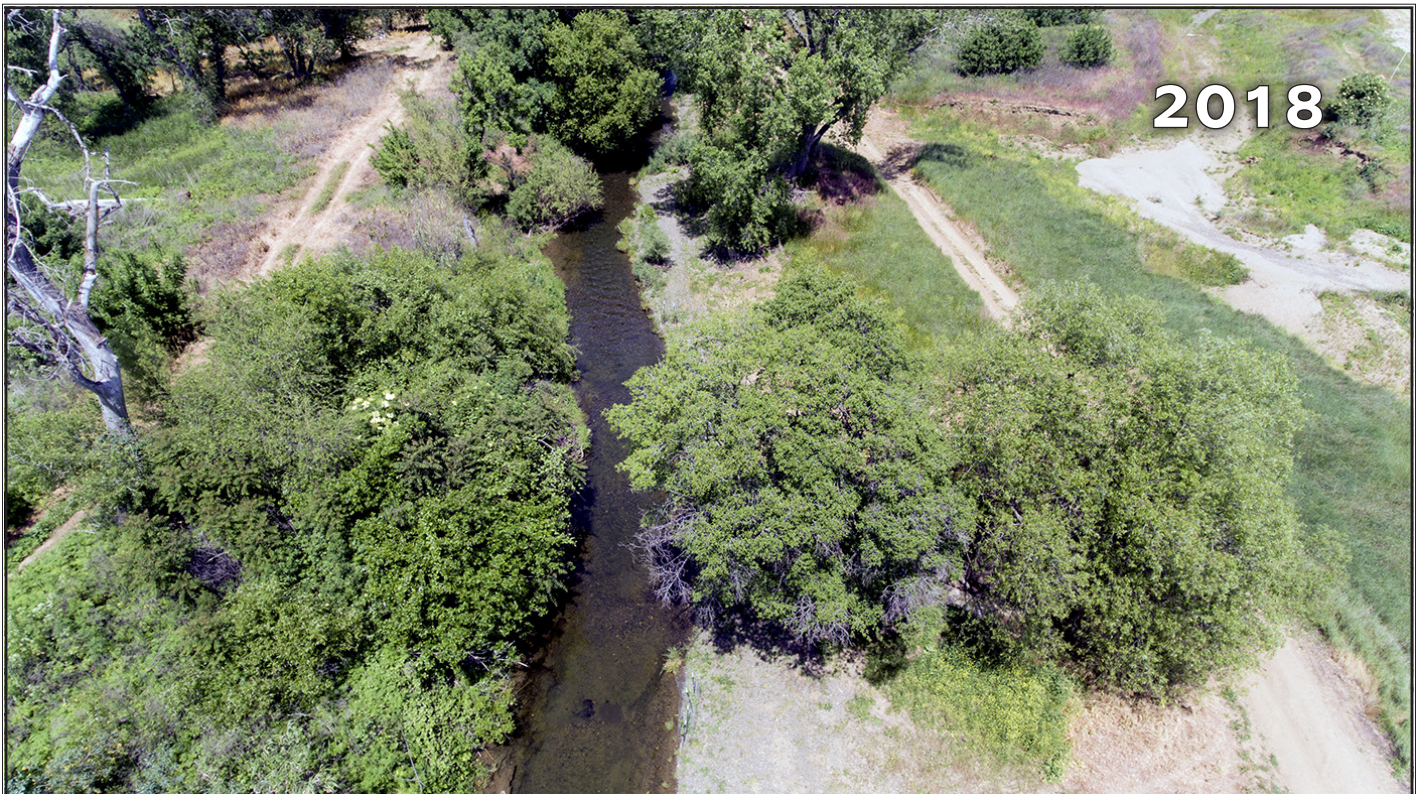
5-1-2018 Aerial image of 2017 Scarification Site # 2. Post Scarification. See on-ground image on Page 3

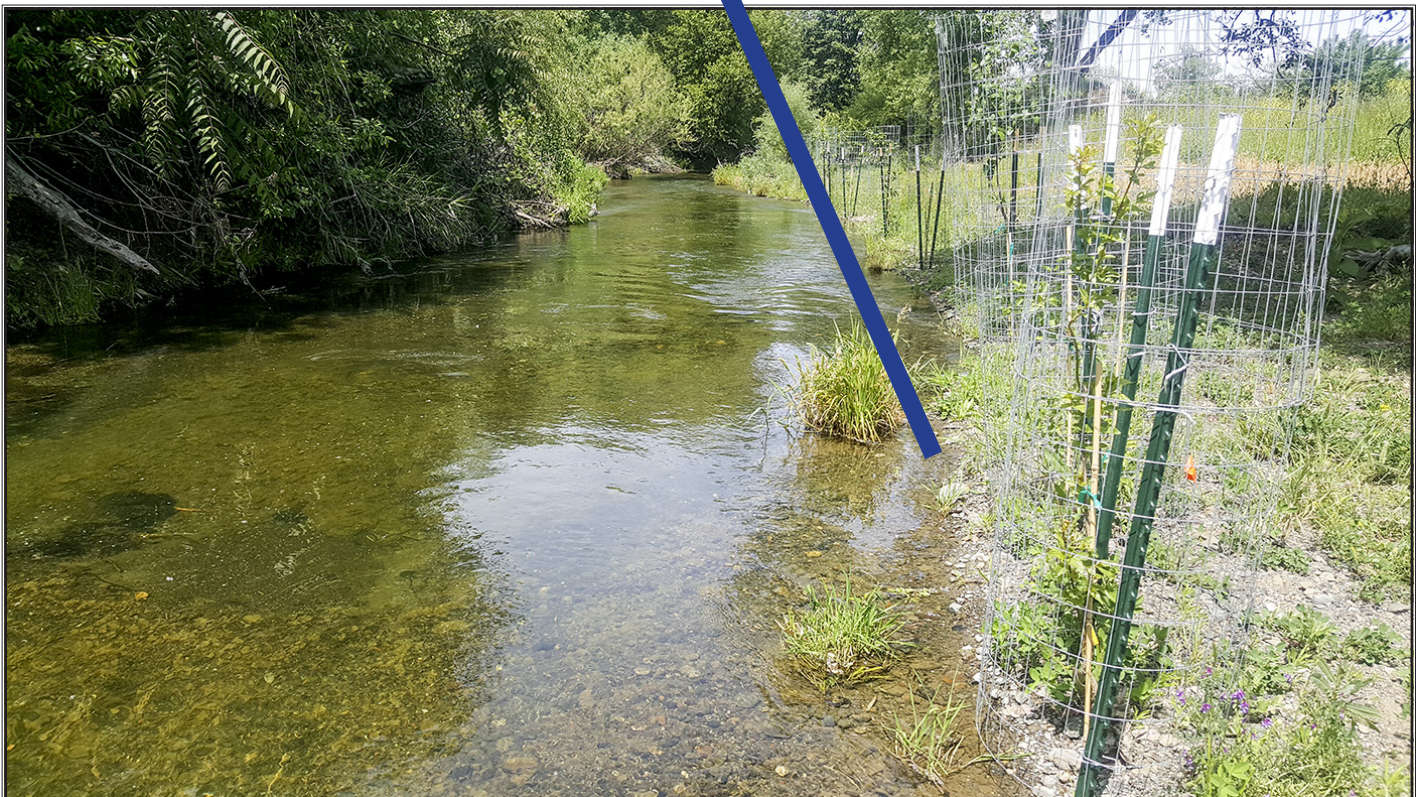
5-1-2018 image of Scarification Site # 2. Post Scarification. Salmon redds can be seen in this image. Arrow shows site of caged trees on aerial image.
