Subject: Scarification / Creek Condition Post 2019 High Water

The following is a brief update on current creek conditions from Pickerel to Morales as of April 14, 2019. I was getting reports of high-water isolation pools which can be another opportunity to find benthic macroinvertebrates that might have migrated down from Miller Creek or other tributaries. It also allows me to determine the current state of juvenile salmon refugia and possible presence of juvenile salmon that survived high-water conditions. I offer the following images, comments, and recommendations:

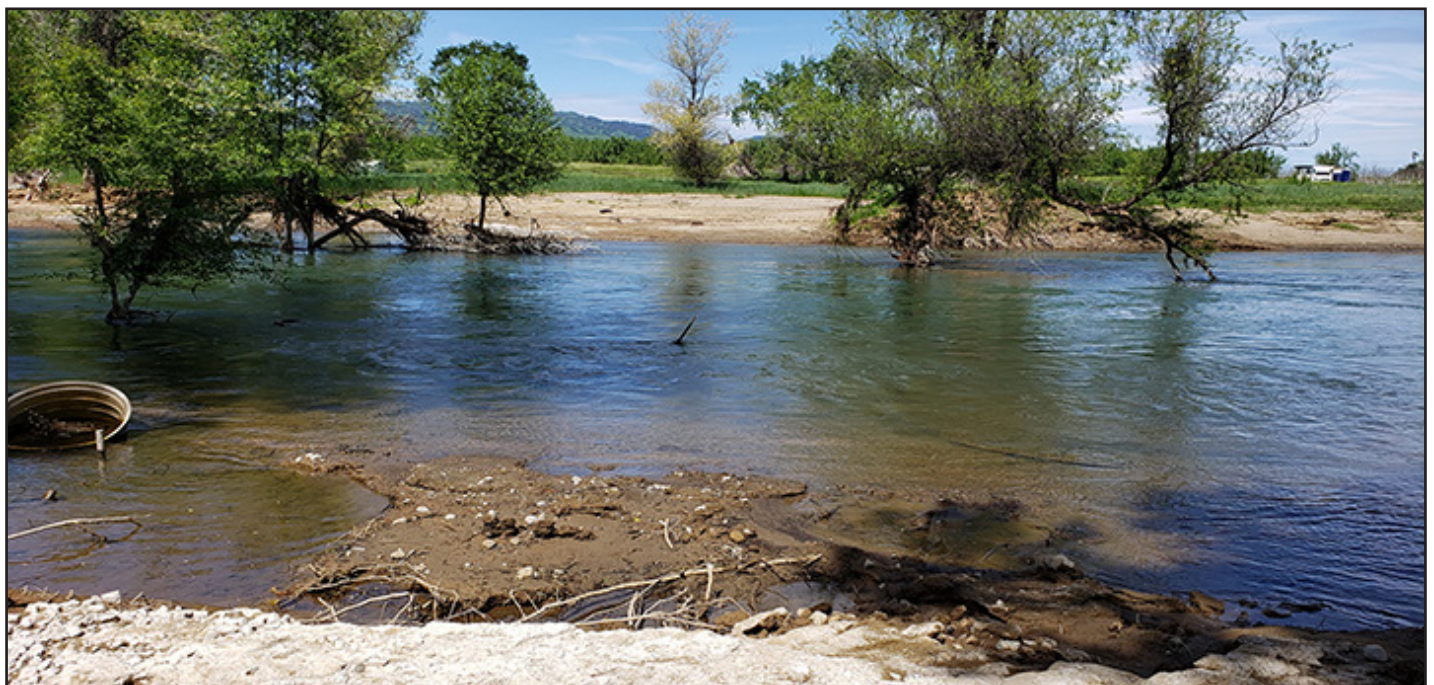
Pickerel Crossing on April 14, 2019

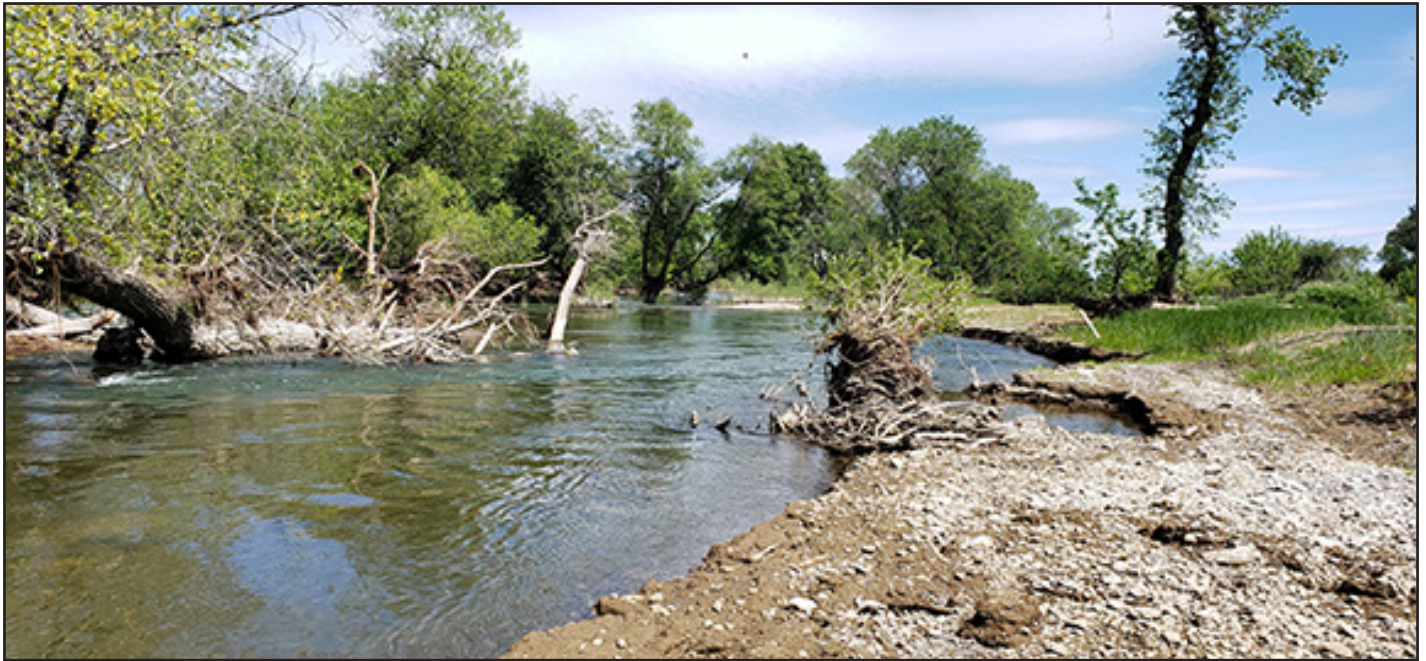
Section between Cody and Harris properties on April 14, 2019

3. **Scarification Future:** As documented on pages 2 and 3, there are significant deposits of cobble that are ideal for spawning Chinook salmon. Some are adjacent to existing scarification sites. Rick Fowler and I will evaluate these sites for their potential inclusion into the 2019 Scarification Project.

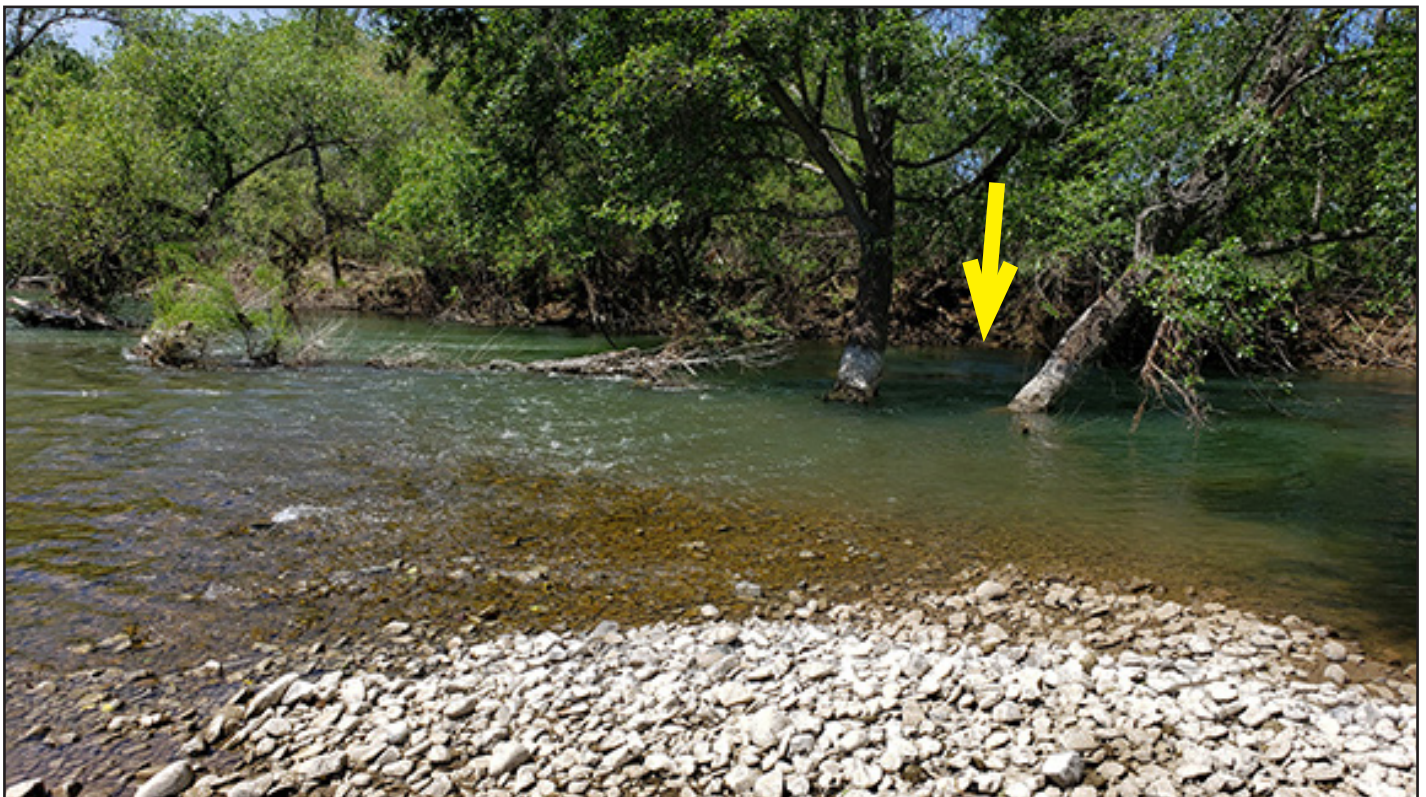
Harris section on April 14, 2019. The 2014 Scarification Control site (yellow arrow) is behind the trees on the right. This area is possibly the best salmon spawning area in Lower Putah Creek.

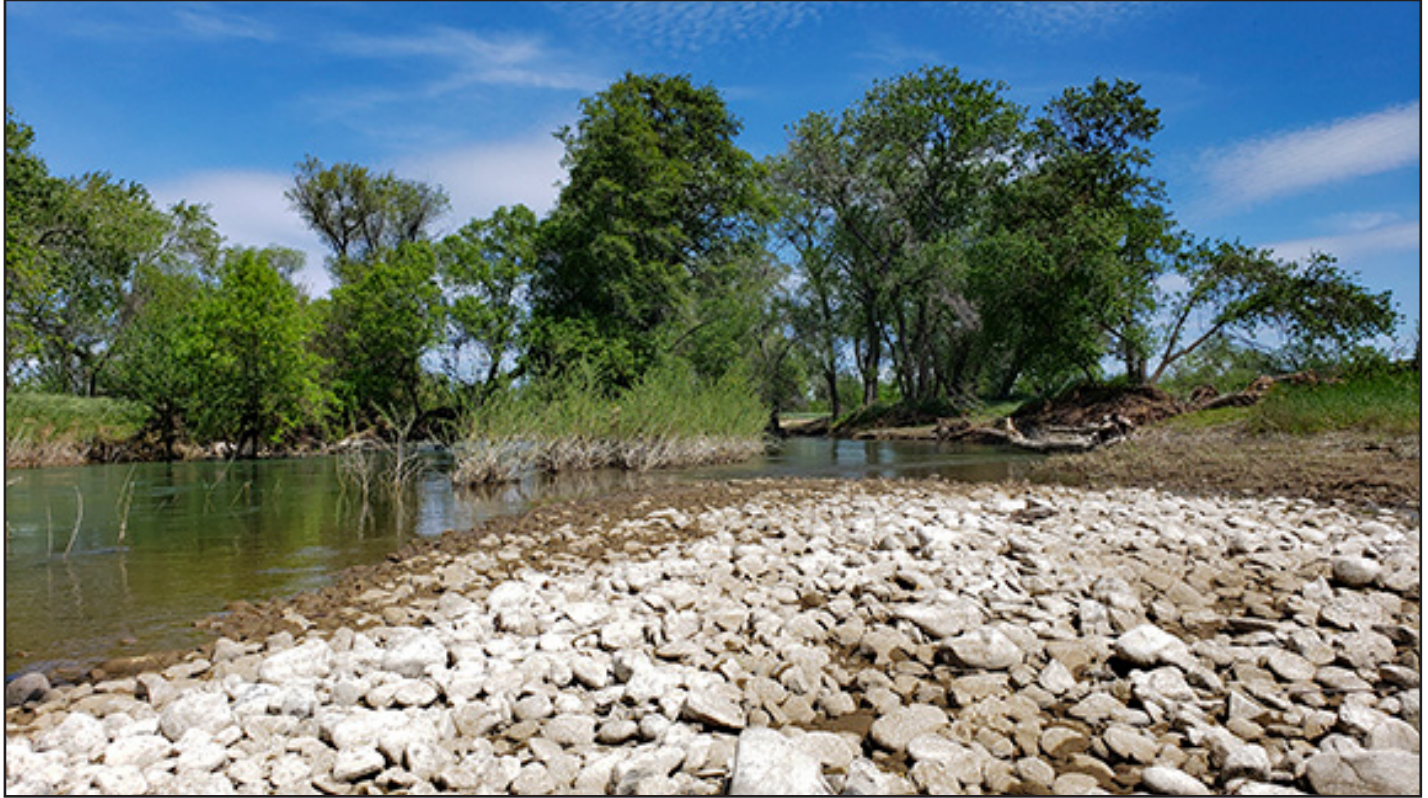
Upper section of Morales property on April 14, 2019
