Wildlife Survey & Photo Service

June 7, 2016

Subject: *Letter From Mr. David Springer (Winters Friends of Putah Creek) dated May 23, 2016*

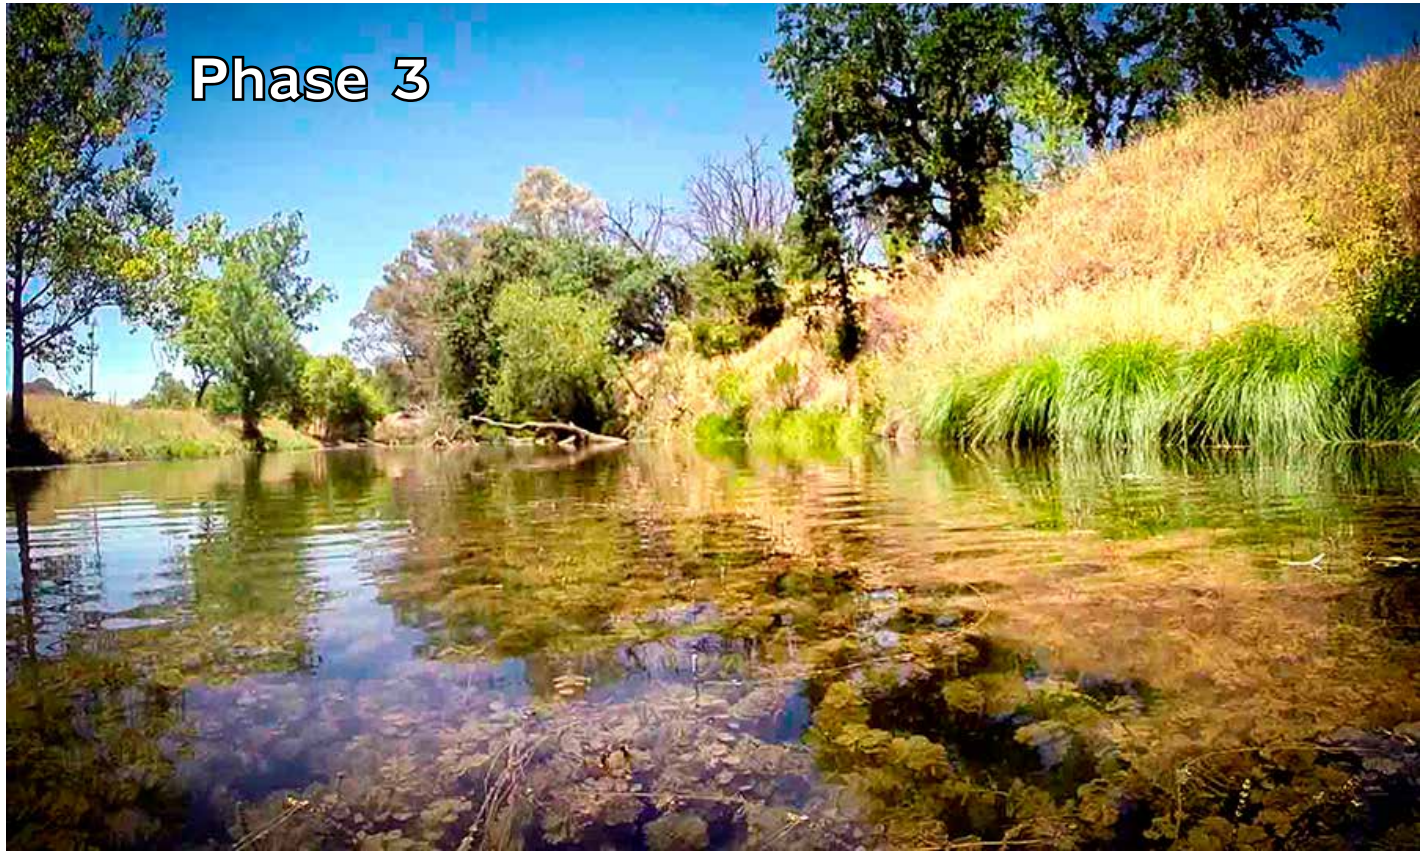
*Phase 3: Image of Phase Three facing upstream. Image shows the dominant water plant *Myriophyllum* sp., an invasive species which is considered a noxious aquatic weed. This image is important because it shows the lack of diversity, the high banks, and lack of riparian cover. Image taken from kayak on 6/22/2016.*

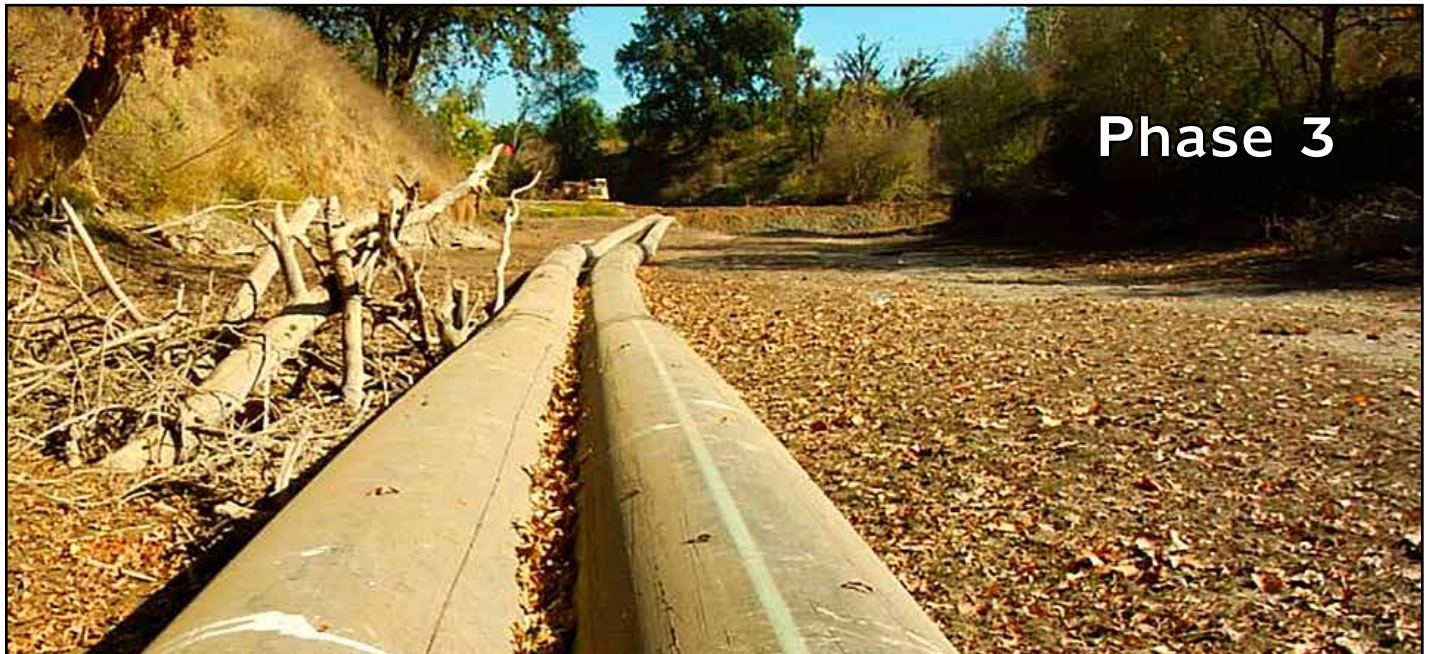
The aquatic diversity of species and habitat in Phase 3 is severely limited. The main aquatic plant species is *Myriophyllum*, an invasive noxious weed. The image below speaks volumes. The dewatered section clearly shows a flat, featureless creek bottom. Contrary to the **Springer Letter**, I expect the "biological diversity" to ultimately increase under the current plan for Phase 3.

Phase 3 - Downstream Section: Taken during the construction phase, this image was taken from video recorded on 10/11/2011. Looking downstream, you can see the crossing between Phase 3 and Phase 2 at the end of the pipes.

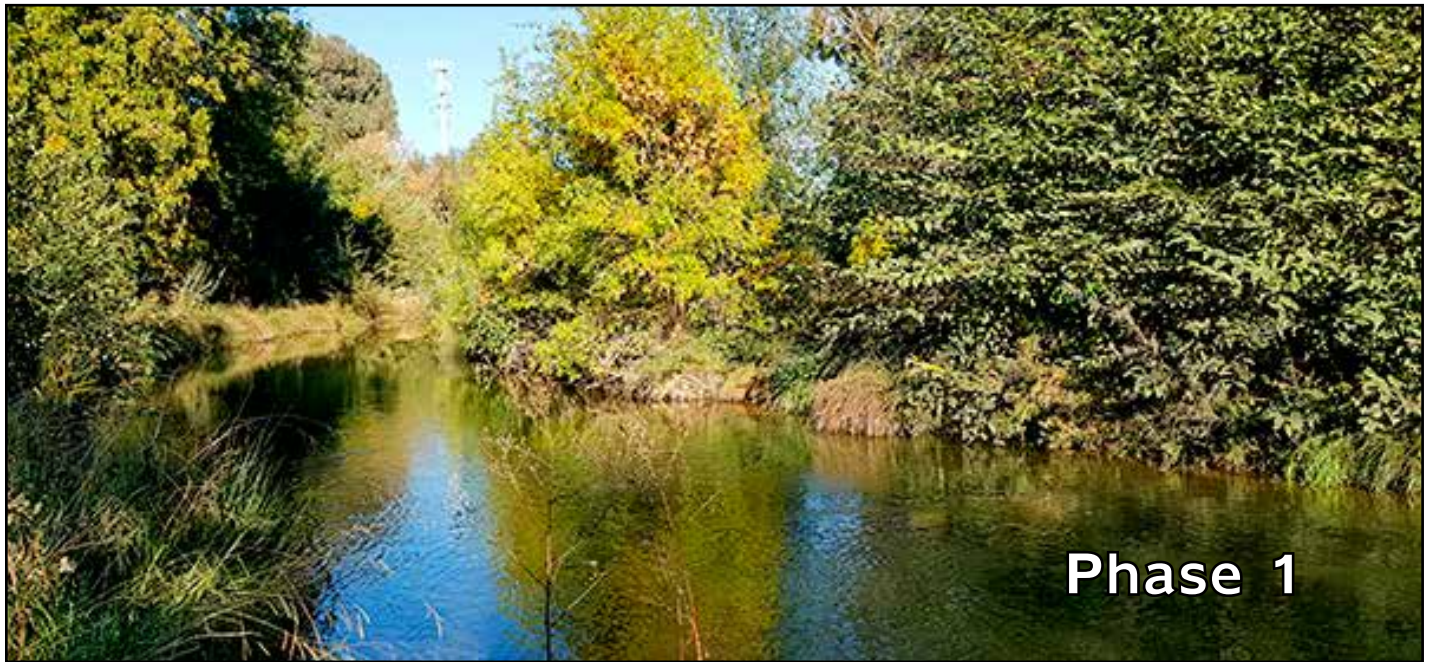
Phase 1: Image taken in Phase One (11/10/2015) just downstream from the Winters Bike Bridge. The section has a complex system of boulders, root wads and some cobble beds. The riparian vegetation (Alders, sedges, and other natives) is magnificent. The section will benefit from a scouring flood in the future. It is by no means perfect....yet.

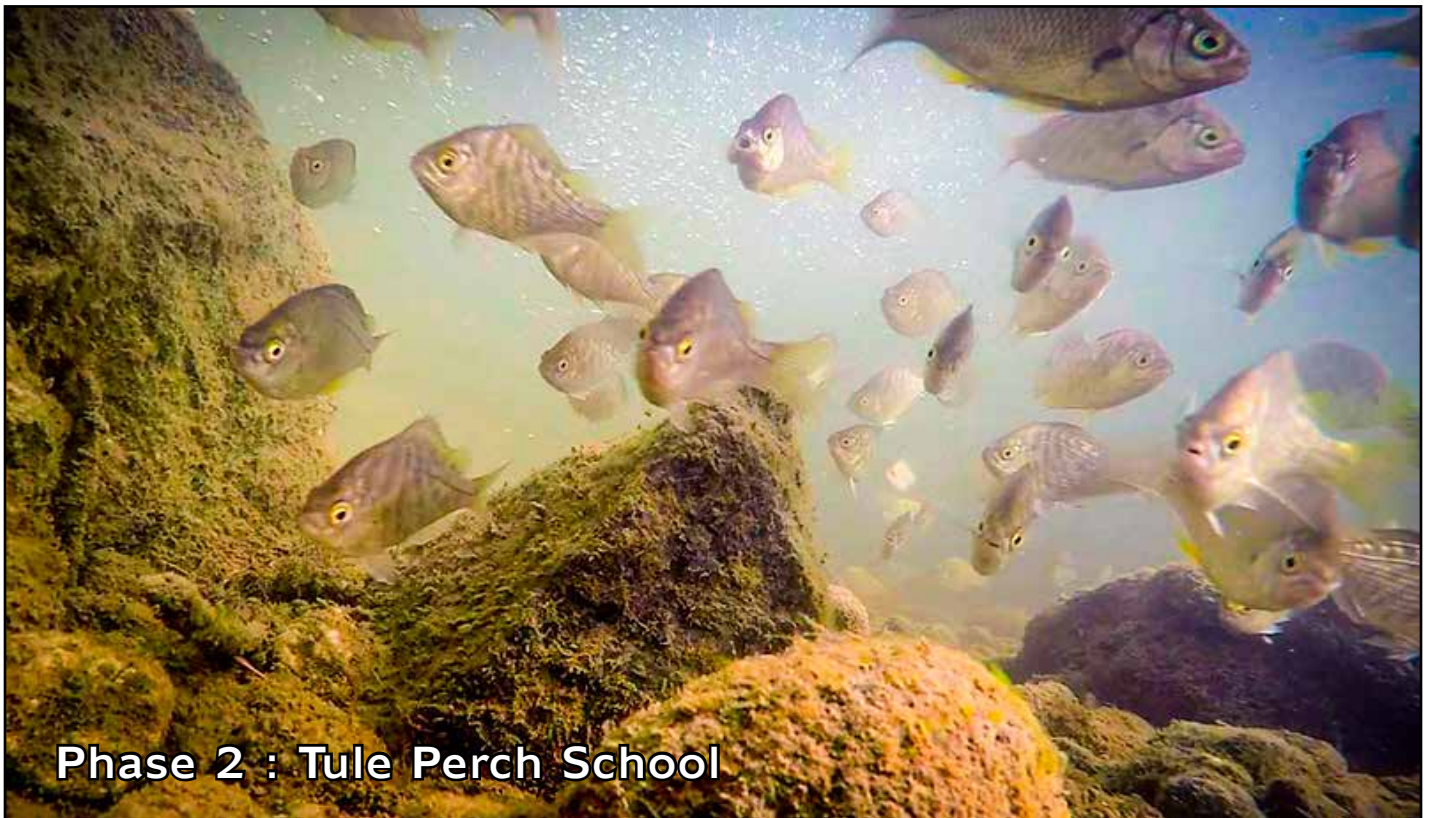
Tule Perch school: Image of a school of Tule Perch which are common denizens in Phase 1 and Phase 2. Image shows the school of perch and a boulder array in Phase 2 that is mixed with large root wads. Clipped from video File 5086-22R18. Trout and other species are also common in this area.

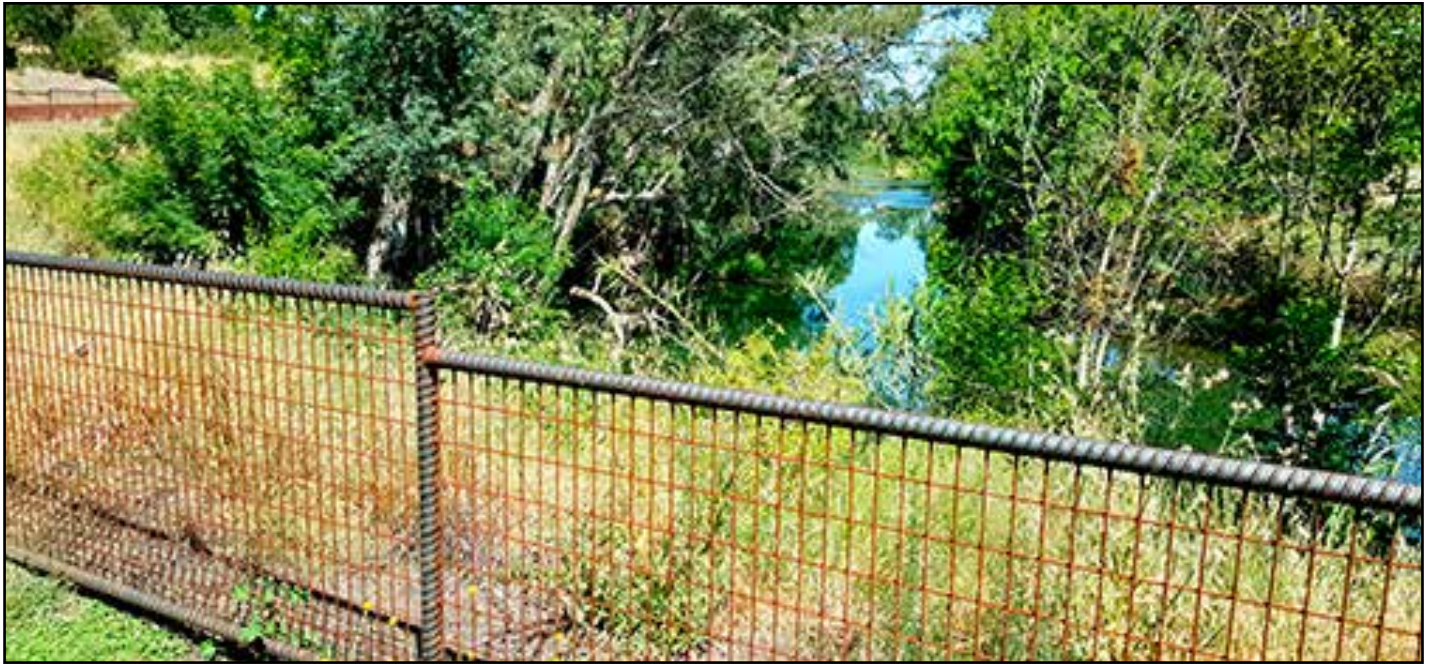
Phase 3 Wildlife Observation Area: *The section of Phase 3 as viewed from the Northside Trail. This is the area claimed to be a unique opportunity for people to view animals. Photo 5/31/2016*

WILDLIFE VIEWING - THE FUTURE: I do believe that if Phase 3 Construction moves forward as planned that wildlife viewing areas can be developed. I have already suggested that a couple areas might be ideal for visitors to get close up views of salmon and potentially other wildlife. That potential depends upon funding, permits and protection of viewing areas. Unfortunately, I have worked on other projects where expensive viewing facilities and kiosks were developed only to be severely vandalized. The interest and energy of the residents represented by the **Springer Letter** can be instrumental to the development and protection of wildlife observation sites.

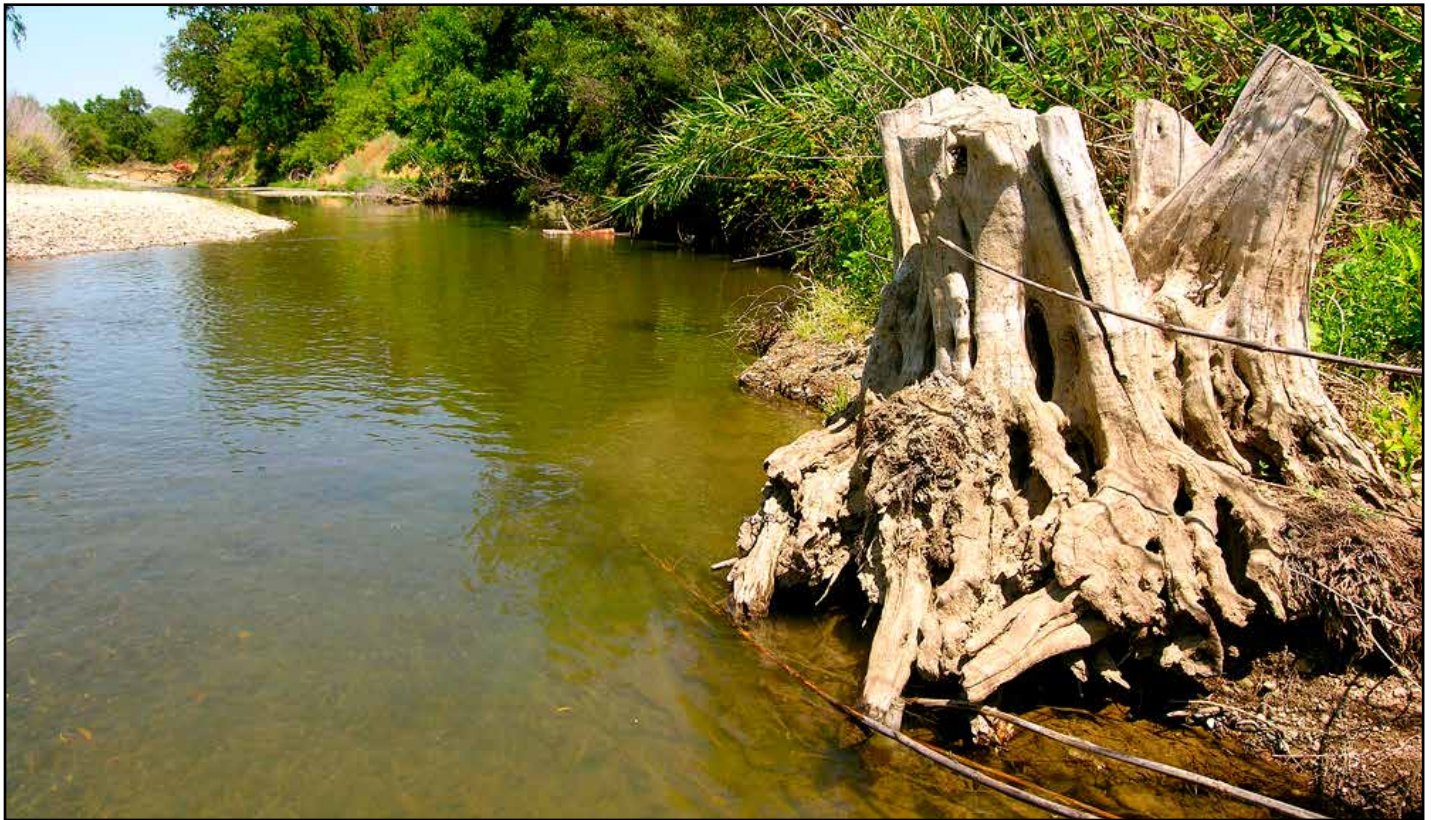
June 24, 2005 Image: Taken near Putah Creek Road. The road is behind the trees on the right side of the image. The aquatic invertebrate community was minimal in this area before realignment. The original channel was determined by a team that consisted of a hydromorphologist and several engineers. The creek was blocked, water diverted, and fish were rescued.

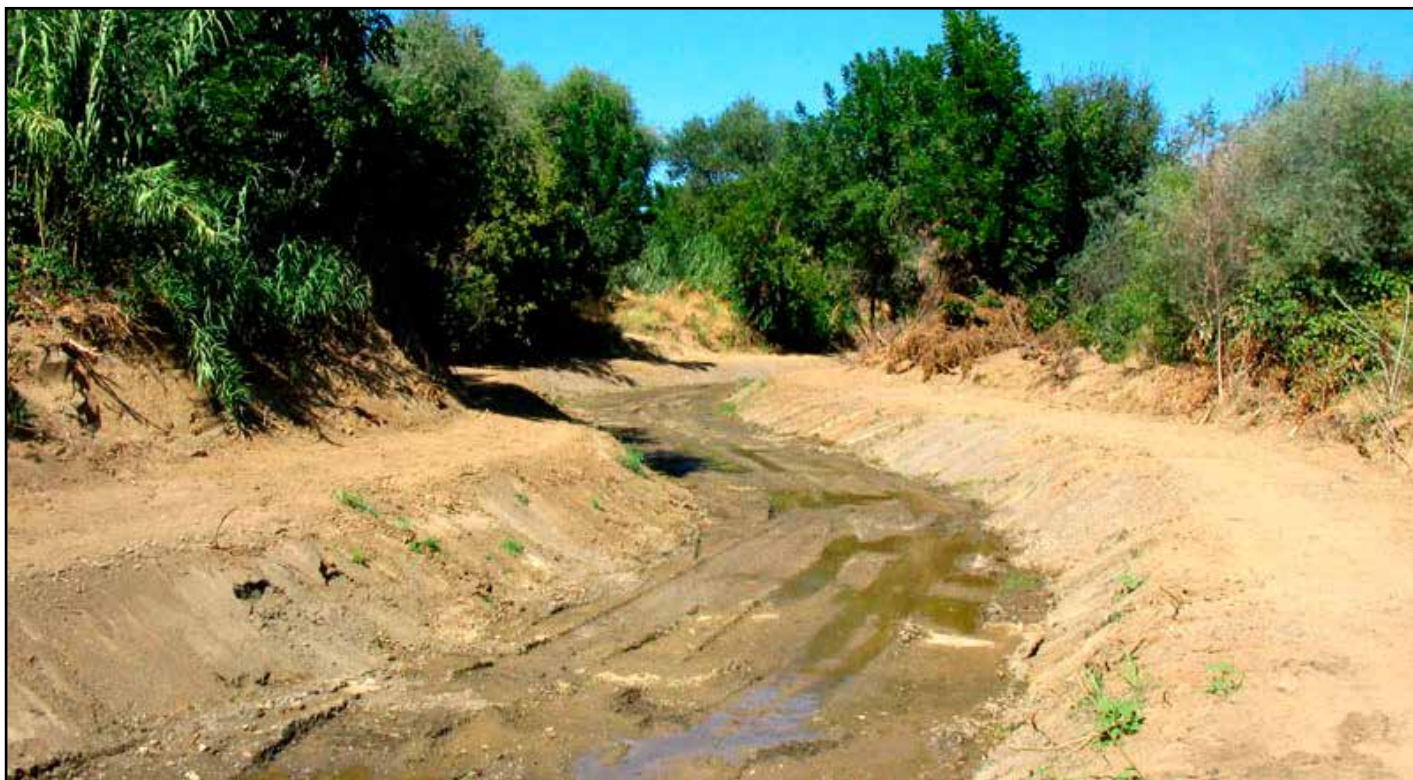
Dry Creek Realignment Project: Image taken on September 1, 2005 before the channel was watered. This is one of several hundred images taken to document various phases of the project.

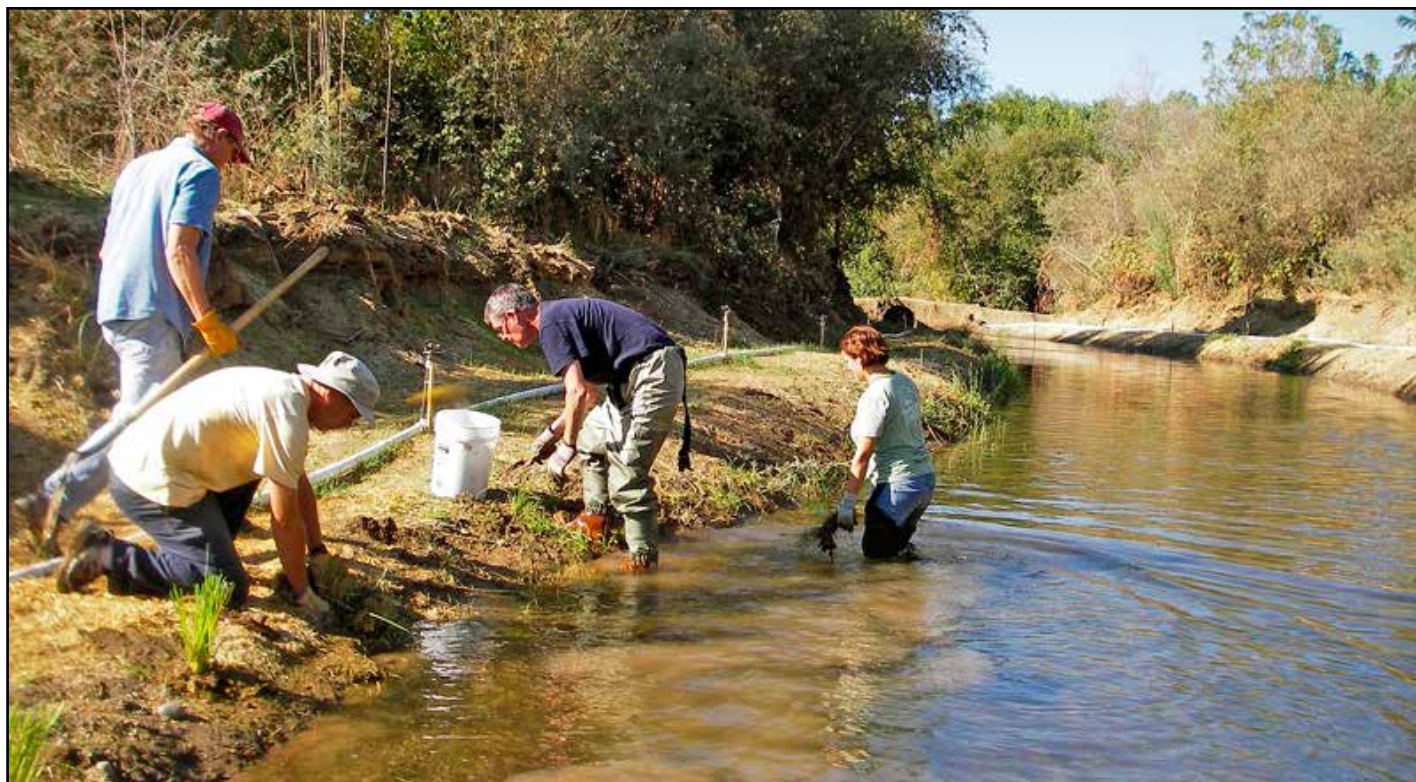
Dry Creek Realignment Project: Image taken on September 30, 2005. The channel had been "watered." Staff from Putah Creek Council and volunteers stabilized the banks and planted numerous riparian plants. Image file # 1743-22AA

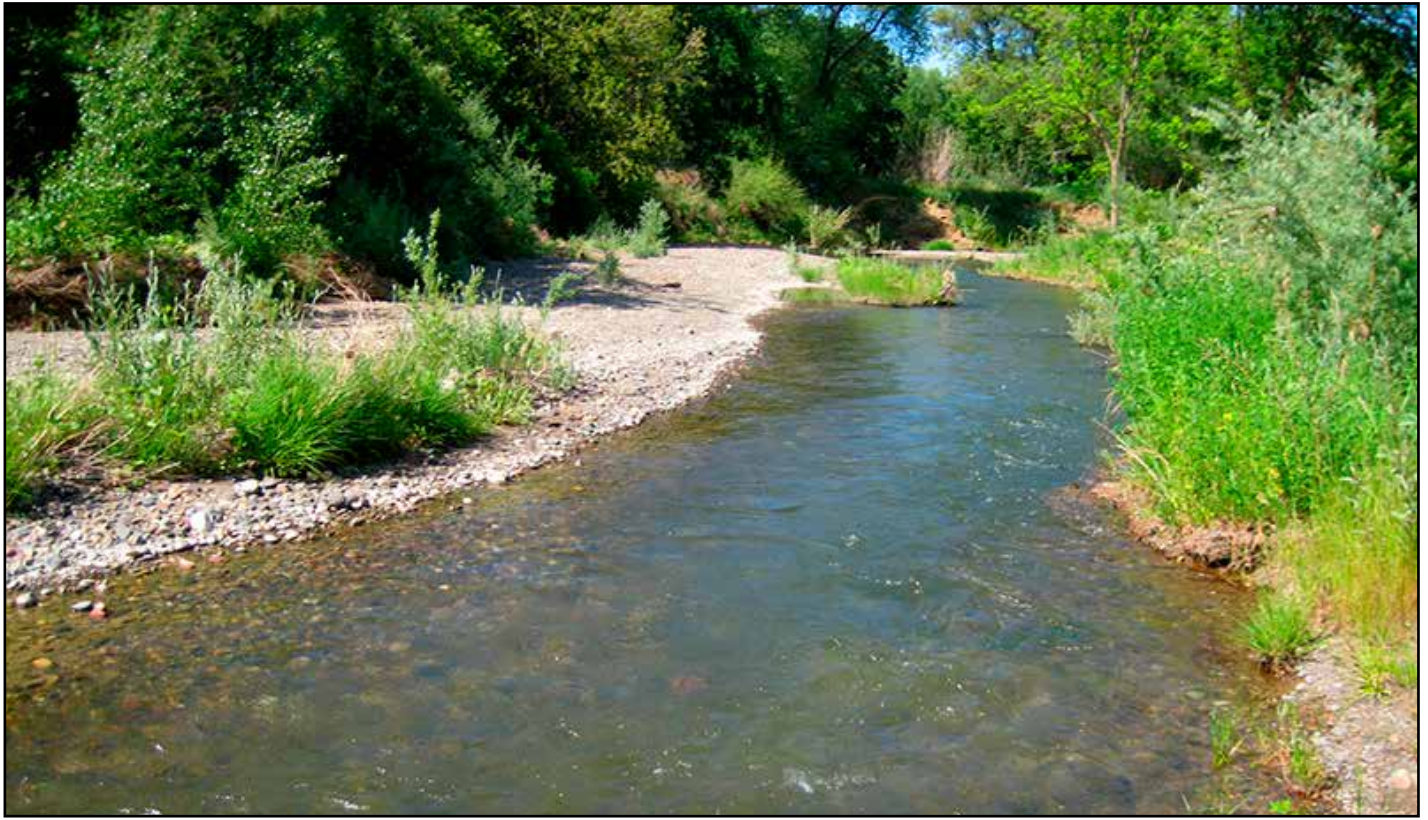
Dry Creek Realignment Project: Image taken on April 29, 2008. This is same site show in previous images. As expected, the creekbed changed during the high flows of 2006. Image File # 2754-22AA.

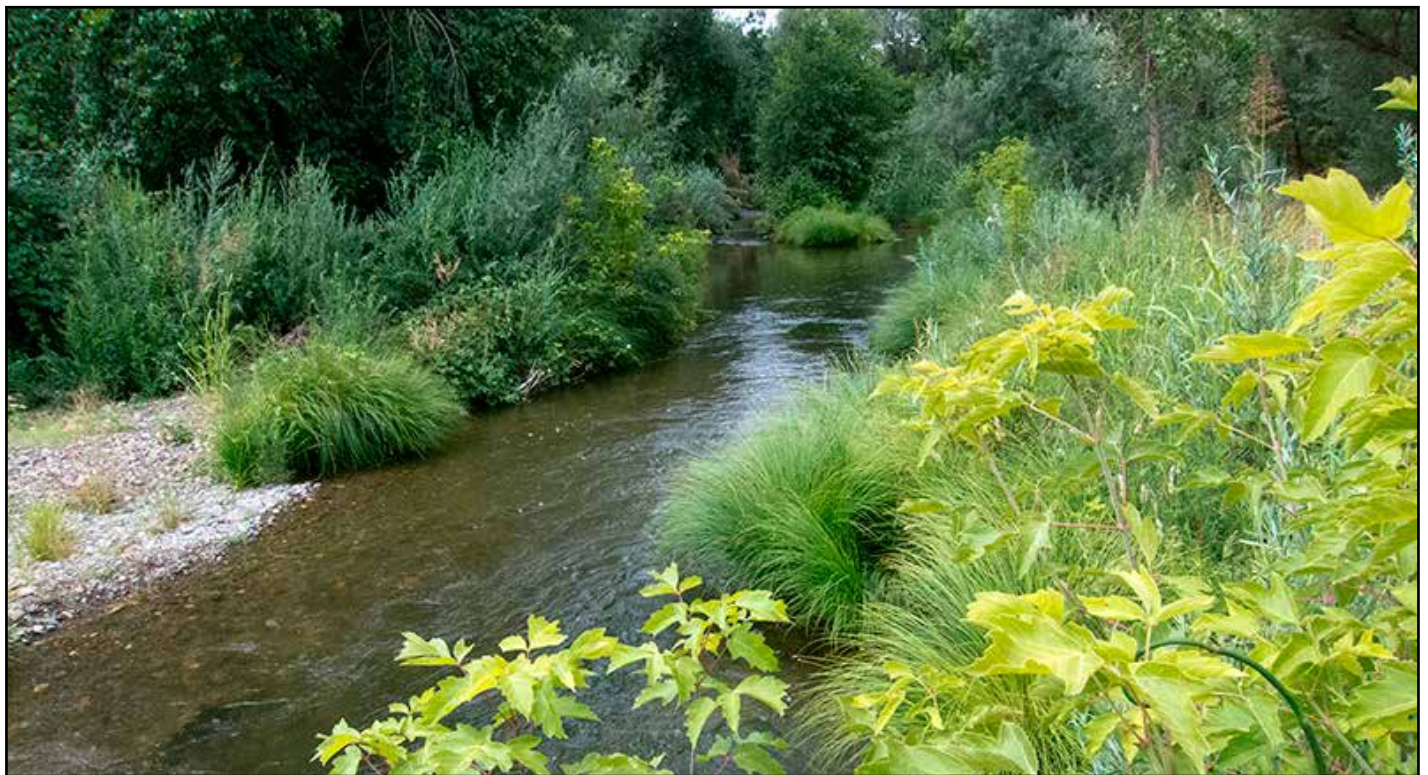
Dry Creek Realignment Project: Image taken on June 10, 2013. Same site as previous images. Image File # 4478-22AA.

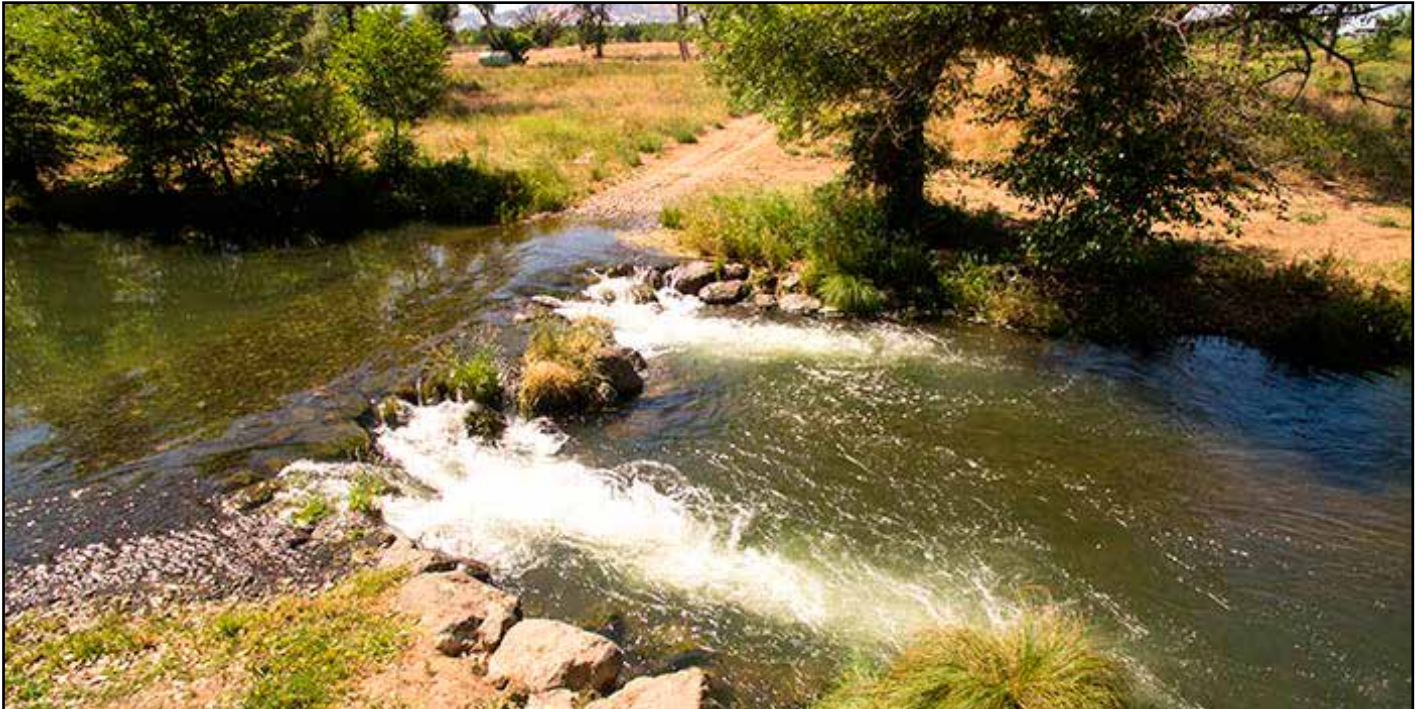
Research Weir: This is a "W" Weir. Boulders are placed in the shape of a "W". Salmon have spawned at this site for the last three years. I believe that the series of smaller restoration projects including the WPCP Project are partially responsible for the increase in the salmon runs in Putah Creek. Drone image.

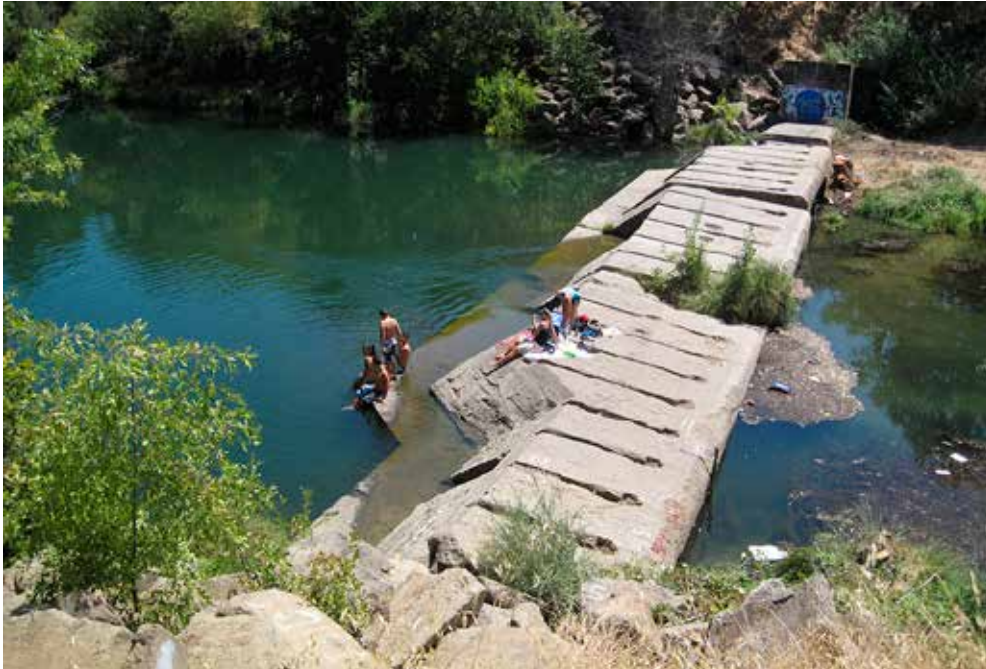
Percolation Dam: *The Percolation Dam before removal. The structure was dangerous with fractured segments, had exposed rebar and served as a barrier to floating debris.*

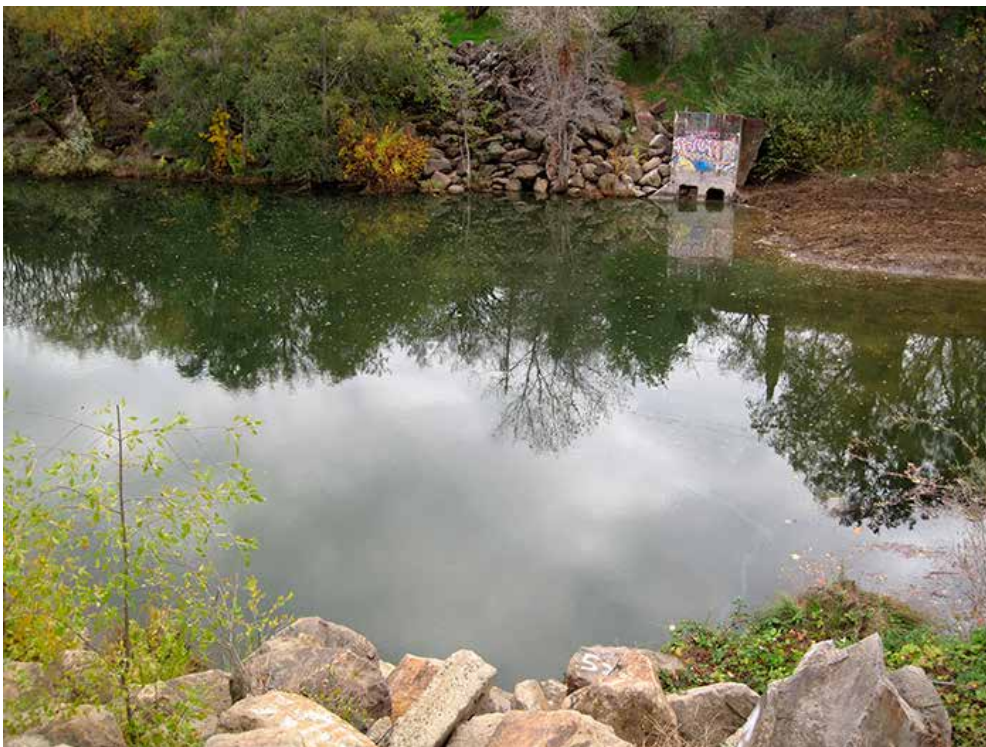
Percolation Dam Site: Taken on November 8, 2009 after removal of the fractured Percolation Dam.

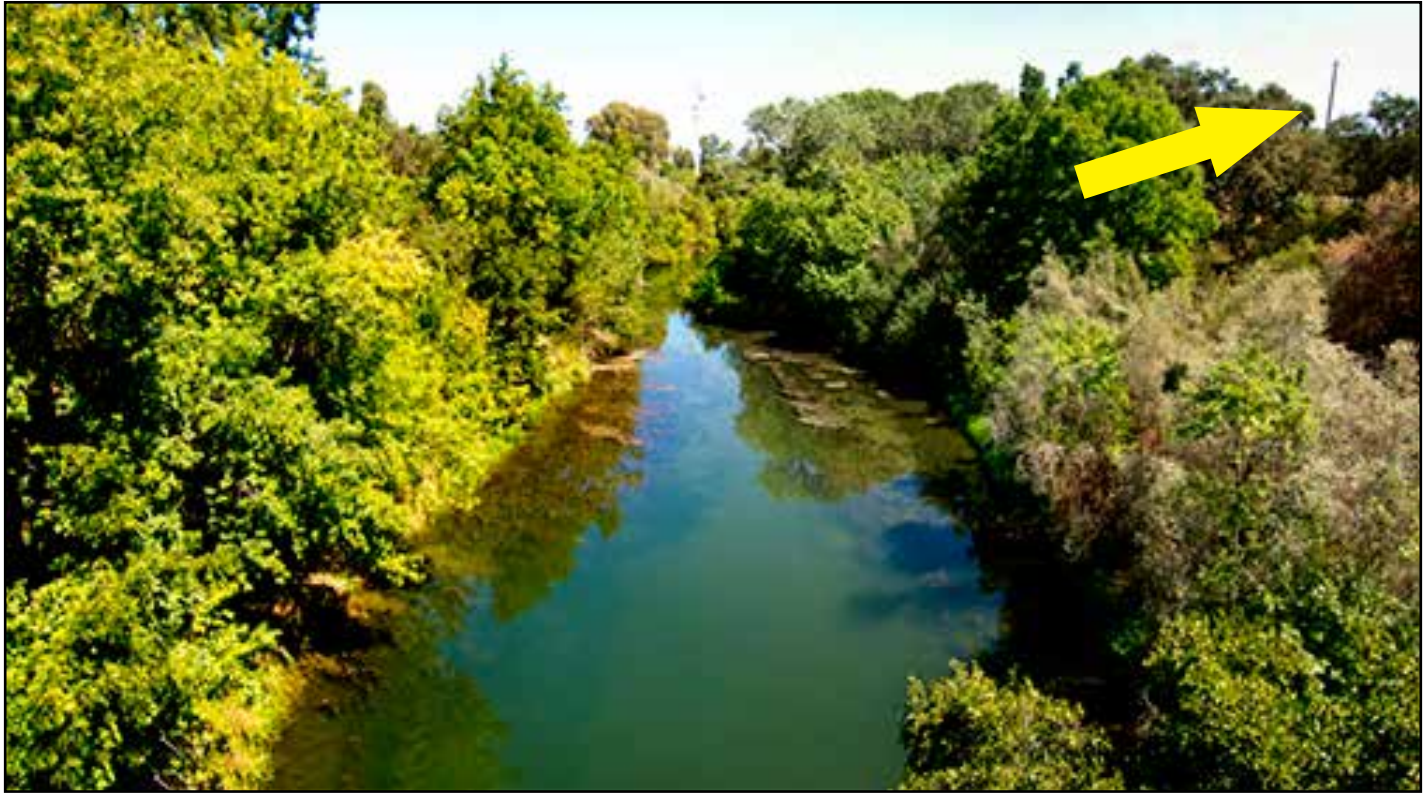
Winters Putah Creek Park: Image taken from the Winters Bike Bridge on September 1, 2011. Note the wide shallow conditions with limited access from either bank. The invasive aquatic weed *Myriophyllum* sp. can be seen in shallow areas on both sides of the waterway.

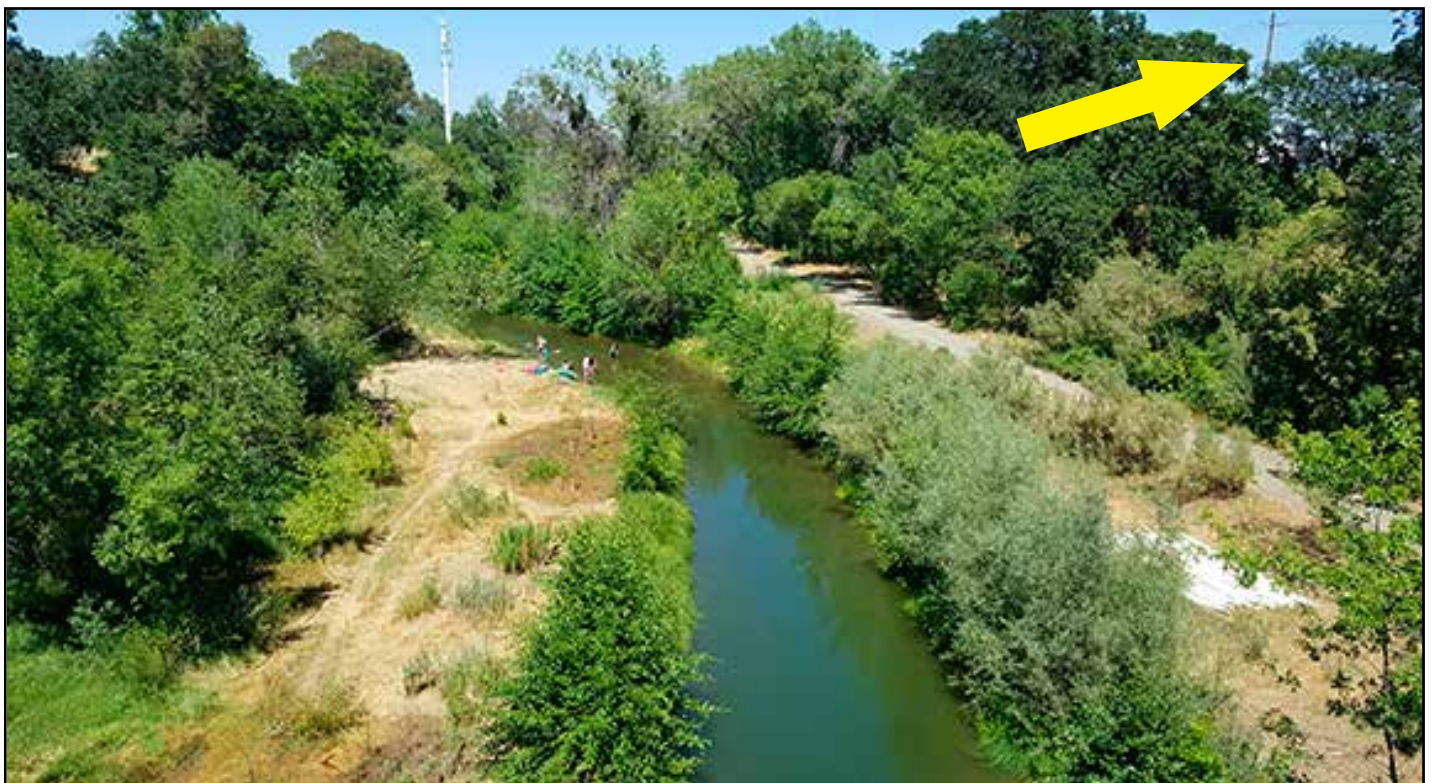
Winters Putah Creek Park: Image taken from the Winters Bike Bridge on May 31, 2016. Note the people swimming and sunbathing in the middle of the creek. Use the power pole on upper right side of images for a site reference.

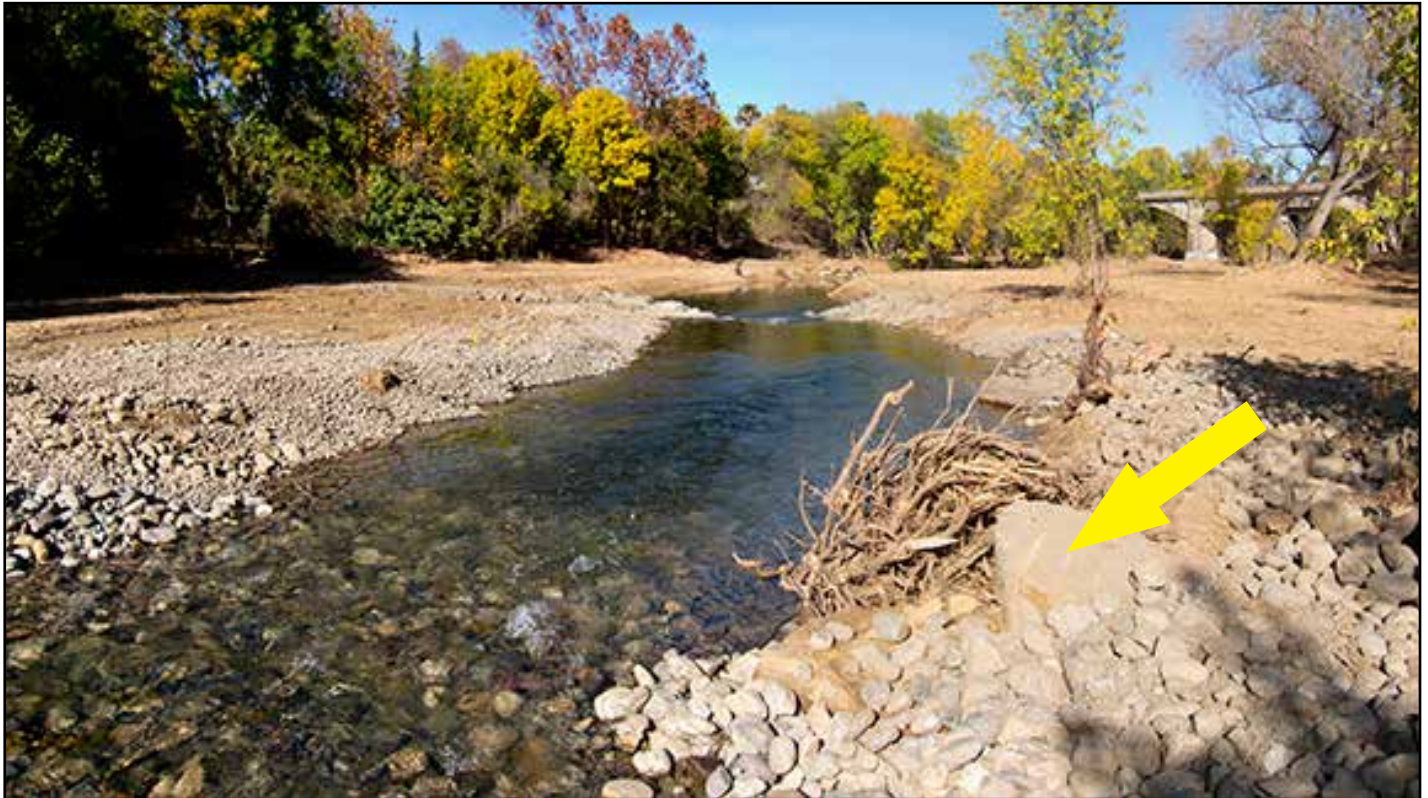
Phase 1 - Neil Crossing and Weir: Image taken on December 12, 2011 after water was returned to the new channel.

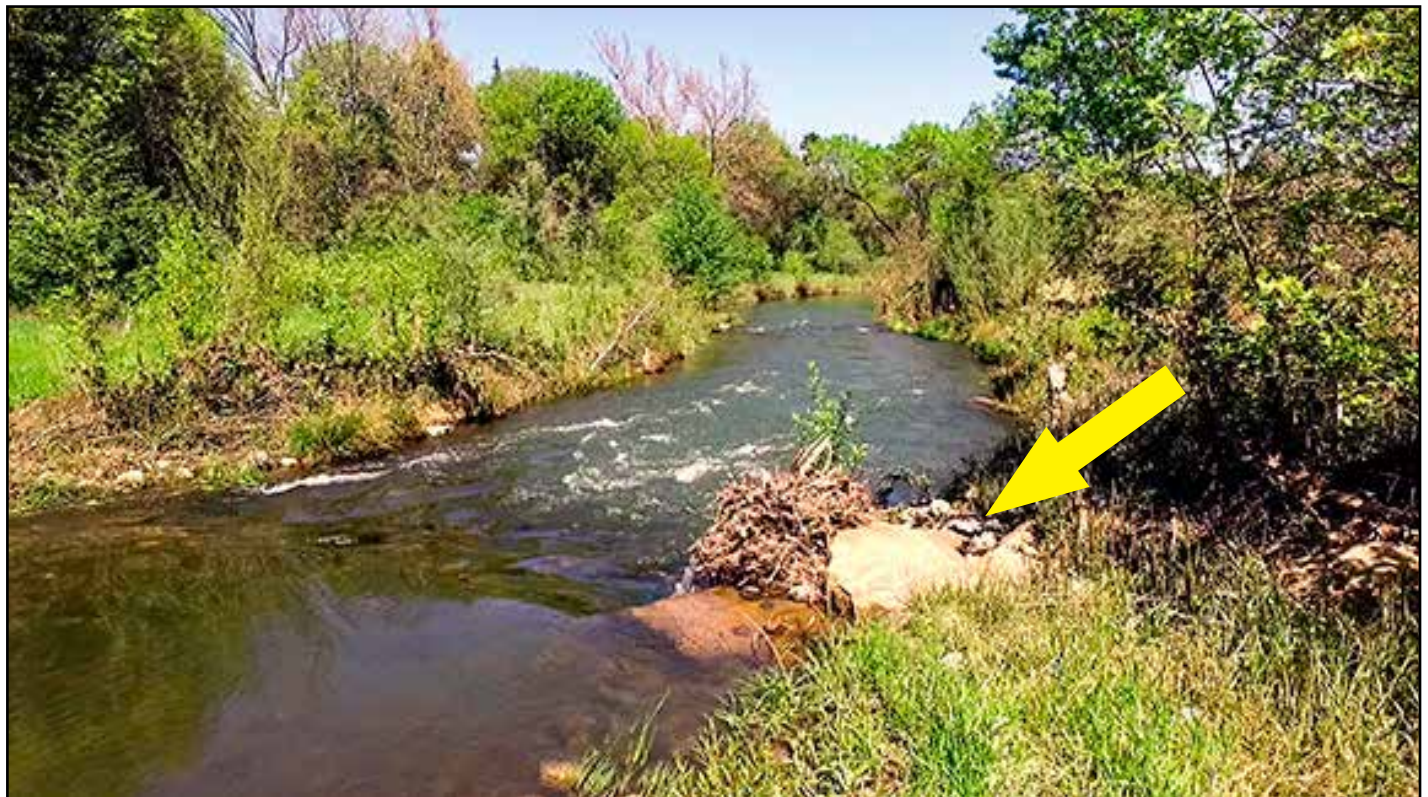
Phase 1 - Neil Crossing and Weir: Image taken on May 17, 2016. Use arrows for site comparison and palm tree in top middle background.

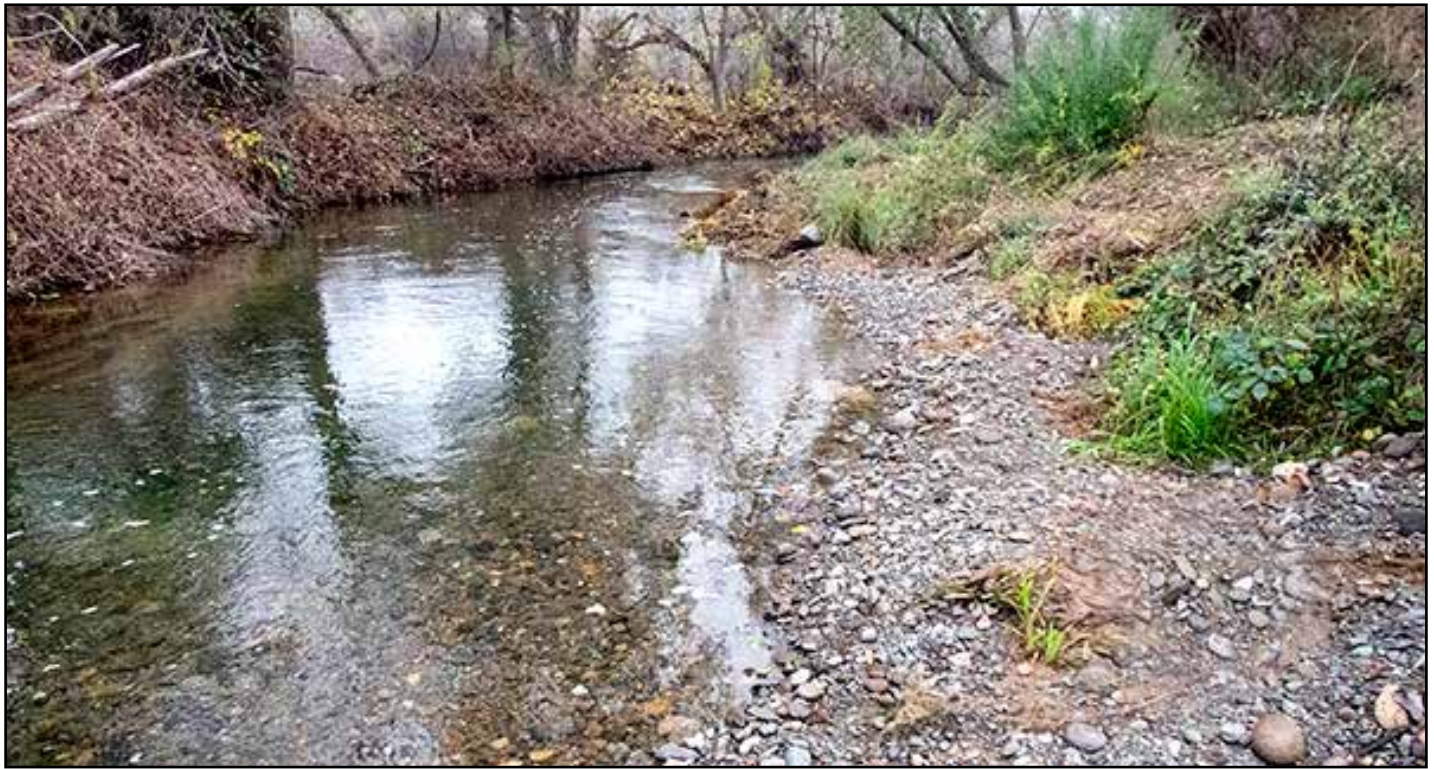
Scarification Site 5. December 10, 2014.

Benthic Scarification: The process of scarifying cemented sections of the creek has shown to benefit aquatic invertebrate communities, spawning trout and spawning salmon.

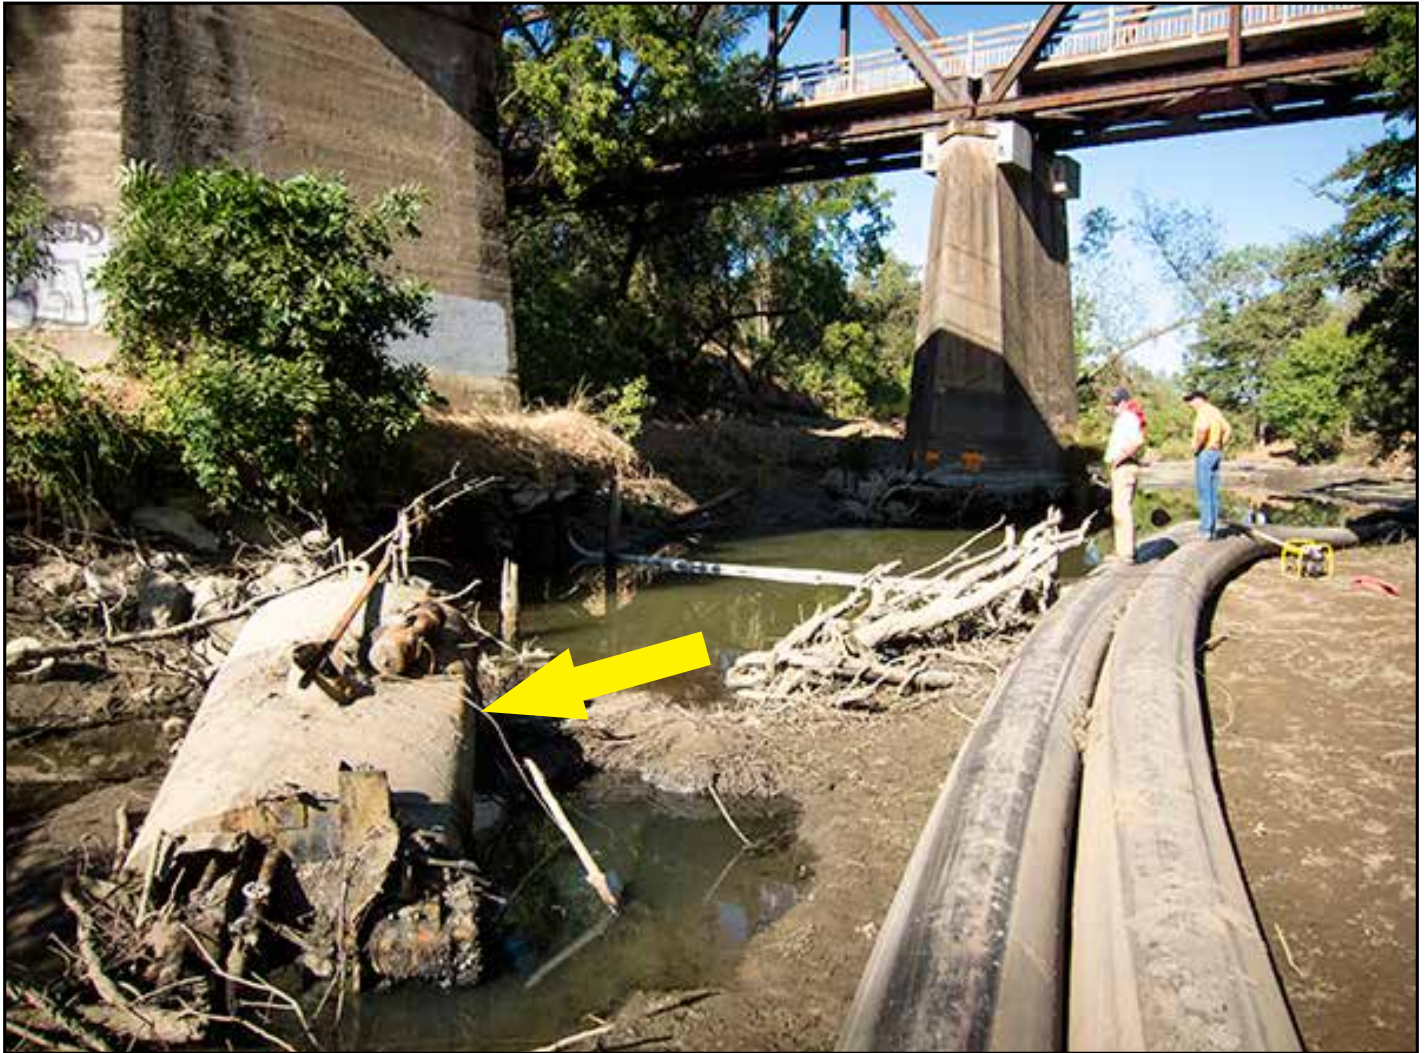
Study this Phase 1 image closely. It is one of many that I took of the trash, tires and other refuse removed from the WPCP Project. The arrow points to the tank of a Tar Truck that had to be removed beneath the old Winters Car Bridge (See current image of the site on Page 23). The car bridge was being undercut and the creekbed was deep mud. I watched a dedicated team remove a plethora of junk and begin the restoration of the Winters Putah Creek Park. Refuse was removed from all sections of the WPCP.

NOTE: I took the above image and an accompanying video on 9/29/2011. Three years later, in December 2014, Chinook salmon spawned in almost exactly the same spot where the men are standing on the pipes. During the 2015 Salmon run, the largest salmon in the run spawned in that very spot.
