Wildlife Survey & Photo Service

June 7, 2016

Subject: *Letter From Mr. David Springer (Winters Friends of Putah Creek) dated May 23, 2016*

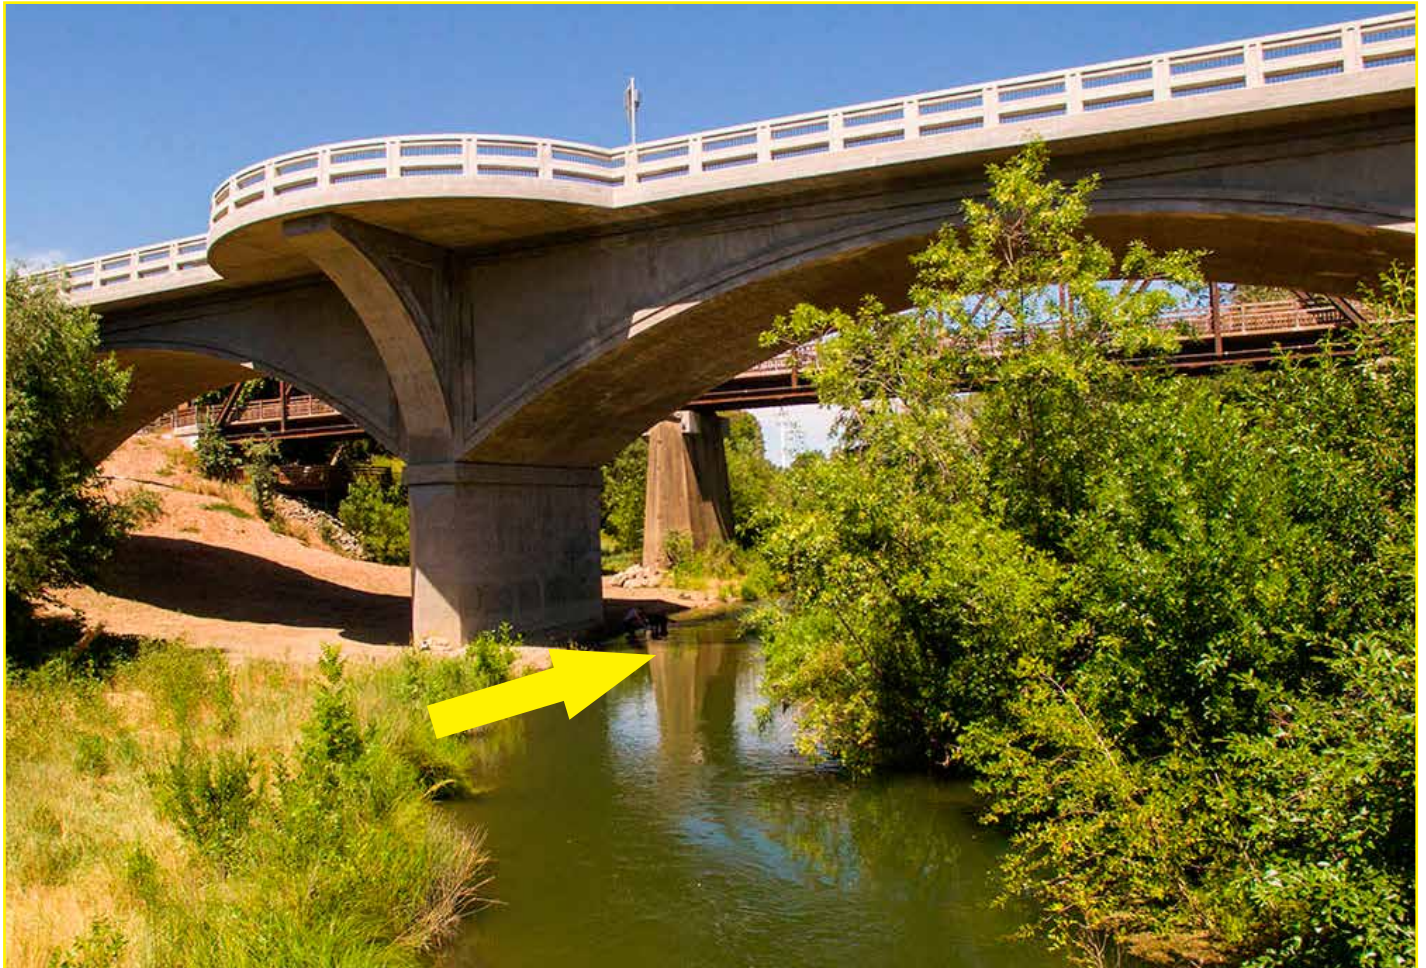
The New Winters Car Bridge: Similar view as construction image on page 21. In December 2015, several pair of Chinook salmon were documented spawning exactly under the new bridge (see arrow). Others spawned nearby. This is an ideal site for the public to safely view spawning salmon on public grounds. Image taken 6/2/2016.
