REPORT 5045 General Update

Subject: General Update with Videos

Habitat in Lower Putah Creek:

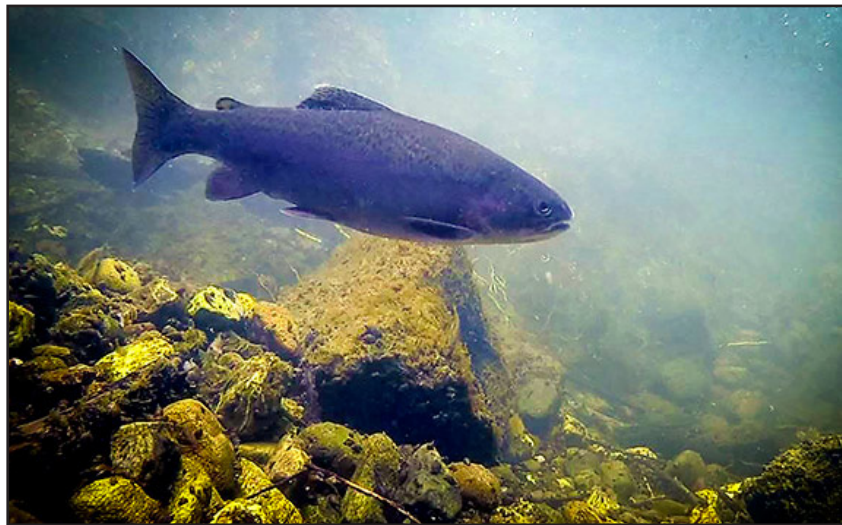
Rainbow Trout at Pickerel Weir. This site is highly productive for aquatic invertebrates and fish. Complete with Putah Creek Burgundy Trout. See Stickleback video that shows aeration below weir. 7/21/2015

Wherever possible, I suggest that weirs, crossveins, or other water-moving aeration devices be installed in Lower Putah Creek. Video footage documents that fish use the areas below the weirs for protection and foraging.

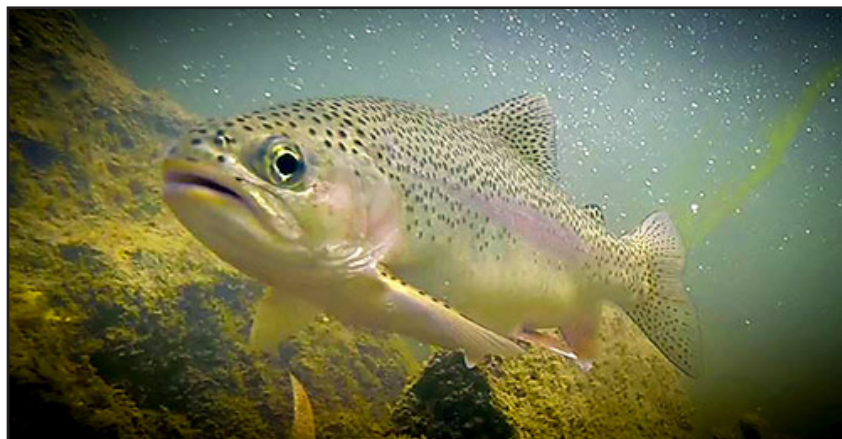
Kilkenny Weir: This site is highly productive for a variety of fish species including trout, Pikeminnow, and Tule Perch. As of 8/10/15, the site supports 8-10 rainbow trout of various sizes. At least two are 15-18 inches in length. 8/10/2015

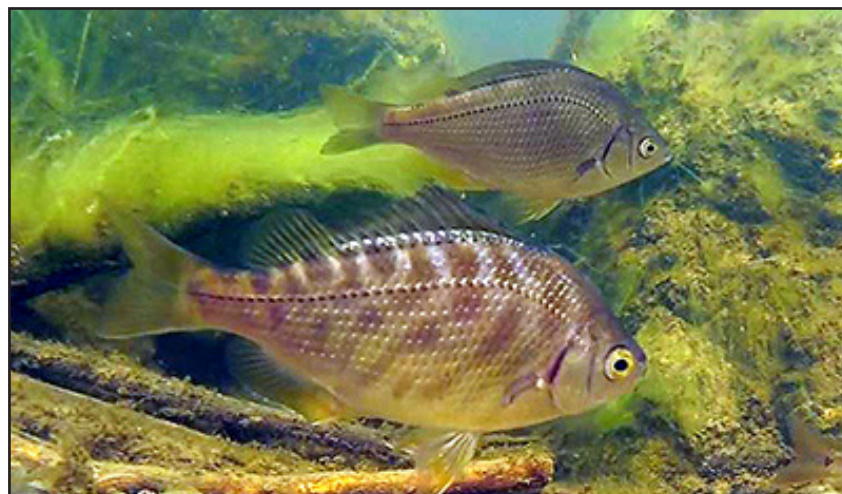
Boulder fields used for bank protection: These areas are highly utilized by a variety of fish species. The ragged boulders give protection from predators not available in open areas. See Tule Perch video.

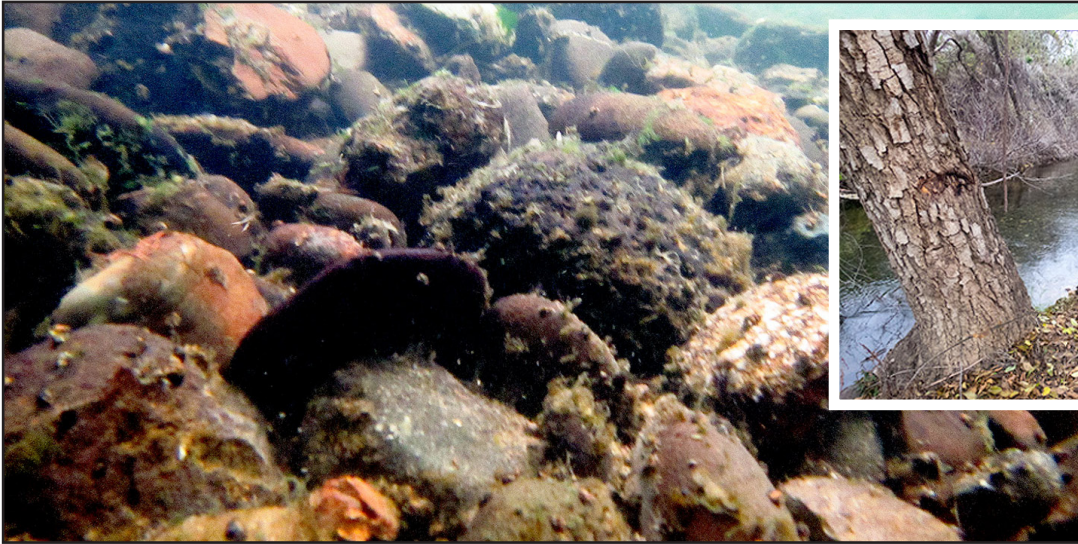
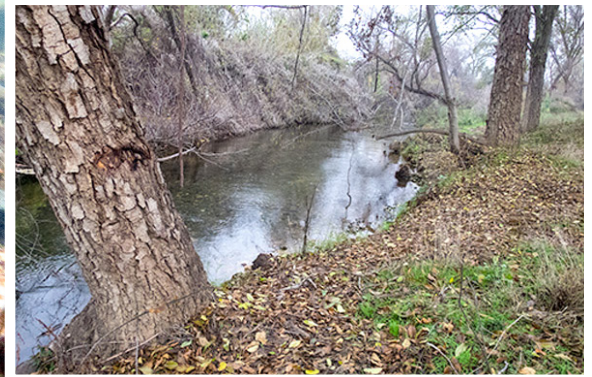
Scarification Section#3

Scarification site # 3: Image shows cobble on the side of a deep salmon redd.

This site was mechanically scoured in early December 2015. Scarified area was used by several pair of spawning salmon. The cobble remains relatively free with no cementation. The interstitial spaces are filling with sediment. The same area has a significantly higher density of aquatic invertebrates and very few New Zealand Mudsnaills when compared to non-scarified areas. There is almost zero (0%) embeddedness in this area.

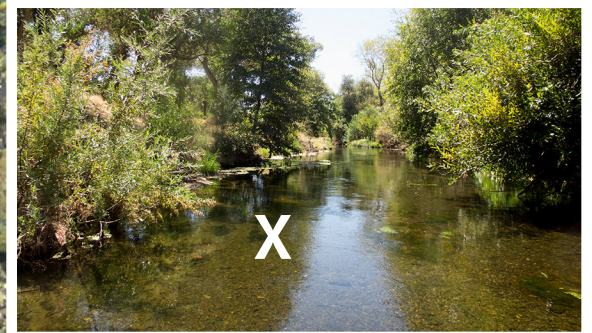
Scarification Control Section (#1): Subsurface image shows surface of creekbed that is being bound by finger-width willow roots. The "X" on image insert is the area the subsurface image was taken.

The scarification control section is just downstream from the Pickerel Property. The site is heavily cemented with most cobble 80-90% embedded. The issue is complicated by several willow roots that have crossed the creekbed. The cobble is almost impossible to remove by hand. The willow roots are further binding the benthic cobble. I believe that it is highly unlikely that a flood condition similar to that seen in 2006 would scarify this section. That opinion is from observations in 2007, embeddedness measurements taken in 2007, and annual observations at numerous sites in the Interdam Reach and in Lower Putah Creek. Cementation measurements and images are available. I am not aware of any other cementation measurements taken by in Putah Creek by UCD, CDFW, or any other entity.

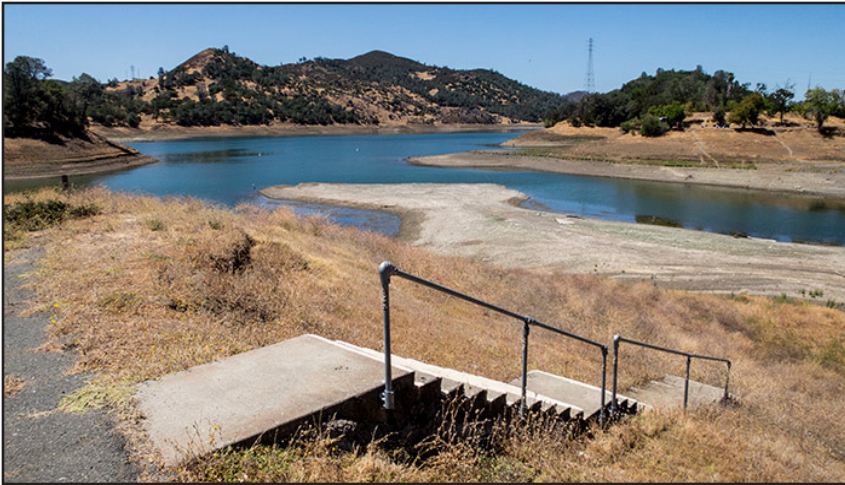
Steele Park Cove: Stairs to former marina at Steele Park. 7/27/2015

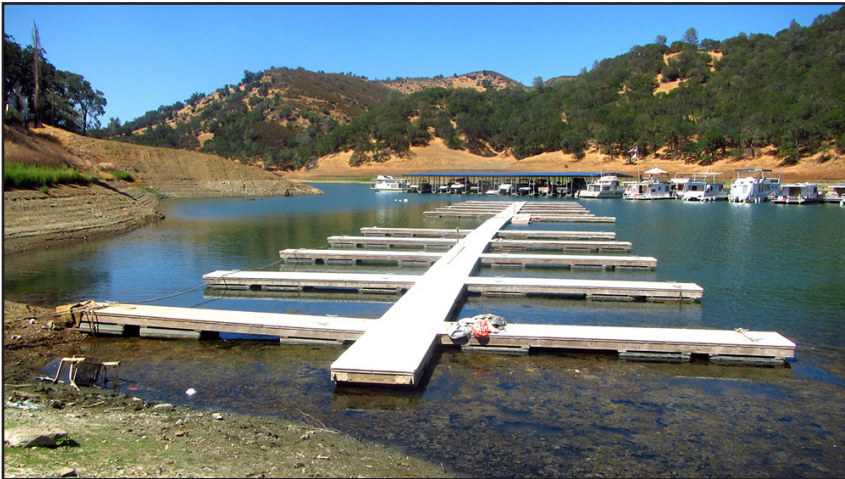
Abandoned dock - Pleasure Cove: 7/27/2015

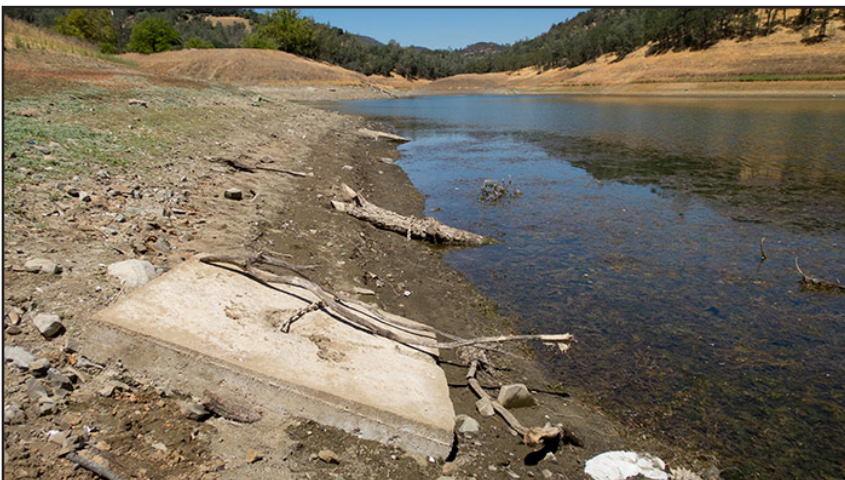
Spanish Flat: Anchoring blocks along bank at Spanish Flat. Bank, blocks and other materials are ideal for low-water mussel surveys. 7/29/2015

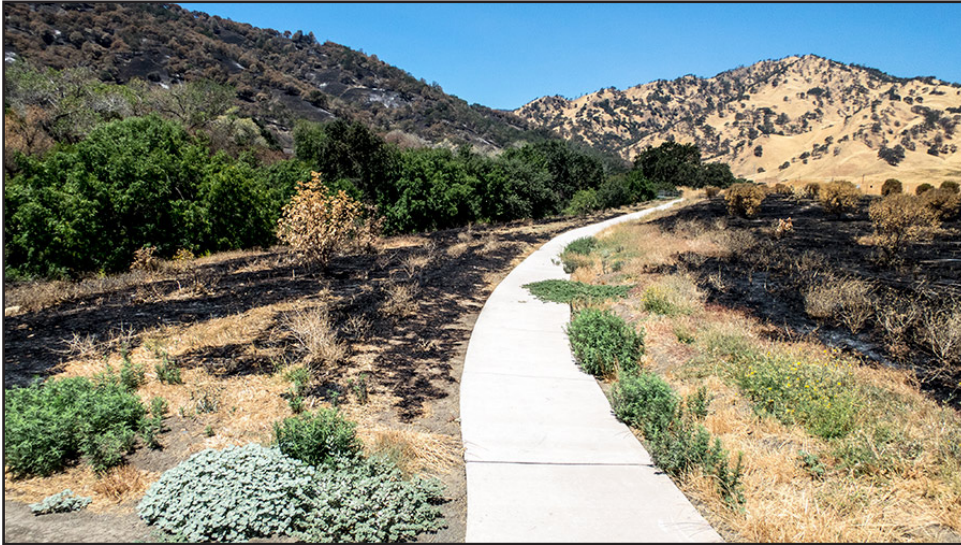
Wragg Fire at Fishing Access # 5: 8/3/2015: I will continue to photograph and monitor the creek when possible.

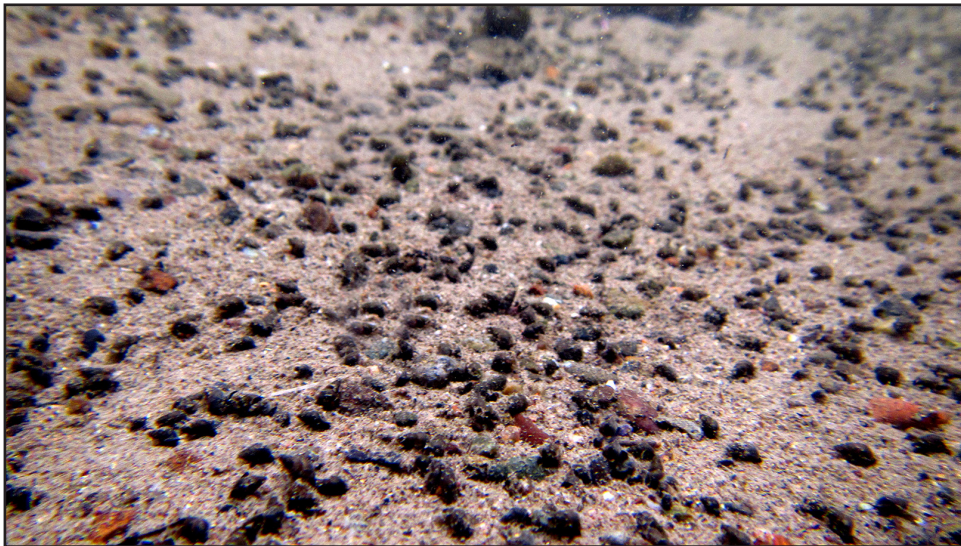
Mudsnails grazing on sandbank: Mudsnail density is high in certain areas. Sub-surface image taken 8/8/2015 at Ken Bertanoia property. The NZMS density is also high in many aquatic weedbeds and open runs.
