Lower Putah Creek

2016 Gravelbed Scarification and Salmon Report

Subject: 2016 Lower Putah Creek (LPC) Gravelbed Scarification and Chinook Salmon Report

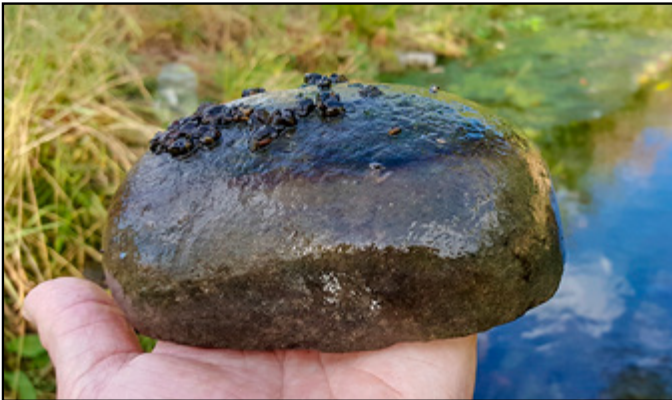
Cobble showing the lower area that was 75% embedded (The lower algae-free section was buried). The top 25% of the cobble was the only section that was usable to benthic macroinvertebrates. Note the *Glossosoma* (caddisfly) cases on the top of the cobble. Most *Glossosoma* can survive fish predation due to their protective cases. Ken W. Davis

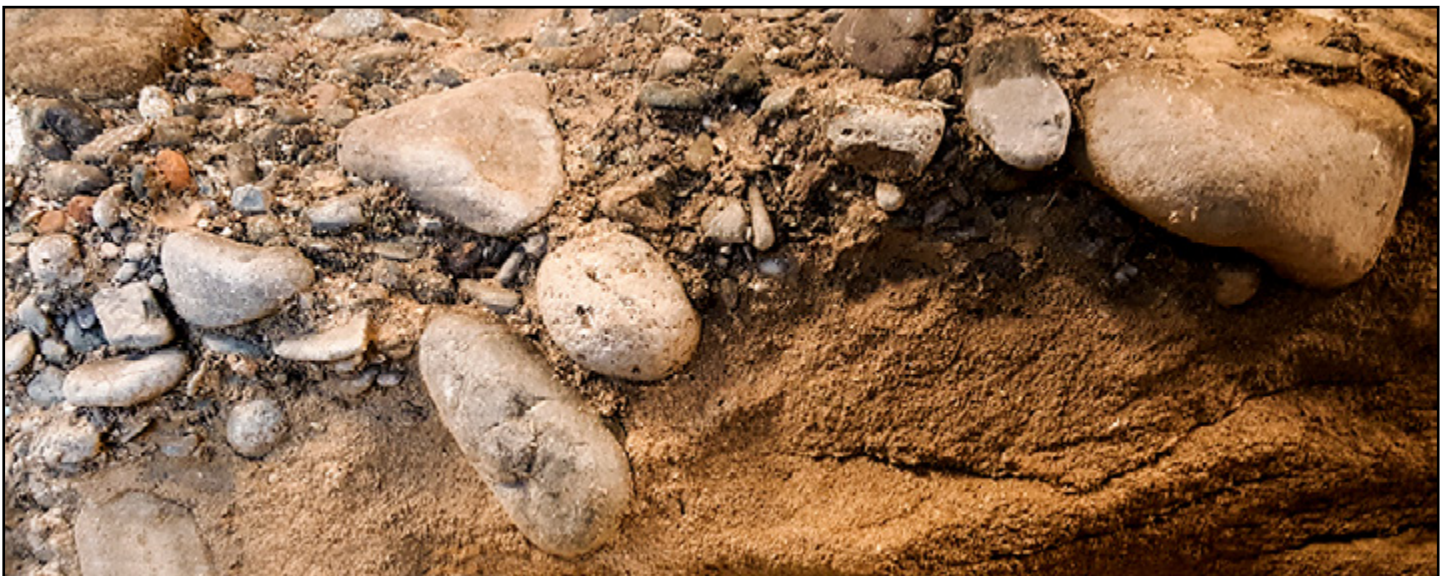
Cross section of large chunk of embedded gravel. Note the layers of small gravel (top), a layer of gravel, and a thick layer of sand and fines. Collected from a section of Lower Putah Creek in an area that is plagued by embedded and cemented gravel.

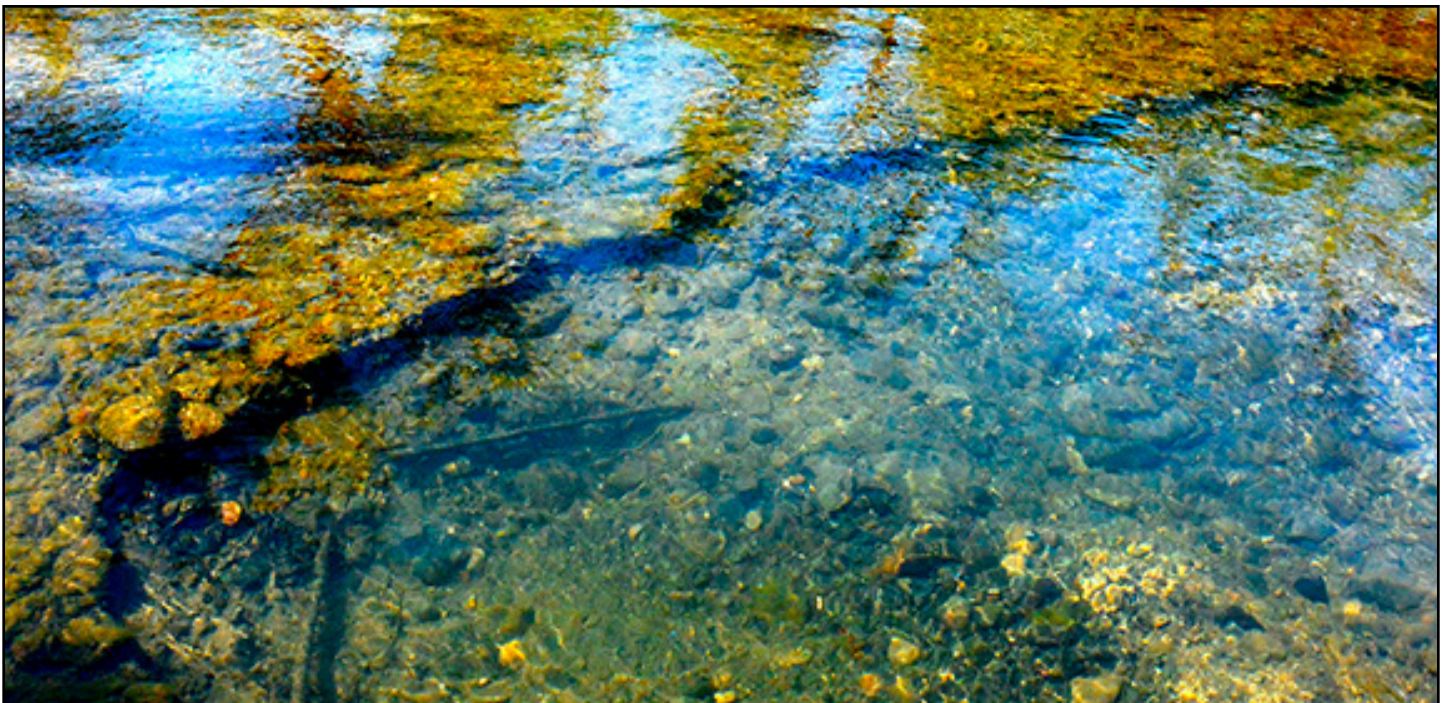
Scarification demonstration site in 2014. Image shows line of embedded cobble that was opened by a medium-reach excavator operating from the bank. Image Ken W. Davis.

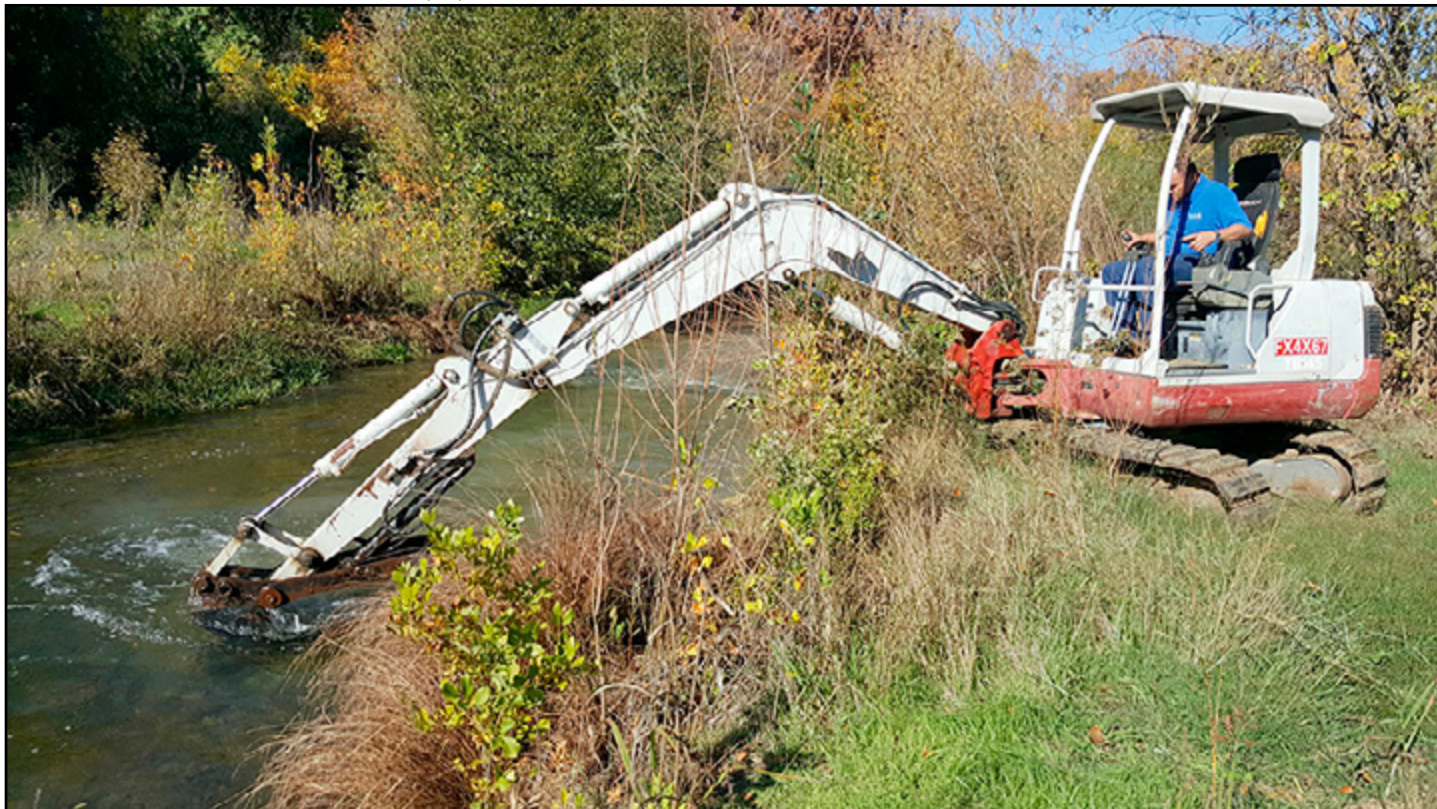
Scarification process prior to the 2016 salmon spawning season. Using expert operators, riparian damage is minimal. A biologist is always on-site before and during the process to watch for wildlife. Image Ken W. Davis.

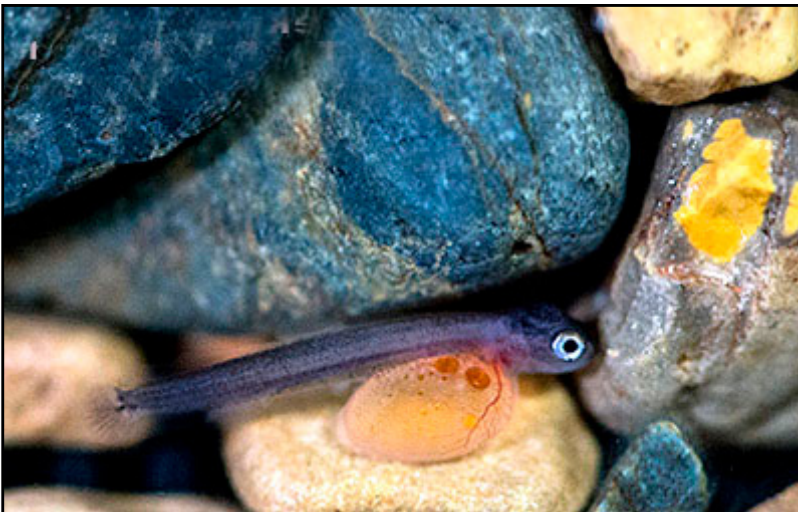
Salmon, trout and steelhead alevin can only survive when they have access to protective interstitial spaces between the appropriate size of cobble. Image Ken W. Davis.

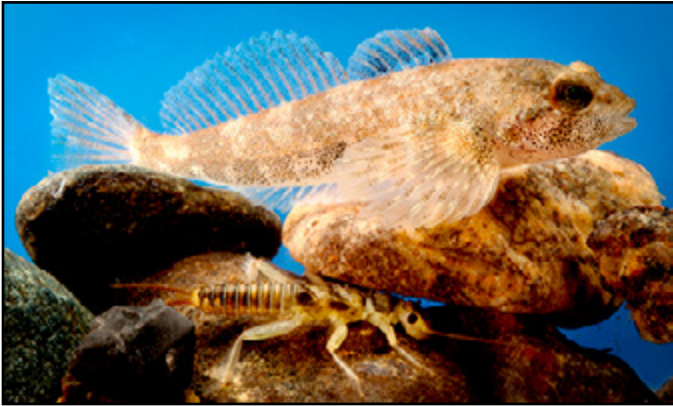
Some important groups of benthic macroinvertebrates can only survive when the spaces between cobble particles are open and allow them to forage and seek harbor from predators such as trout and other predatory fish. Ken W. Davis

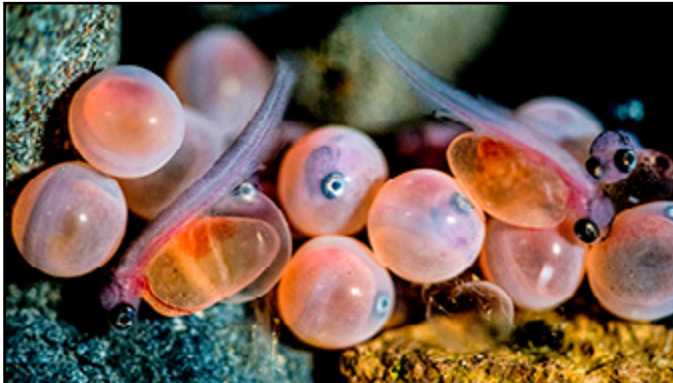
Open interstitial spaces between cobble is crucial to the protection and survival of salmonid eggs and alevin. Ken W. Davis

the food resources within the egg sac. The embedded condition closes those spaces and prevents the survival of salmonid eggs and alevin. Of course, when the gravel is embedded, survival of alevin is a moot point because the adults can not successfully spawn.

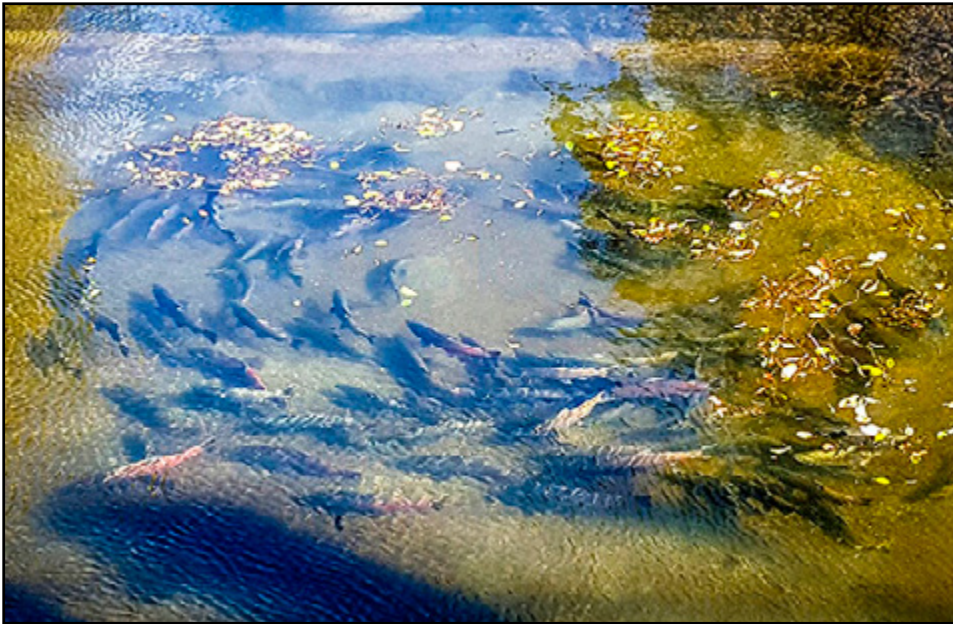
November 29, 2016 Putah Diversion Dam (PDD) Forebay: Shows small group of Chinook salmon in the PDD Forebay. Many remained for several days then moved downstream. Some even attempted to spawn in area of forebay that has very large boulders. Image Ken W. Davis.

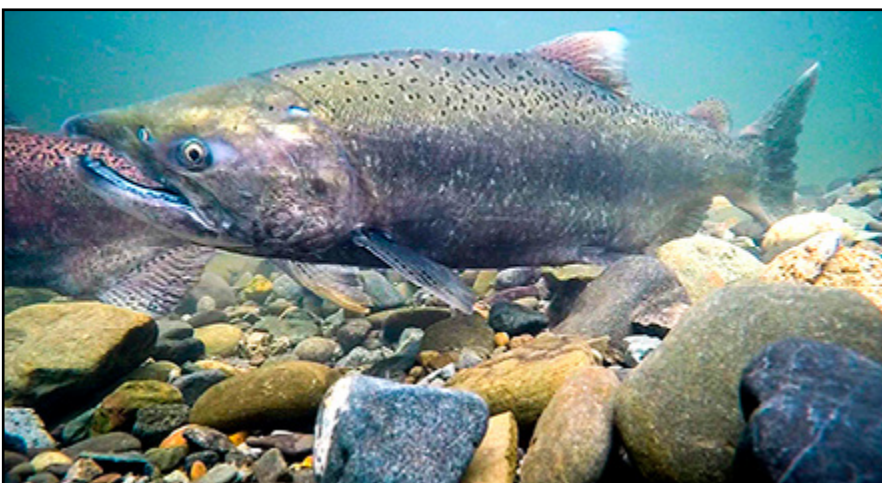
Salmon over a redd developed in a Scarification Test Site. Note the smaller cobble in the middle of the "pot" and the larger cobble used to armor the redd. Image Ken W. Davis.

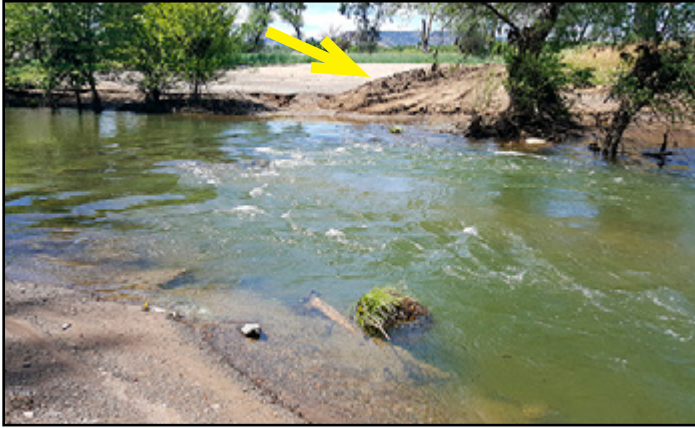
Post-flood section on 5/4/2017 at the Pickerel crossing and weir. Note the copious amount of sand on the opposite side of the crossing. Image Ken W. Davis.

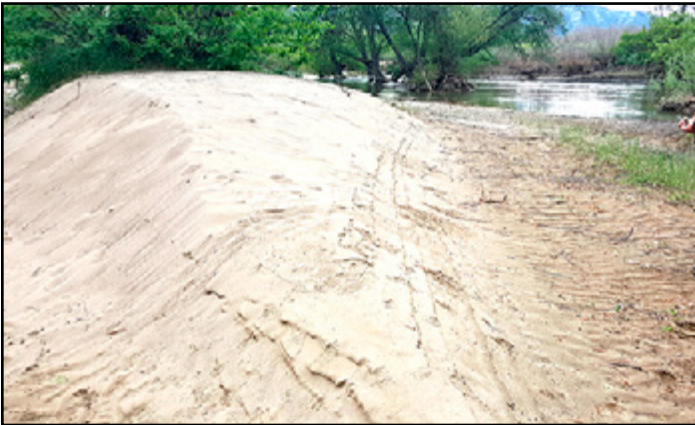
Post 2017 flood. Sand dune developed along Lower Putah Creek near the Morales property. 4/5/2017 Image Ken W. Davis.

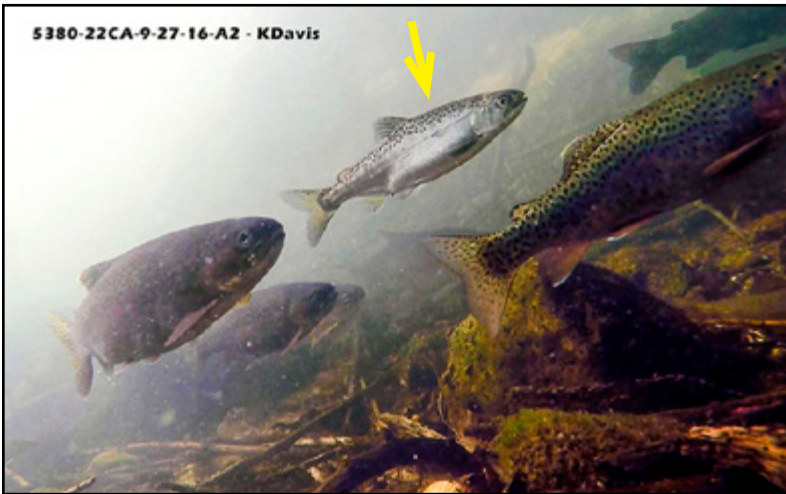
Image taken on 9-27-2017 shows a young salmon that was one of several that remained near the Putah Diversion Dam until late October 2016.

Juvenile salmon have a history of remaining in the system well past the Spring Pulse Flows that are designed to mimic spring storms and to signal the juveniles to migrate downstream. The fact that thousands of juveniles remained in the system at least until late May 2013 is not only curious and also important to managing the creek. It has been well documented that a few salmon even remain near the Putah Diversion Dam due primarily to conditions that include cool water, some safe harbor, and sufficient food conditions. The image on the upper left shows a small Chinook that remained near the Putah Diversion Dam until late October 2016.

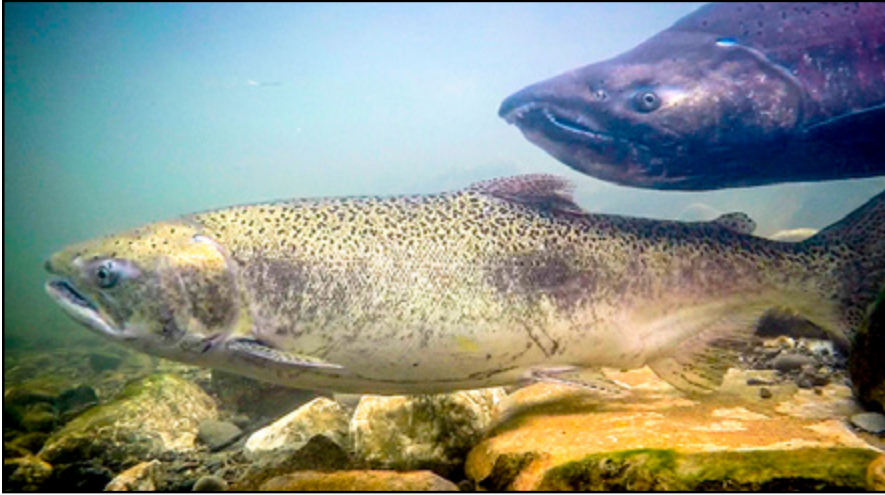
A pair of Chinook Salmon that eventually spawned in a section that has marginal benthic conditions for effective salmonid spawning. Most of the boulders were moved by the female. Image Ken W. Davis.

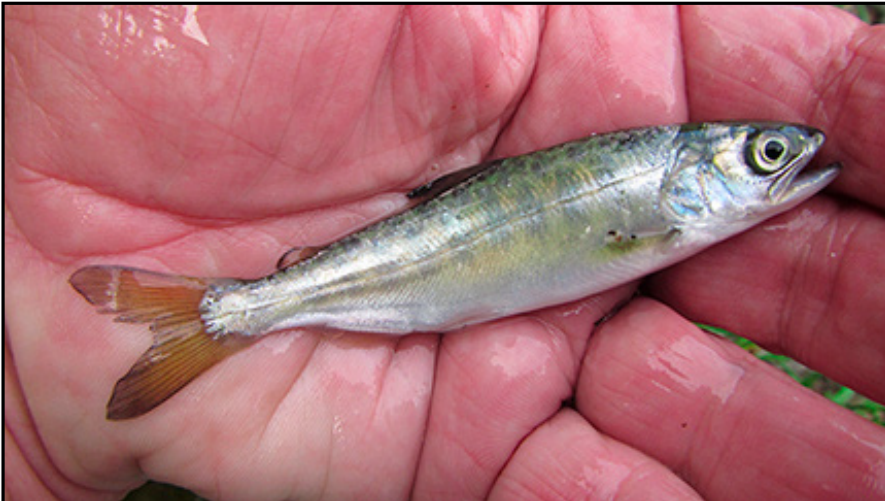
Juvenile Chinook on 5/19/2016. Image Ken W. Davis

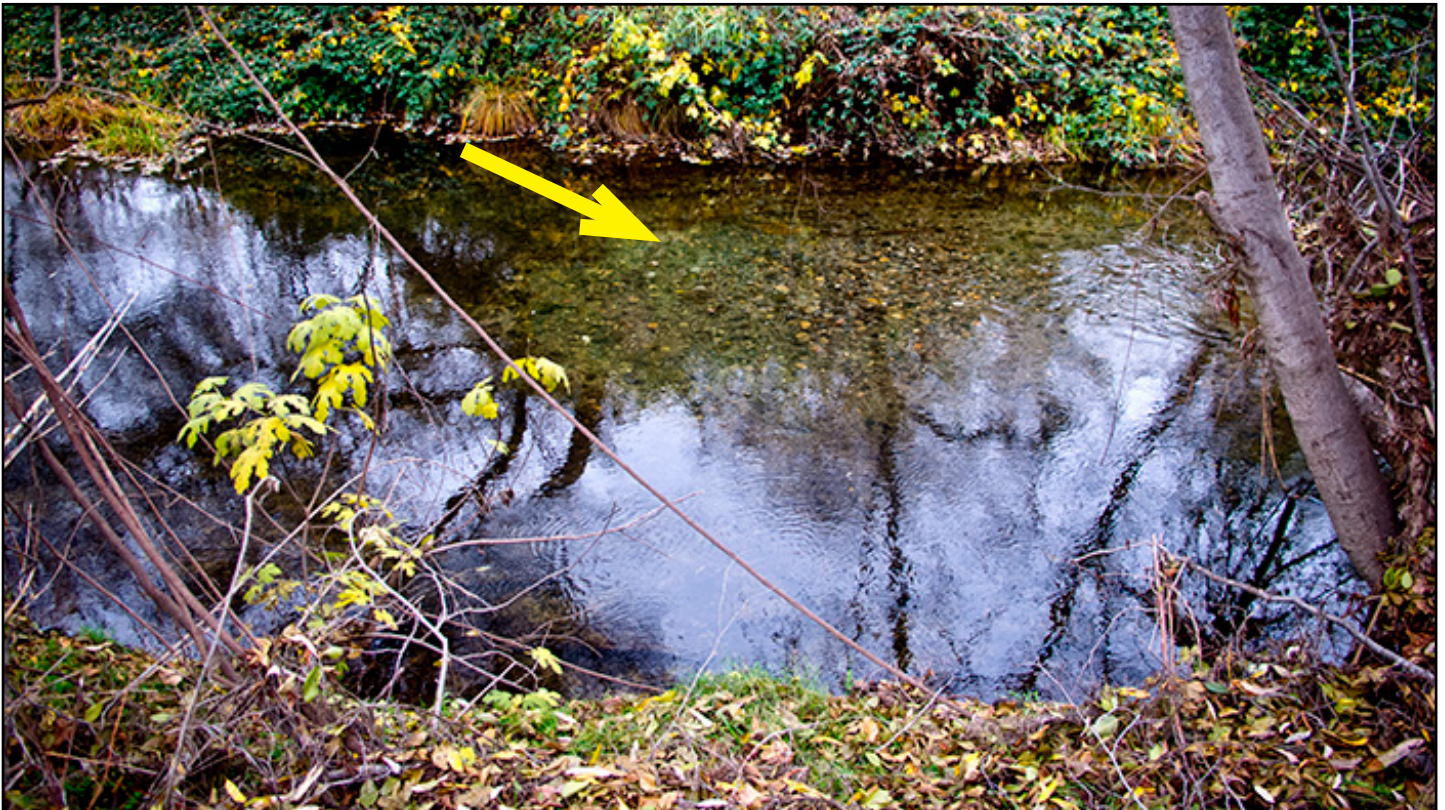
Chinook redd taken on 12/13/2010. Note the large overall size and shallow nature of the redd. No adult salmon were seen in 2010. Image Ken W. Davis

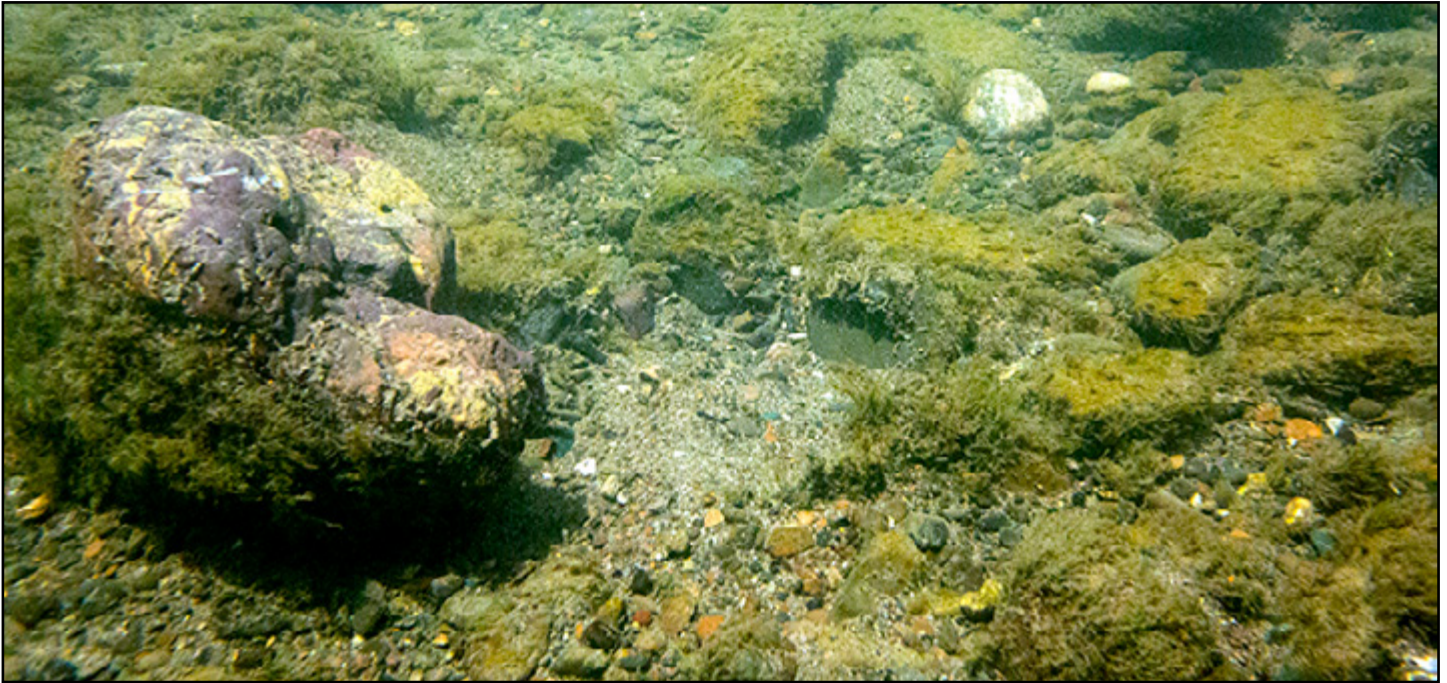
Image shows a cemented group of cobbles that was flipped over, in the creekbed, leaving a "footprint" in a hard base of embedded gravel and sand. Only a limited number of BMI taxa can survive in this benthic condition. Planned Morales Scarification Site, 2017. Image Ken W. Davis.
