August 18, 2014

To: Mr Chris Lee
Solano County Water Agency

Subject: Report of Mussel-like organisms on boat moored in Lake Berryessa

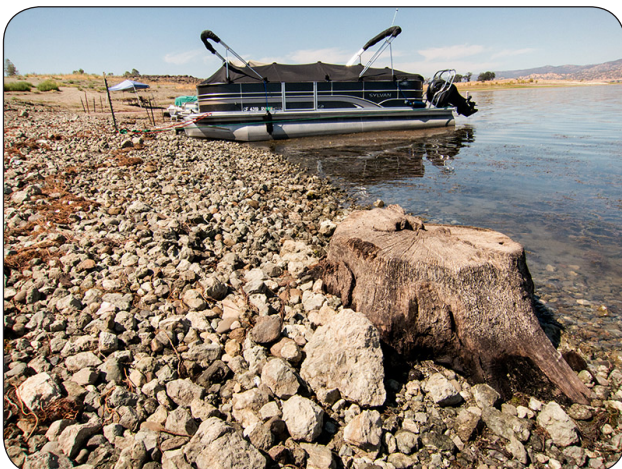
Boat moored near the Lake Berryessa Pines Community. Note tree trunk that was recently submerged.

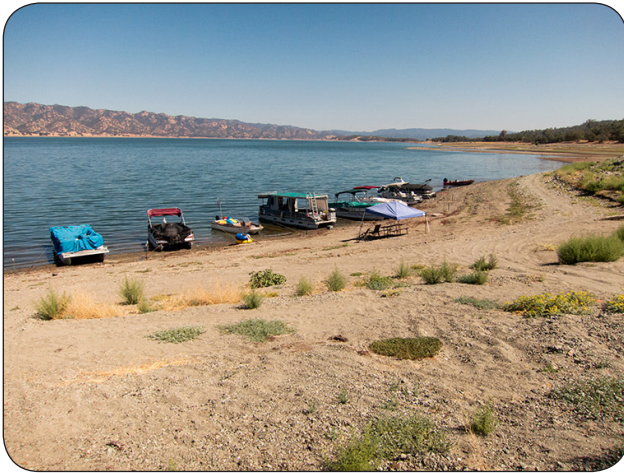
Beach used by residents of Lake Berryessa Pines community to moor boats.

Comment: Yes. More than 600 yards of shoreline was closely examined for adult Eurasian Mussels. The survey was negative for adult mussels.

Note: The original description was a boat hull, at this site, that was entirely covered by mussel-like organisms. If that was accurate, I suspect that cobble, pipes and other structures would also be covered with mussels. The survey on 8/15/2014 was negative for adult Eurasian mussels.

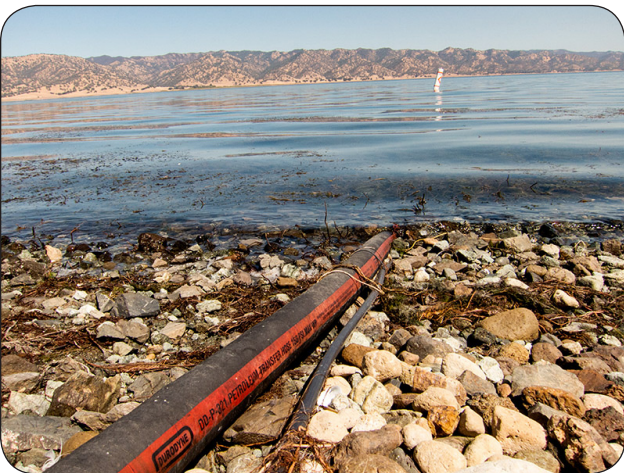
Conveyance pipes on shoreline near boats

Comment: Yes. Existing infrastructure are routinely used for mussel surveys because they are attractive substrate for mussel attachment. The pipes shown on the left, chains used to anchor buoys, and boat mooring ropes were all negative for adult mussels.

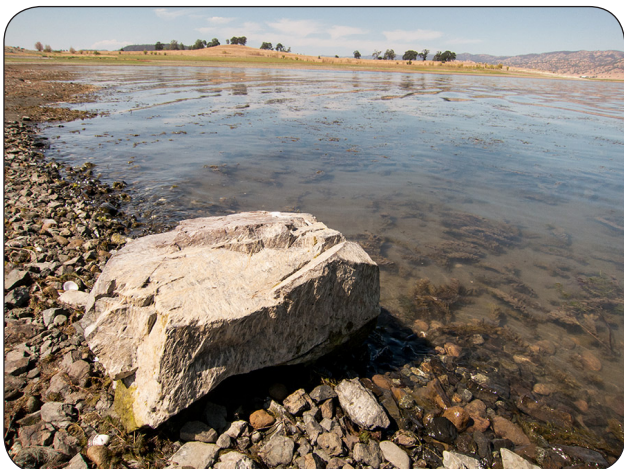
Boulder that was recently submerged in area near boats moored at the "Pines Beach."

Comment: Yes. Natural-occurring structures such as the boulder shown on left are ideal substrate for mussel infestations. The boulder photographed on the left is near the mooring area used by "The Pines" residents. It and other structures were examined for adult mussels. No adult mussels were found on natural substrates. .

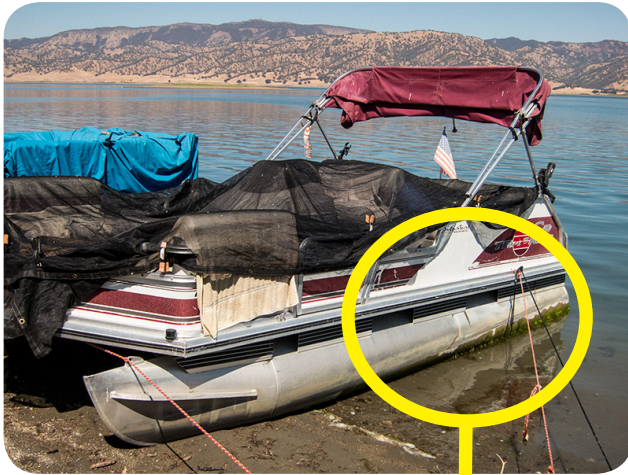
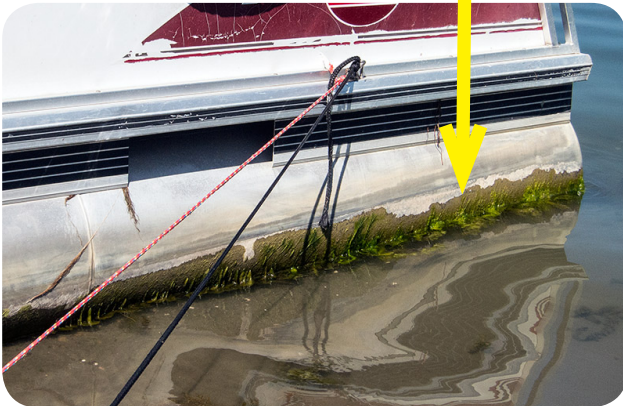
Comment: Yes. A simple visual survey was conducted on eight watercraft moored at the site. None of the watercraft in the area were touched or boarded. In the near future, I plan on getting subsurface video footage of the submerged hulls of several of the boats on site. That task can be accomplished with a video tool recently purchased specifically for this project. Video can be captured without touching the moored watercraft.

1. Take subsurface video of the hull of the boat in question ASAP.
2. Survey the area around the Lake Berryessa Pines on a regular basis for at least six months. Those surveys will include visual and plankton surveys.
3. There was a report that "Samples were put into a bag and given to a sheriff." I will continue to investigate if specimens were indeed removed from the Morton watercraft and given to a sheriff or DFW Warden. To date, that claim remains questionable.
