Subject: Mechanical Scarification of Cemented Gravelbeds in Lower Putah Creek

Report 5030 Scarification Benefits

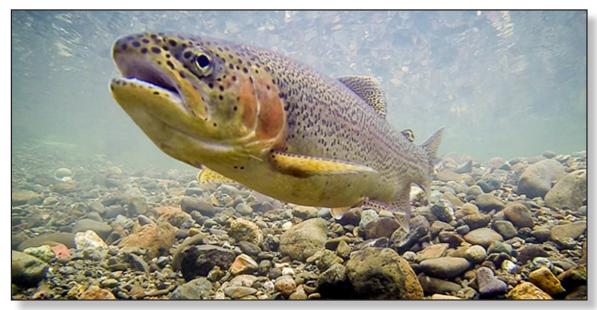
Female rainbow trout above her redd in Lower Putah Creek. December 2014

Salmon and Trout Spawning: Benthic scarification will also dramatically improve salmon and trout spawning areas as documented in December 2014. Spawning improved dramatically without additional water releases or other significant cost.

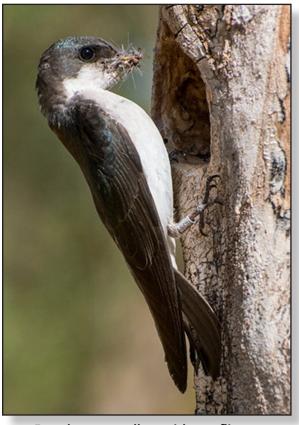
It has been well documented that several bird species prey heavily on the adult phase of aquatic insects for their own subsistence and feeding their chicks. This female Tree Swallow repeatedly brought beak-fulls of adult mayflies to her chicks in the cavity nest.

Female tree swallow with mayflies.

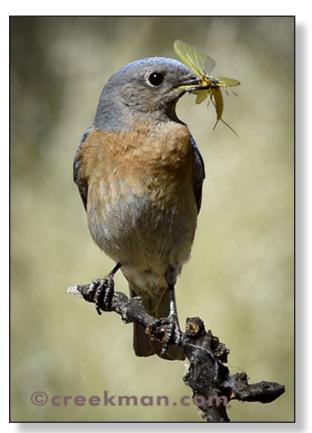
Female blue bird with an adult Hexagenia, a large mayfly.

Blue birds take advantage of adult aquatic invertebrates, even large species such as *Hexagenia*, one of the largest mayflies on the West Coast (Image left). The adults feed directly on the mayflies and feed same to their chicks.

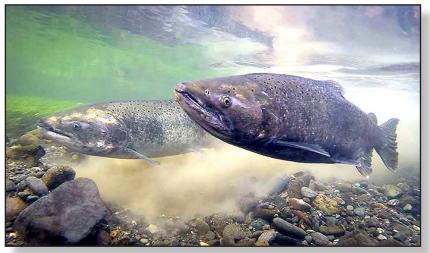
Salmon spawning in control section (nonscarified) of Lower Putah Creek. December 2014

Non-scarified Areas: We know that salmon can marginally spawn in non-scarified areas. The rate of success is unknown. The depth of the redds is severely limited, typically a few inches. The eggs tend to wash downstream per documentation in 2004 near Yolo Housing.

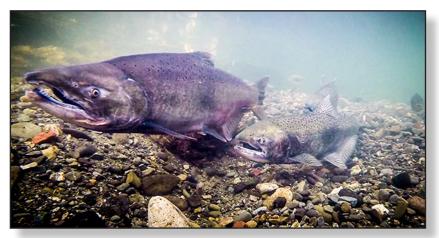
Salmon above redd in scarified section of Lower Putah Creek. December 2015

Scarified Areas: The sections scarified in Lower Putah Creek (2014) were the first to be used by spawning salmon and rainbow trout. Per the image on the left, the gravel was loose and easily dug by female Chinooks.

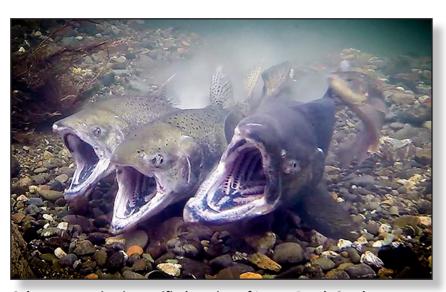
Salmon spawning in scarified section of Lower Putah Creek.

Spawning in Scarified Areas: Same redd as image above. All of the scarified areas were utilized by spawning salmon and trout. It also appears that the scarification enhanced the Benthic Macroinvertebrate community and decreased the New Zealand Mudsnail density (Survey ongoing).

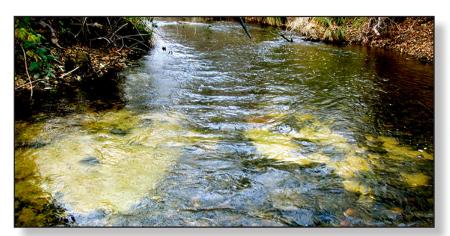
Failed Spawning: It appeared that the salmon redds shown on the left (2004) failed as I was picking up salmon eggs in a drift net several yards below the redds. The gravel was not deep enough for spawning and was primarily one layer just on top of the claypan.

Failed spawning area near Yolo Housing. December 2004

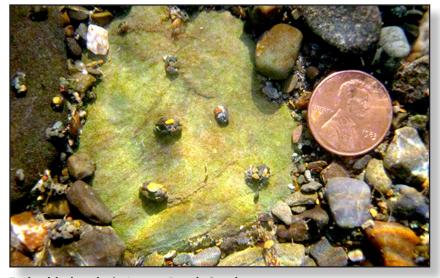
Embedded Cobble: Embedded, highly cemented cobble dominated the Pickerel Weir section prior to natural scour caused by the weir. The embedded condition limits the diversity and density of benthic macroinvertebrates. The only invertebrate species that can survive this condition are primarily those that construct protective cases such as Glossosoma sp. A small caddisfly, Glossosoma larval cases are shown on the top of the cobble (image left).

Embedded rocks in Lower Putah Creek.
