Report 5098 LPC Algae Mats

October 29. 2015

Subject: Lower Putah Creek - Algal mats near Wimmer Property

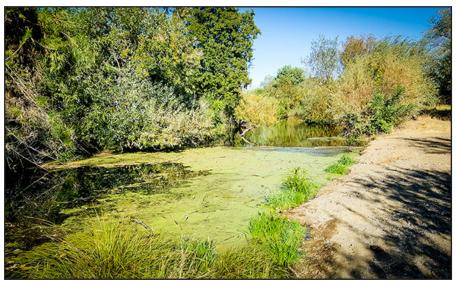
Mixed mat of Duckweed and a filamentous algae near the Parker Property.

1. The floating mats are a mixture of Lemna sp. (Common Duckweed) and a filamentous green algae. Neither is harmful.

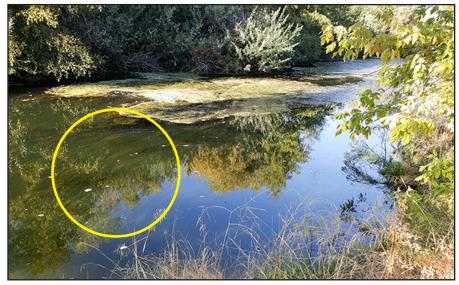
Mixed mat of Duckweed and a filamentous algae that appears to be caught on a bed of *Myriophyllum*. If you zoom on the image you can see subsurface plants in the circle.

2. The mixed mats appear to be getting caught in beds of *Myriophyllum* and trapped due to slow water conditions.

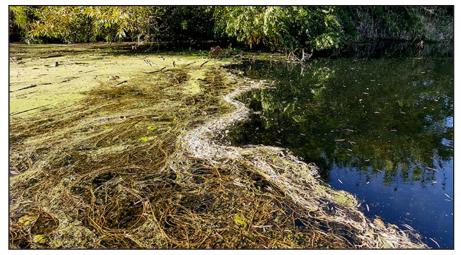
Mixed mat of Duckweed and a filamentous algae near the Parker Property.

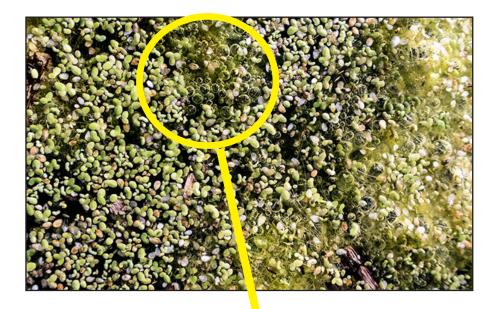
Image left shows Duckweed and a species of oxygen-producing fiamentous algae. Close-up image shows how the oxygen bubbles also help the mat float.

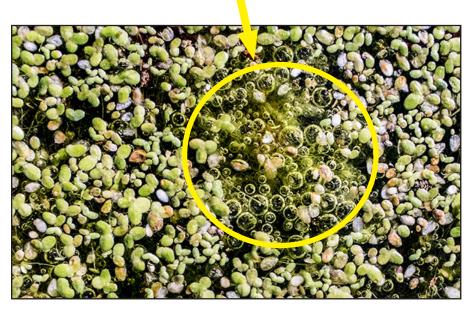
6. I have provided close-up images of a duckweed / algal mat on Page 2 of this document.

5. I plan on returning to the site next week to collect plankton samples as the water does appear to be slightly discolored. I would like to examine the water for the presence / absence of Cyanophyta species. Many species are common in Lake Berryessa but rarely reach a density of concern. This action is simply a precaution as I have no basis for concern.
