# **INVESTIGATION OF SOURCES OF TURBIDITY, SEDIMENT, AND AQUATIC VEGETATION IN PUTAH SOUTH CANAL**

## **Solano County Water Agency**

## **Northwest Hydraulic Consultants Inc.**

***May 14, 2010***

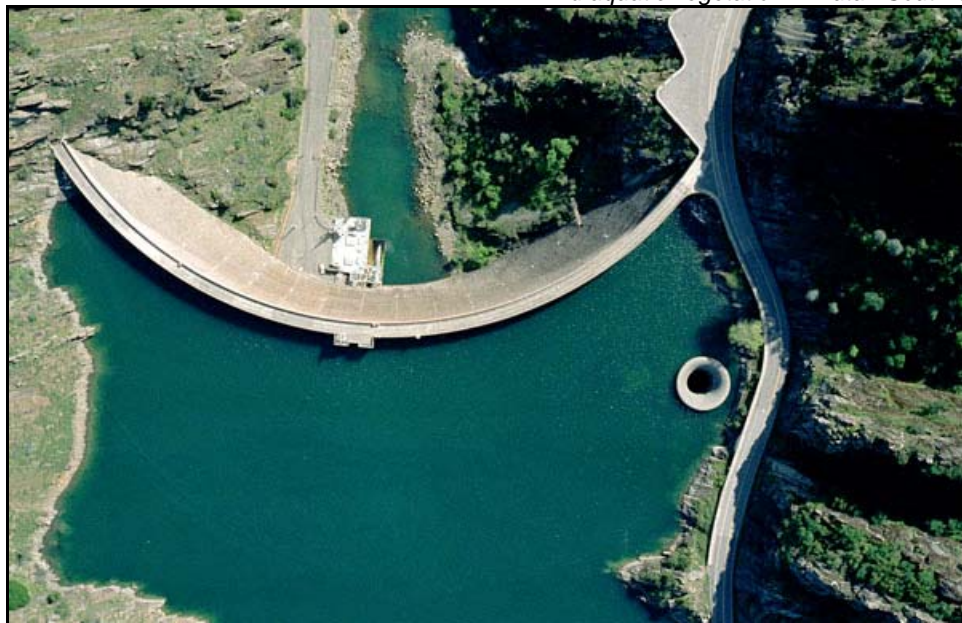
**Figure 1.2.** Monticello Dam and Lake Berryessa. Photo from <http://www.scwa2.com>.

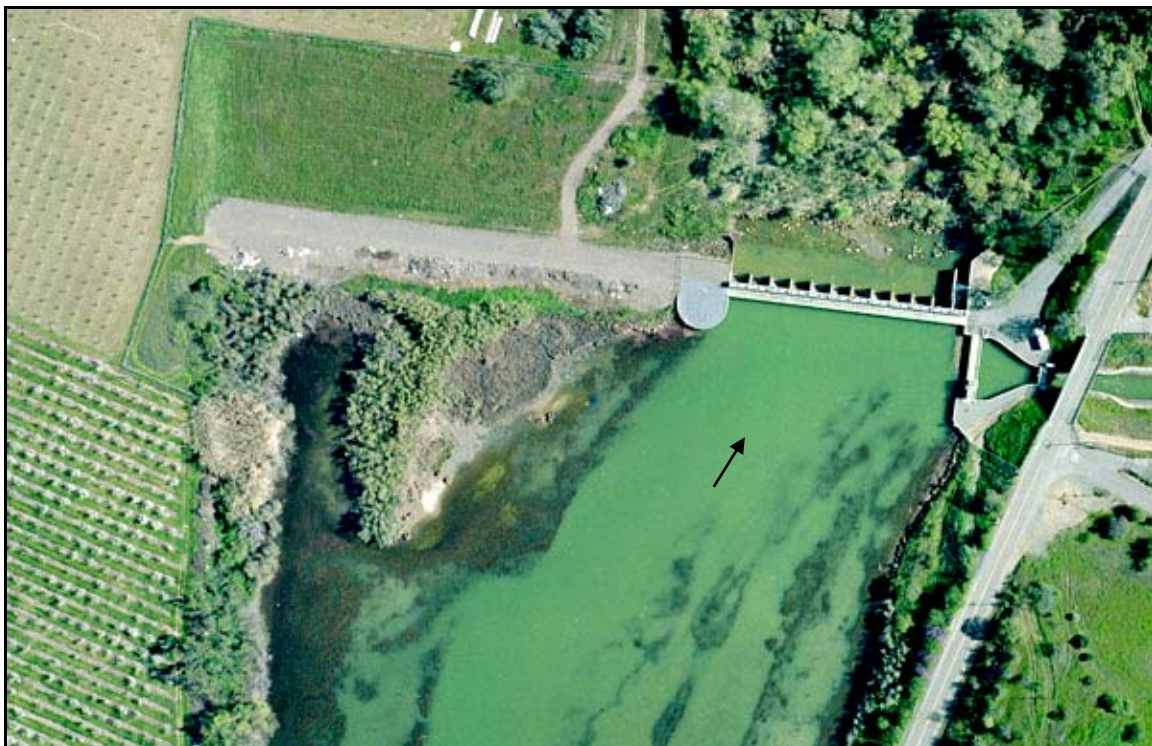
**Figure 1.3.** Putah Diversion Dam, Solano Lake, and Putah South Canal inlet structure. Photo from <http://www.scwa2.com>. Note sediment deposits in Lake Solano near canal inlet.

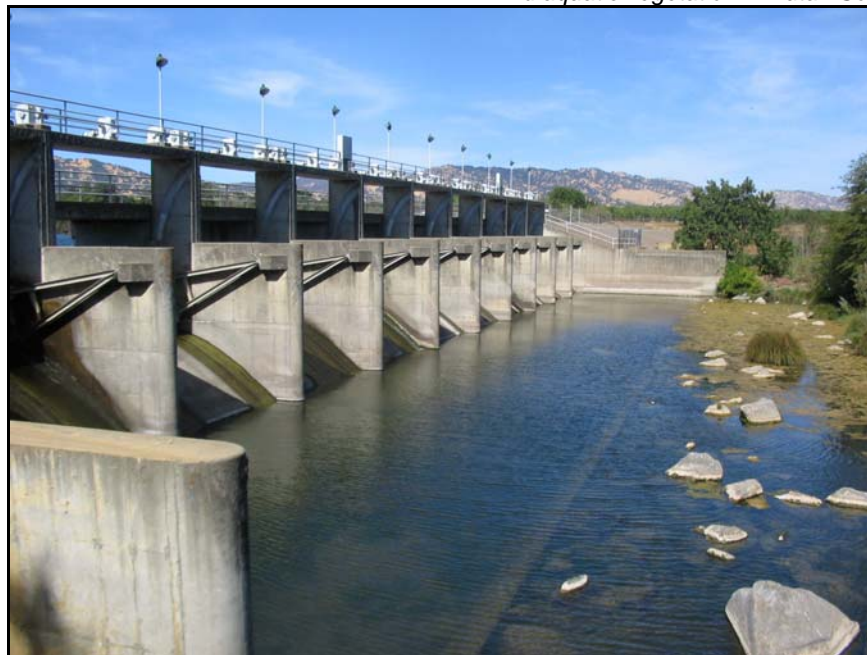
**Figure 1.4.** Downstream face of Putah Diversion Dam. Flow left to right.  
Photo of September 19, 2006.

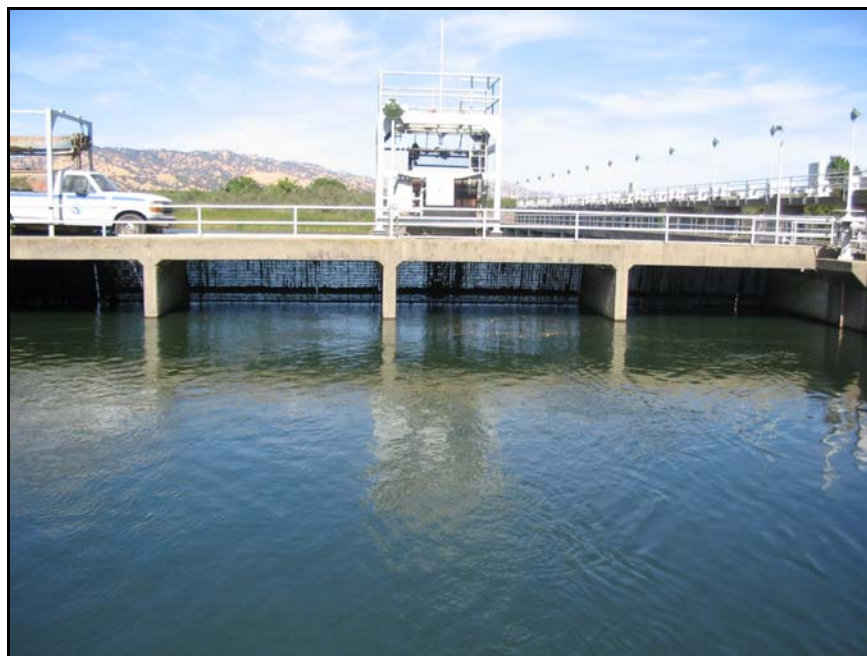
**Figure 1.5.** Headworks structure at inlet to Putah South Canal. View upstream. Note sediment and algae deposited on fish/trash screen. Photo of September 19, 2006.

The Putah Diversion Dam develops enough head at the PSC Headworks to maintain gravity flow into the PSC. The Headworks is located on the south bank of Lake Solano immediately upstream of the diversion dam (Figure 1.5). Flow into the PSC is regulated by two parallel bottom-up tainter gates (Figure 1.6). The PSC is a 33-mile long concrete-lined open channel (Figure 1.7) extending south along the eastern toe of the English Hills through the Cities of Vacaville and Fairfield to the Terminal Reservoir in Green Valley. The canal has a diversion capacity of 956 cfs with a terminal capacity of 116 cfs. The PSC serves municipal, industrial, and agricultural customers and frequently transitions from rural to urban settings. During the spring and summer months approximately 75% of the water deliveries provided through the PSC are for irrigation and agricultural uses. Municipal and industrial (MI) water users along the PSC withdraw raw water year round from the canal and treat it in order to meet current drinking water standards. The total length of the canal is divided up into 12 reaches or controlled checks (see Table 1.1). Along the canal, there are 5 operational spills (2 inactive), 11 plant intakes (1 inactive), and approximately 55 pumped or gravity turnouts/laterals consisting of combinations of open channel and/or pipe conveyance infrastructure. The plant intakes are summarized in Table 1.2. Canal section properties are given in Table 1.3. The longitudinal profile of the canal is shown in Figure 1.8. Canal longitudinal slope ranges from 0.00010 to 0.00015. Longitudinal distribution of typical winter and summer flows in the PSC are shown in Figure 1.9. Mean daily winter and summer outtakes from different reaches of the PSC during water year 2008 and design storage capacity of each check are shown in Figure 1.10 (water year, or WY, is the 12-month period from October 1 to September 30, designated by the calendar year in which it ends).

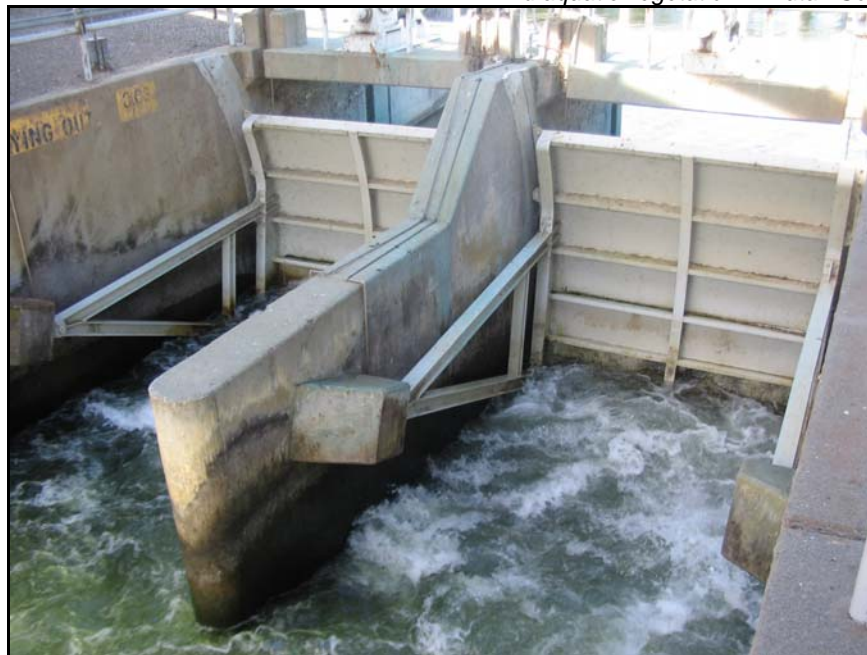
**Figure 1.6.** Tainter gates at inlet to Putah South Canal. Photo of September 19, 2006.

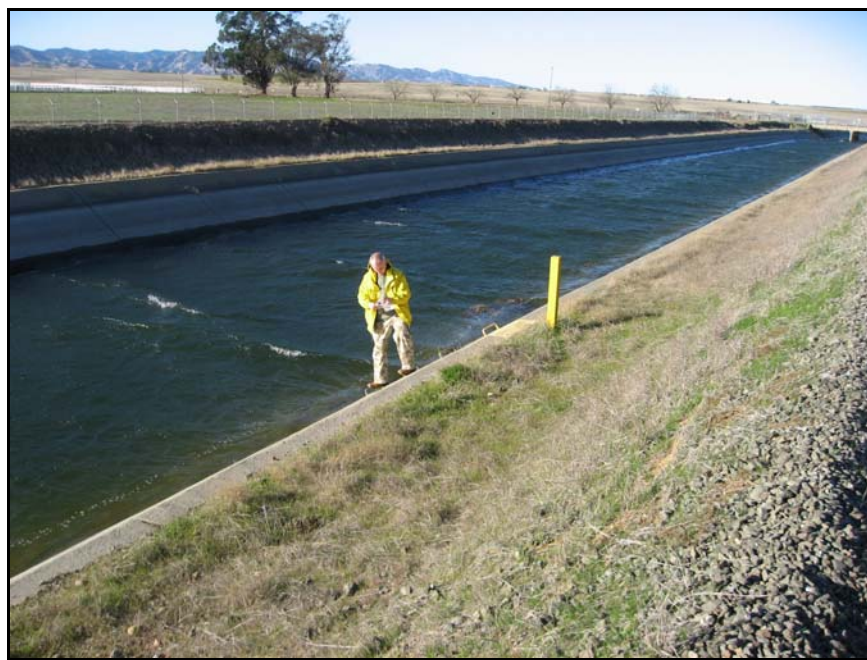
**Figure 1.7.** Putah South Canal, Sweeney Check. View upstream.  
Photo of December 27, 2006.

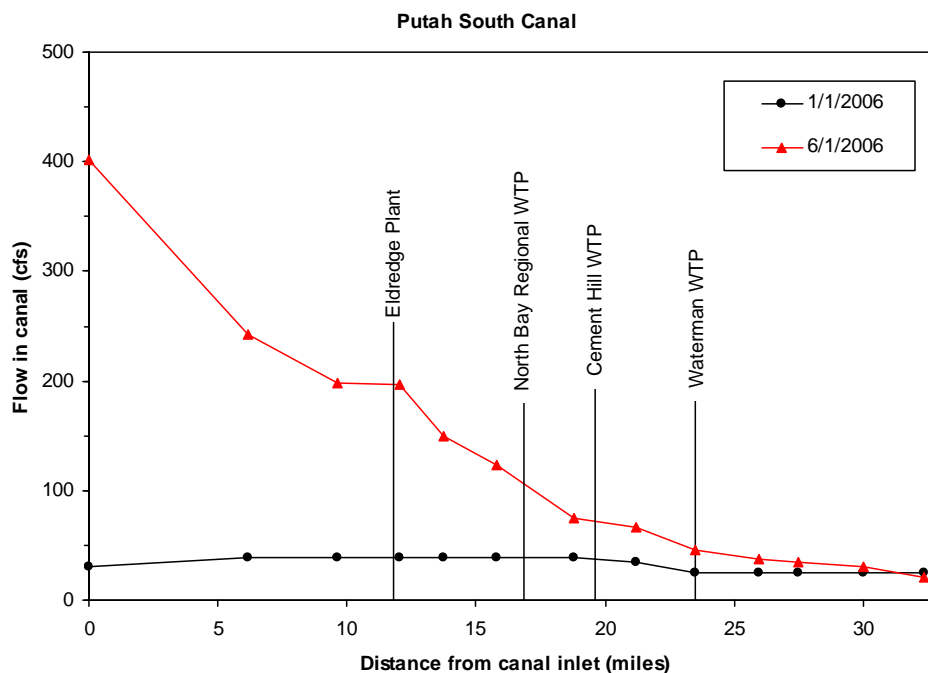
**Figure 1.9.** Longitudinal distribution of winter and summer flows in Putah South Canal (SID data for water year 2006).

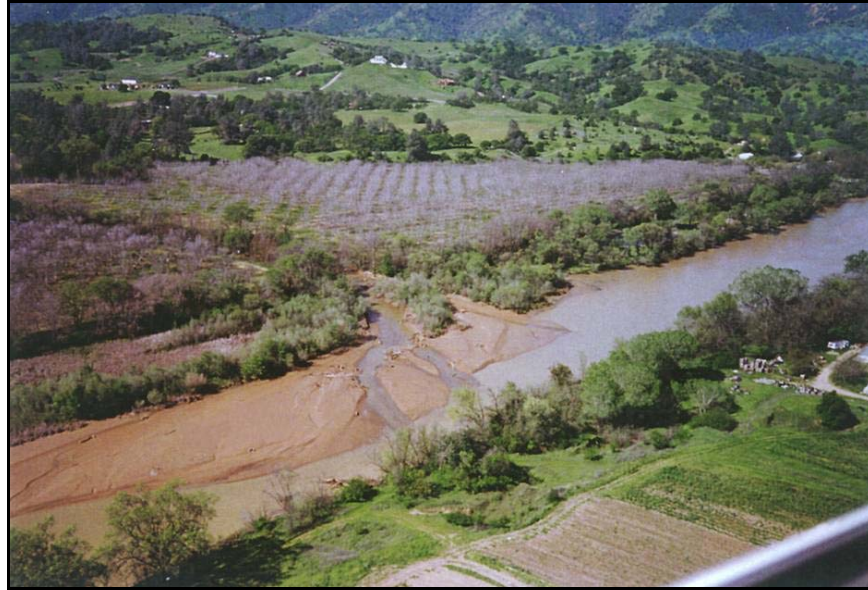
**Figure 1.11.** Sediment deposits in delta of Pleasants Creek in 1995.  
Photo from NHC (1998) report.

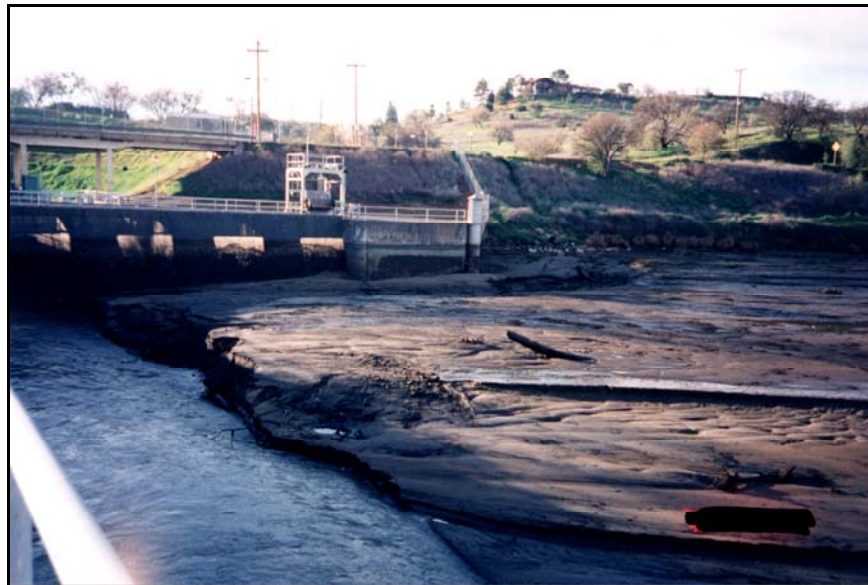
**Figure 1.12.** Sediment deposits in Lake Solano at entrance to Putah South Canal.  
Photo of February 26, 1997 (from NHC 1998 report).

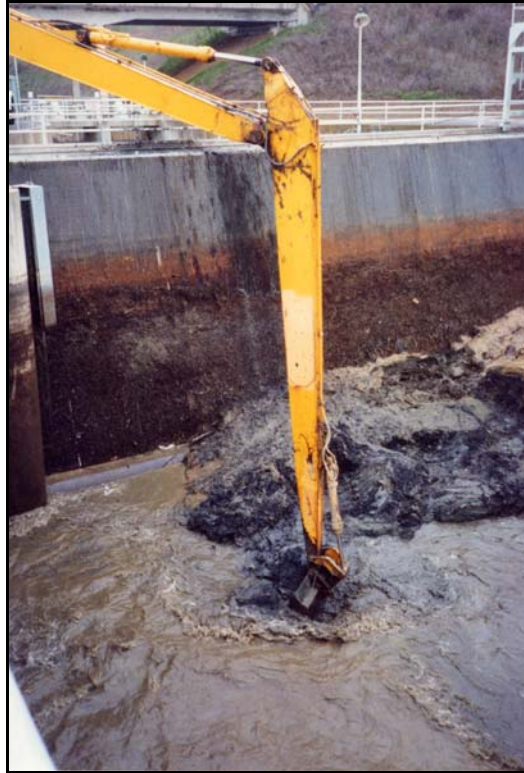
**Figure 1.13.** Sediment removal at inlet of Putah South Canal on February 7, 1995  
(photo from NHC 1998 report).

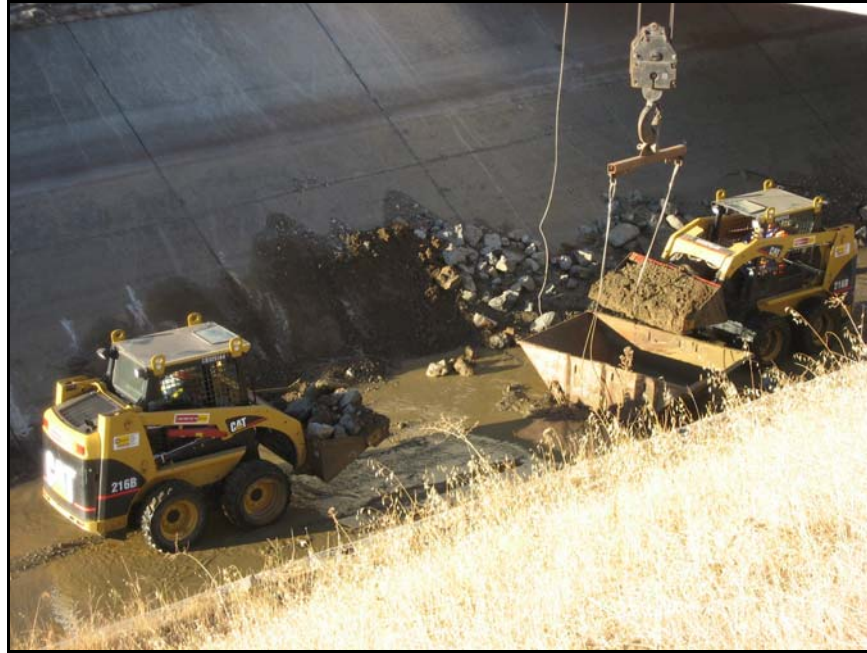
**Figure 2.1.** Removal of sediment from Sweeney Check at MP 0.5.  
Photo of October 18, 2006.

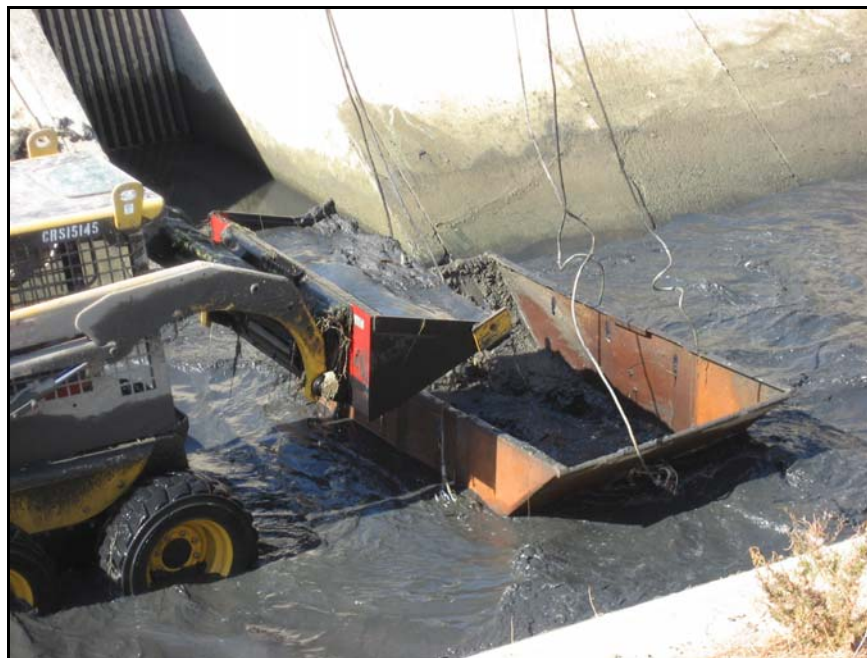
**Figure 2.2.** Cleanout of Alamo Check at MP 12.84.  
Photo of October 30, 2006.

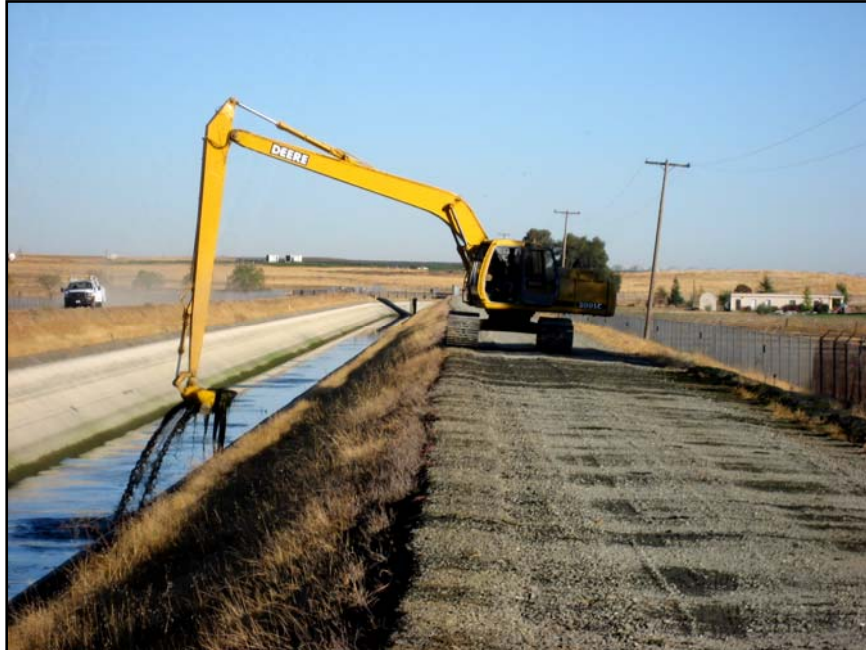
**Figure 2.3.** Removal of weeds and sediment from Sweeney Check at MP 6.15.  
View upstream. Photo of October 19, 2006.

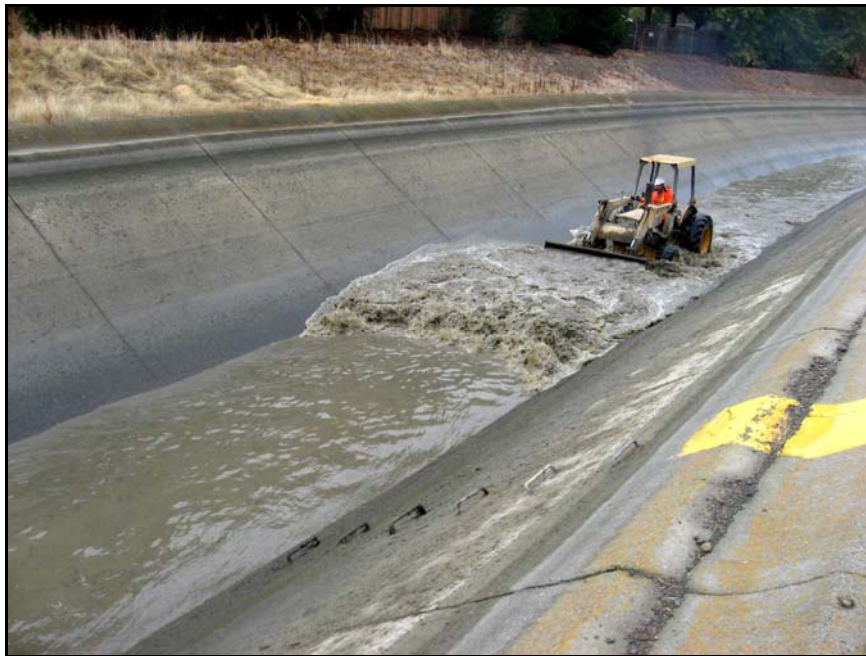
**Figure 2.4.** Pushing sediment down Union Check at MP 14.80.  
Photo of November 3, 2006.

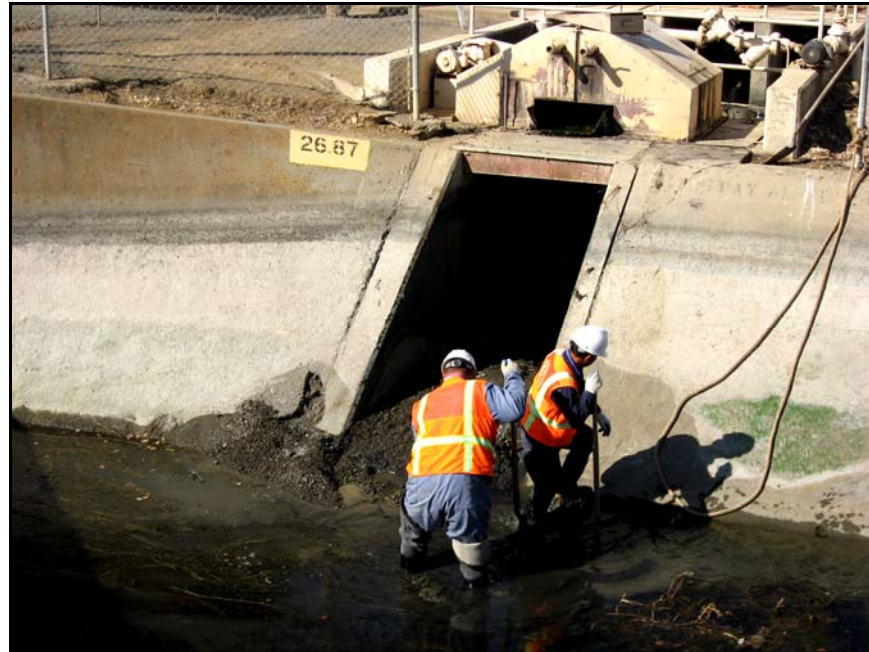
**Figure 2.5.** Manual removal of sediment from intake in Suisun Check at MP 26.87. Flow right to left. Photo of October 31, 2006.

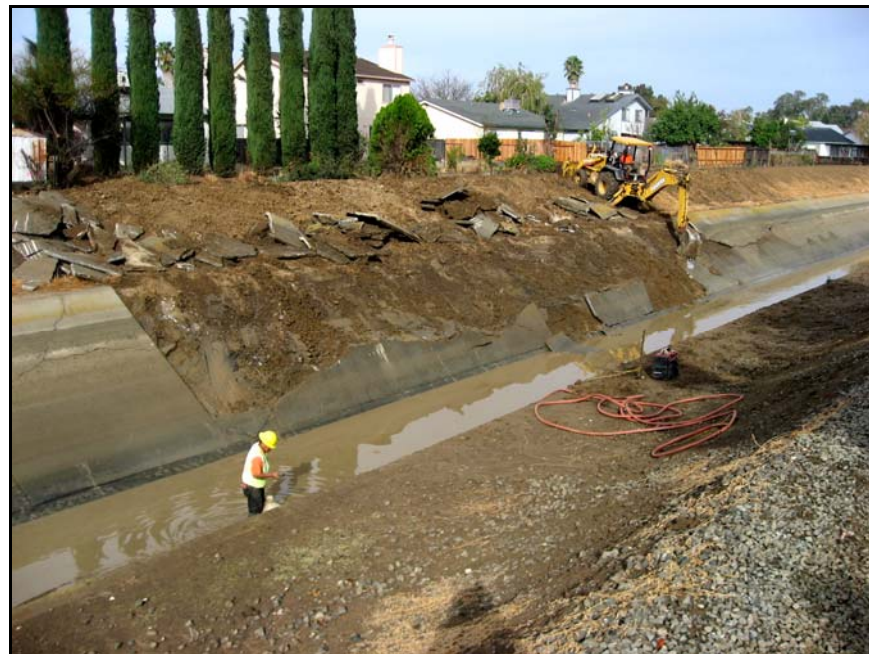
**Figure 2.6.** Repair of failed panels in Union Check at MP 14.0. Flow right to left. Photo of November 3, 2006.

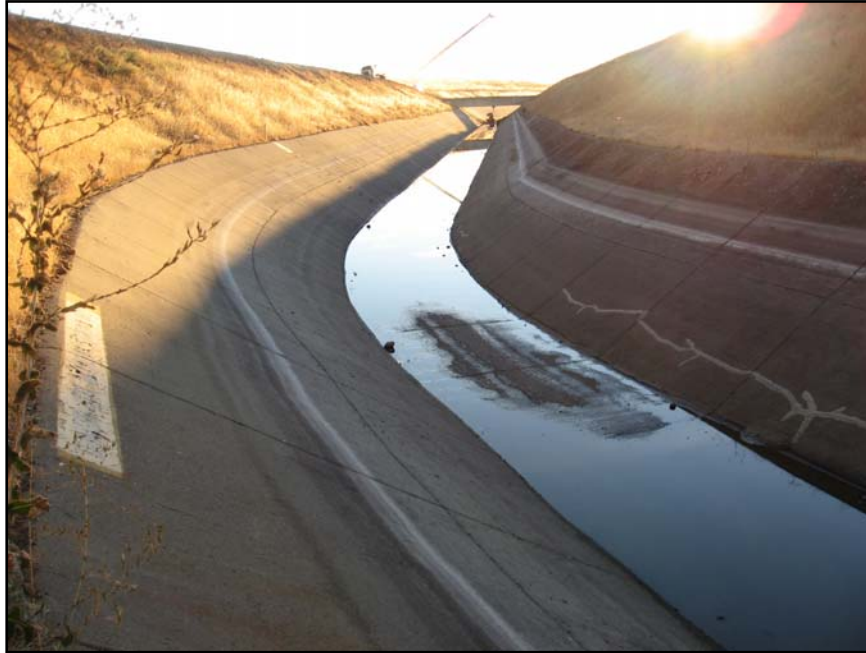
**Figure 2.7.** Clean upstream reach of Sweeney Check at MP 0.36. View downstream.  
Photo of October 18, 2006.

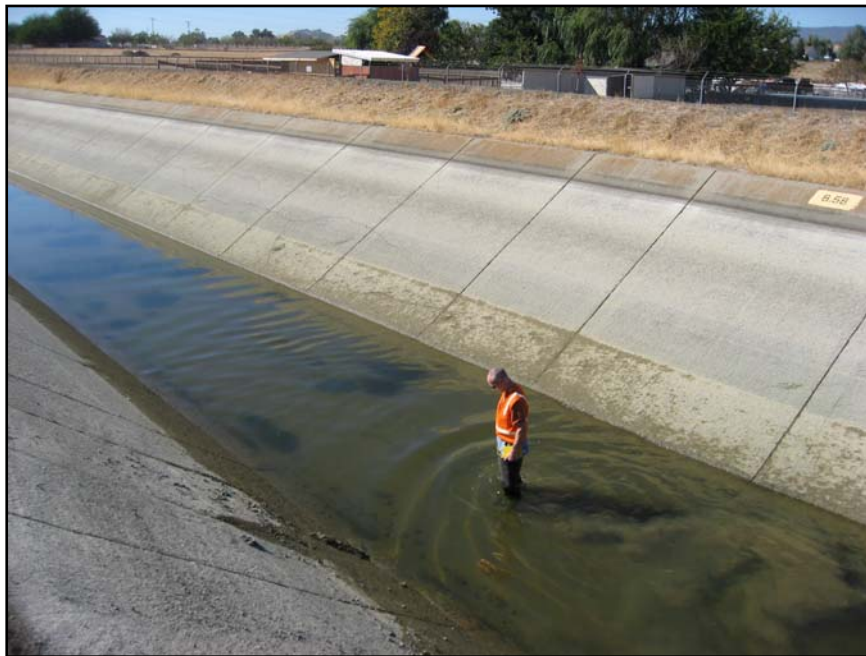
**Figure 2.8.** Clean upstream reach of Gibson Check at MP 8.58. View downstream.  
Photo of October 19, 2006.

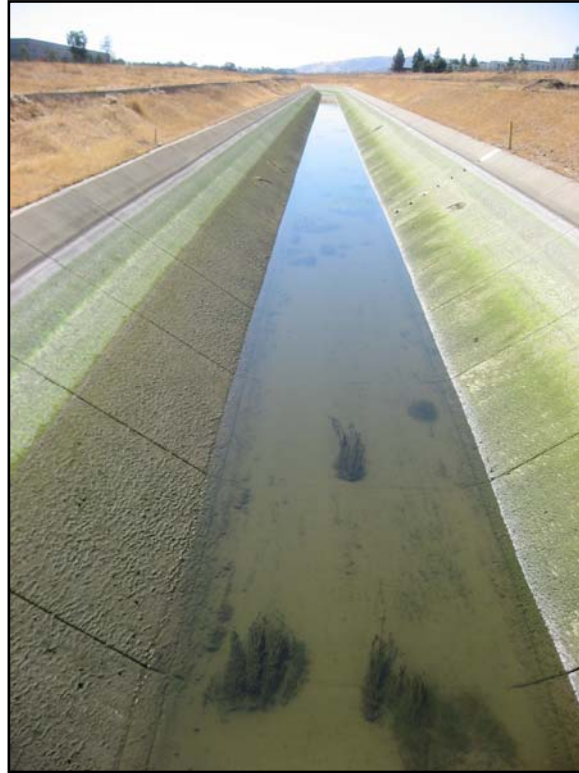
**Figure 2.9.** Clean upstream reach of Highway 80 Check at MP 10.23. View downstream.  
Note algae growing on canal sides. Photo of October 19, 2006.

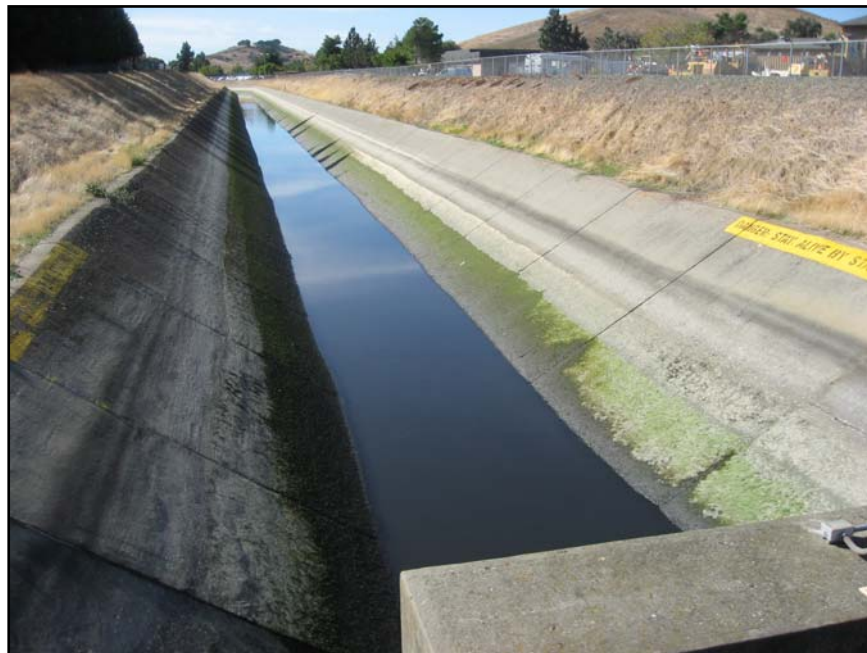
**Figure 2.10.** Clean upstream reach of Serpas Check at MP 21.42. View downstream.  
Photo of November 9, 2006.

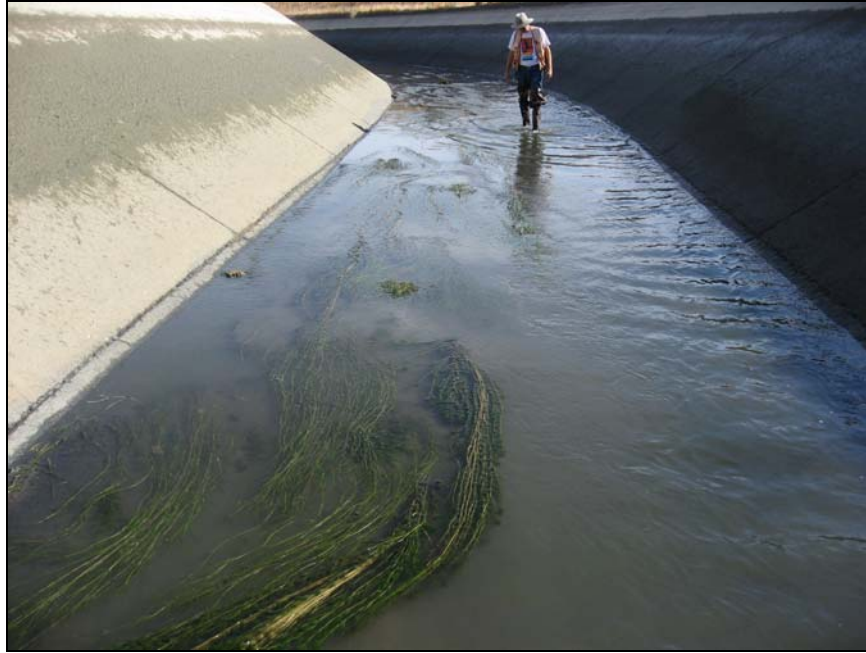
**Figure 2.11.** Mud and weeds in downstream portion of McCoy Check at MP 18.80. View upstream. Photo of November 6, 2006.

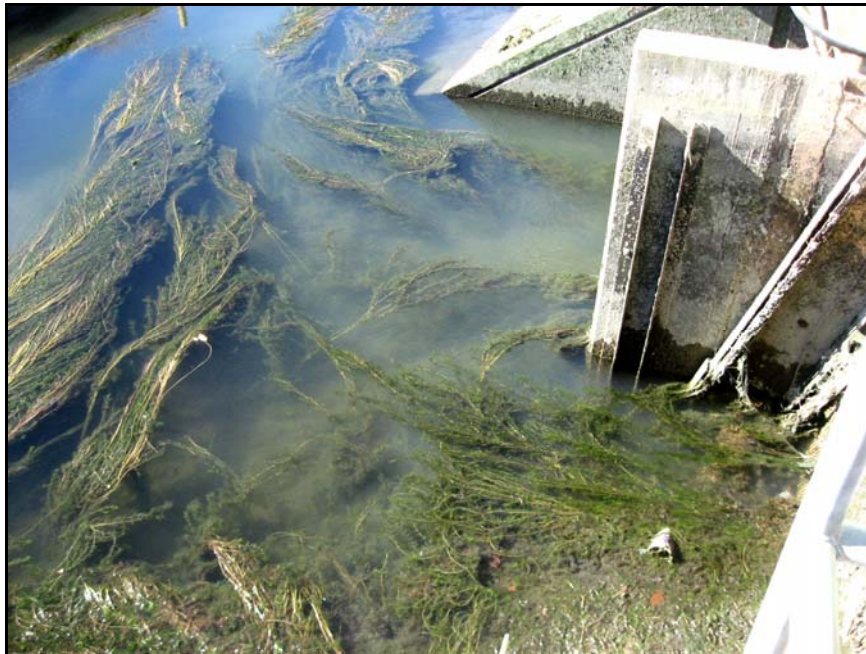
**Figure 2.12.** 2-ft thick deposit of mud and weeds in Serpas Check at Waterman Plant intake at MP 23.50. View downstream. Photo of November 9, 2006.

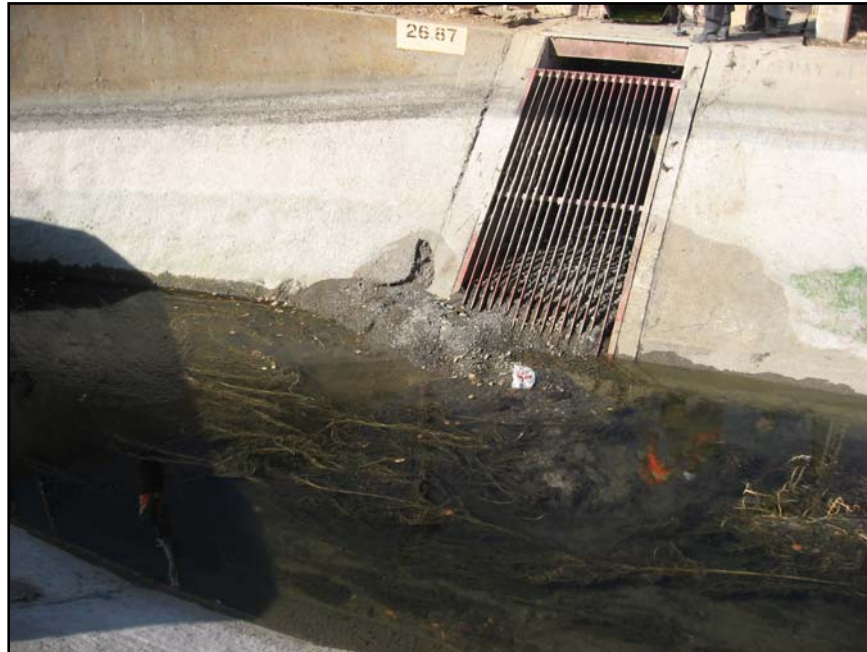
**Figure 2.13.** Mud deposits at intake in Suisun Check at MP 26.87. Flow right to left. Photo of October 31, 2006.

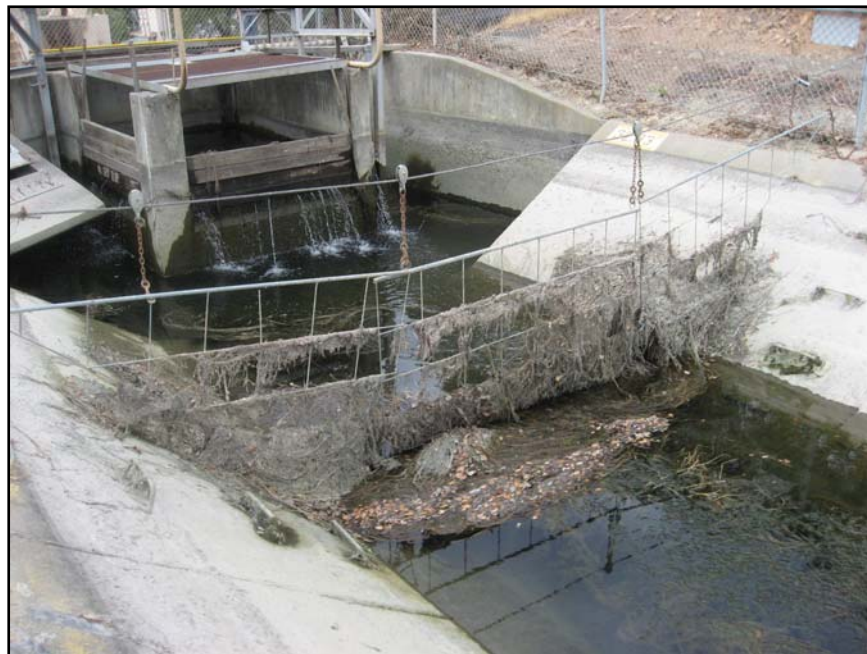
**Figure 2.14.** Mud and weeds at siphon in Terminus Check at MP 32.33. View downstream. Photo of November 1, 2006.

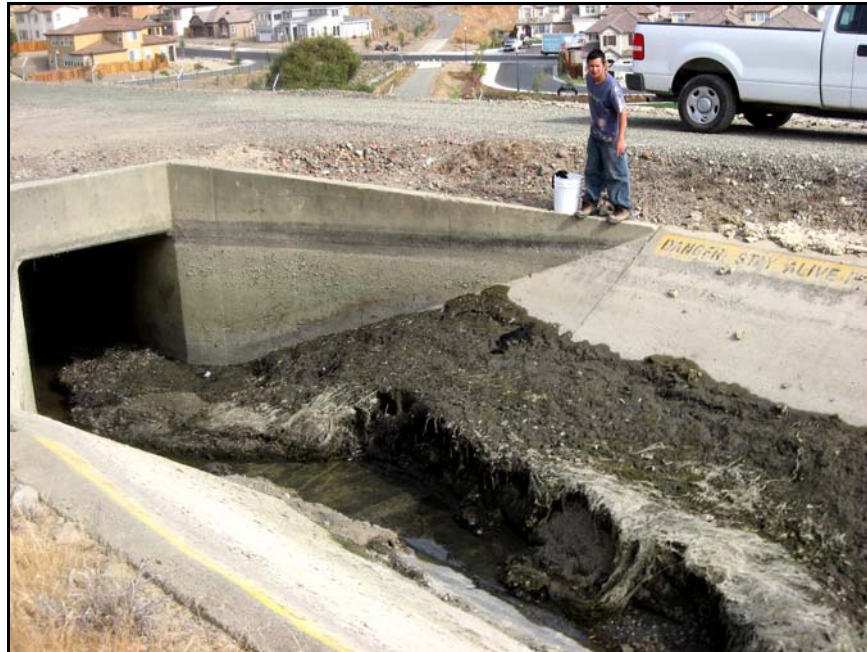
**Figure 2.15.** Sediment deposition at siphon outlet in Terminous Check at MP 31.29.  
Flow left to right. Photo of November 1, 2006.

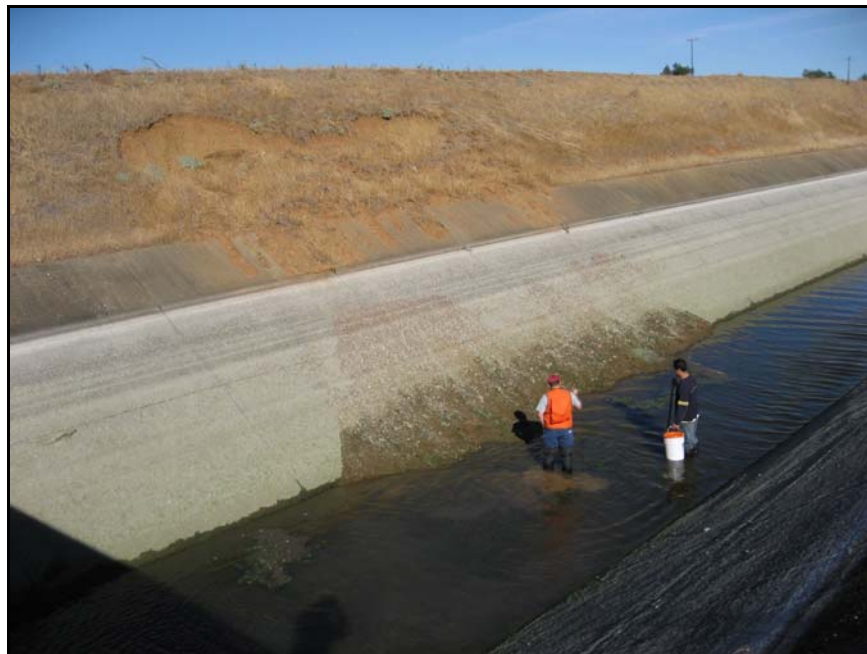
**Figure 2.16.** Pile of sand/gravel from bank failure in Sweeney Check at MP 3.44.  
Flow right to left. Photo of October 18, 2006.

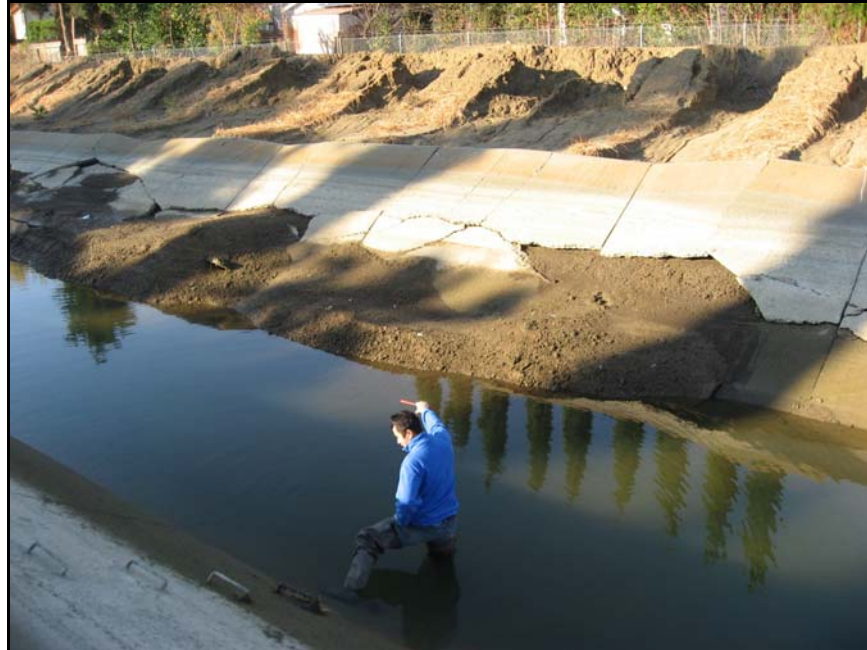
**Figure 2.17.** Failed earthen bank and canal panels in Union Check at MP 14.0. Flow right to left. Photo of October 30, 2006.

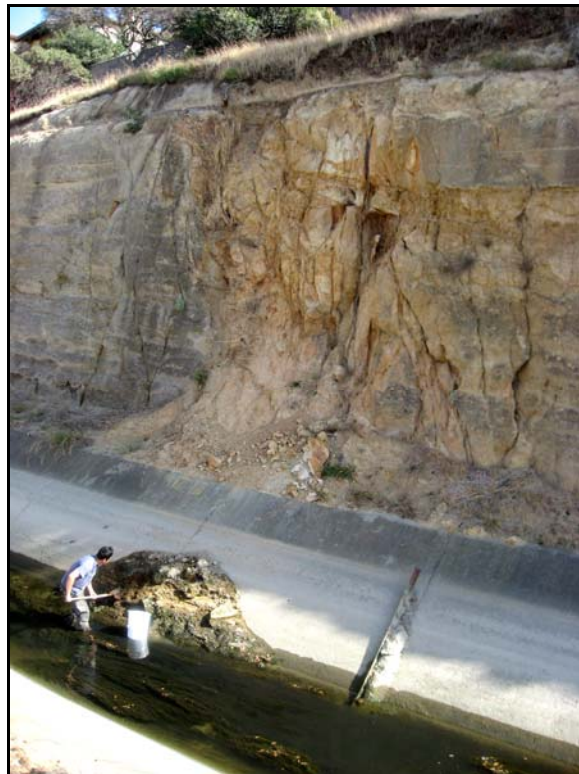
**Figure 2.18.** Sediment from failed bank in Terminous Check at MP 31.0. Flow left to right. Photo of November 1, 2006.

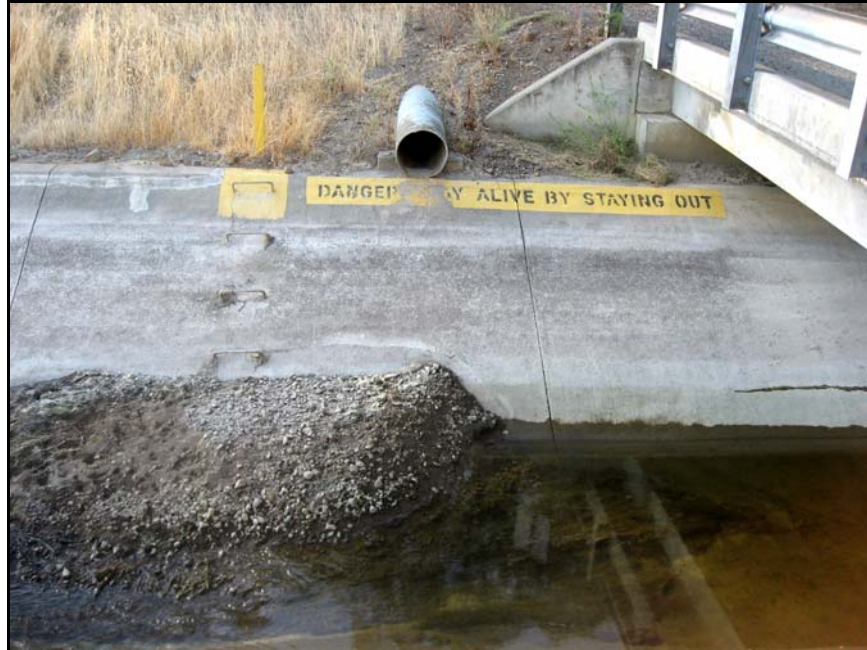
**Figure 2.19.** Pile of sand and gravel from local open drainage in Rockville Check at MP 29.54. Flow right to left. Photo of October 31, 2006.

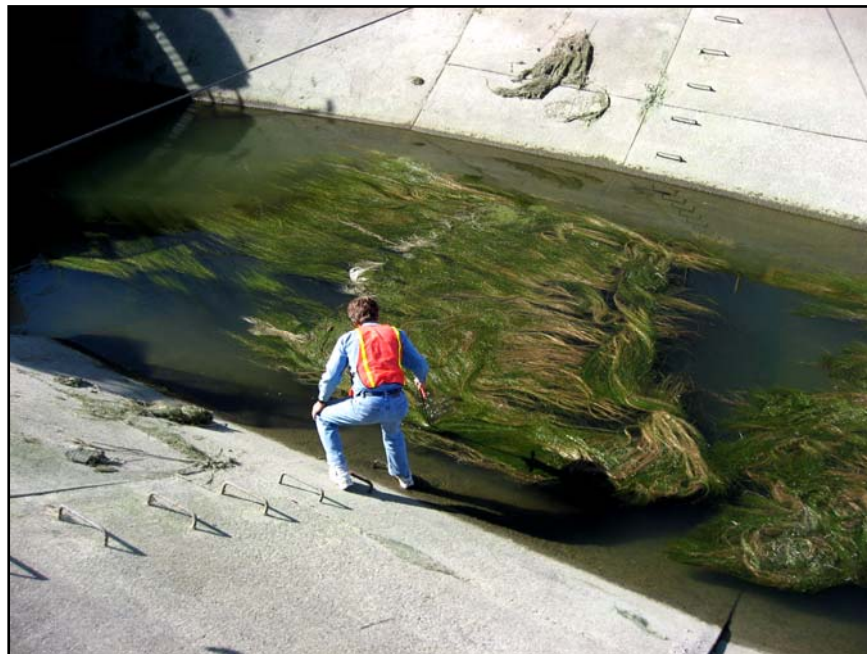
**Figure 2.20.** Mud and weeds in downstream portion of Sweeney Check at MP 6.15. Flow right to left. Photo of October 18, 2006.

Deposition of fine sediments in the canal promotes growth of aquatic weeds (Figures 2.20-2.21). The growth of aquatic weeds, in turn, captures more fine sediment and promotes more sediment deposition. In the fall of 2006, the distribution of weeds in the canal generally followed the sediment deposition pattern. There was an apparent direct correlation between fine sediment deposits and weed growth in the canal – the more the fine sediment, the more the weeds. Weed growth tended to increase in the downstream direction (Figure 2.23). At many locations, particularly upstream of flow control structures, aquatic weeds occupied the entire width of the canal.

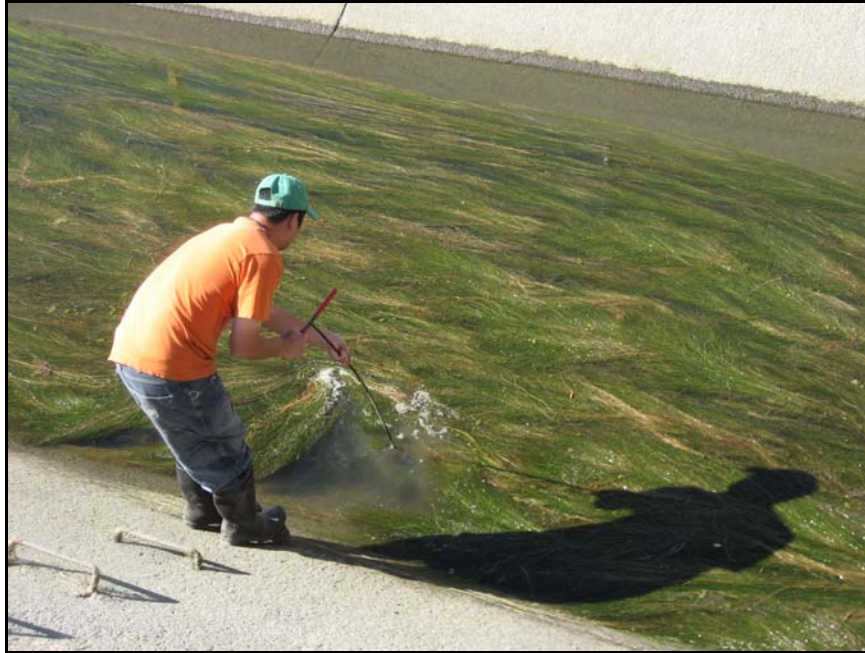
**Figure 2.21.** Mud and weeds in downstream portion of Gibson Check at MP 9.46. Flow right to left. Photo of October 19, 2006.

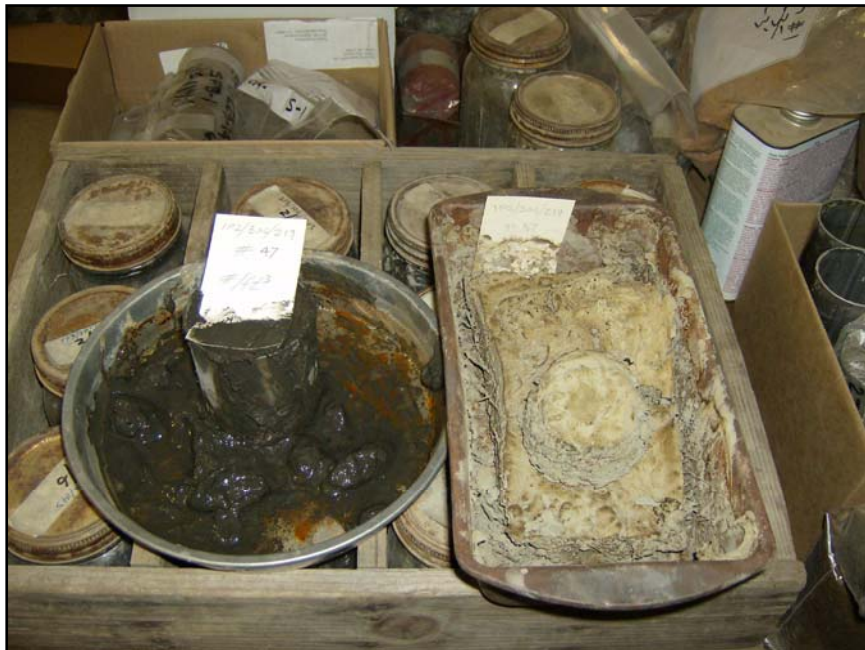
**Figure 2.22.** Sediment from Putah South Canal before and after drying.

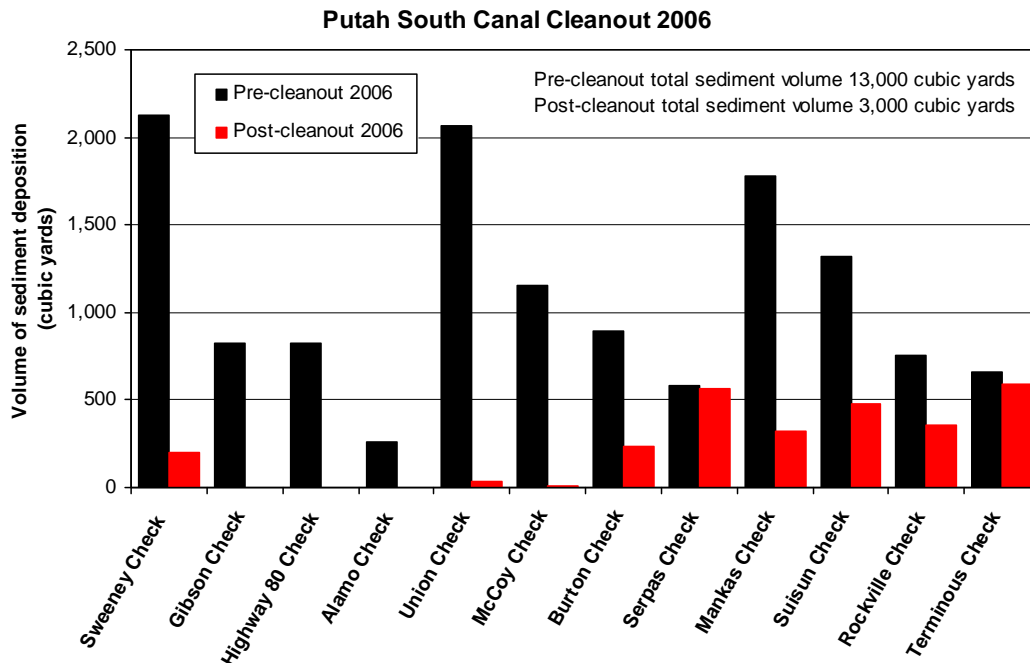
**Figure 2.25.** Estimated volumes of sediment deposits in each check before and after fall 2006 cleanout.

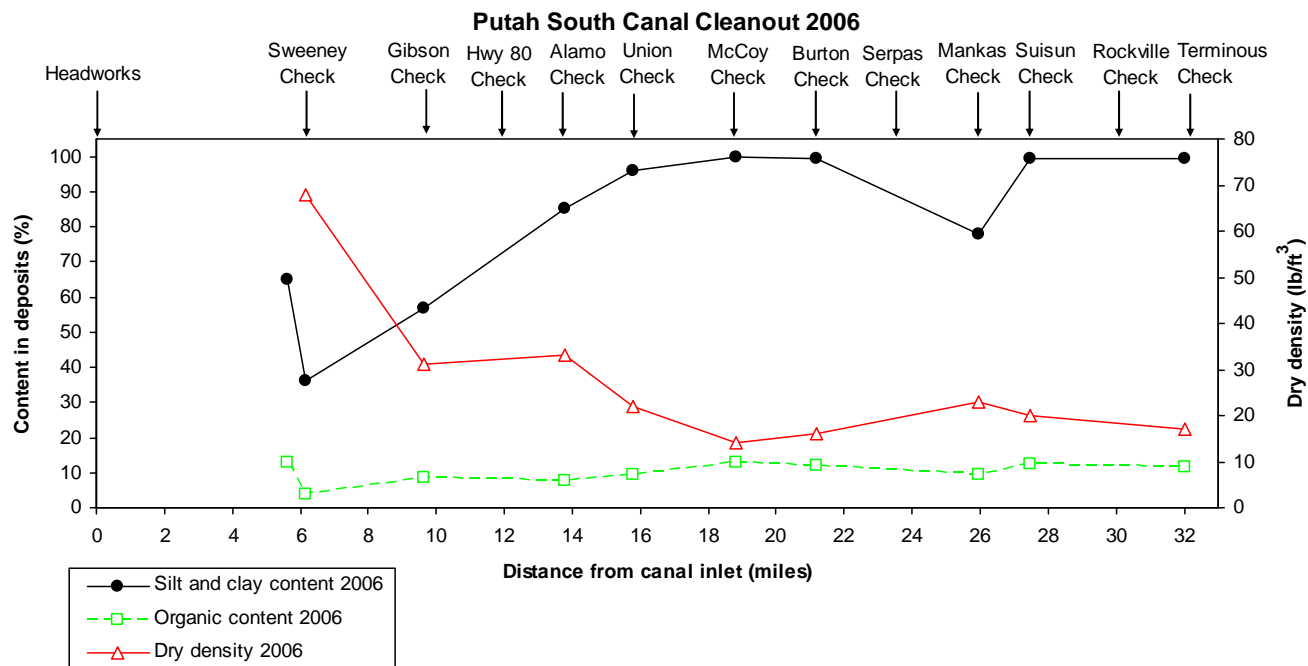
**Figure 2.26.** Longitudinal variation of bed material properties (according to measurements taken during fall 2006 cleanout).

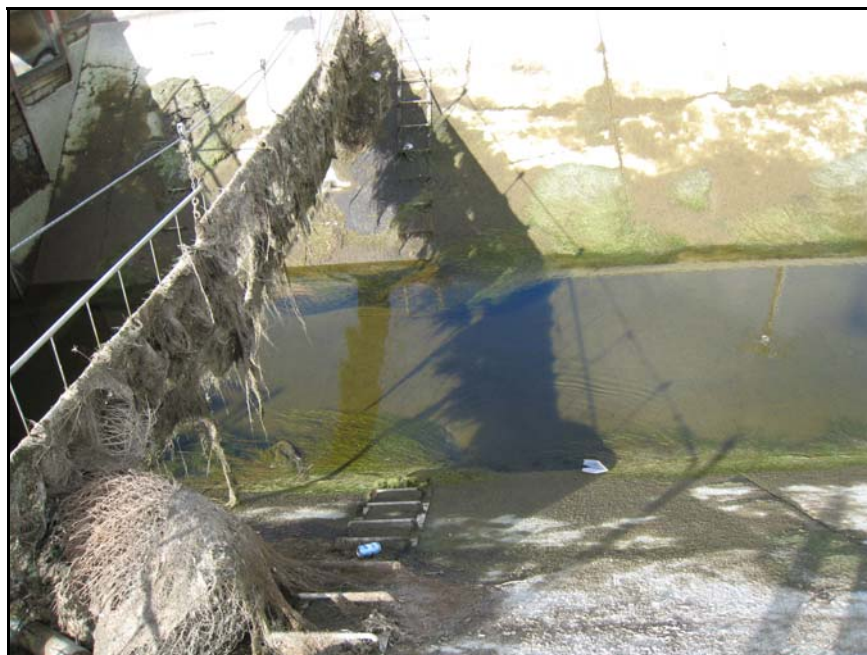
**Figure 2.27.** Relatively clean canal bottom upstream of Gibson Check gate at MP 9.64. Flow right to left. Photo of October 19, 2007.

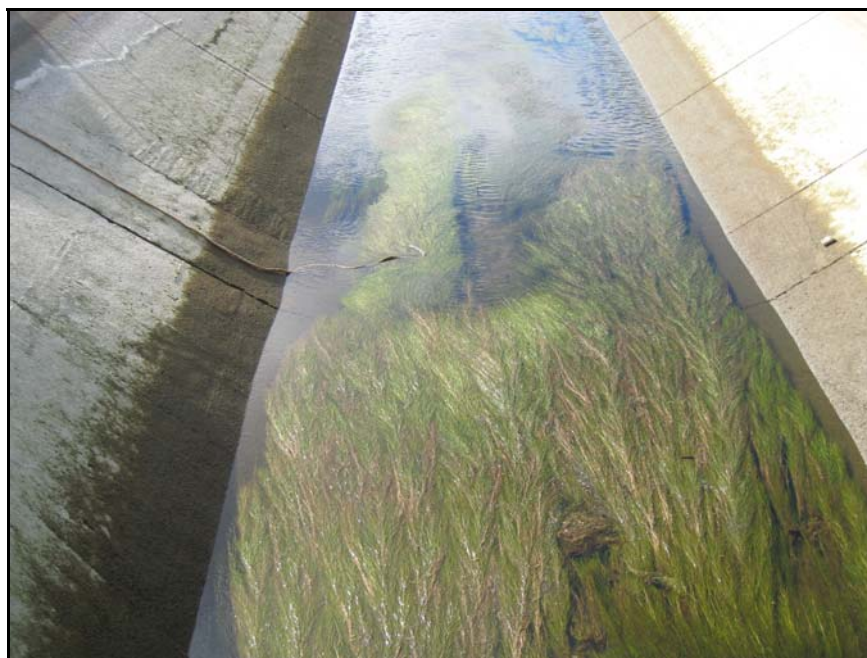
**Figure 2.28.** Mud and weed accumulation in Highway 80 Check at MP 9.66. View downstream. Photo of October 19, 2007.
