# **INVESTIGATION OF SOURCES OF TURBIDITY, SEDIMENT, AND AQUATIC VEGETATION IN PUTAH SOUTH CANAL**

## **Solano County Water Agency**

## **Northwest Hydraulic Consultants Inc.**

***May 14, 2010***

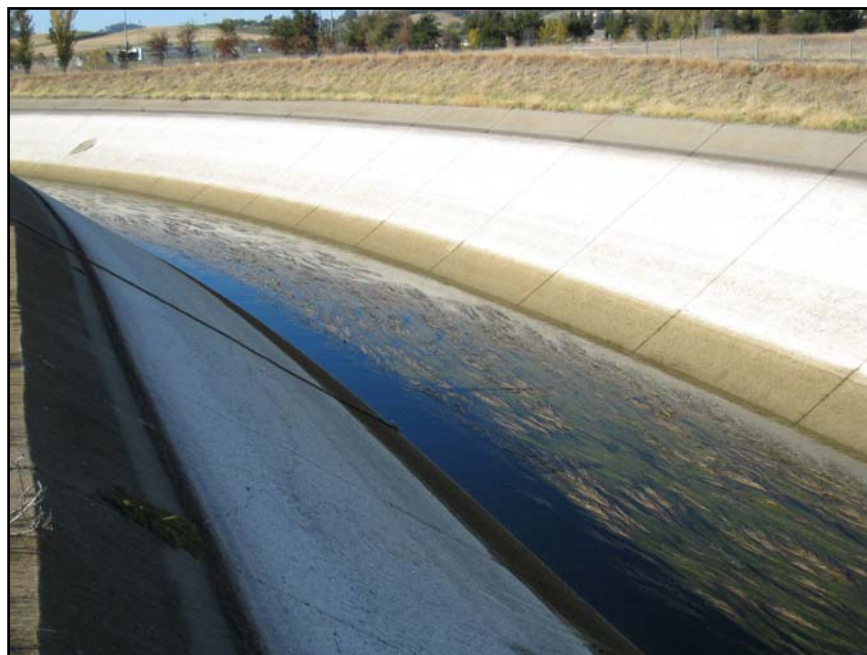
**Figure 2.29.** Mud and weeds completely covering bottom in Highway 80 Check at MP 11.10. View downstream. Photo of October 23, 2007.

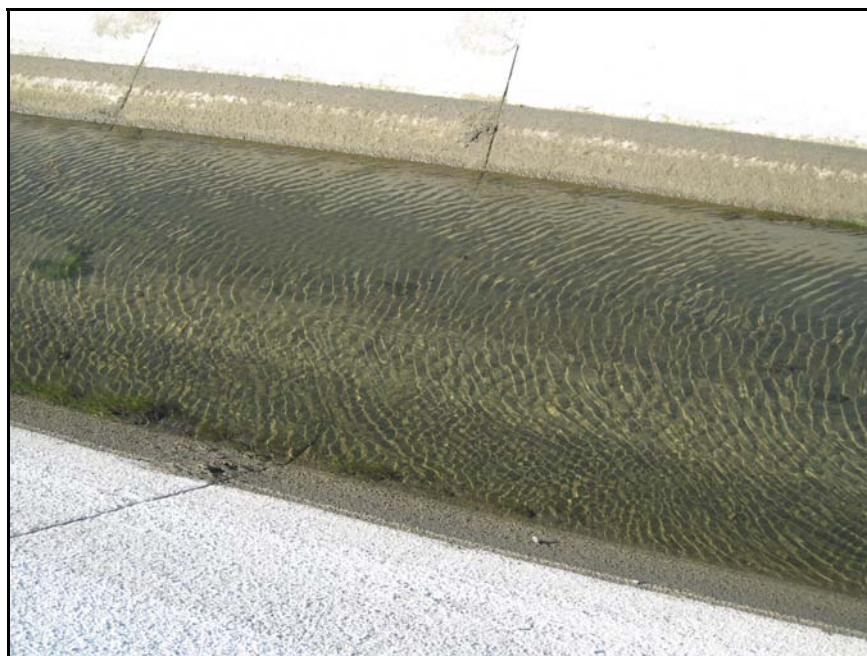
**Figure 2.30.** Clean canal bottom in Highway 80 Check at MP 11.57. Flow right to left. Photo of October 23, 2007.

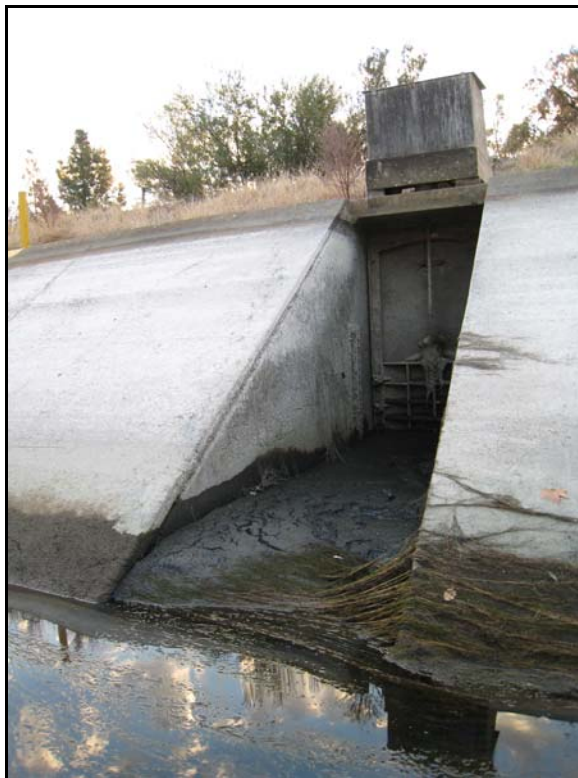
**Figure 2.31.** Accumulation of mud and organic deposits at intake structure upstream of Alamo Check gate at MP 13.76. Flow left to right. Photo of October 29, 2007.

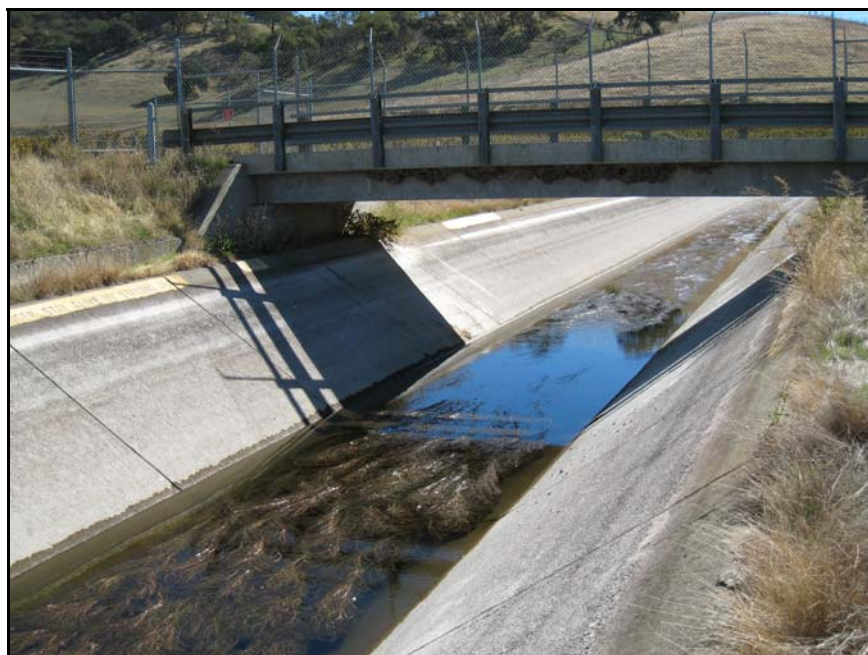
**Figure 2.32.** Weed growth in Mankas Check at MP 25.35. View upstream. Photo of October 22, 2007.

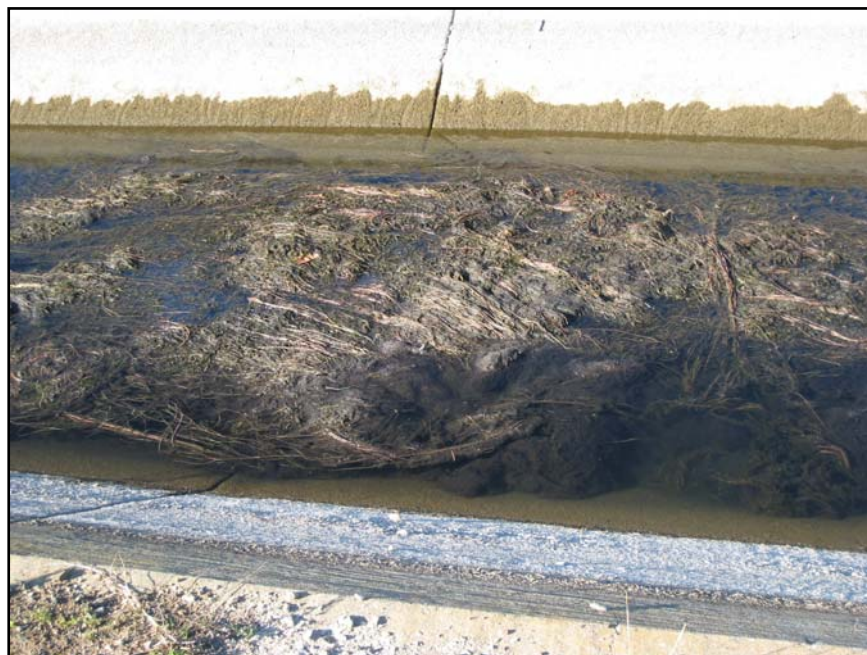
**Figure 2.33.** Large patch of mud and vegetation in Suisun Check at MP 28.45. Flow right to left. Photo of November 2, 2007.

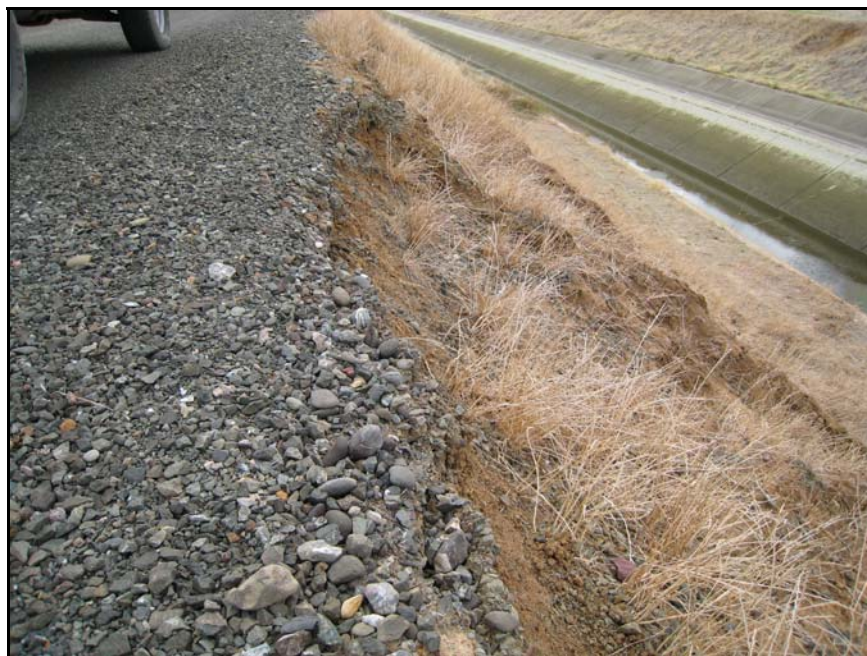
**Figure 2.34.** Eroding road and embankment above canal in Gibson Check at approximately MP 9. View downstream. Photo of October 18, 2007.

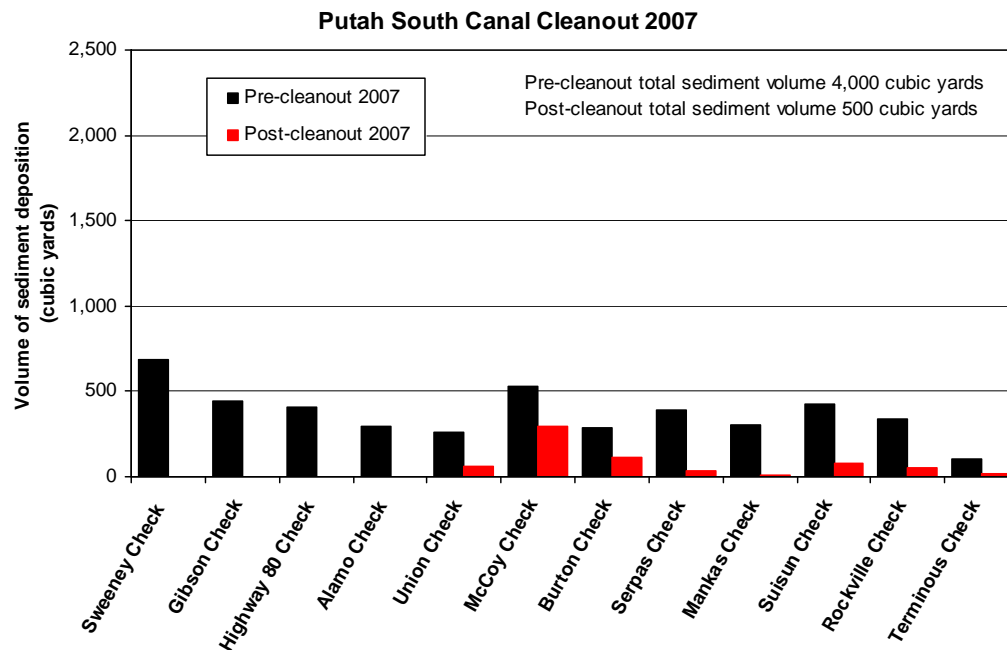
**Figure 2.37.** Estimated volumes of sediment deposits in each check before and after fall 2007 cleanout.

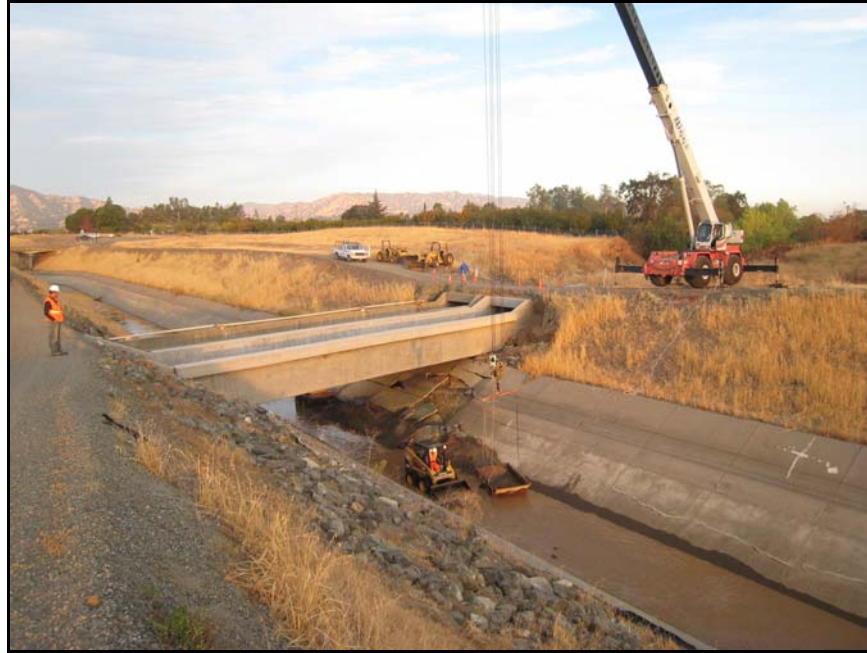
**Figure 2.39.** Eroded bank and damaged panels in Sweeney Check at McCune Creek Crossing at MP 0.47. View upstream. Photo of October 17, 2008.

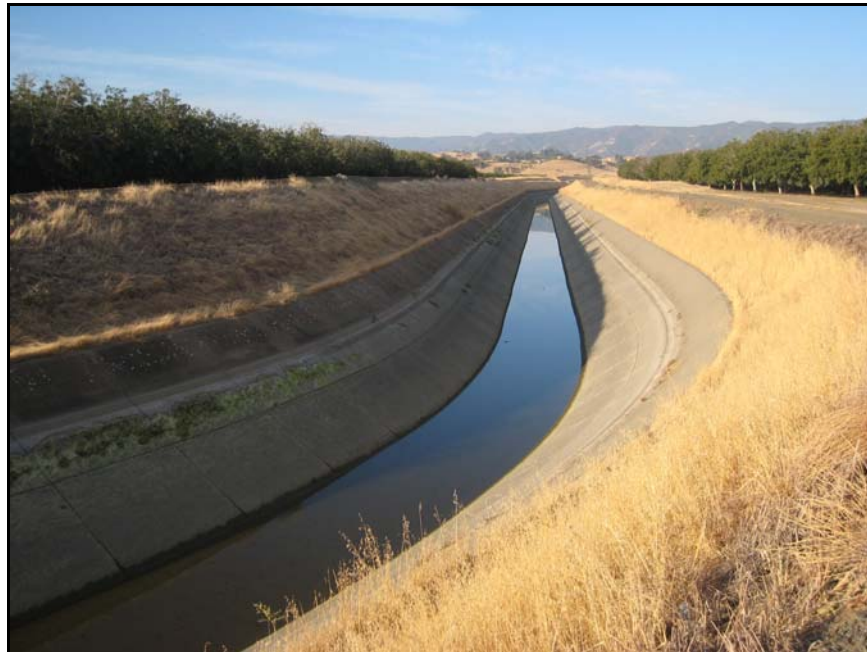
**Figure 2.40.** Clean canal in Sweeney Check at MP 1.50. View upstream. Photo of October 17, 2008.

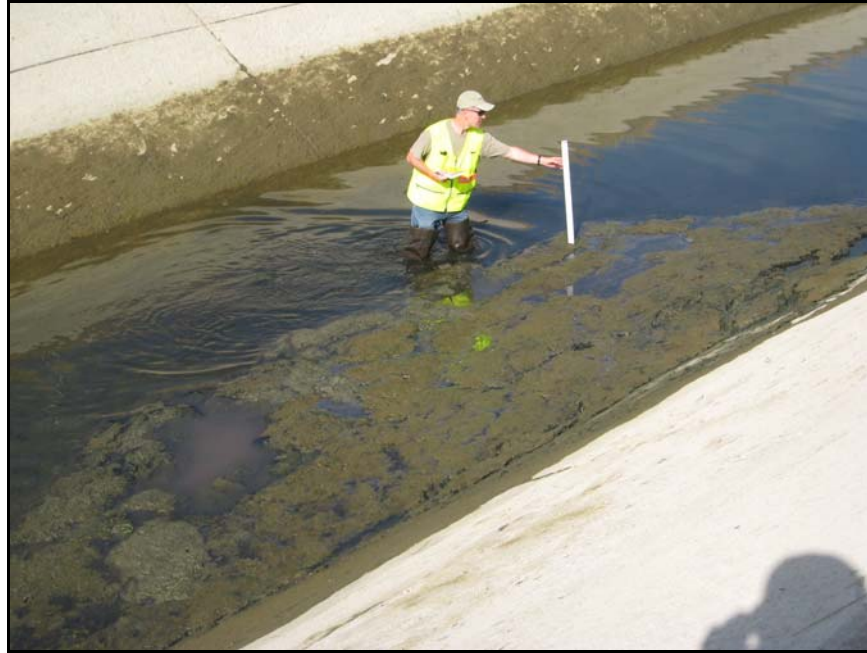
**Figure 2.41.** Sediment deposition in Sweeney Check at intake at MP 5.62.  
Flow right to left. Photo of October 17, 2008.

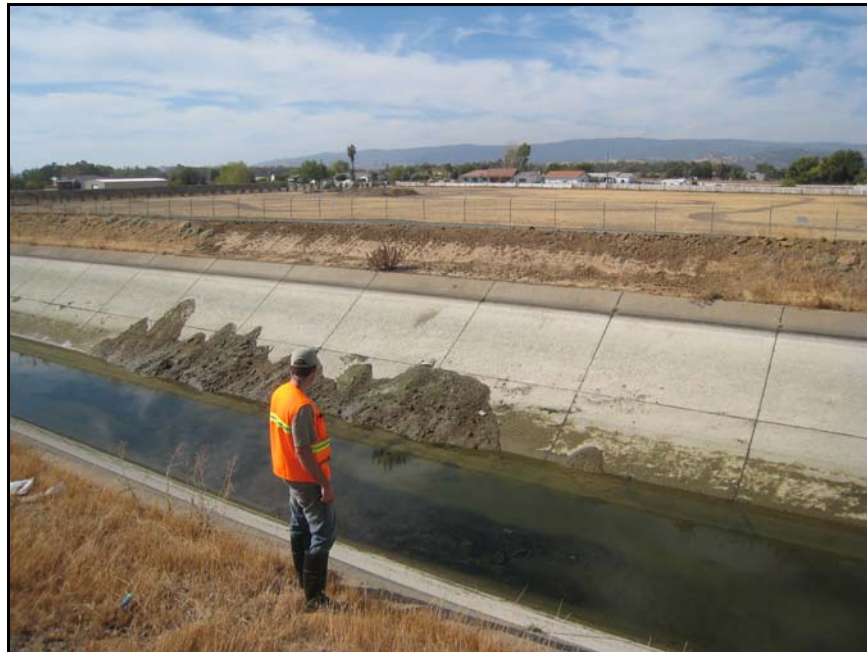
**Figure 2.42.** Sediment deposition from eroded right bank in Sweeney Check at MP 5.65.  
Flow right to left. Note repaired section of right bank. Photo of October 17, 2008.

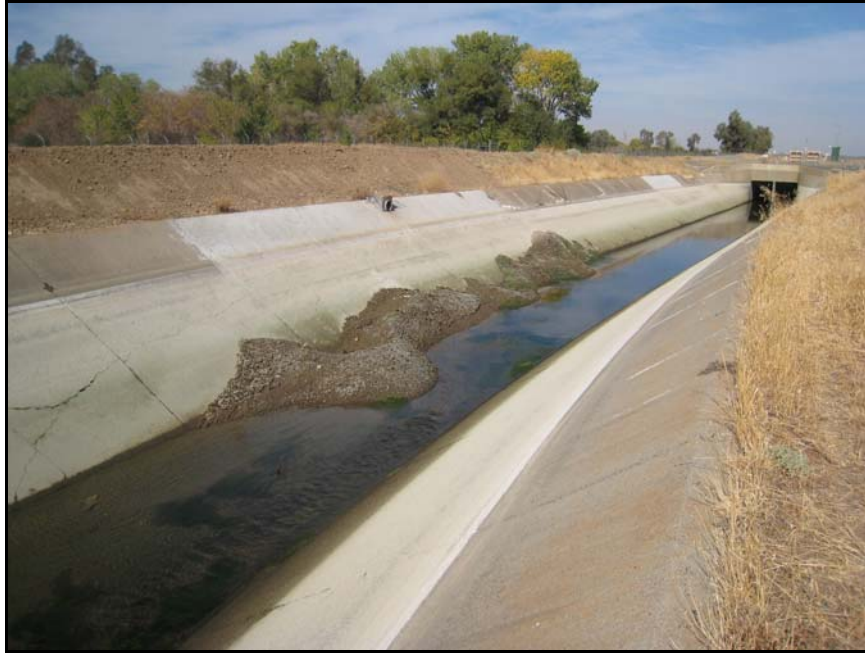
**Figure 2.43.** Sediment deposition from eroded right bank in Gibson Check at MP 6.21. View upstream. Note repaired section of right bank. Photo of October 17, 2008.

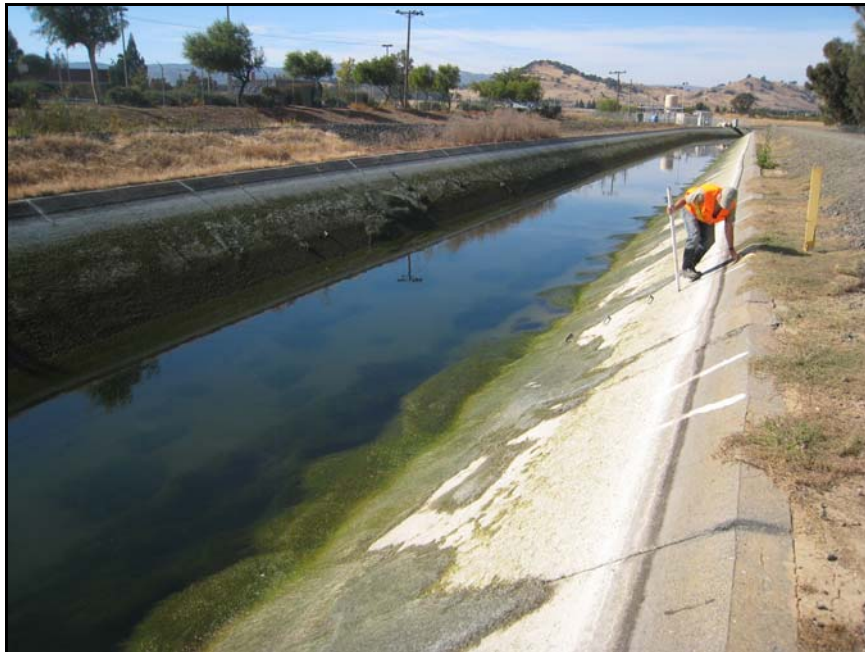
**Figure 2.44.** Thick matts of weeds in Highway 80 Check at MP 11.90. View upstream. Photo of October 17, 2008.

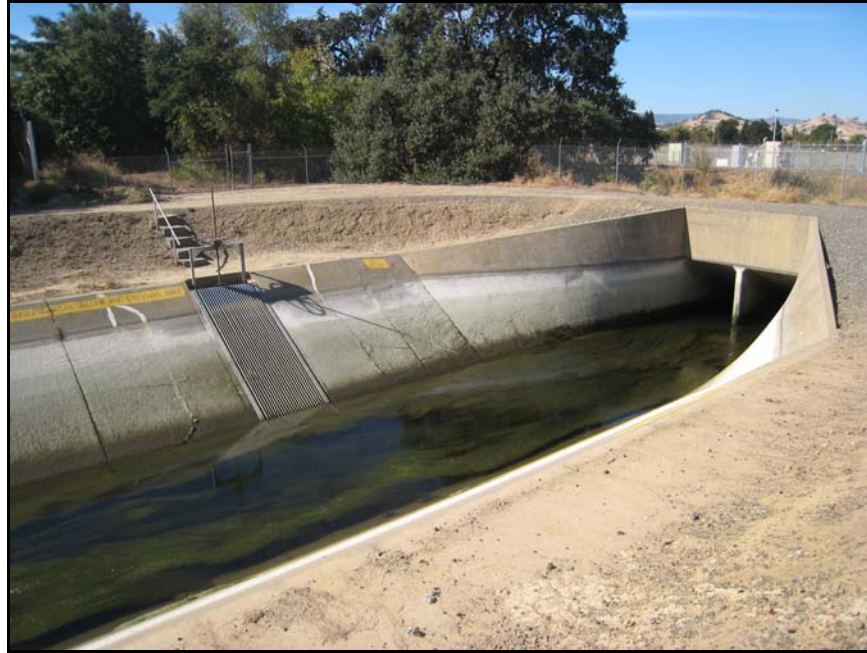
**Figure 2.45.** Mud and weed accumulation in Alamo Check at MP 12.84. Flow right to left. Photo of October 20, 2008.

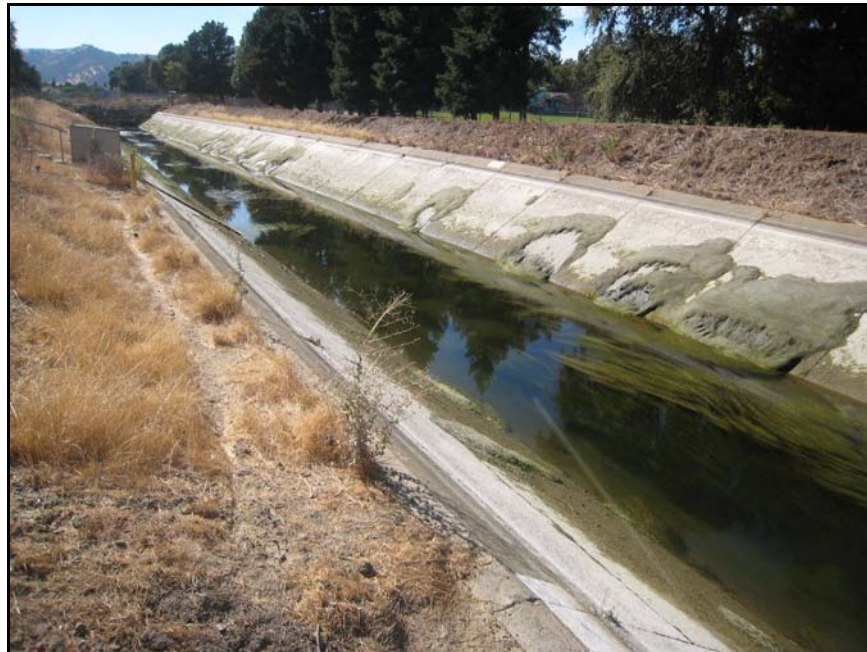
**Figure 2.46.** Mud and weed in Alamo Check at MP 13.76. View downstream. Photo of October 20, 2008.

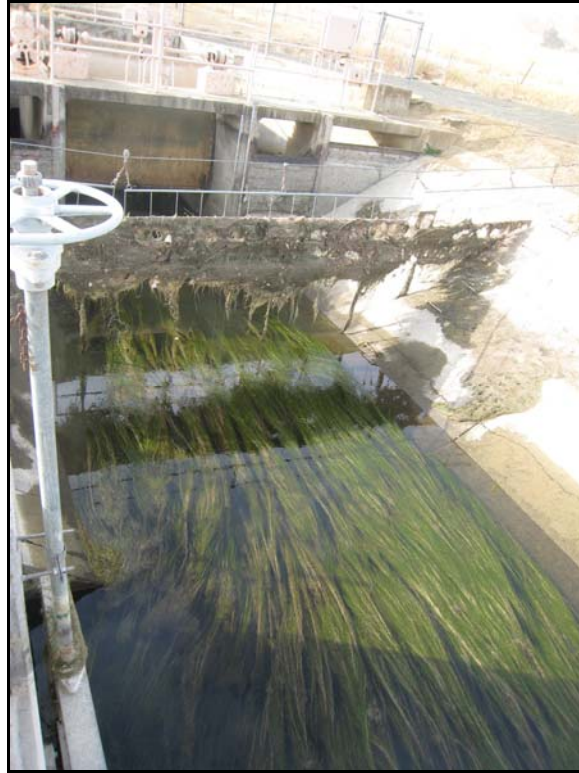
**Figure 2.47.** Mud and weed upstream of Union Check gate at MP 15.82.  
View downstream. Photo of October 27, 2008.

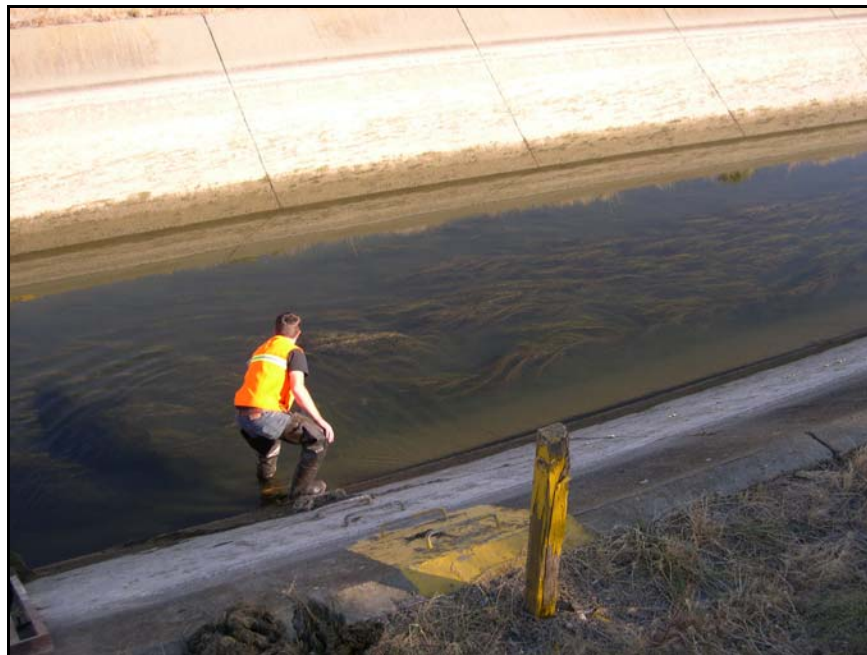
**Figure 2.48.** Sediment and weeds in McCoy Check at NBR WTP intake at MP 16.85.  
Flow right to left. Photo of October 29, 2008.

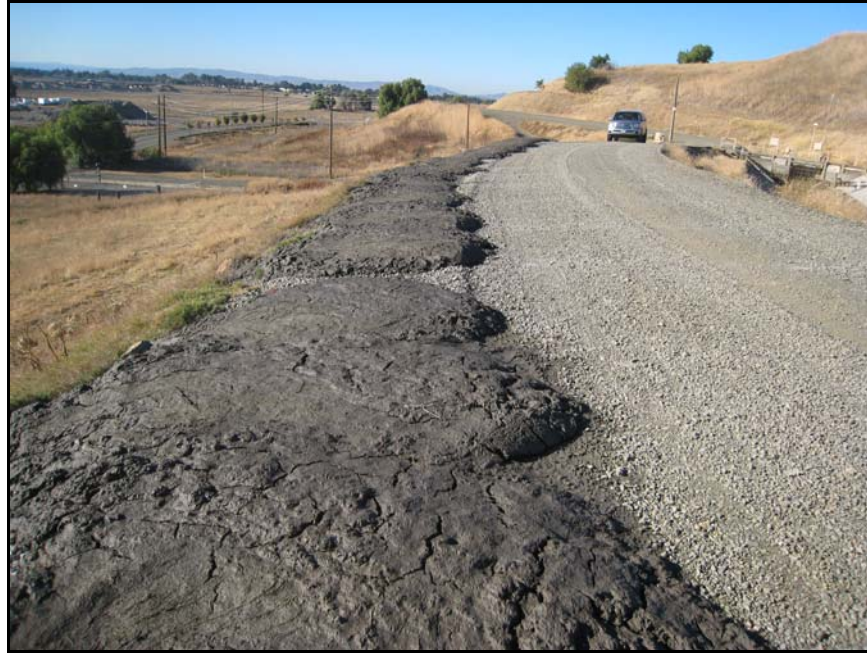
**Figure 2.49.** Sediment removed from McCoy Check at MP 18.80.  
Photo of November 6, 2008.

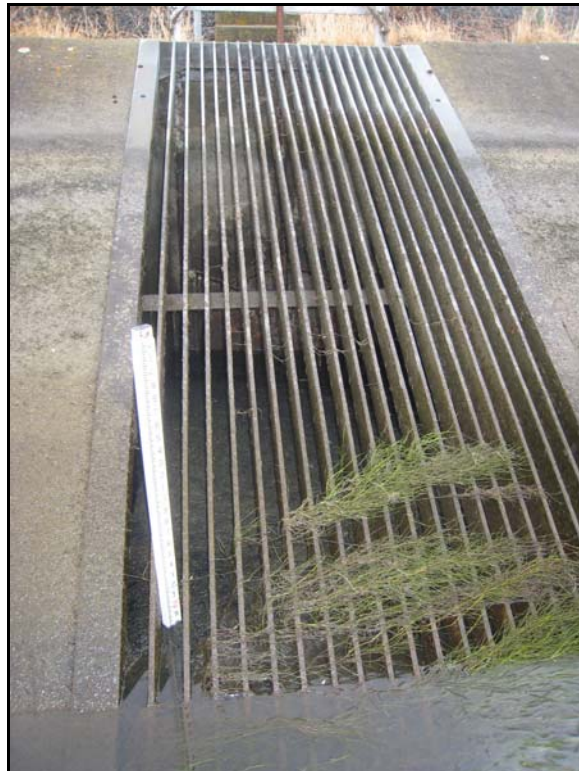
**Figure 2.50.** Almost 2 ft of sediment deposit in intake at MP 19.37 in Burton Check.  
Photo of October 31, 2008.

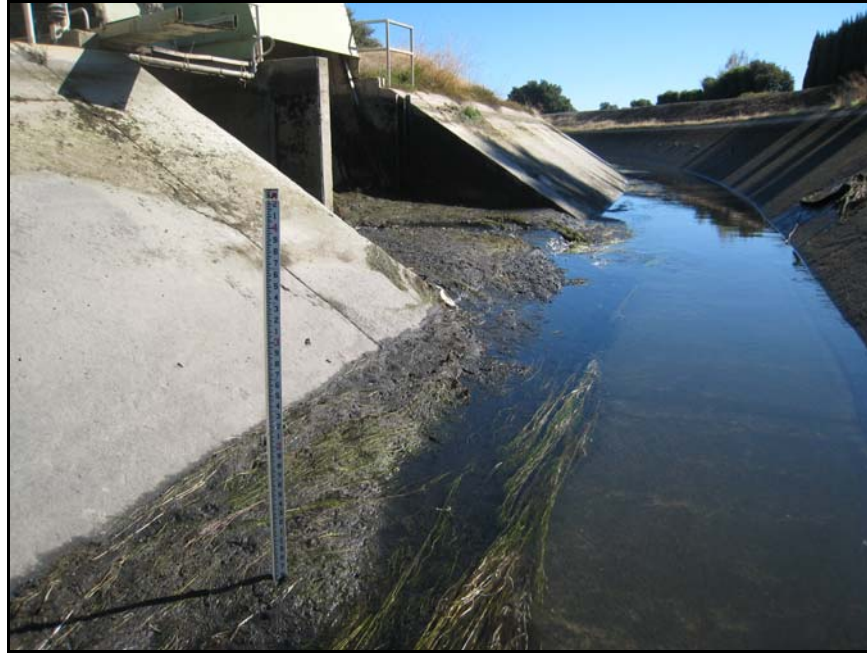
**Figure 2.51.** Sediment and weeds in Serpas Check at Waterman WTP at MP 23.50. View upstream. Photo of November 6, 2008.

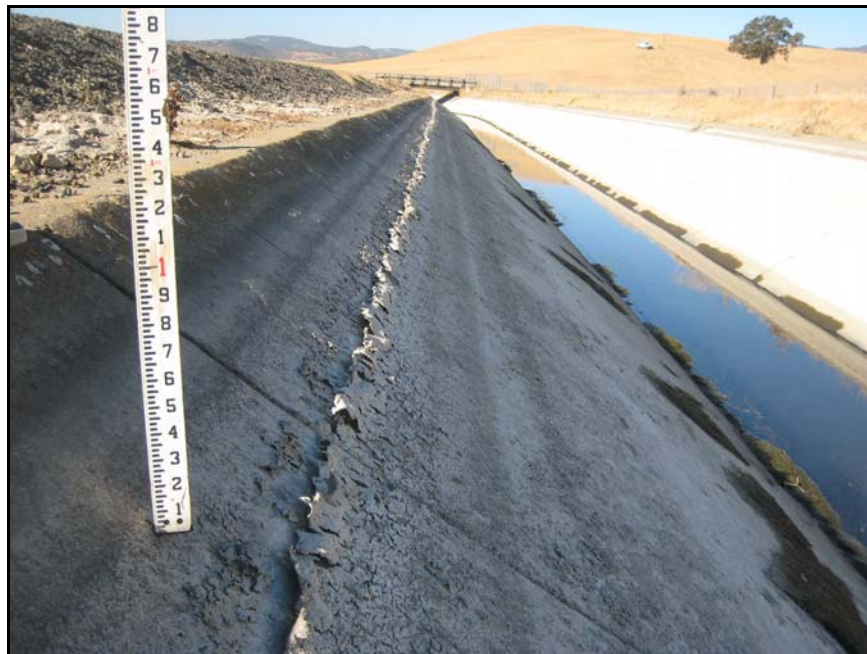
**Figure 2.52.** Deposits on canal panels in Mankas Check at MP 25.63. View downstream. Photo of October 23, 2008.

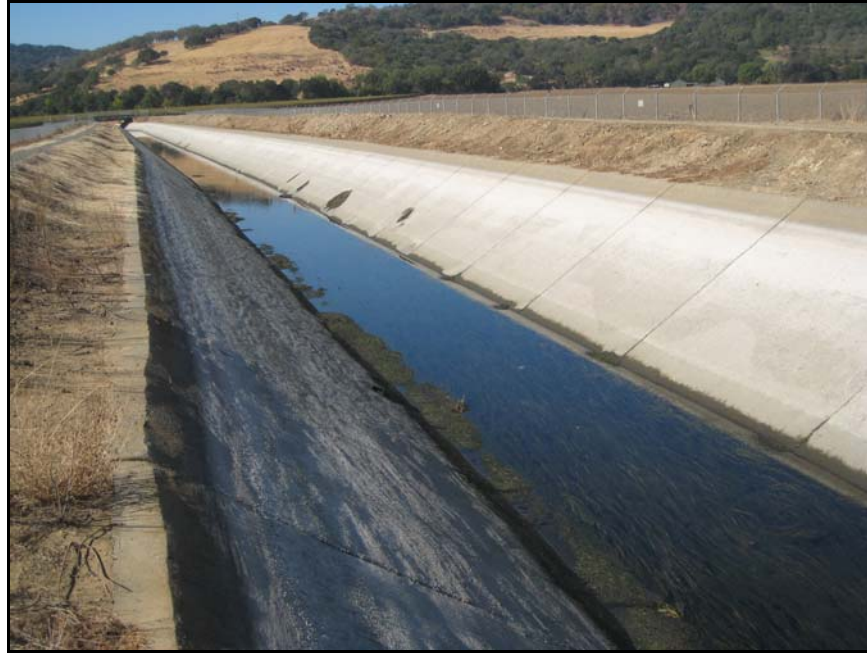
**Figure 2.53.** Weeds and 0.5 ft thick sediment deposits in Suisun Check at MP 26.95. View downstream. Photo of October 23, 2008.

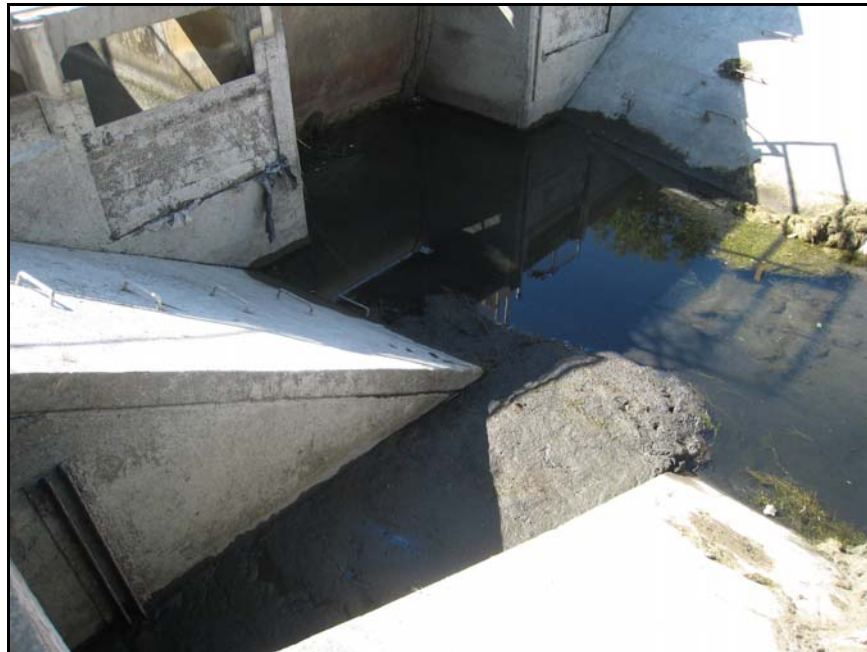
**Figure 2.54.** Over 2 ft thick sediment deposits in intake structure immediately upstream of Suisun Check gate at MP 27.48. Flow right to left. Photo of October 23, 2008.

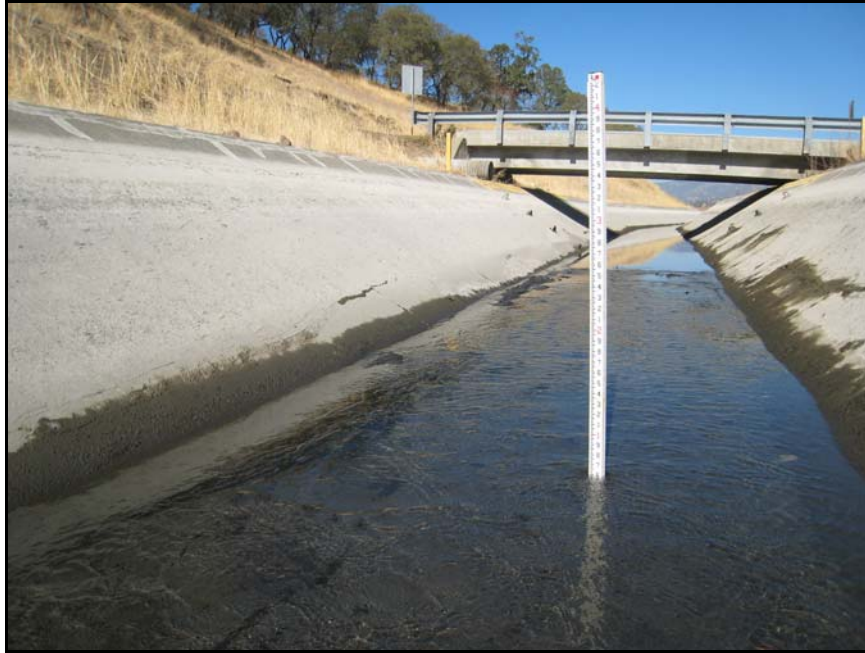
**Figure 2.55.** 0.5 ft thick deposit of sand from open drainage in Rockville Check at MP 29.54. View upstream. Photo of October 23, 2008.

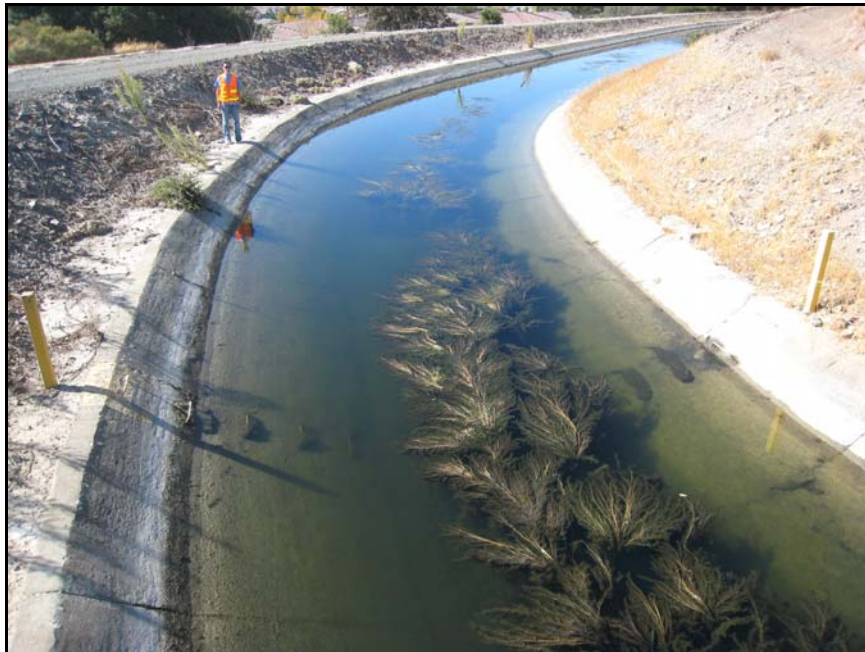
**Figure 2.56.** Thick sediment deposits and weed growth in Terminous Check at MP 31.60. View downstream. Photo of October 23, 2008.

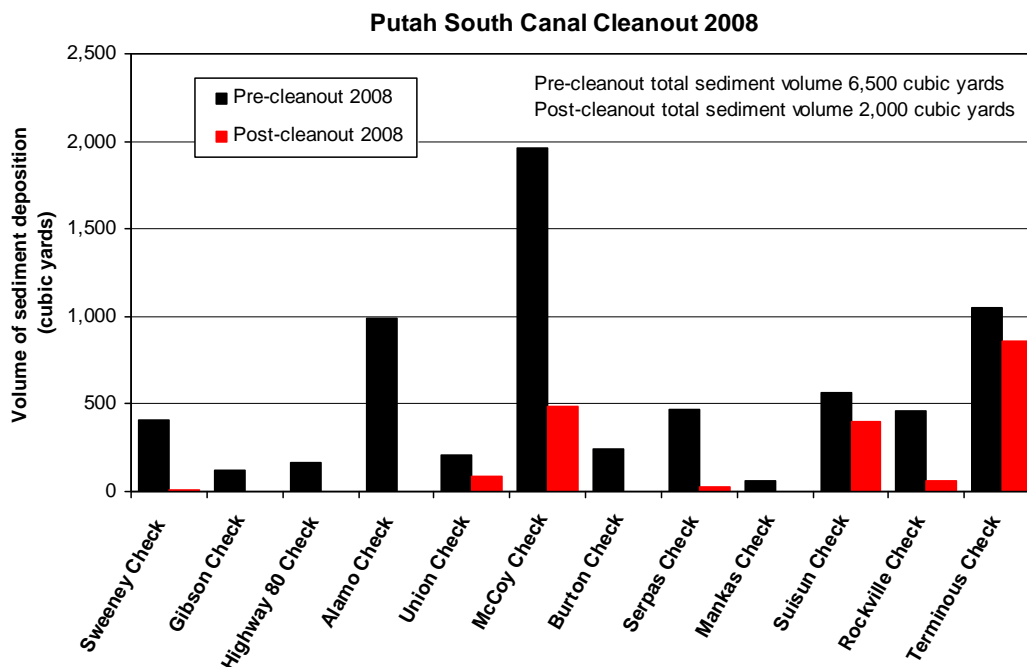
**Figure 2.59.** Estimated volumes of sediment deposits in each check before and after fall 2008 cleanout.

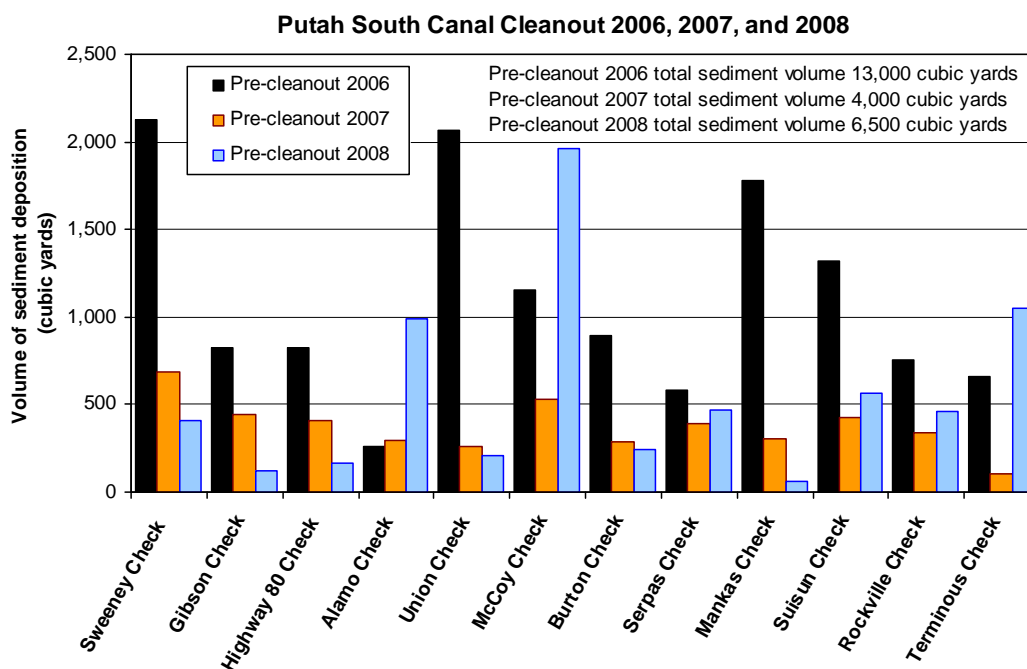
**Figure 2.60.** Comparison of estimated pre-cleanout volumes of sediment deposits in 2006 (wet year), 2007 (dry year), and 2008 (moderate year).

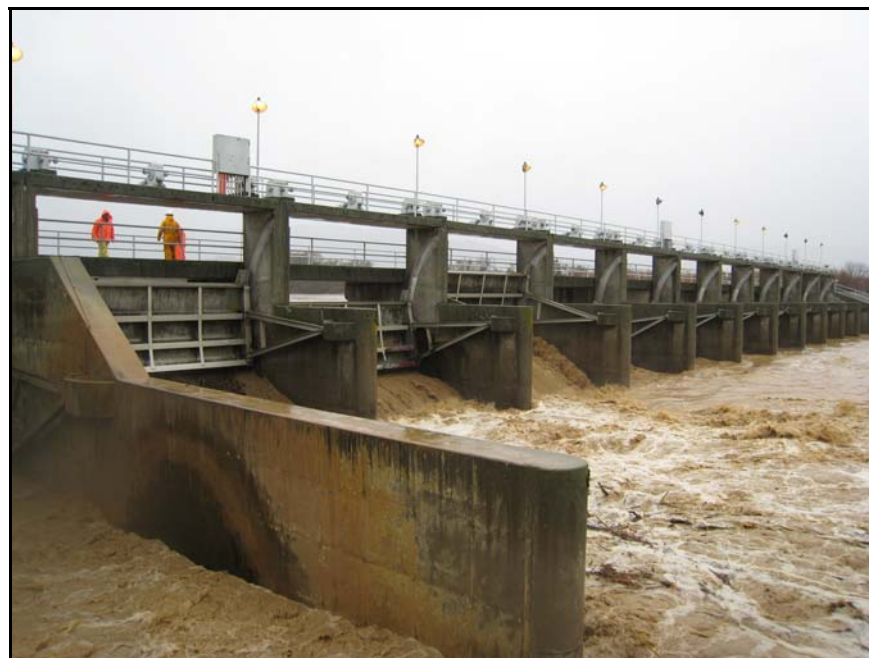
**Figure 3.3.** Putah Creek downstream of diversion dam on Lake Solano on January 4, 2008 at 3:00 pm.

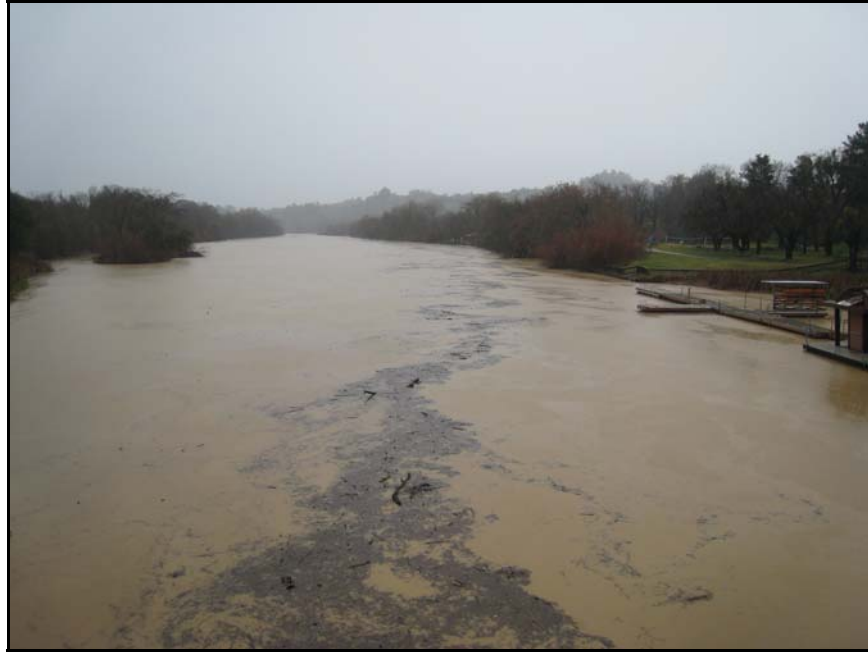
**Figure 3.4.** Putah Creek below Pleasants Valley Road on January 4, 2008 at 2:00 pm.  
View downstream.

The storm event of January 4, 2008 was the first significant storm event in the WY 2008 winter rainy season. This “first flush” event turned out to be a very significant storm event. During and following the January 4, 2008 storm, the PSC experienced significant sediment loading from Lake Solano and especially from lateral sources along the canal (which included road cast and open drainages, overland runoff, and high flows in creeks that overwhelmed the capacity of flume/culvert crossings). The storm started at 2:45 am and lasted for approximately 14.5 hrs. The peak 15-minute rainfall depth was 0.52 inches and the 24-hr accumulated rainfall depth was 8.5 inches (Figure 3.2). Return periods for this event were estimated by the SCWA using the SCWA (1999) hydrology manual and ranged from 36 to 10,000+ years (see Table 3.2). Daily average total inflow to Lake Solano on January 4, 2008 was 898 cfs with outflows of 932 cfs to Putah Creek and 20 cfs to the PSC (USBR 2008). Flow passing through the Lake Solano diversion dam is shown in Figure 3.3. Flow in Putah Creek downstream from Lake Berryessa was only 45 cfs (USBR 2008, USGS 2008). This indicates that much of the inflow to Lake Solano was attributed to the Interdam tributaries such as Pleasants Creek which ramped up significantly in response to the intense storm. Putah Creek below Pleasants Valley Road is shown in Figure 3.4 and Pleasants Creek at Putah Creek Road is shown in Figure 3.5.

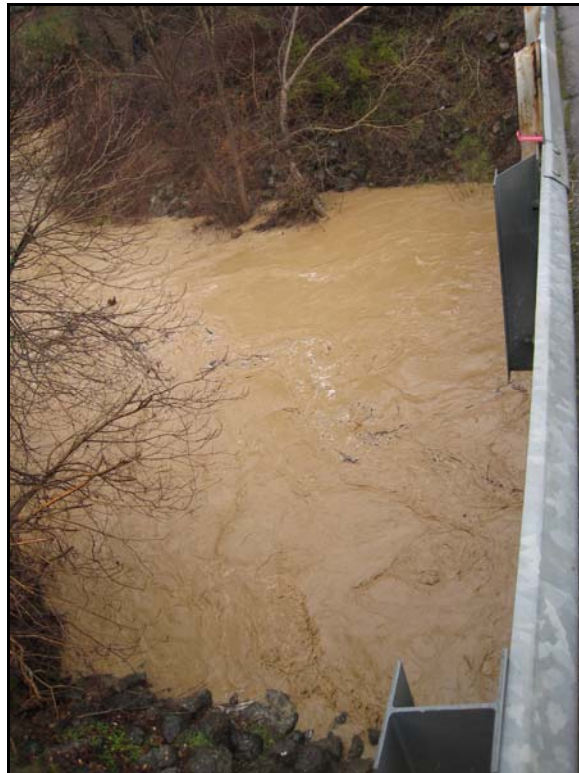
**Figure 3.5.** Pleasants Creek at Putah Creek Road Bridge on January 4, 2008 at 12:30 pm.  
Flow right to left.

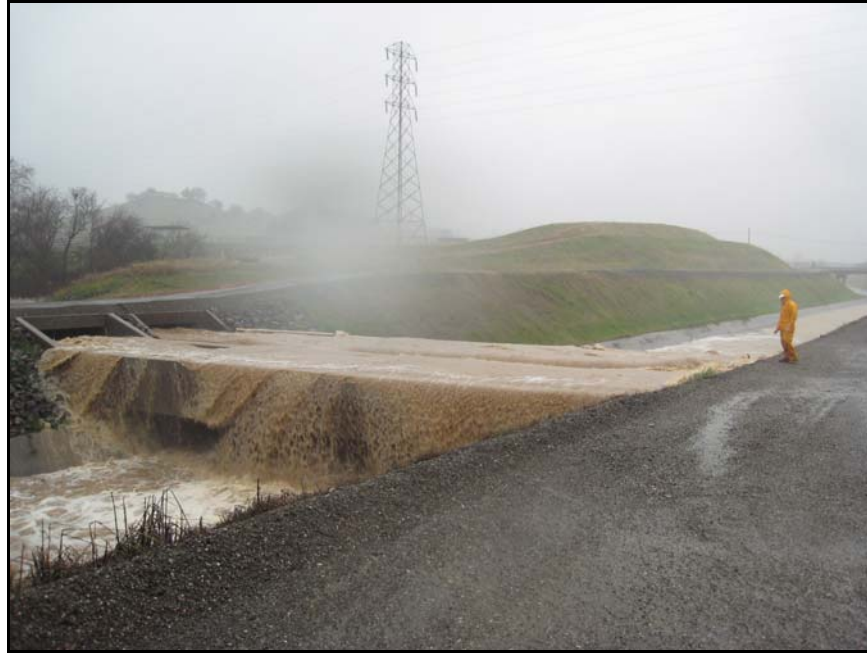
**Figure 3.6.** McCune Creek crossing over Putah South Canal at MP 0.47 on January 4, 2008 at 11:00 am. Flow in creek from left to right.

At approximately 11:00 am the Headworks was shut down in response to flows from McCune Creek that were overwhelming the flume overpass at MP 0.47 (Figures 3.6 and 3.7). The capacity of the flume and culvert system below the road embankments was exceeded and highly turbid water from McCune Creek was uncontrollably pouring into the canal. Sweeney Creek also overtopped its banks spilling its turbid water into the canal and eroding earthen banks downstream of the Sweeney Check at multiple locations (Figures 3.8-3.10). Additional inflows of turbid runoff occurred in the downstream reaches of the canal from multiple open drainages (Figures 3.11 and 3.12).

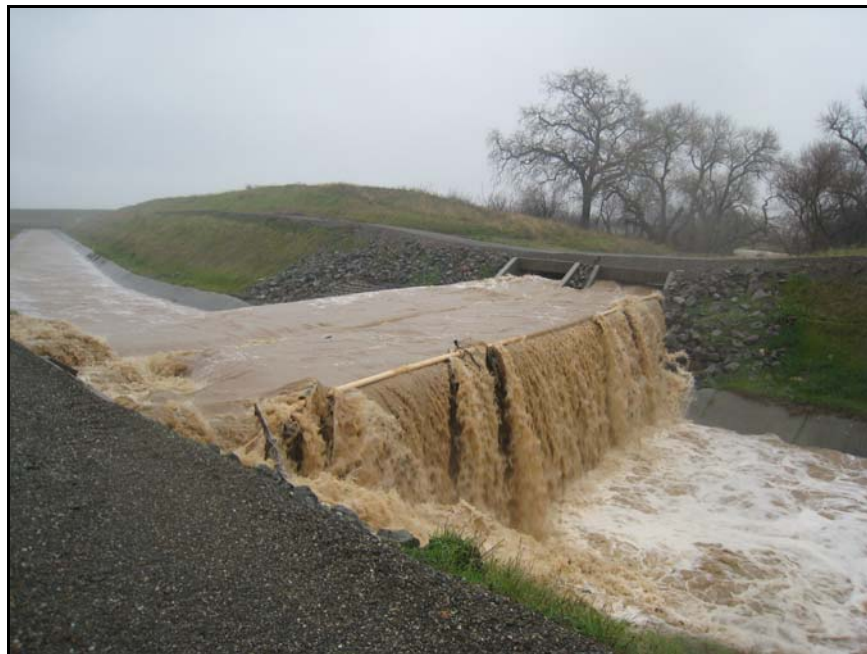
**Figure 3.7.** McCune Creek crossing over Putah South Canal at MP 0.47 on January 4, 2008 at 11:00 am. Flow in creek from right to left.

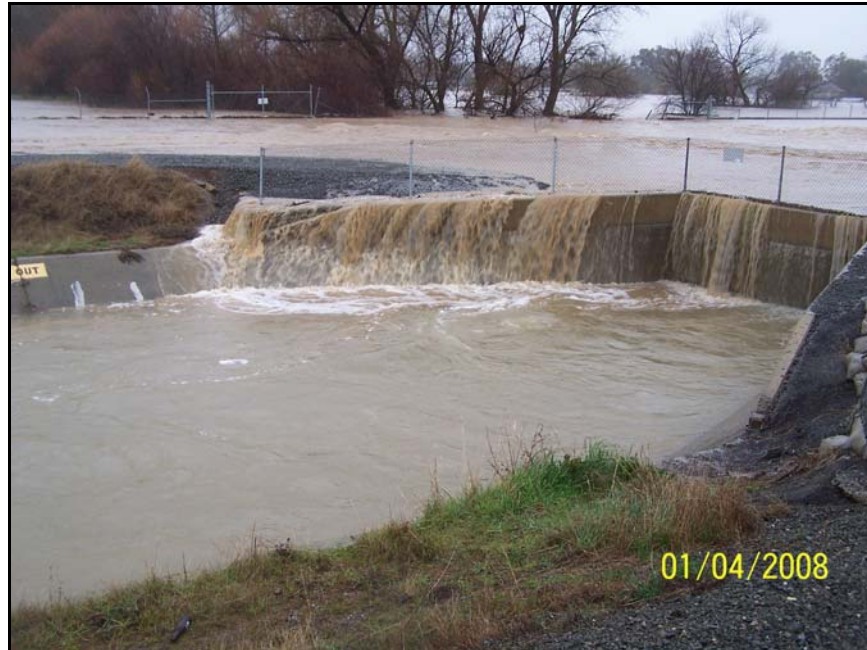
**Figure 3.8.** Overflow from Sweeney Creek into Putah South Canal downstream of Sweeney Check at MP 6.15 on January 4, 2008 at 2:00 pm. Flow in canal from right to left.

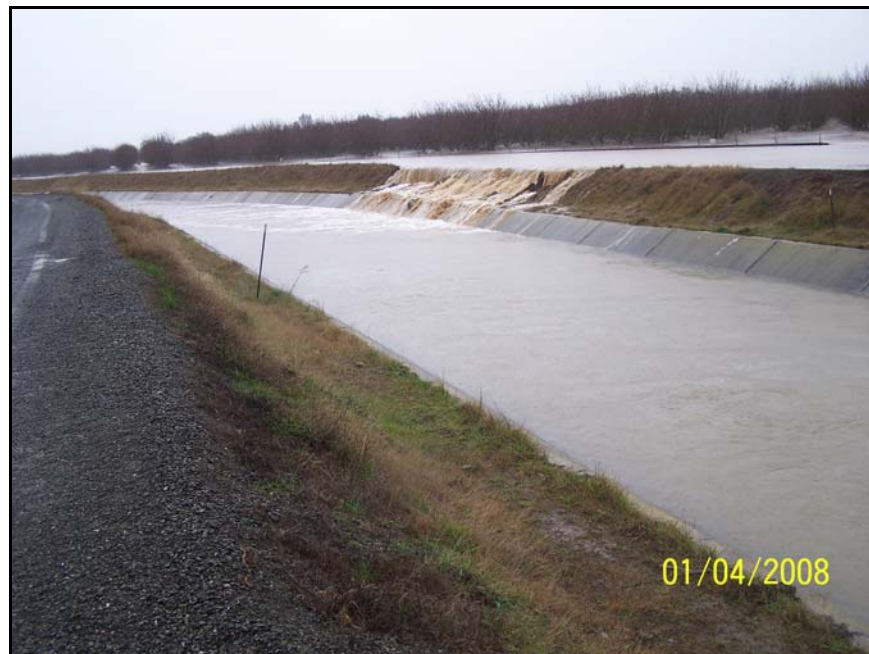
**Figure 3.9.** Overbank flow into Putah South Canal downstream of Sweeney Check on January 4, 2008 at 2:00 pm. View downstream.

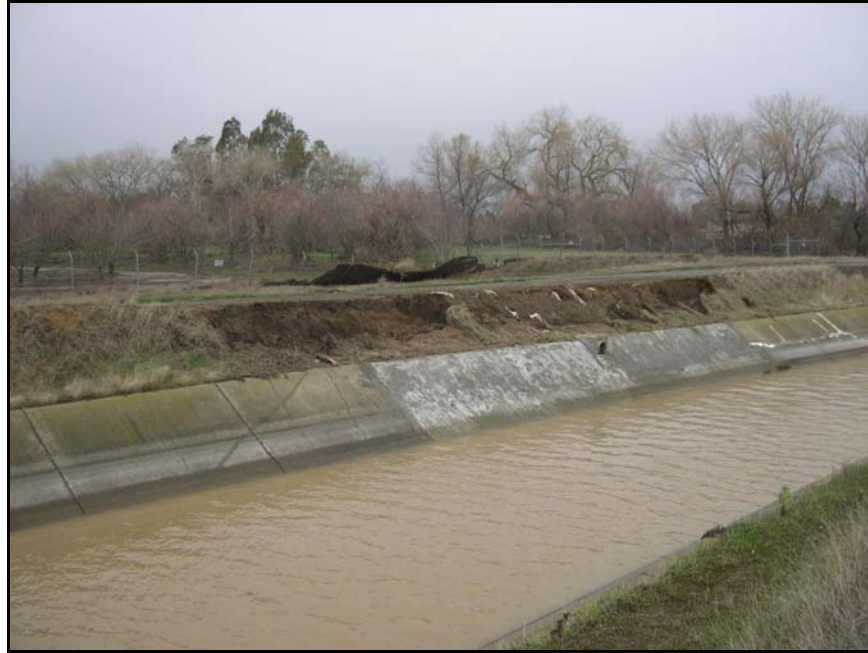
**Figure 3.10.** Bank erosion caused by overbank flows into Putah South Canal downstream of Sweeney Check. Photo of January 5, 2008. Flow right to left.

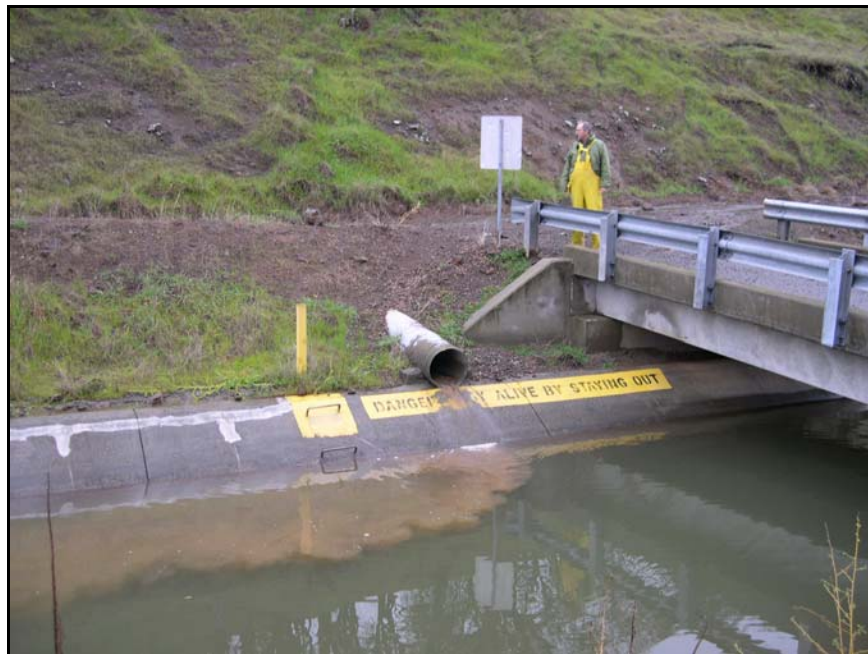
**Figure 3.11.** Local drainage spilling turbid storm water into canal from open pipe at MP 29.54 on January 5, 2008. Flow right to left.

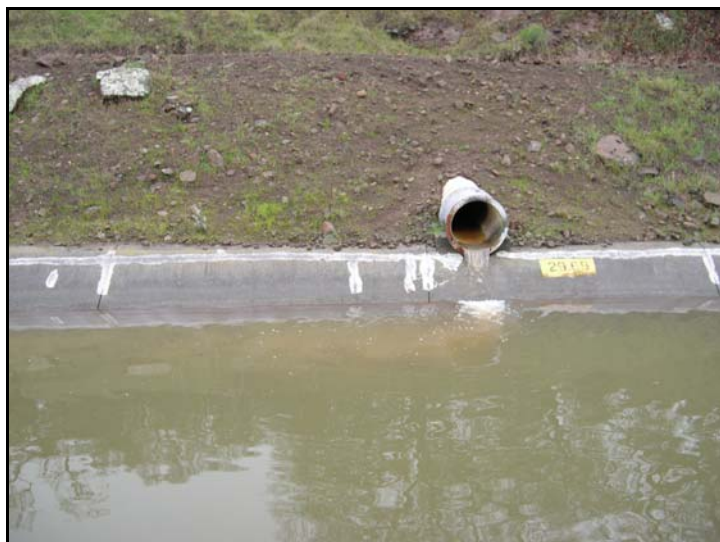
**Figure 3.12.** Local drainage spilling turbid storm water into canal at MP 29.69 on January 5, 2008. Flow right to left.
