# **INVESTIGATION OF SOURCES OF TURBIDITY, SEDIMENT, AND AQUATIC VEGETATION IN PUTAH SOUTH CANAL**

## **Solano County Water Agency**

## **Northwest Hydraulic Consultants Inc.**

***May 14, 2010***

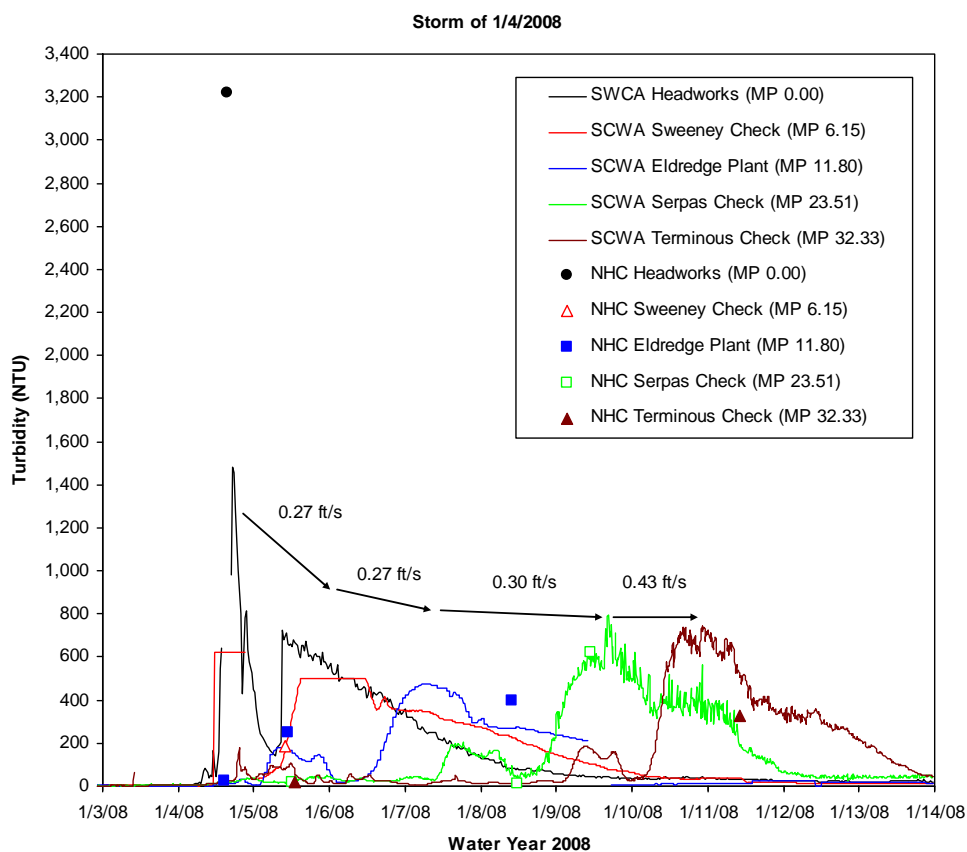
**Figure 3.13.** Propagation of turbidity plume along Putah South Canal during and following January 4, 2008 storm event. Data gaps exist in SCWA data for Headworks (from January 3, 2008 3:10 pm to January 9, 2008 12:10 am). Arrows and velocities denote travel speed of turbidity plume.

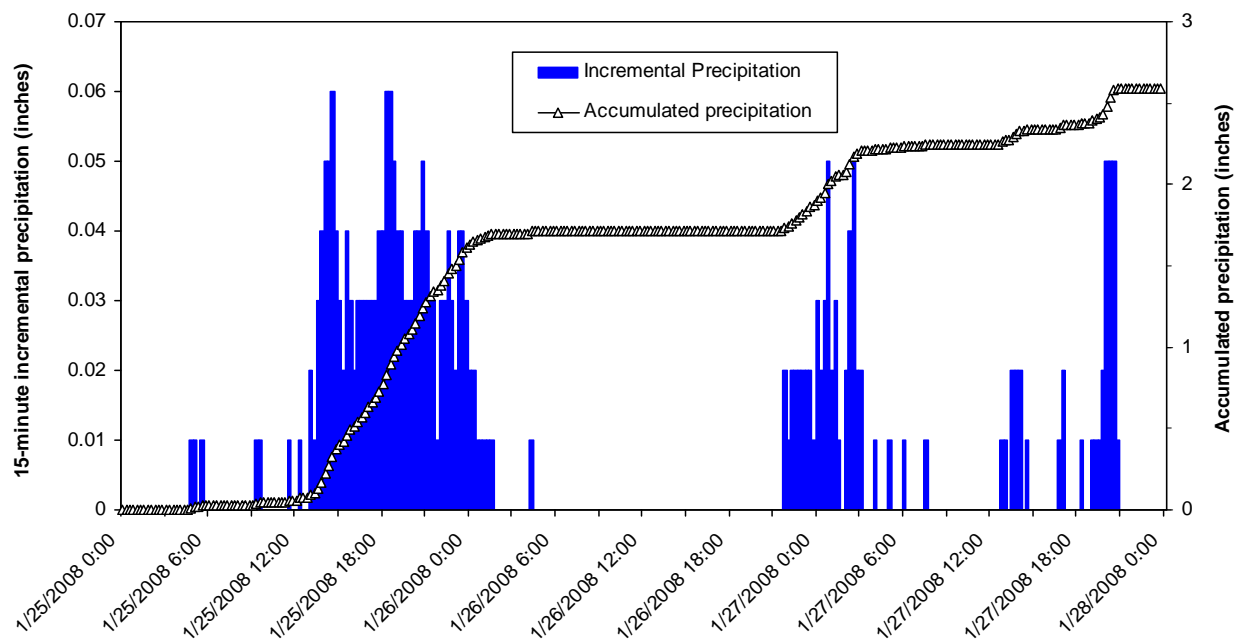
**Figure 3.14.** Precipitation record from SCWA rain gage at Sweeney Check for January 25, 2008 through January 27, 2008.

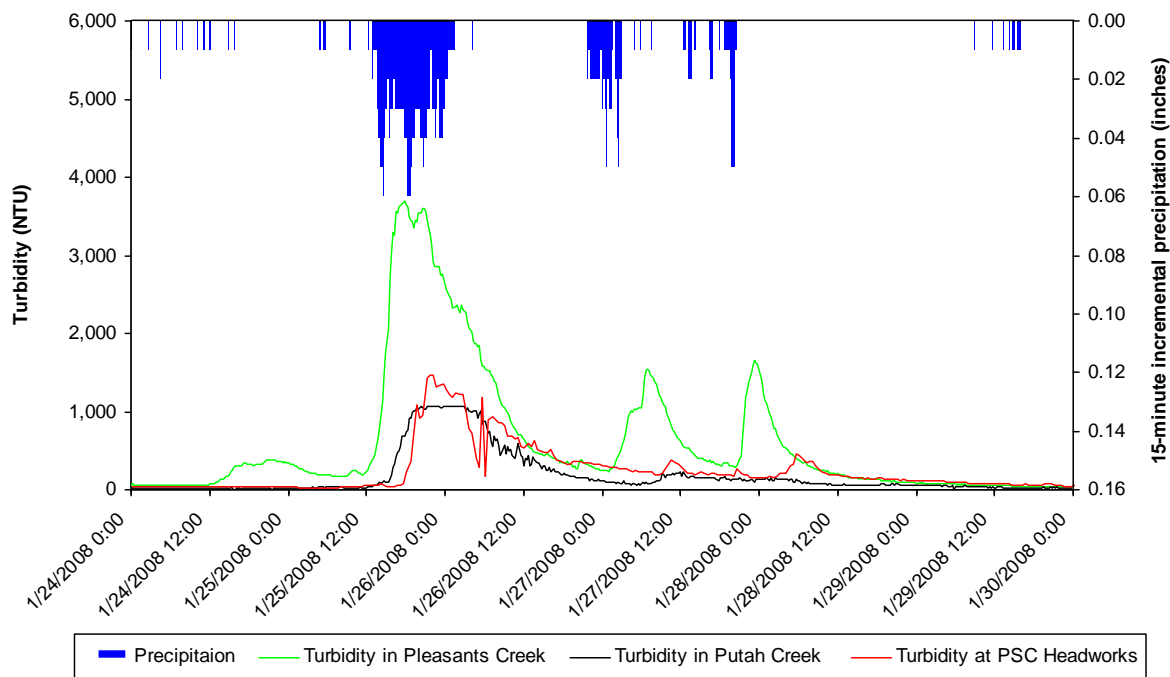
**Figure 3.15.** Turbidity response at Pleasants Creek, Putah Creek, and PSC Headworks to precipitation recorded by SCWA rain gage at Sweeney Check during January 25, 2008 storm event.

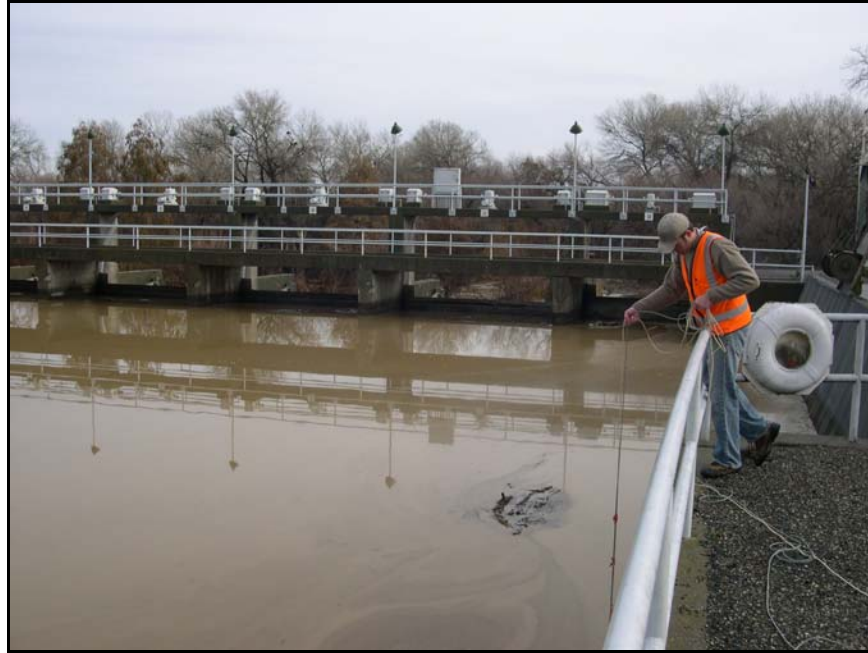
**Figure 3.16.** Highly turbid water in Lake Solano on January 26, 2008.

In anticipation of this event, field measurements of pre-storm conditions were undertaken on Pleasants Creek at Putah Creek Road and in the PSC at the Headworks (MP 0.00) and at the USGS gaging Weir (MP 0.18) on January 23, 2008. Field monitoring of the effects of this event was initiated early in the morning on January 26, 2008. At that time peak turbidity had already passed the Headworks and was within the first 3 miles of the canal. PSC turbidity monitoring was conducted at the established winter monitoring stations and continued until February 1, 2008. To obtain additional information on the turbidity plume characteristics, measurements of water turbidity and SSC were also collected in the PSC at the Weir at MP 0.18, at a bridge crossing at MP 0.72, and downstream of the siphons located at MP 2.56 and MP 3.77. Section-average turbidity and SSC data collected prior to and following the storm of January 25, 2008 are summarized in Table 3.1. Comparison of field turbidity measurements at the SCWA turbidity stations and SCWA turbidity readings is provided in Table 3.3. Ground photos of the canal during the measurements are given in Figures 3.16-3.23.

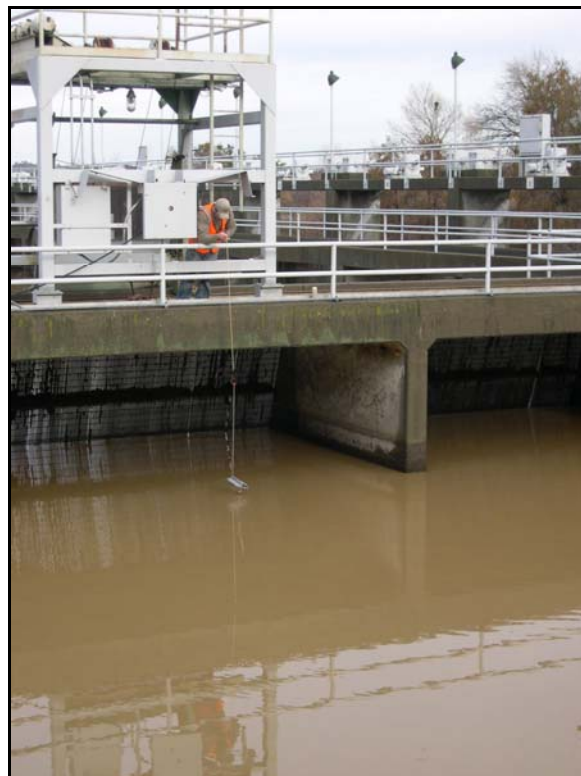
**Figure 3.17.** Sampling suspended sediment at Putah South Canal Headworks on January 26, 2008. View upstream.

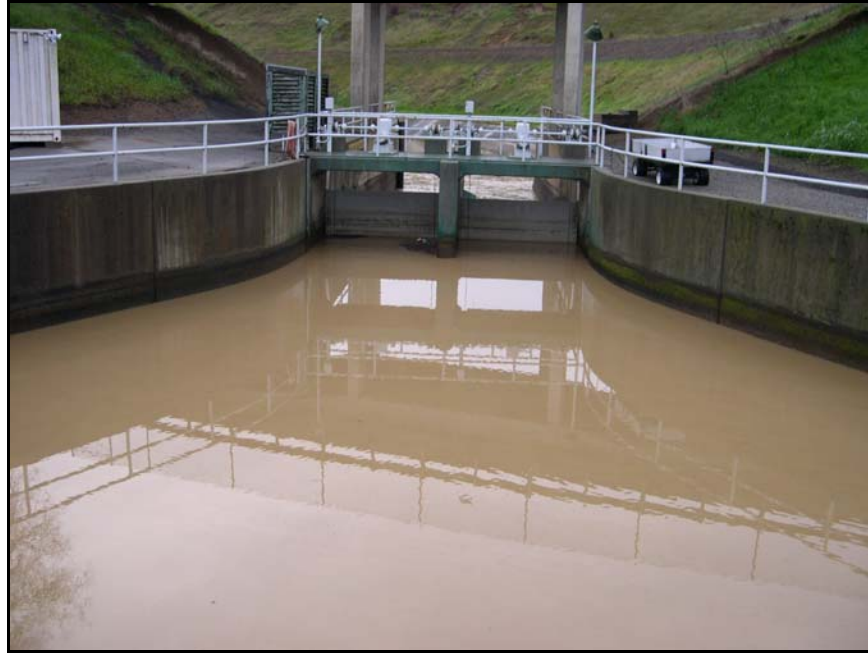
**Figure 3.18.** Gates at entrance to Putah South Canal on January 26, 2008. View downstream. Note muddy water entering canal.

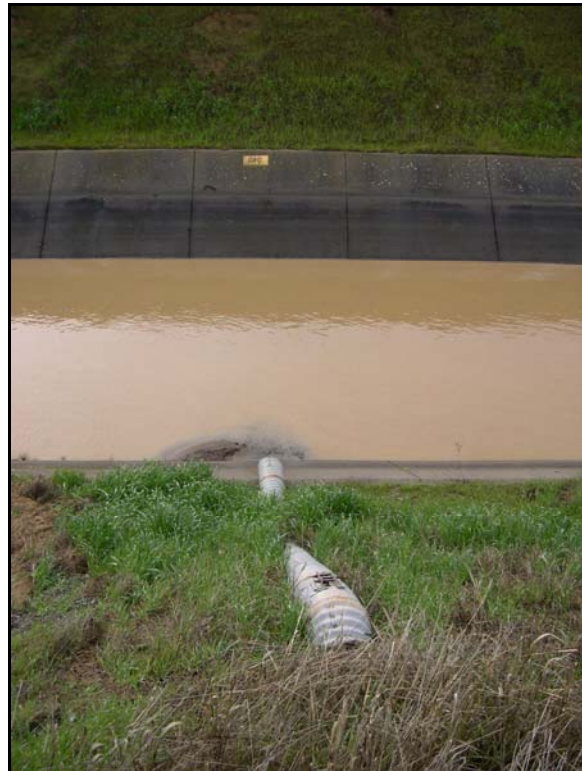
**Figure 3.19.** Putah South Canal at MP 0.10 on January 26, 2008. Flow right to left. Note deposit of sediment in canal supplied by open drainage.

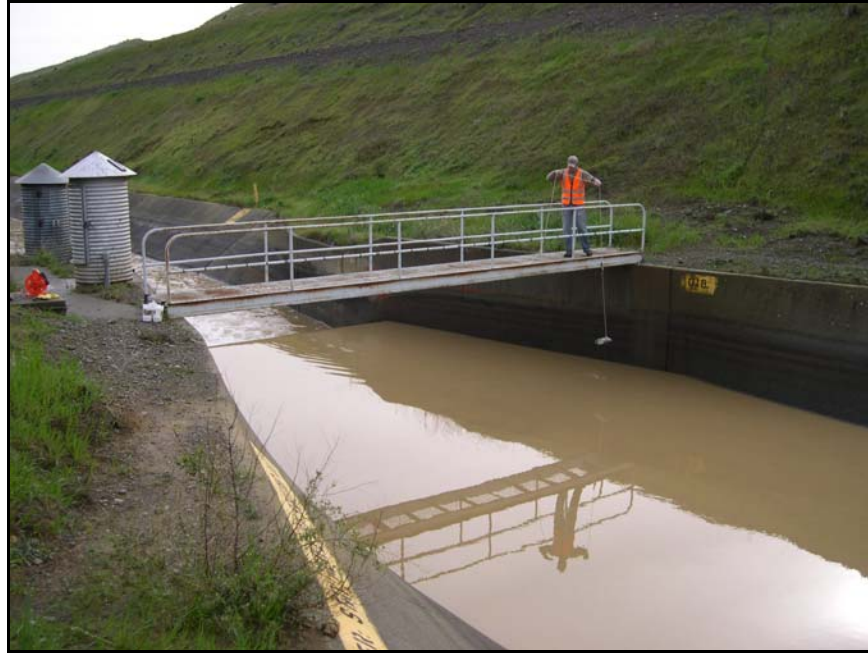
**Figure 3.20.** Suspended sediment sampling at PSC Weir at MP 0.18 on January 26, 2008. View downstream. Note muddy water in canal.

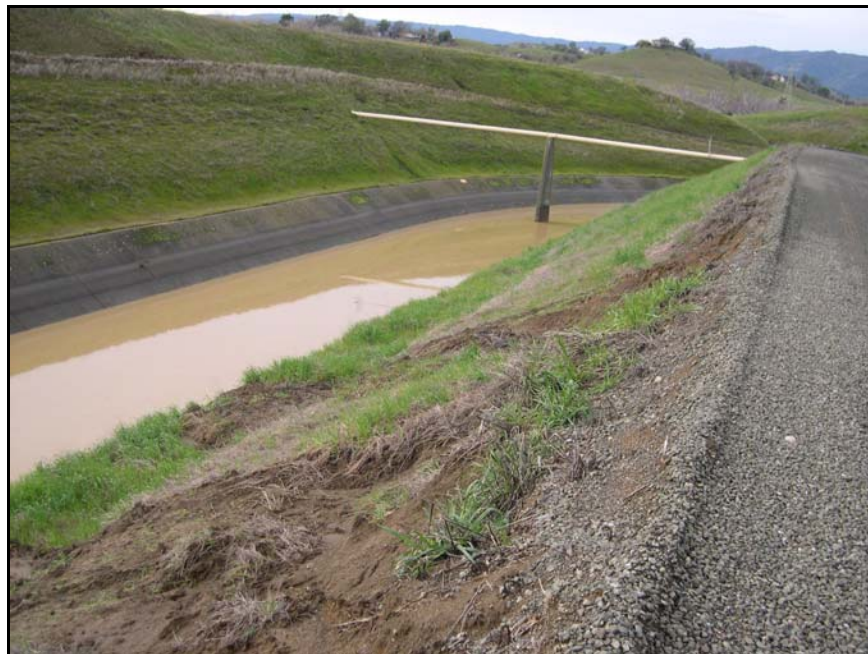
**Figure 3.21.** Erosion of bank of Putah South Canal at MP 0.74 caused by heavy rains. View upstream. Photo of January 26, 2008.

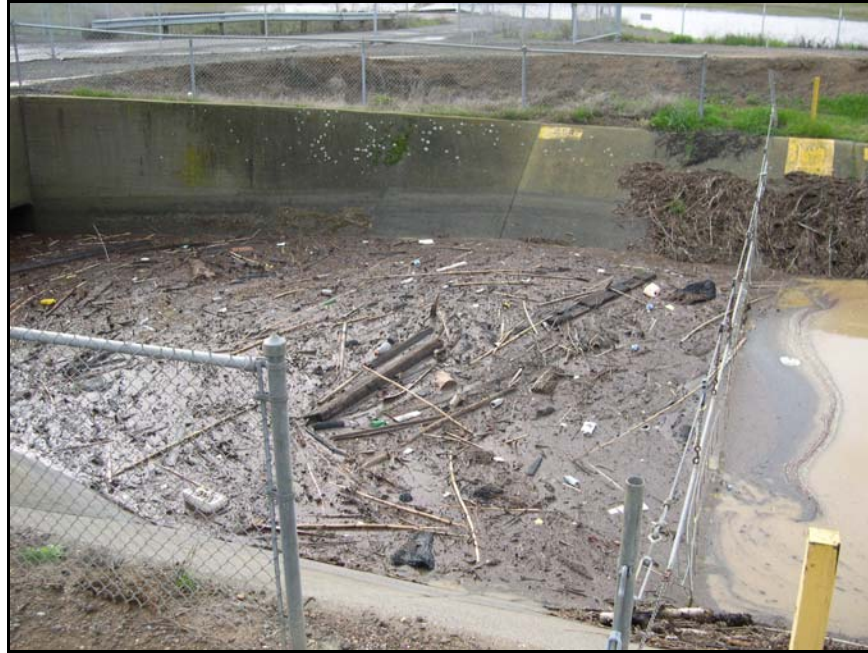
**Figure 3.22.** Deposition of debris in Putah South Canal upstream of siphon at MP 2.54 on January 26, 2008. Flow right to left.

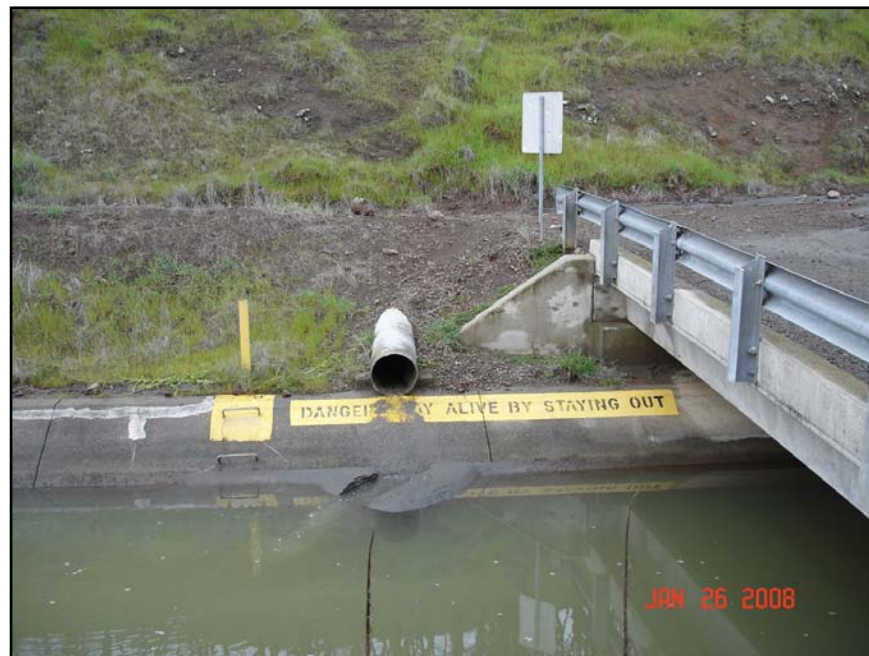
**Figure 3.23.** Sediment from open drainage deposited in Putah South Canal at MP 29.54 on January 26, 2008. Flow right to left.

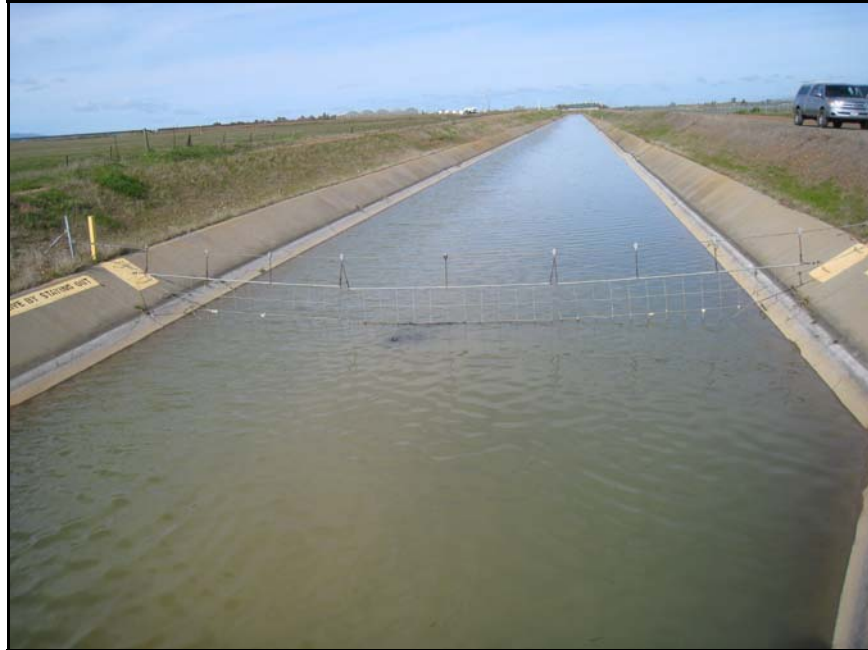
**Figure 3.26.** Leading edge of turbidity plume above siphon at MP 3.74 on February 25, 2008 at 13:40 pm. View upstream. Measured turbidity at this location is about 28 NTU.

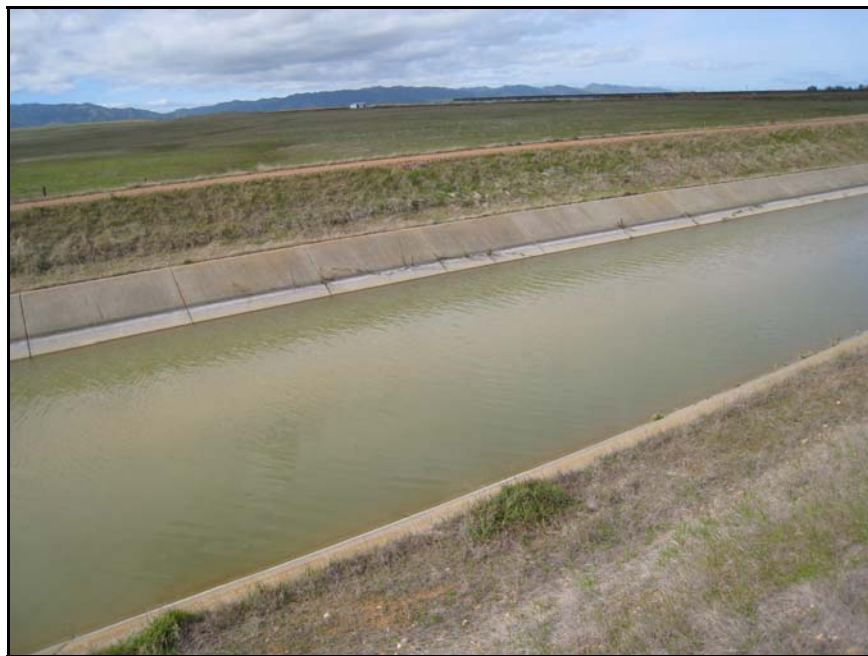
**Figure 3.27.** Leading edge of turbidity plume just upstream of siphon at MP 3.74 on February 25, 2008 at 13:40 pm. Flow right to left.

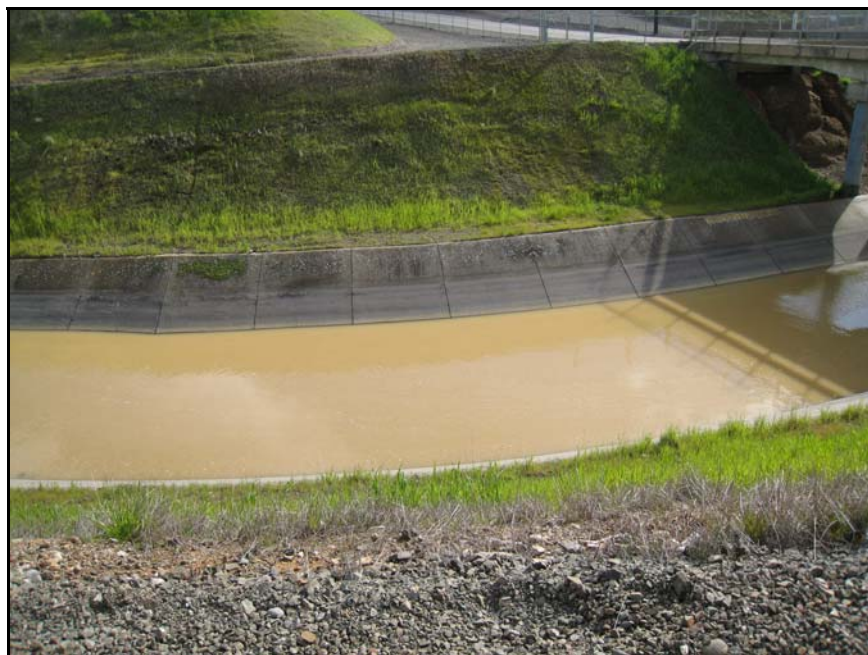
**Figure 3.28.** Receding turbidity plume at Olive School Lane at approximately MP 0.4 on February 25, 2008 at 14:30. Flow left to right. Measured turbidity at this location is about 170 NTU.

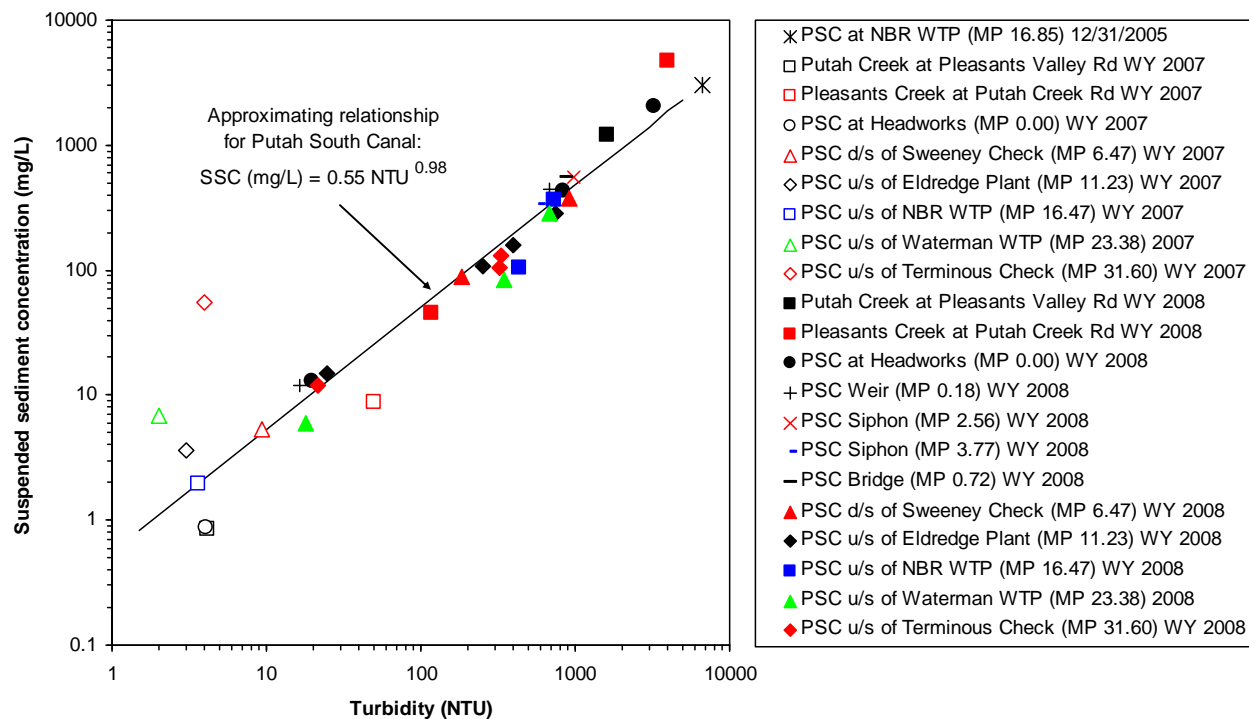
**Figure 3.30.** Relationship between water turbidity and suspended sediment concentration. Correlation coefficient is 0.99 and root mean square error is 118 mg/L.

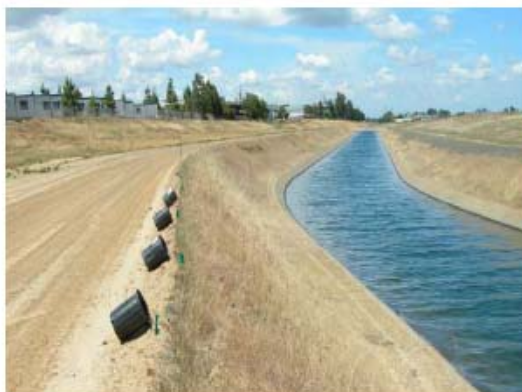
Vaca Valley Parkway to North  
Plots similar to adjacent areas

Table 5.4 shows the monitoring results. Photographs showing conditions observed on the third monitoring event conducted on June 4, 2009 are found in Figure 5.2. Four sites performed poorly: Vaca Valley Parkway, Elmira Road, Cement Hill, and to some extent Suisun Valley North. These sites were characterized by minimal cover of the seeded species (or bare), weed presence, particularly at the toe of the bank, and remaining bank area bare or nearly bare.

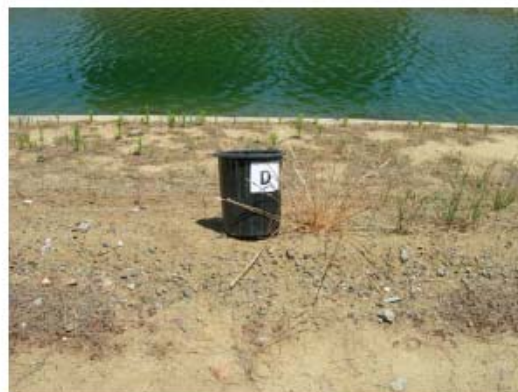
Elmira to East  
Mix D- Wimmera Rye Plot – bare

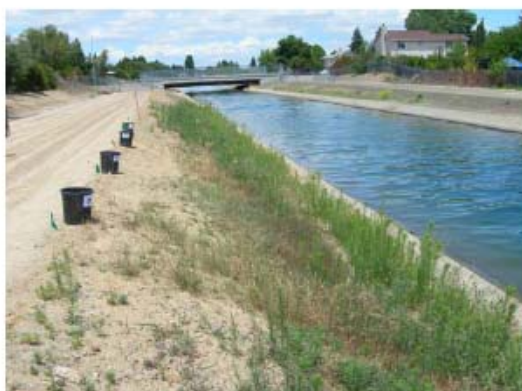
Youngsdale to North  
Closest Plot – Mix D -Wimmera Rye

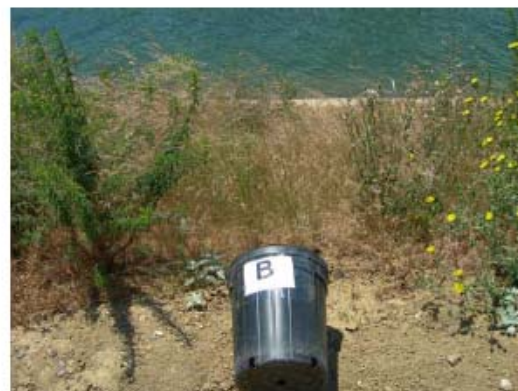
Dover to North  
Mix B - Nodding needlegrass & broadleaf weeds

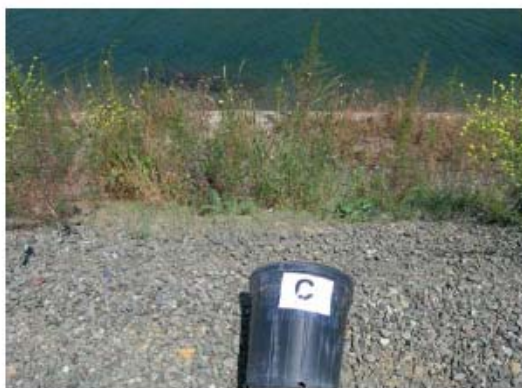
Dover to South  
Seed Mix C - Note California barley in  
foreground and weed presence

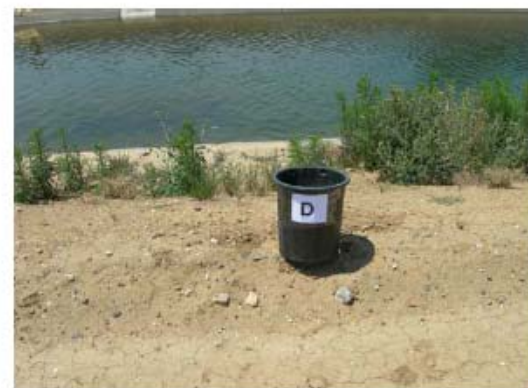
Cement Hill  
Seed Mix D – Wimmera Rye – 4 grass plants

**Figure 5.2.** Photos showing pilot study grass seeding trial locations.  
Date of photos – June 4, 2009.

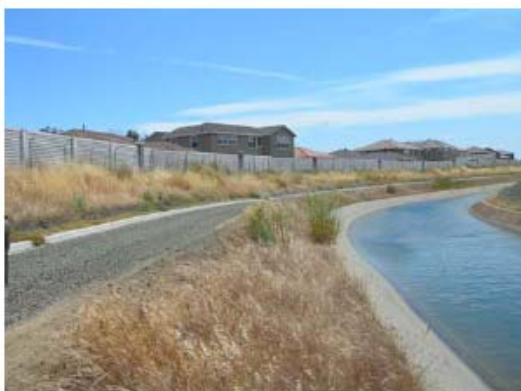
Cement Hill Adjacent area to East  
(Not in study area)

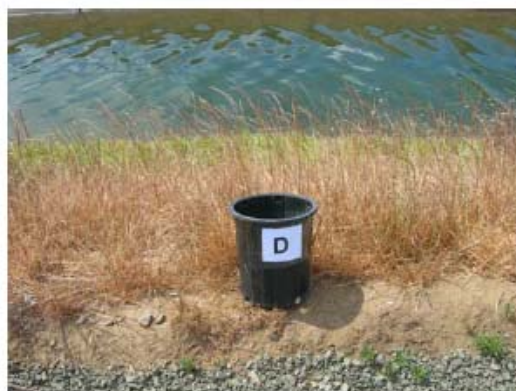
Mankas Junction Mix D -Wimmera Rye  
Note weed presence at toe

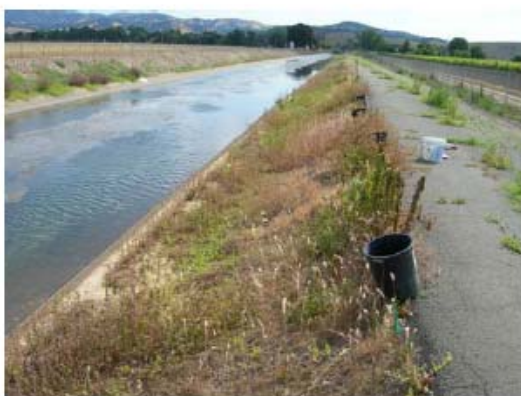
Suisun Valley, South Side  
Broadleaf weeds dominate plots

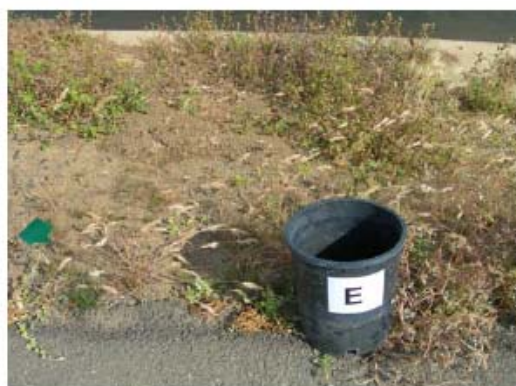
Suisun Valley, North Side  
Mix E - Bentgrass at flag, otherwise missing

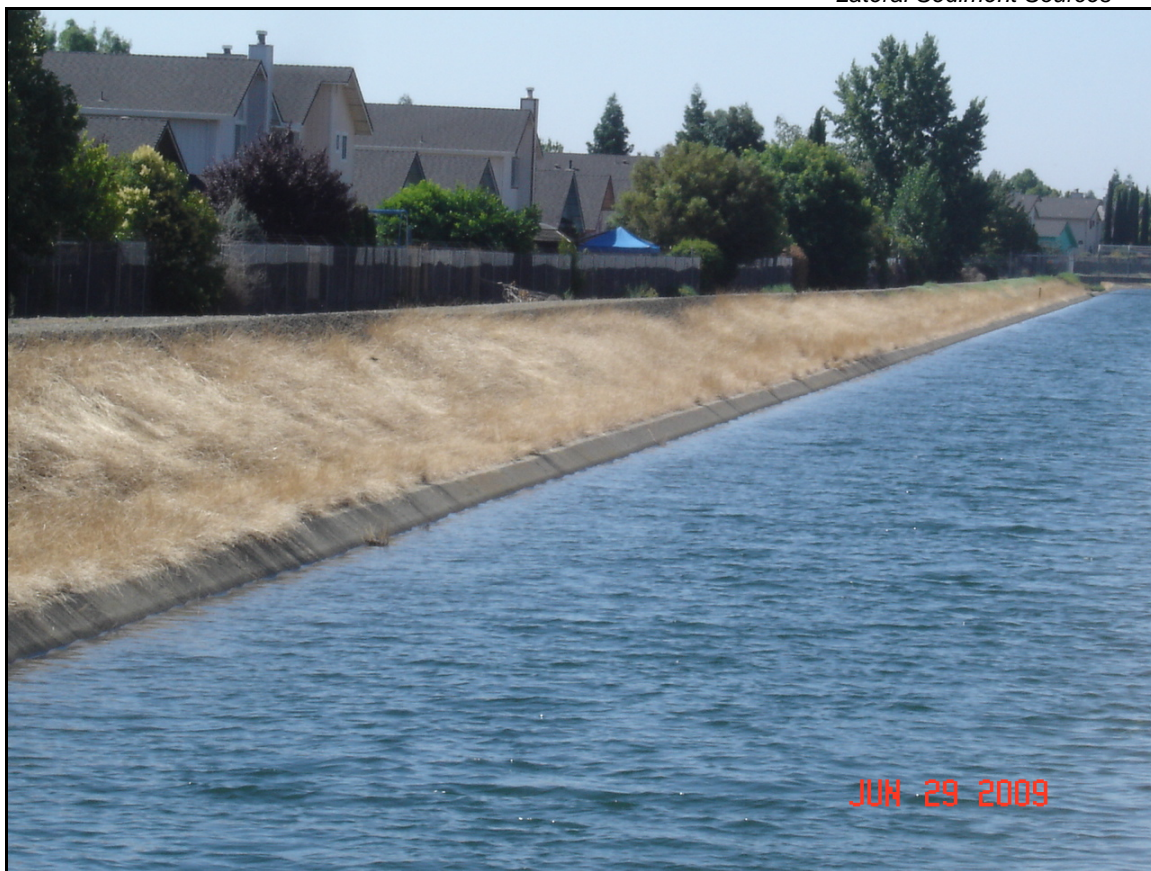
**Figure 5.3.** Volunteer Italian ryegrass growing on canal bank. View downstream from Alamo Drive, Vacaville,  
Date of Photo June 29, 2009.

The remarkably successful establishment of a dense cover of volunteer Italian rye (Figure 5.3) indicates that successful treatment of miles of the canal can be accomplished simply by not applying broad-spectrum herbicides typically used to kill all grass on the canal banks. However, there are some trade-offs associated with allowing the establishment of Italian ryegrass. It is becoming resistant to certain herbicides and allowing its establishment along the Putah South

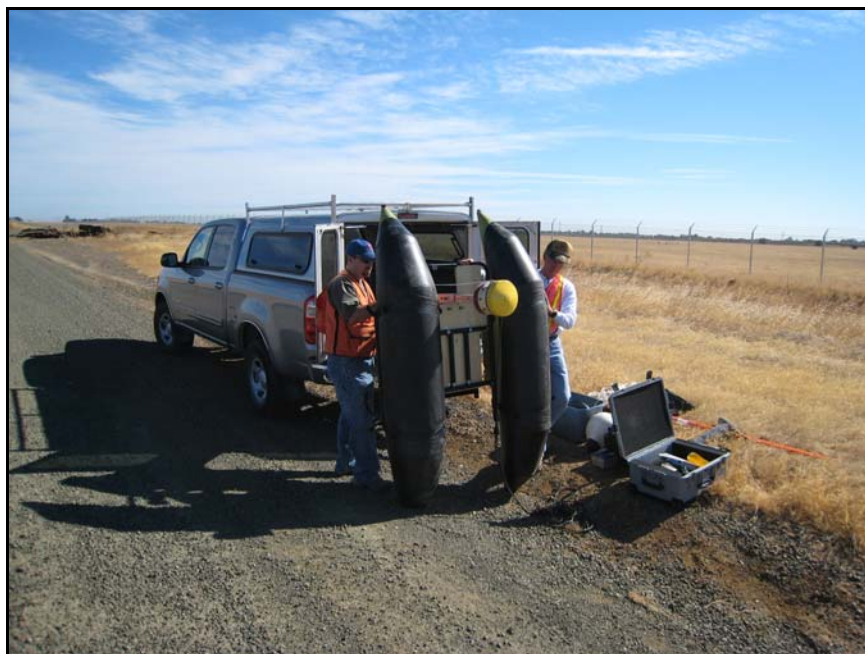
**Figure 6.1.** Inflatable pontoon boat with WorkHorse Rio Grande ADCP mounted beneath it. Photo of September 24, 2007.

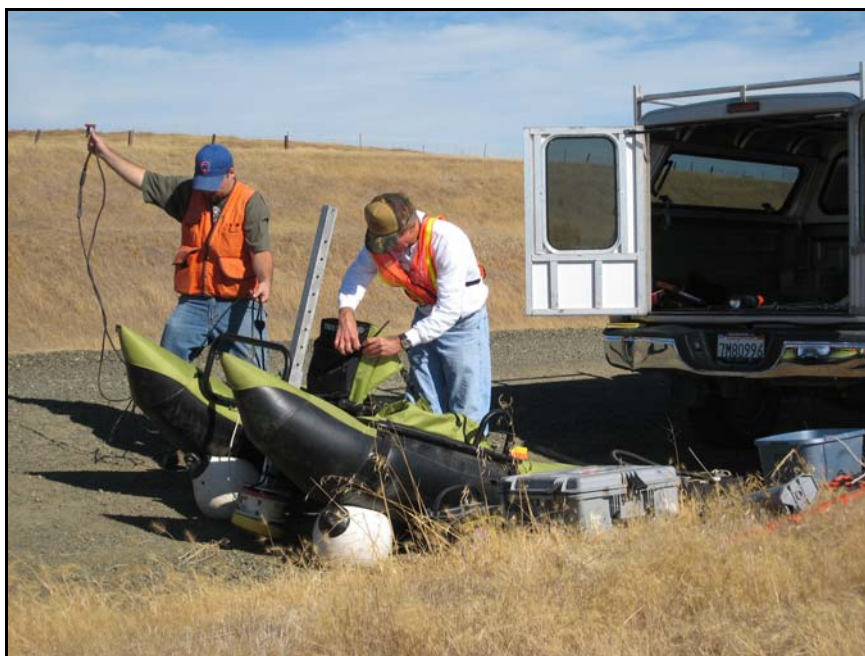
**Figure 6.2.** Inflatable pontoon boat with WorkHorse Rio Grande ADCP, battery pack, and radio-telemetered instrument package. Photo of September 24, 2007.

Figures 6.1 and 6.2 show the ADCP mounted on a Madison inflatable double pontoon Trout Unlimited drift boat. Instrument commands and data communication with the ADCP occurs through a wireless (radio-telemetered) connection between the ADCP unit mounted on the boat and a portable laptop computer located on the shore. Sixteen equally spaced transect locations at 50-ft spacing were laid out normal to the canal alignment starting at MP 5.6, at the Weyand Intake structure and progressed approximately 750 ft upstream from the Weyand Intake. ADCP measurements taken near the Weyand Intake structure were made on September 24, 2007. The upstream portion of the study reach is a straight channel where flow is expected to be relatively straight and parallel to the canal alignment (Figure 6.3). These measurements were compared to ADCP measurements made around the gentle left-hand bend portion of the study reach to show that there is a higher concentration of flow along the outside portion of bends which explains why sediment and aquatic vegetation tend to colonize inner portions of canal bends. Additional canal measurements were obtained in the vicinity of the Waterman WTP (near MP 23.5) on September 28, 2007.

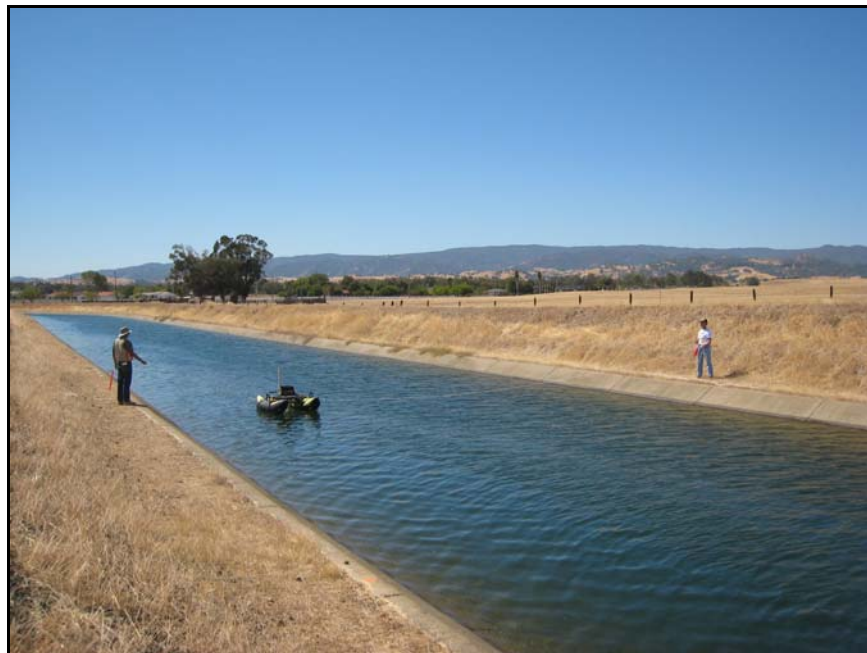
**Figure 6.3.** Boat-mounted ADCP being used to measure current profiles in Putah South Canal upstream from Weyand Intake structure. Photo of September 24, 2007.

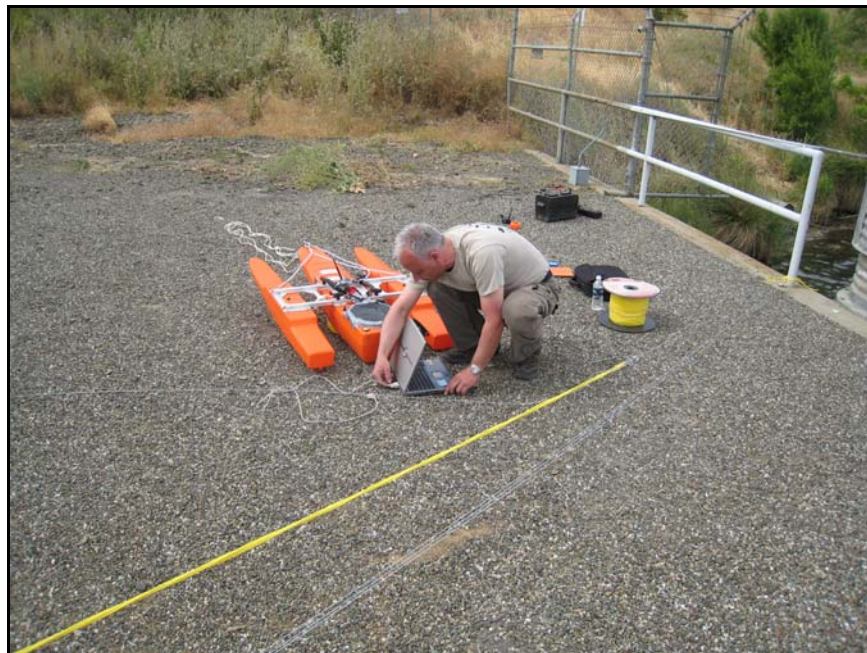
**Figure 6.5.** WorkHorse Rio Grande ADCP, battery pack, and radio-telemetered instrument package mounted in Oceanscience RiverBoat at Lake Solano. Photo of May 20, 2008.

Figure 6.4 shows the approximate locations of the nine velocity measurement transects used in Lake Solano and the Headworks on May 20, 2008. Figures 6.5 and 6.6 show the WorkHorse Rio Grande ADCP, battery pack, and radio-telemetered instrument package mounted in an Oceanscience RiverBoat and being deployed at Lake Solano.

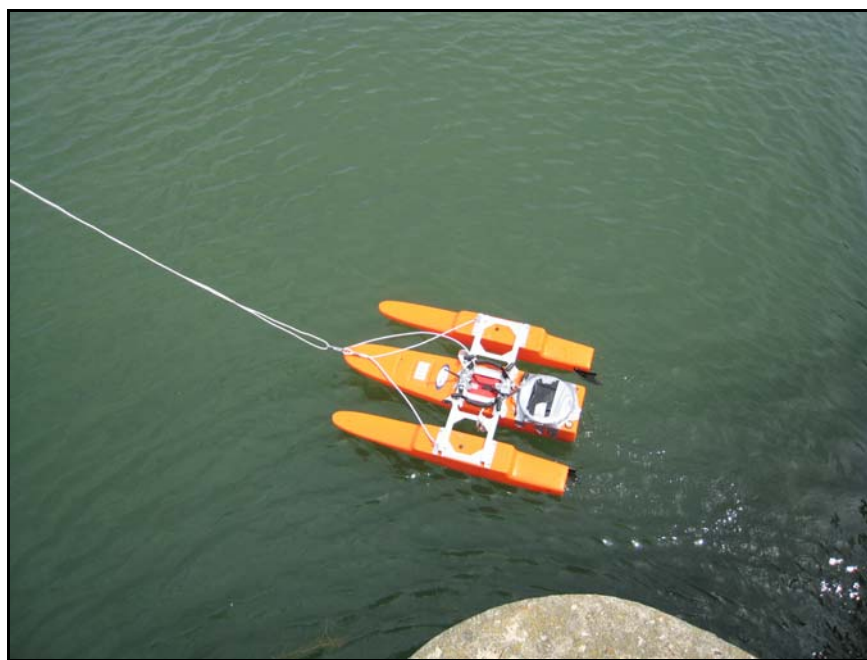
**Figure 6.6.** WorkHorse Rio Grande ADCP, battery pack, and radio-telemetered instrument package being deployed in Oceanscience RiverBoat at Lake Solano near Headworks. Photo of May 20, 2008.

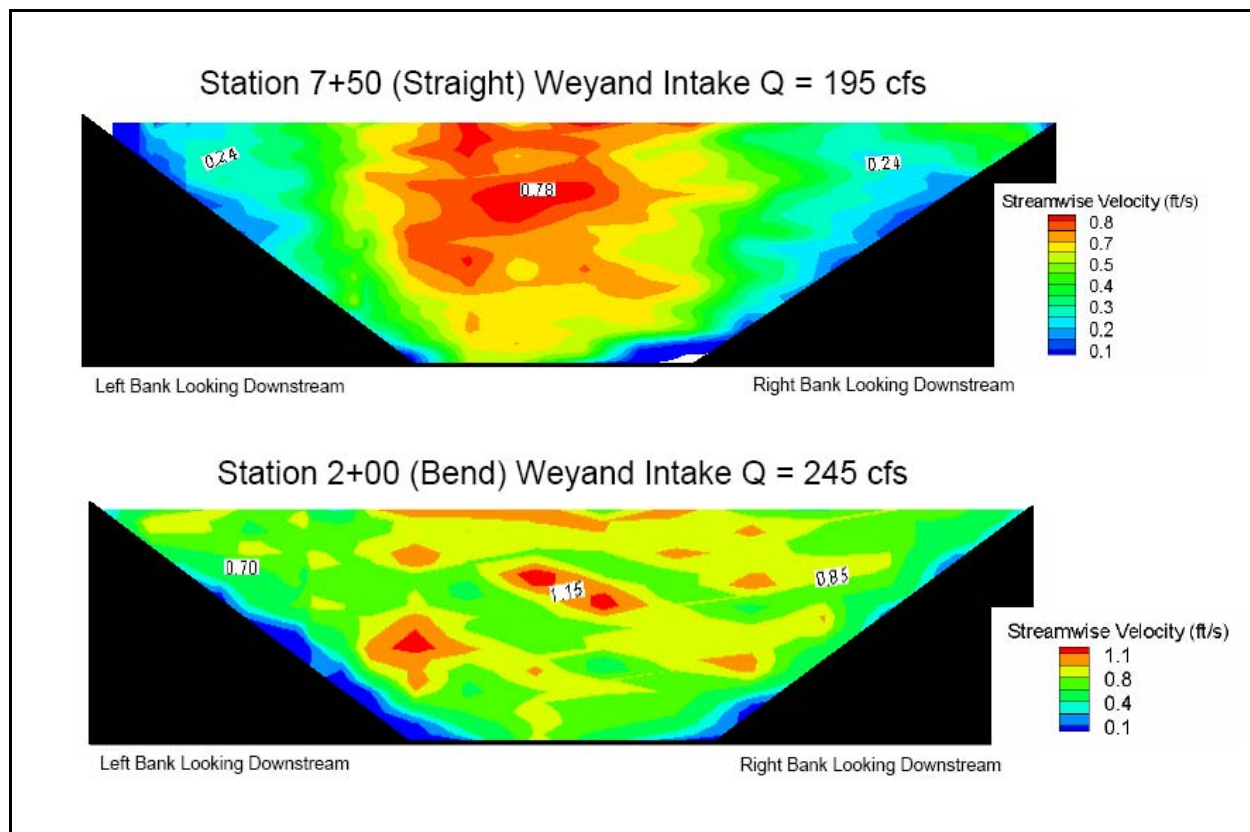
**Figure 6.7** ADCP velocity field measurements at Station 7+50 in straight reach of Putah South Canal and at Station 2+00 in canal bend reach upstream from Weyand Intake.

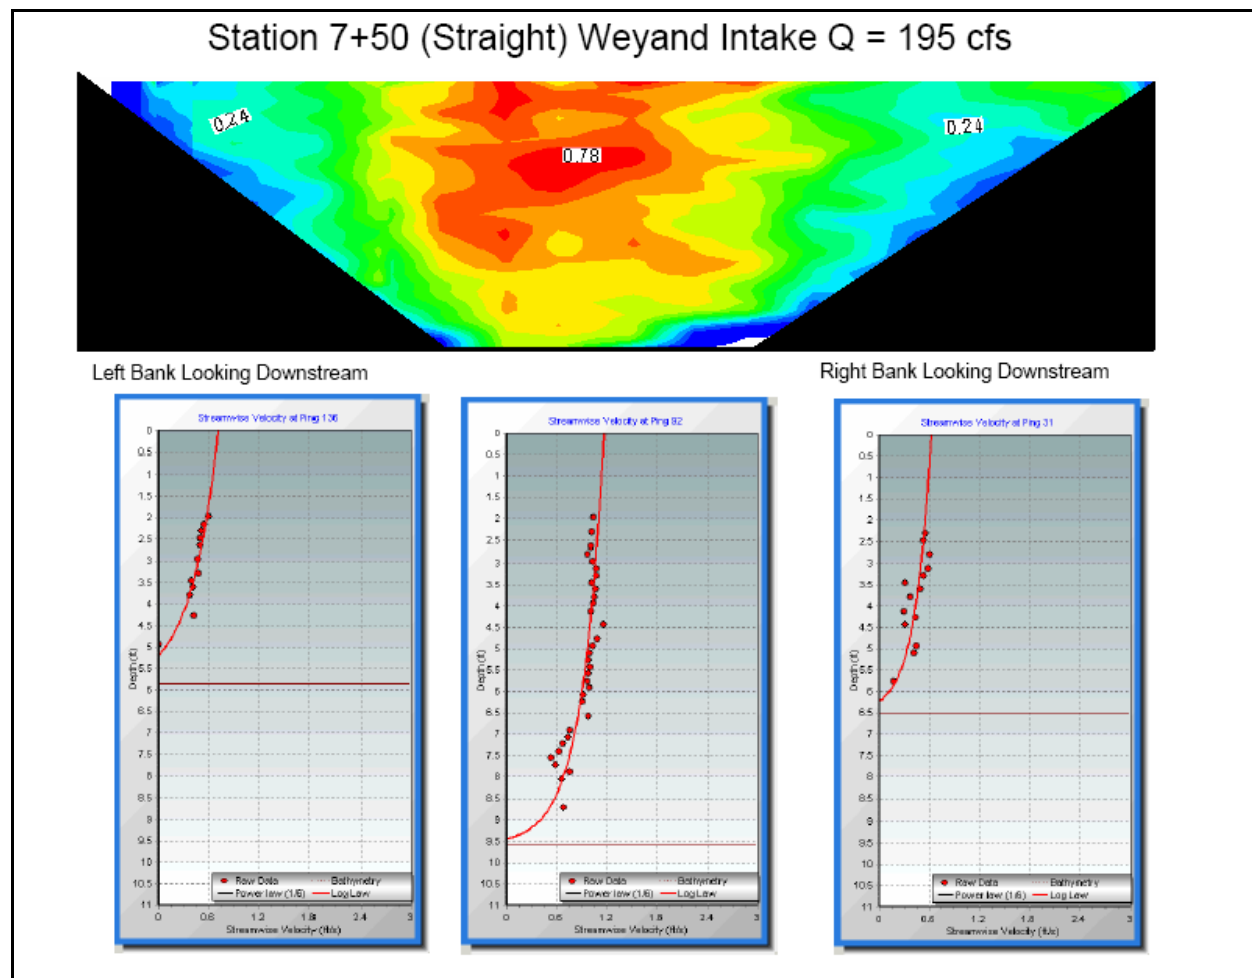
**Figure 6.8.** Measured vertical velocity profiles are well represented by a typical “log law” distribution in straight reaches of Putah South Canal.

ADCP flow measurements in a heavily vegetated reach of the PSC at the Waterman WTP revealed the dramatic effect that aquatic vegetation has on flow distribution in the canal. Thick vegetation (forests of aquatic weeds) growing on the bottom of the trapezoidal canal significantly slow the flow in the central portion of the canal and result in highly non-uniform velocity distributions in the canal. Velocities in the lower 1/2 to 1/3 of the water column in the vegetated portion of the canal were near zero. The highest velocities in heavily vegetated reaches were observed in free-flowing zones near the water surface along the canal edges. Partial removal of the vegetation increased stream velocities in the central portion of the flow and resulted in more uniform vertical and lateral velocity distributions. Maximum velocities measured at the Waterman WTP were approximately 0.6-0.8 ft/s.

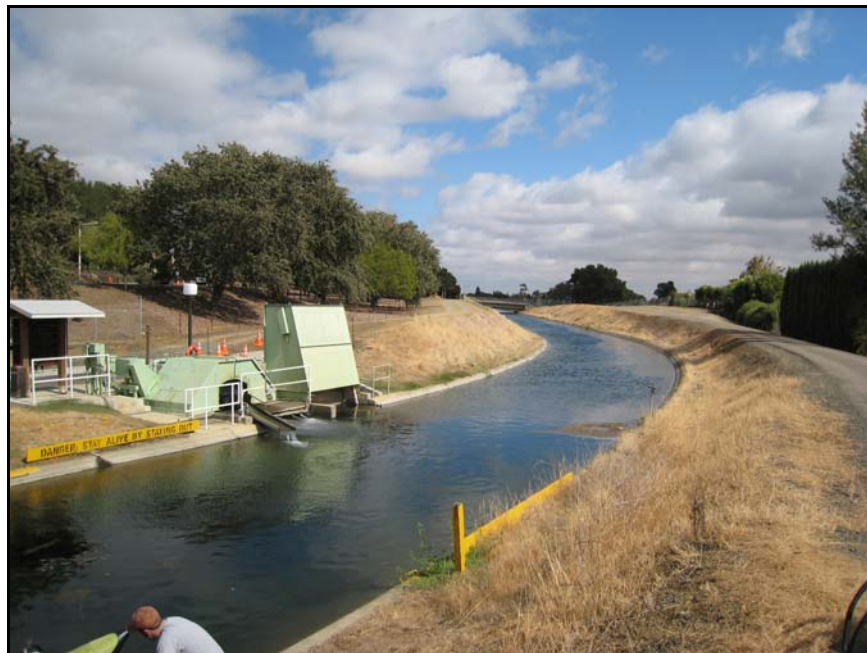
**Figure 6.9.** Putah South Canal near Waterman WTP at MP 23.50 during ADCP measurements. View upstream. Photo of September 28, 2007.

Additional ADCP measurements were conducted in the canal near the Waterman WTP Intake on September 28, 2007. Velocity measurements were made in a short reach of the canal located approximately 200 ft upstream from the Waterman WTP Intake. There was a significant amount of aquatic vegetation (macrophytes and algae) growing in the reach. Figure 6.9 presents a view of the reach looking upstream from the Serpas Check.

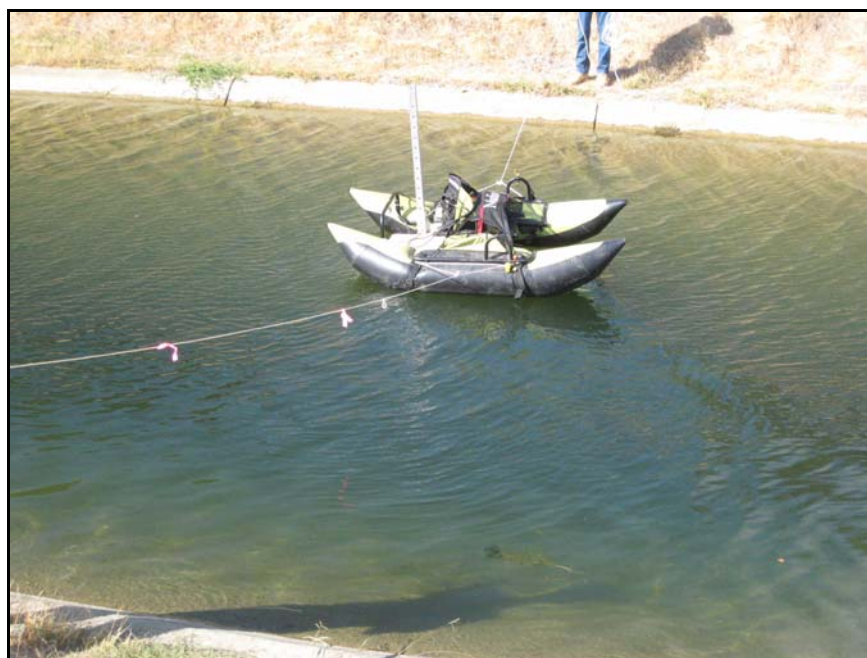
**Figure 6.10.** ADCP measurements upstream from Waterman WTP. Photo of September 28, 2007.

Figure 6.10 shows the ADCP being deployed in the straight section of canal approximately 300 ft upstream from the Waterman WTP. A first set of flow and velocity measurements were collected across the canal section with all of the vegetation in place. Then, prior to the next set of measurements, our field team dragged a steel tow chain along the bottom of a 200-ft section of the canal to remove some vegetation growing in the canal. The field team was only able to dislodge a portion of the higher aquatic plants and weeds; some clumps of vegetation remained in place. A second set of flow and velocity measurements was made at the previous transect location with a portion of the vegetation removed. Figure 6.11 shows both sets of measurements made at the same transect; the upper figure with vegetation in place and the lower figure with a portion of the vegetation removed. This comparison shows how the growth of thick colonies of macrophytes in the canal can dramatically affect flow distribution and efficiency in the canal. If the field team had been able to dislodge more attached vegetation from the canal sides and bottom, the measured differences would have been even more dramatic. Nevertheless, these results show how thick colonies of vegetation significantly reduce channel conveyance and alter the location of relatively free-flowing zones of water toward the upper and outer edges of the canal. Note that there is a significant portion in the center and bottom of the canal where there is little or no flow velocity due to thick mats of vegetation and deposits of sediment and organic materials that accumulate beneath the vegetation. Our field team spoke with operators at the Waterman WTP and they said that they have to manually remove aquatic vegetation along the right canal bank in the vicinity of the plant's intake quite frequently. Figure 6.11 shows the effects of previous vegetation removal along the right bank line where pockets of flow are located near the surface along the right bank.
