# **INVESTIGATION OF SOURCES OF TURBIDITY, SEDIMENT, AND AQUATIC VEGETATION IN PUTAH SOUTH CANAL**

## **Solano County Water Agency**

## **Northwest Hydraulic Consultants Inc.**

***May 14, 2010***

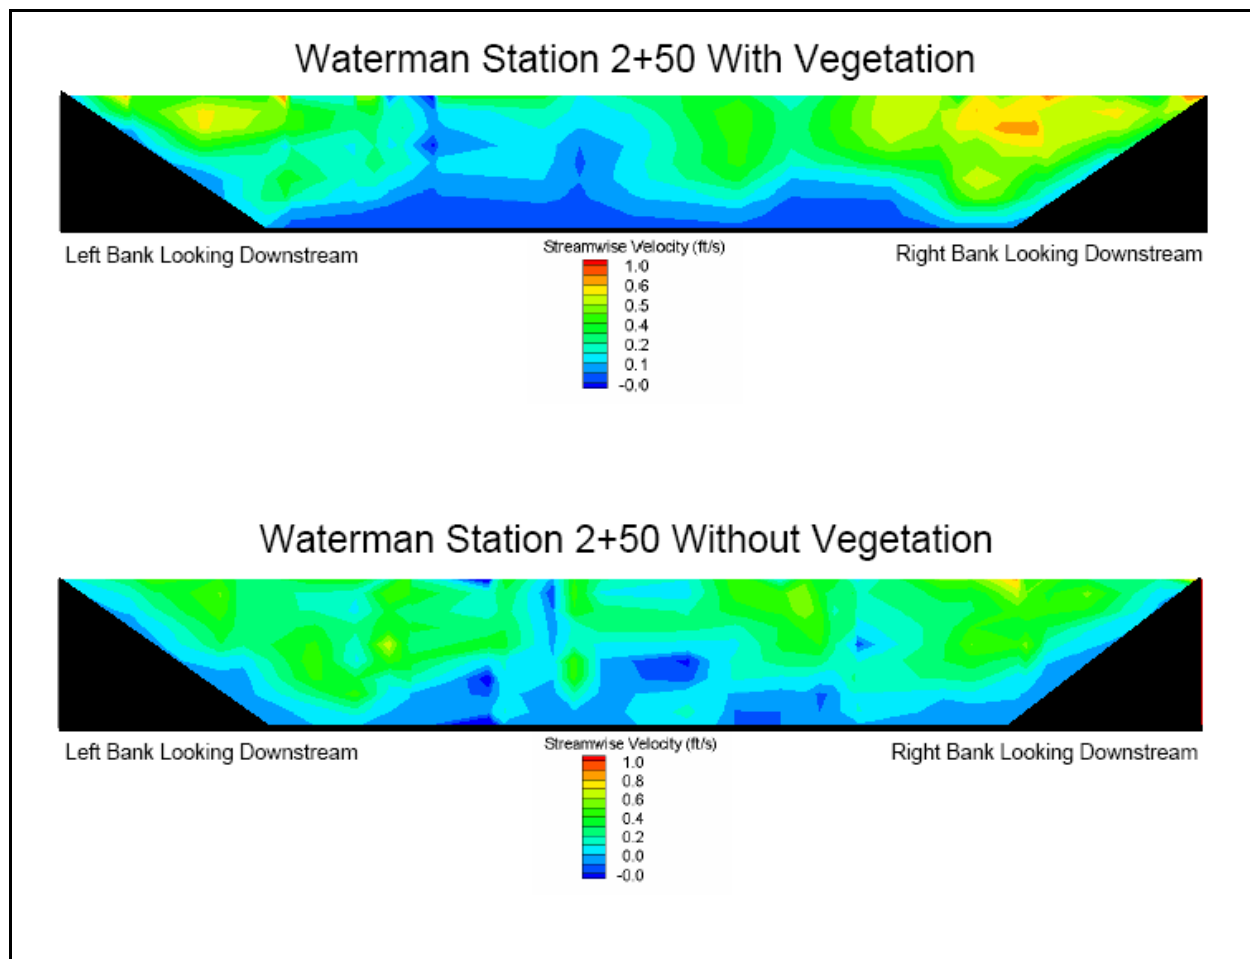
**Figure 6.11.** Measured velocity distributions in Putah South Canal near Waterman WTP Intake showing how flow distribution and channel conveyance can be significantly affected by presence of aquatic vegetation.

ADCP flow measurements in a heavily vegetated reach of the PSC at the Waterman WTP revealed the dramatic effect that aquatic vegetation has on flow distribution in the canal. Thick vegetation (forests of aquatic weeds) growing on the bottom of the trapezoidal canal significantly slow the flow in the central portion of the canal and result in highly non-uniform velocity distributions in the canal. Velocities in the lower 1/2 to 1/3 of the water column in the vegetated portion of the canal were near zero. The highest velocities in heavily vegetated reaches were observed in free-flowing zones near the water surface along the canal edges. Partial removal of the vegetation increased stream velocities in the central portion of the flow and resulted in more uniform vertical and lateral velocity distributions. Maximum velocities measured at the Waterman WTP were approximately 0.6-0.8 ft/s.

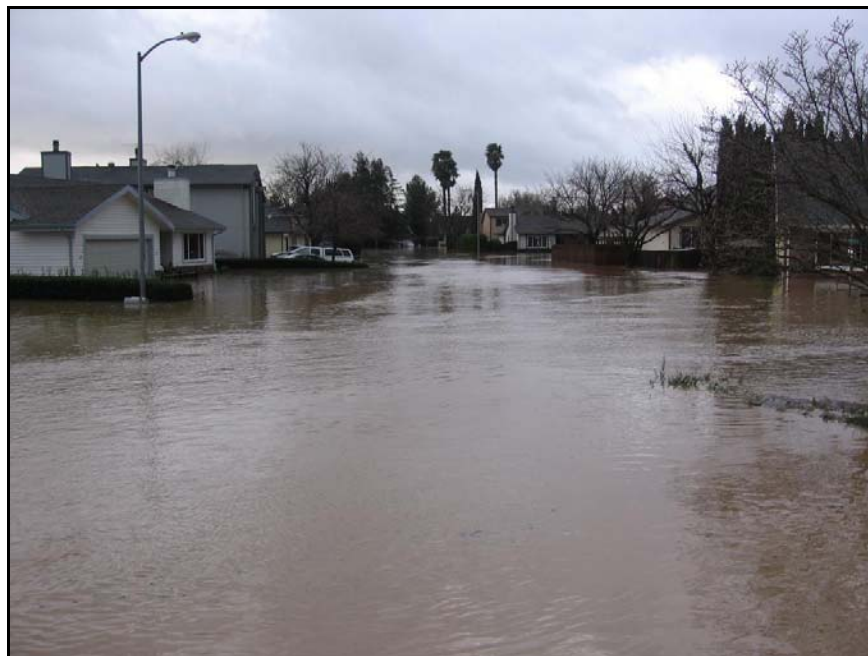
**Figure 8.1.** Flooding in Vacaville near Putah South Canal from Alamo Creek during December 31, 2005 storm. Photo from <http://www.vacavilleflood.com>.

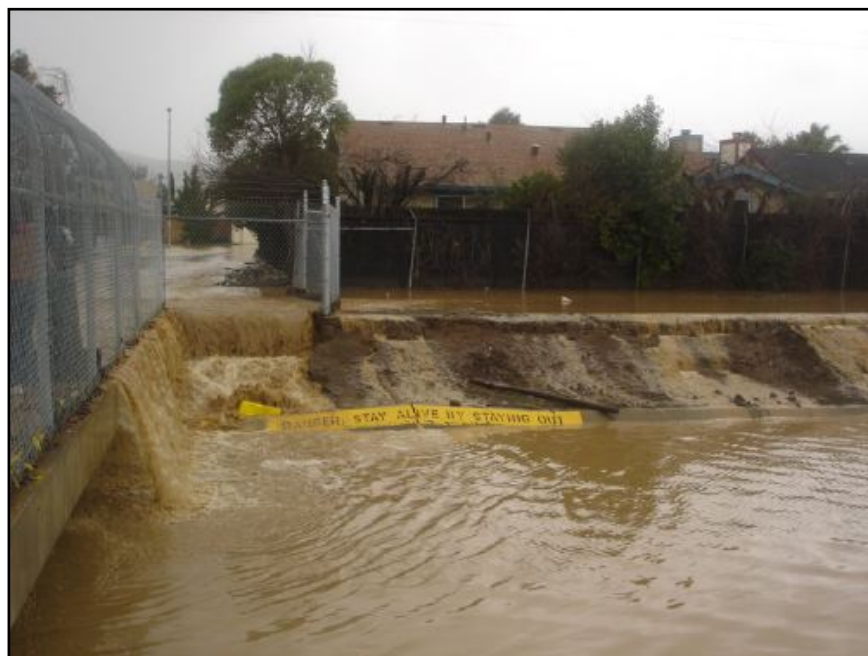
**Figure 8.2.** Lateral inflow to Putah South Canal in Vacaville during December 31, 2005 storm. Photo from Internet.

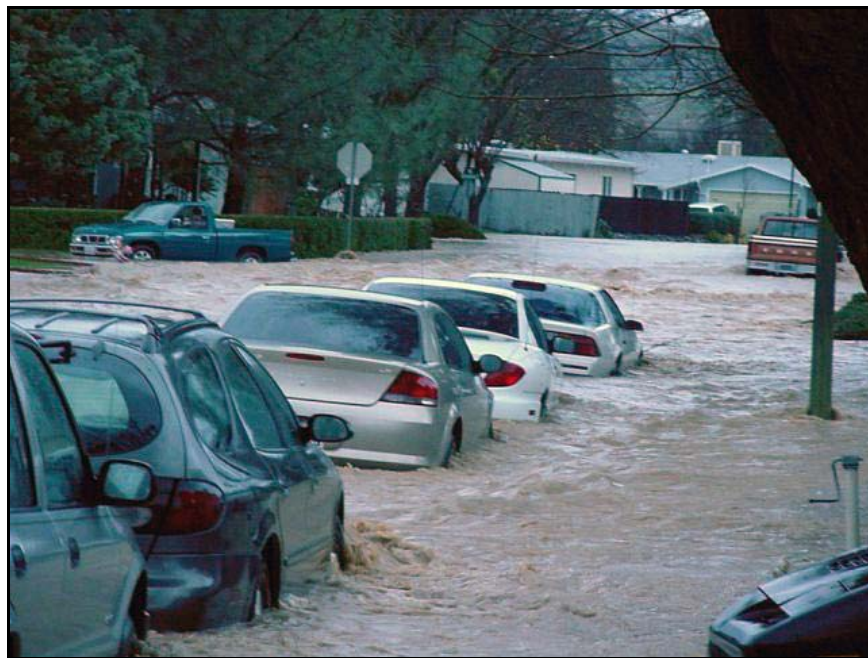
**Figure 8.3.** Flooding in Vacaville (Citrus Ave) during December 31, 2005 storm.  
Photo from <http://www.vacavilleflood.com>.
