9. ASSESSMENT OF ISSUES AND CONCERNS REGARDING AQUATIC VEGETATION IN PUTAH SOUTH CANAL

9.3. Issues and Observations

11. RECOMMENDATIONS FOR MANAGING SEDIMENT AND VEGETATION

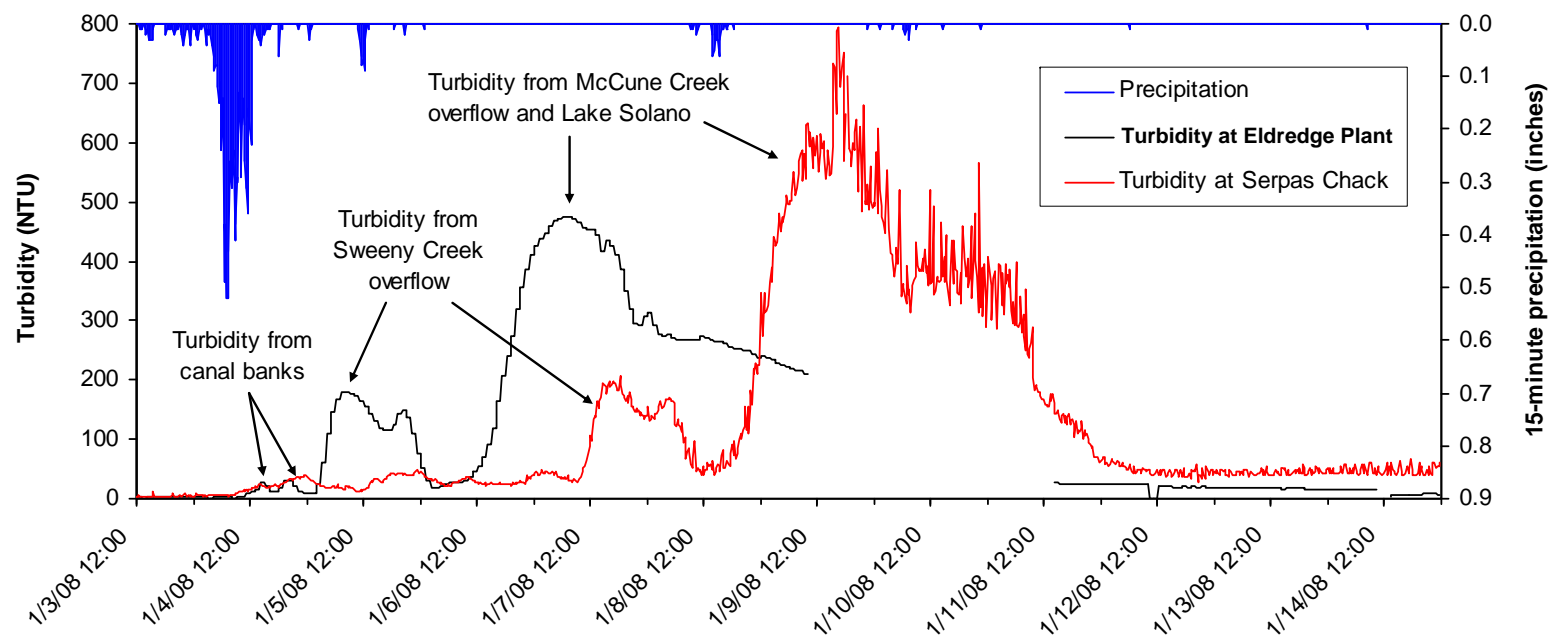
Figure 8.4. Turbidity response at Serpas Check and Eldredge Plant to precipitation intensities recorded by SCWA rain gage at Sweeney Check after January 4, 2008 storm.

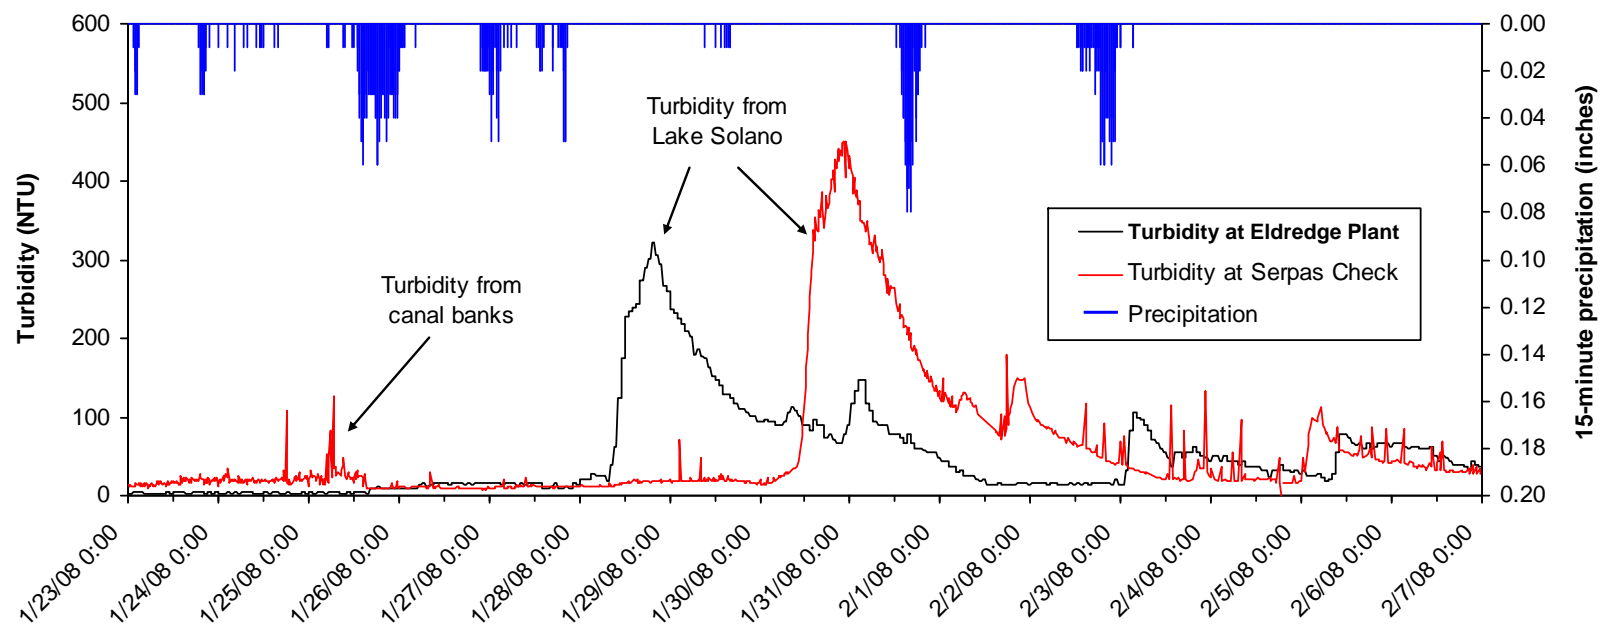
Figure 8.5. Turbidity response at Serpas Check and Eldredge Plant to precipitation intensities recorded by SCWA rain gage at Sweeney Check after January 25, 2008 storm.

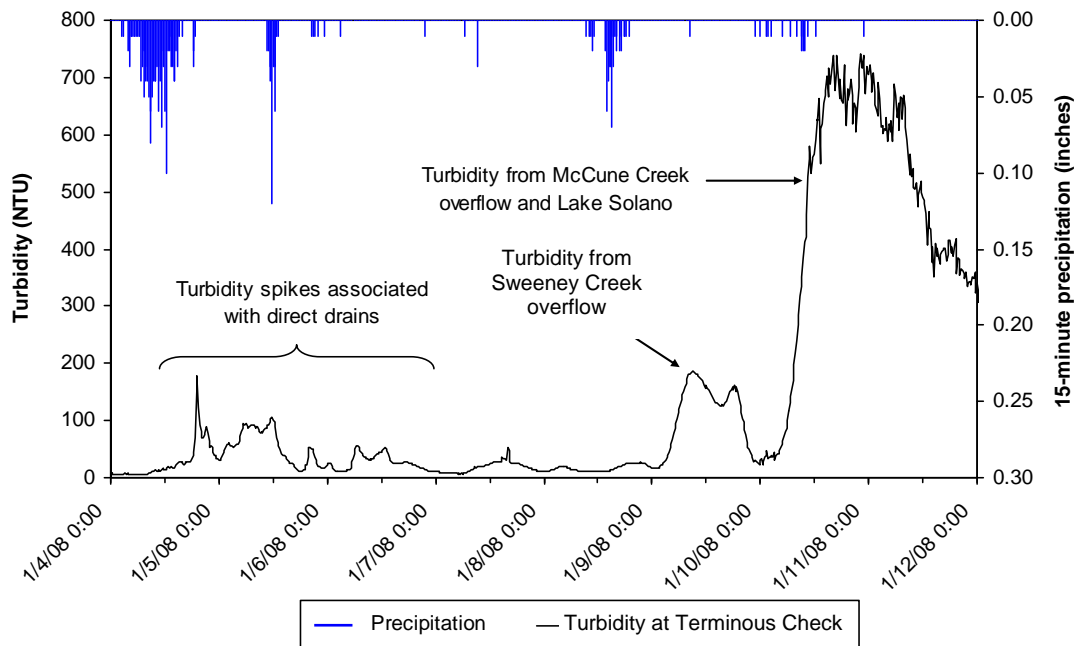
Figure 8.6. Turbidity response at Terminous Check to precipitation intensities recorded by SCWA rain gage at Gregory Hill Station during January 4, 2008 storm.

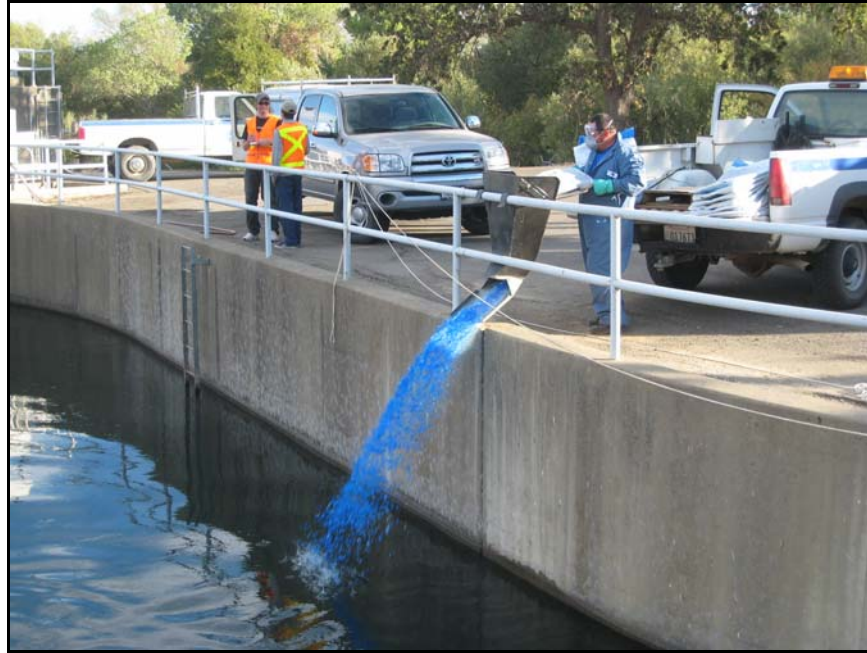
Figure 9.1. Application of copper sulfate at Headworks. Photo of September 25, 2008.

The primary issue of concern for the Solano Project weed control specialist is the need to better understand how best to control algae in the PSC. Controlling algae, especially filamentous algae is essential because it grows very rapidly in the canal and can quickly clog water intake structures, which dramatically affects their performance. Daily “raking” of algae and higher aquatic vegetation (weed fragments) from intake trash racks is labor intensive, costly, and does not address the growing problems associated with the growth of aquatic vegetation in the canal. Solano Project operators used to use stronger herbicides that were more effective at controlling algae and other vegetation, but the application of broad-range herbicides such as *acrolein* is no longer allowed. Present vegetation management consists of application of copper sulfate in the canal to treat algae (Figure 9.1) and manual “raking” and removal of vegetation from intake screens.

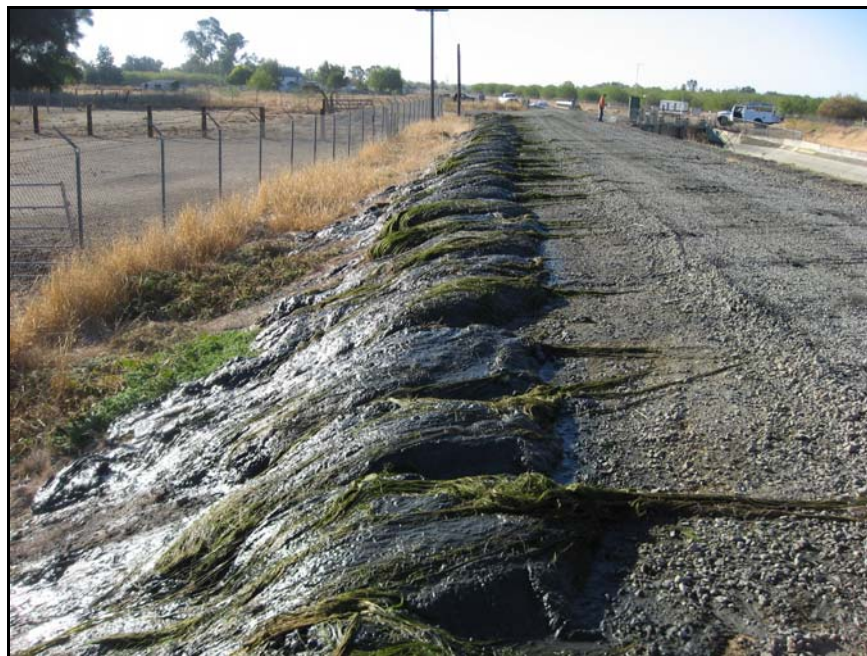
Figure 9.2. Aquatic vegetation, organic sludge, and sediment removed from Sweeney Check during canal cleanout. Photo of October 18, 2006.

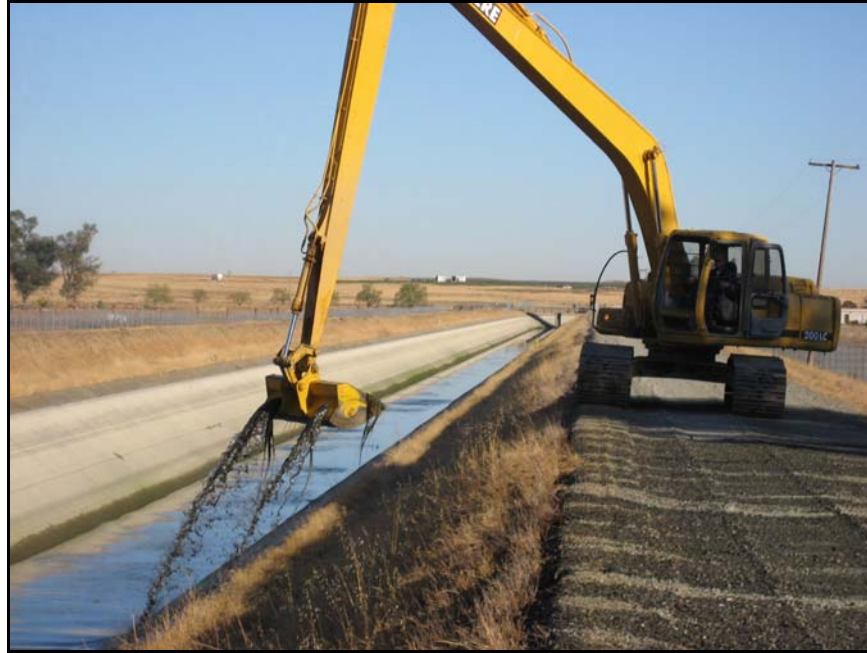
Figure 9.3. Backhoe removing sediment, vegetation, and sludge deposits from Sweeney Check. View upstream. Photo of October 19, 2006.

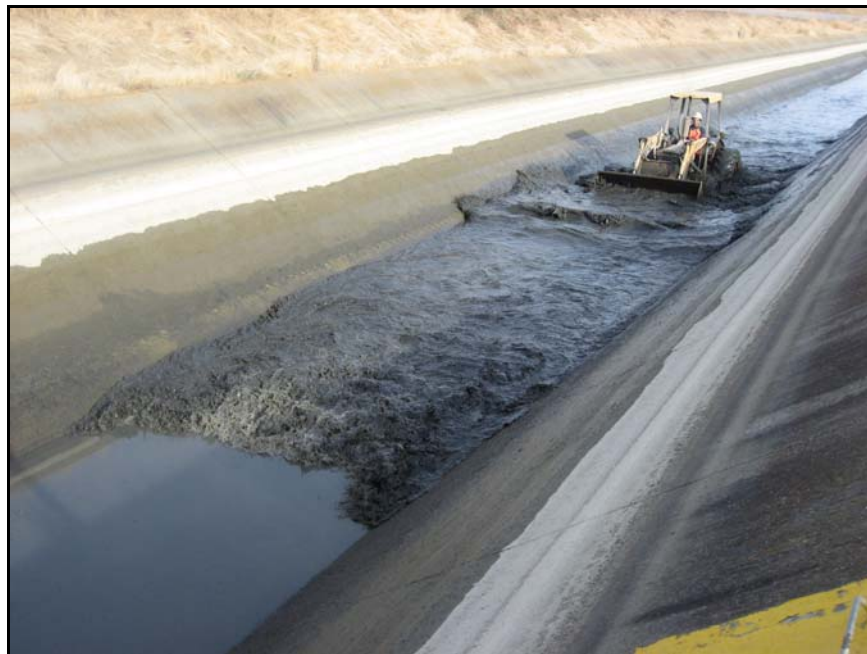
Figure 9.4. Tractor pushing sediment, vegetation, and sludge deposits downstream in McCoy Check. Photo of October 30, 2006.

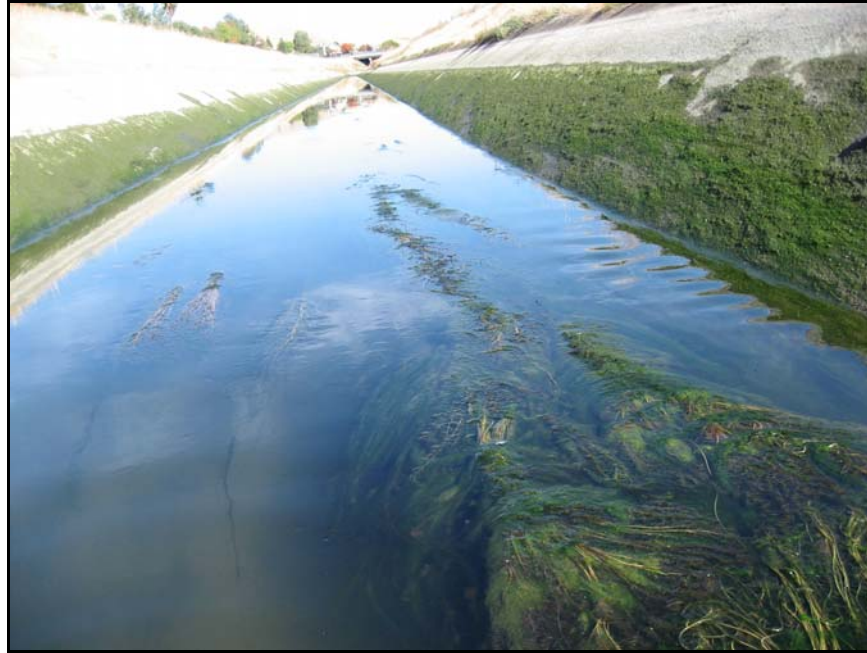
Figure 9.8. Thick mats of attached algae growing on canal sides and thick mats of macrophytes growing on canal bottom in Serpas Check. A mixture of sediment and decayed plant materials lies beneath the mats of macrophytes. These deposits can become 6 to 18 inches thick.
Photo of November 9, 2006.

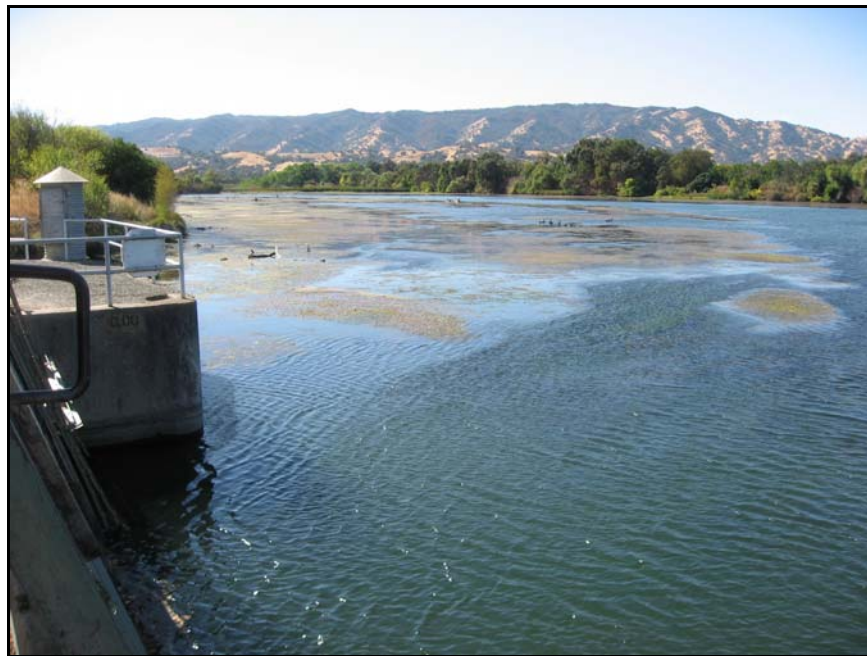
Figure 9.9. Thick mats of aquatic vegetation growing in Lake Solano.
View upstream from Headworks. Photo of October 10, 2006.

Source-specific management and control is very important. Chapters 4 and 8 discuss erosion hazards and identify sources of sediment that enter the canal. Figure 9.9 shows a photograph of Lake Solano, looking upstream (west) from the Headworks. There are thick mats and submerged forests of algae and macrophytes growing in the lake. It is apparent that Lake Solano is the primary source of aquatic vegetation entering the canal through the Headworks. Propagules, including seeds, plant fragments, turions, shoots, and tubers enter with the flows diverted into the canal through the Headworks. Figure 9.10 shows a large bloom of Mosquito Fern (*azolla*) that occurred in the lake during the winter of 2007. Portions of such blooms can enter the canal with flows through the Headworks.

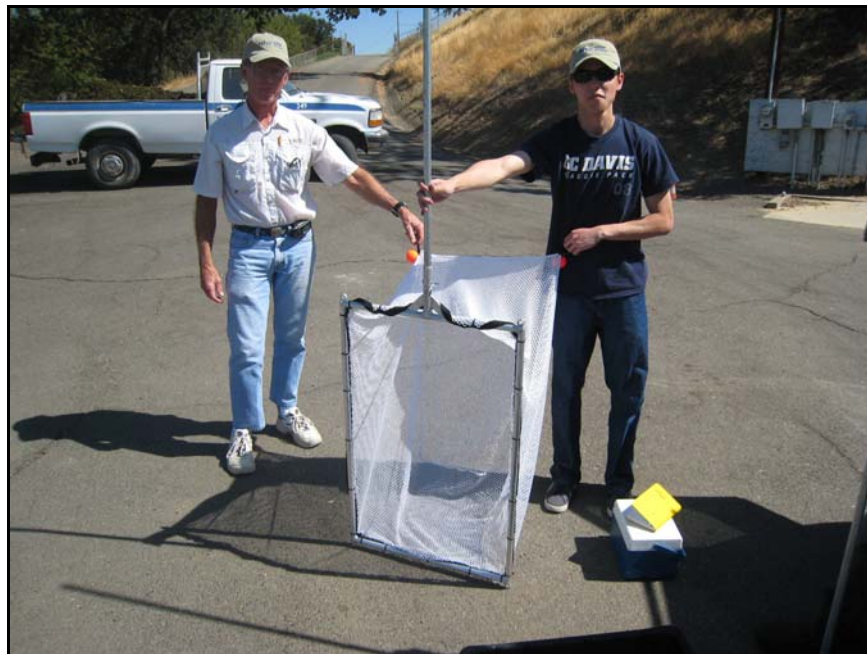
Figure 9.11. Aquatic vegetation sampler (2 ft by 3 ft frame with ¼ inch mesh). Photo of September 24, 2008.

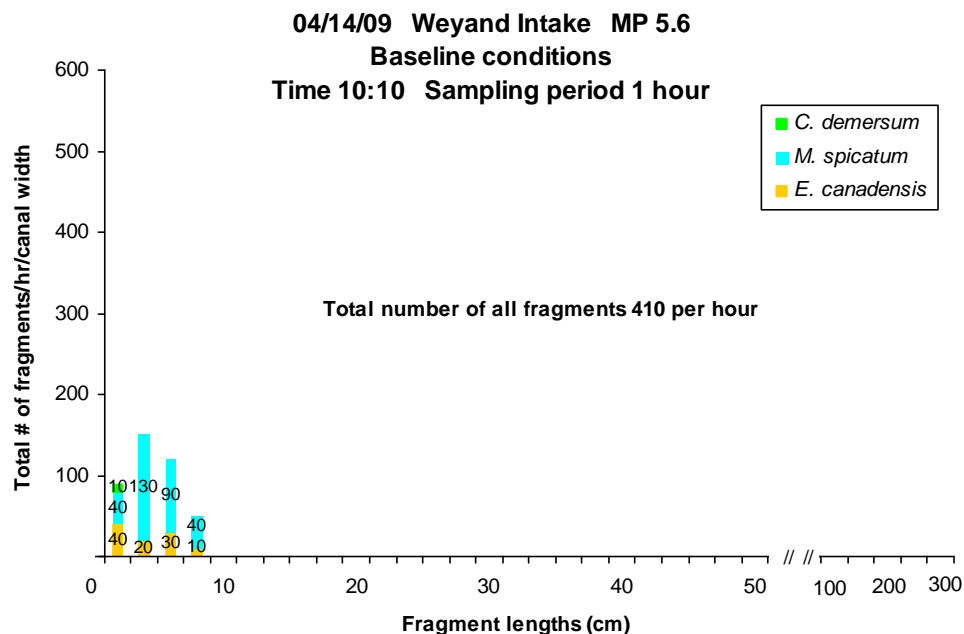
Figure 9.22. Total vegetation influx from Putah South Canal to Weyand Intake at MP 5.6 measured during baseline conditions on April 14, 2009.

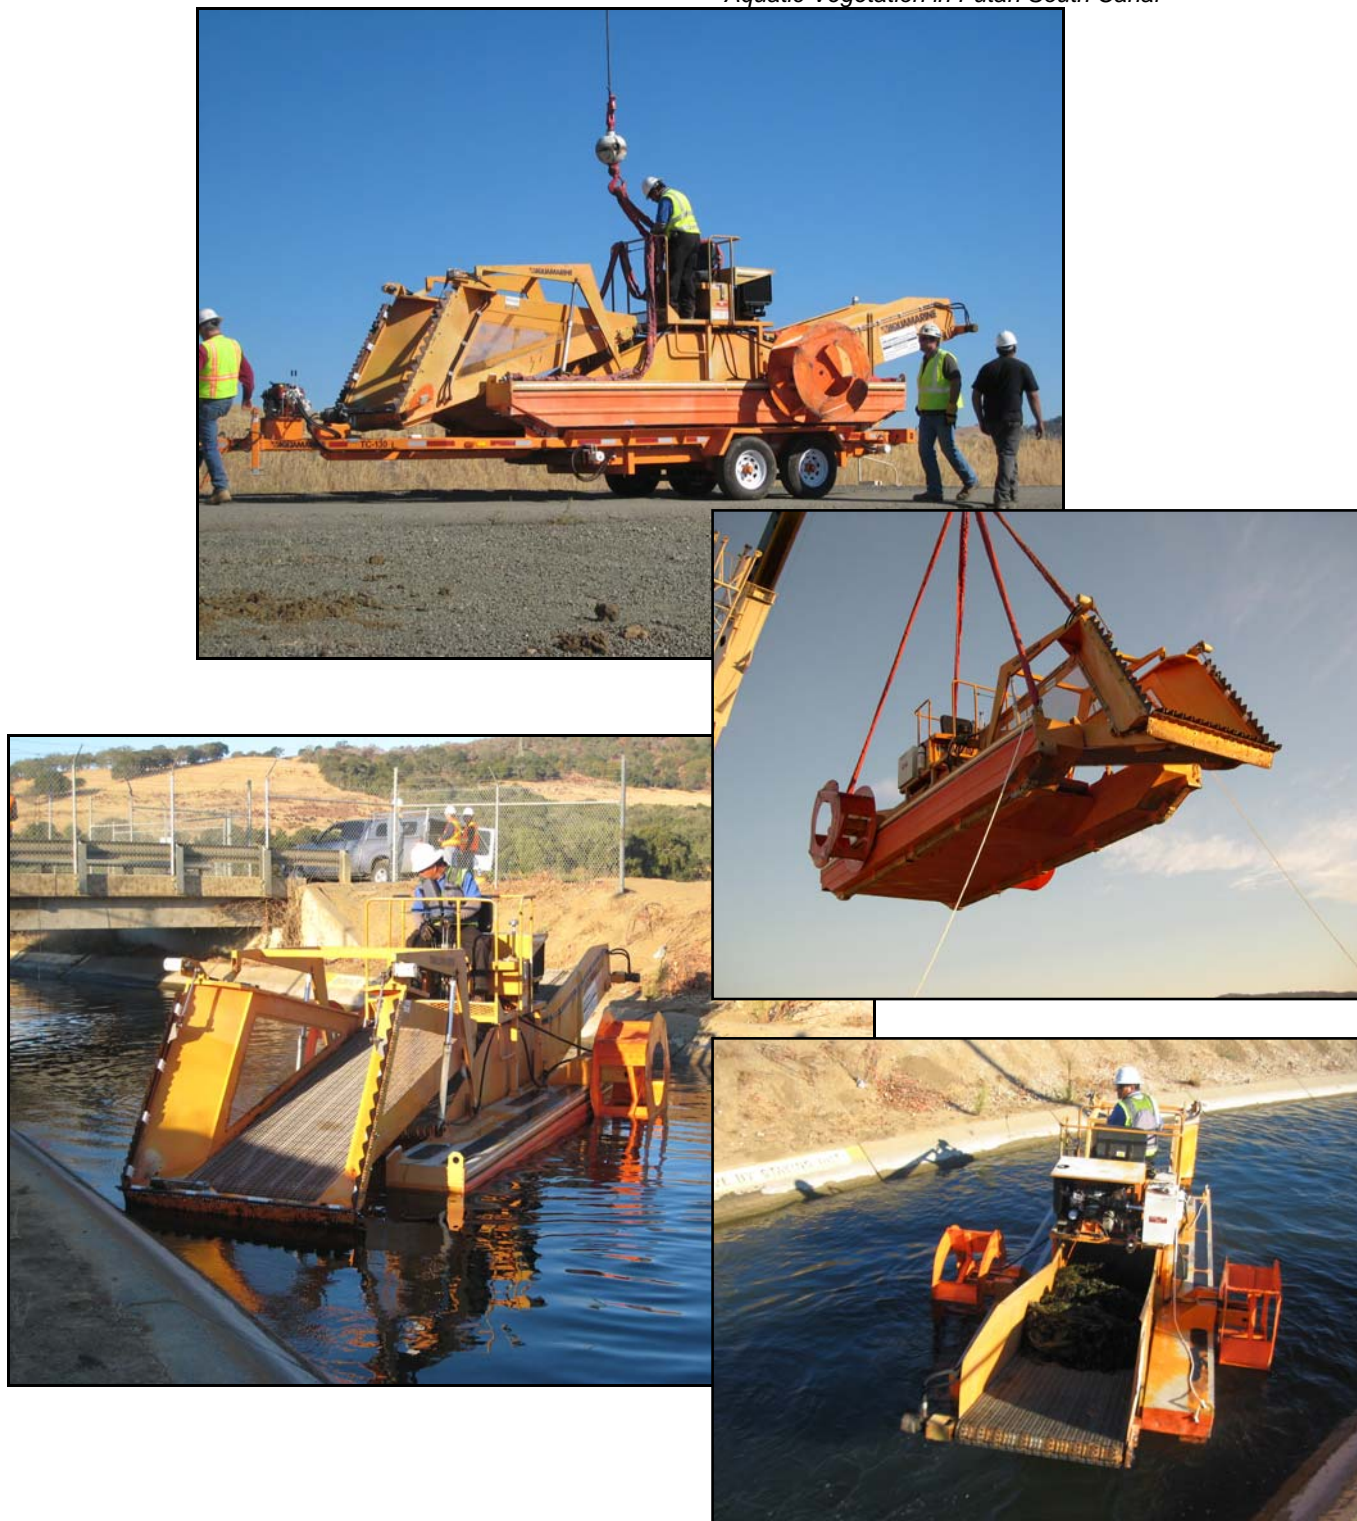
Figure 9.30. Aquamarine H5-130 Harvester. Photos of October 16, 2008.

Reach 1 – Suisun Check between MP 26.87-27.11. The reach is about 700 yd long and is located between Suisun Valley Road at MP 26.87 and a bridge crossing at MP 27.11. Water depth in the canal during testing was about 5-6 ft and stream velocity was around 0.1-0.2 ft/s. The selected reach represented typical conditions in the PSC with respect to volume and density of weed growth. According to visual estimates, about 50-80% of the canal was occupied by weeds growing up to the water surface. The bottom of the canal was covered with 0.5-1 ft thick layer of sediment. Prior to harvesting, turbidity booms were installed at the downstream end of the test section to minimize impact to water quality in the downstream reaches (Figure 9.32). The cutting head of the harvester was lowered to just above the sediment layer in an effort to keep from disrupting sediment deposits. A total of three full passes were made to cut all the submerged vegetation (Figure 9.33). Less than one full load of plant material was collected (about 300 lb). The harvested biomass was disposed of on the south bank of the canal. Upon completion of harvesting, the H5-130 was removed from the canal and transported to the second test location.

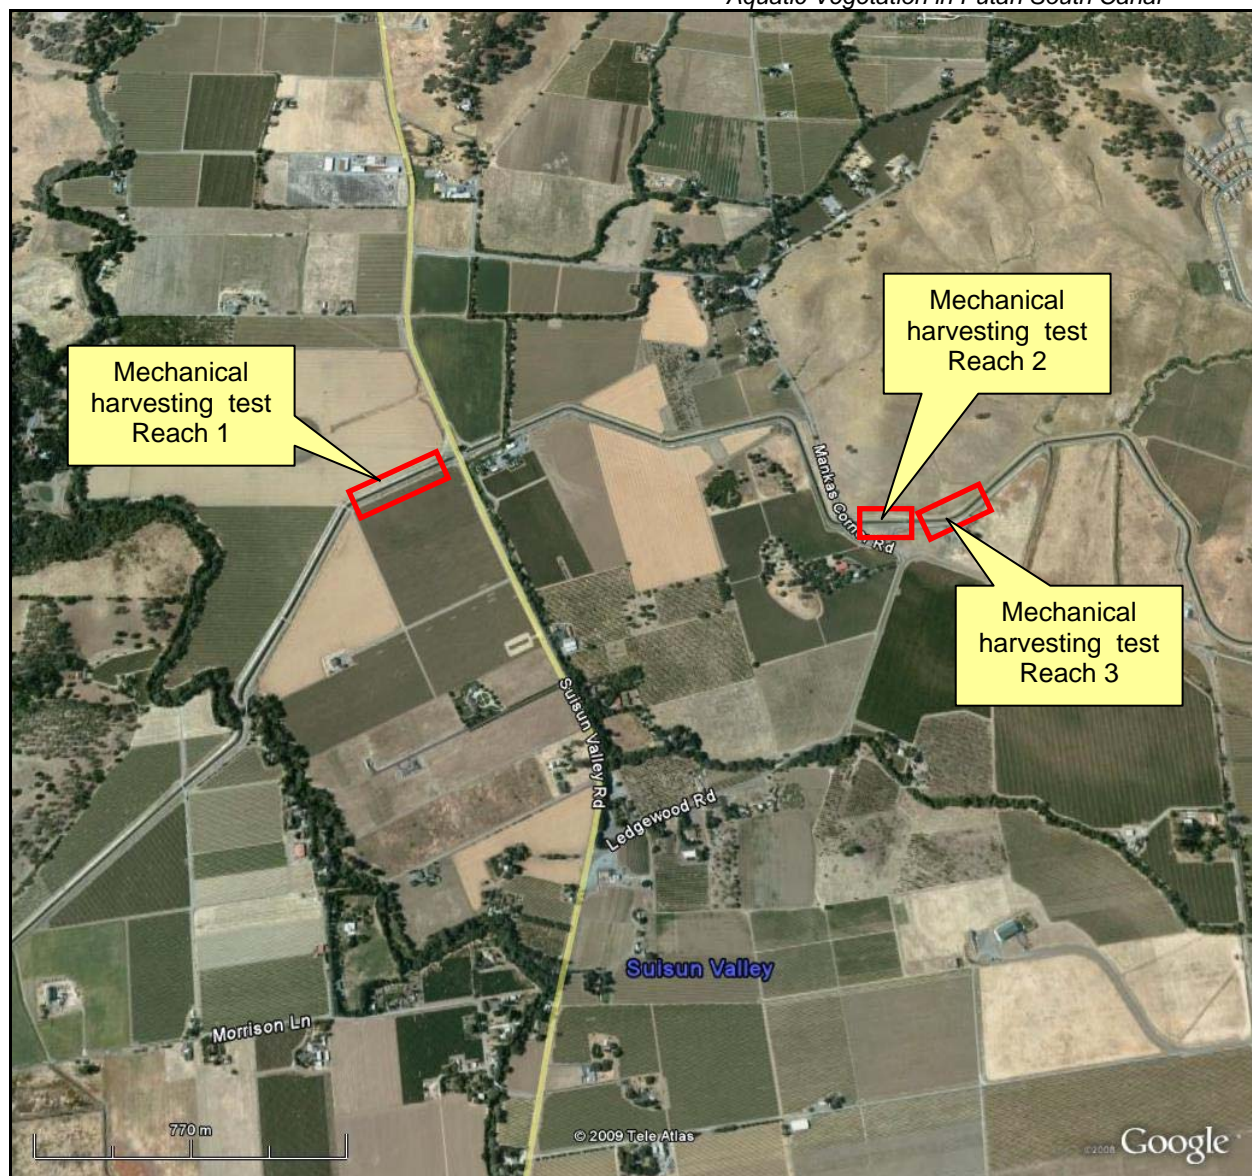
Figure 9.31. Location of mechanical harvesting test reaches.

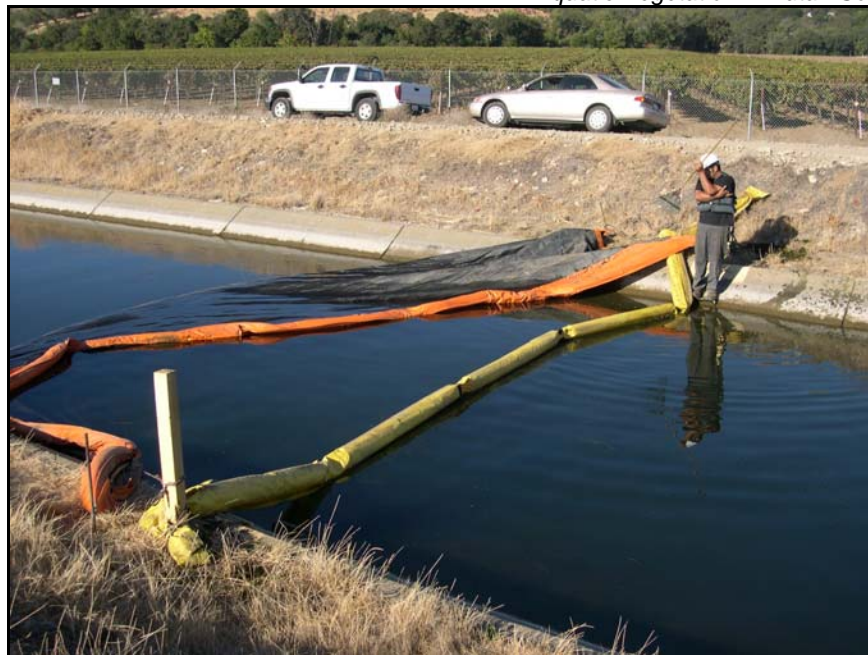
Figure 9.32. Fragments and turbidity booms in Reach 1. Flow right to left. Photo of October 16, 2008.

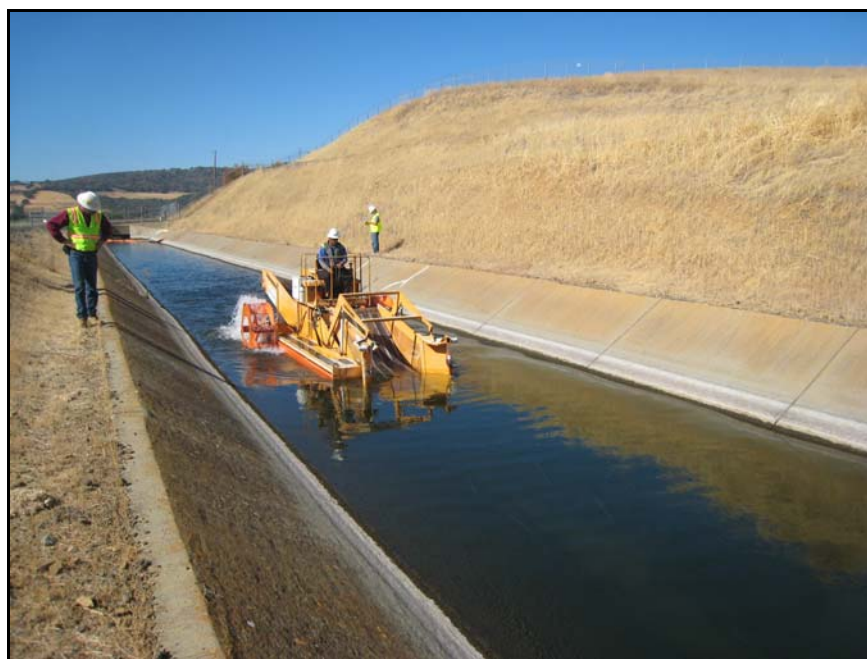
Figure 9.35. Cutting vegetation and pushing sediment in Reach 2. View downstream. Photo of October 16, 2008.

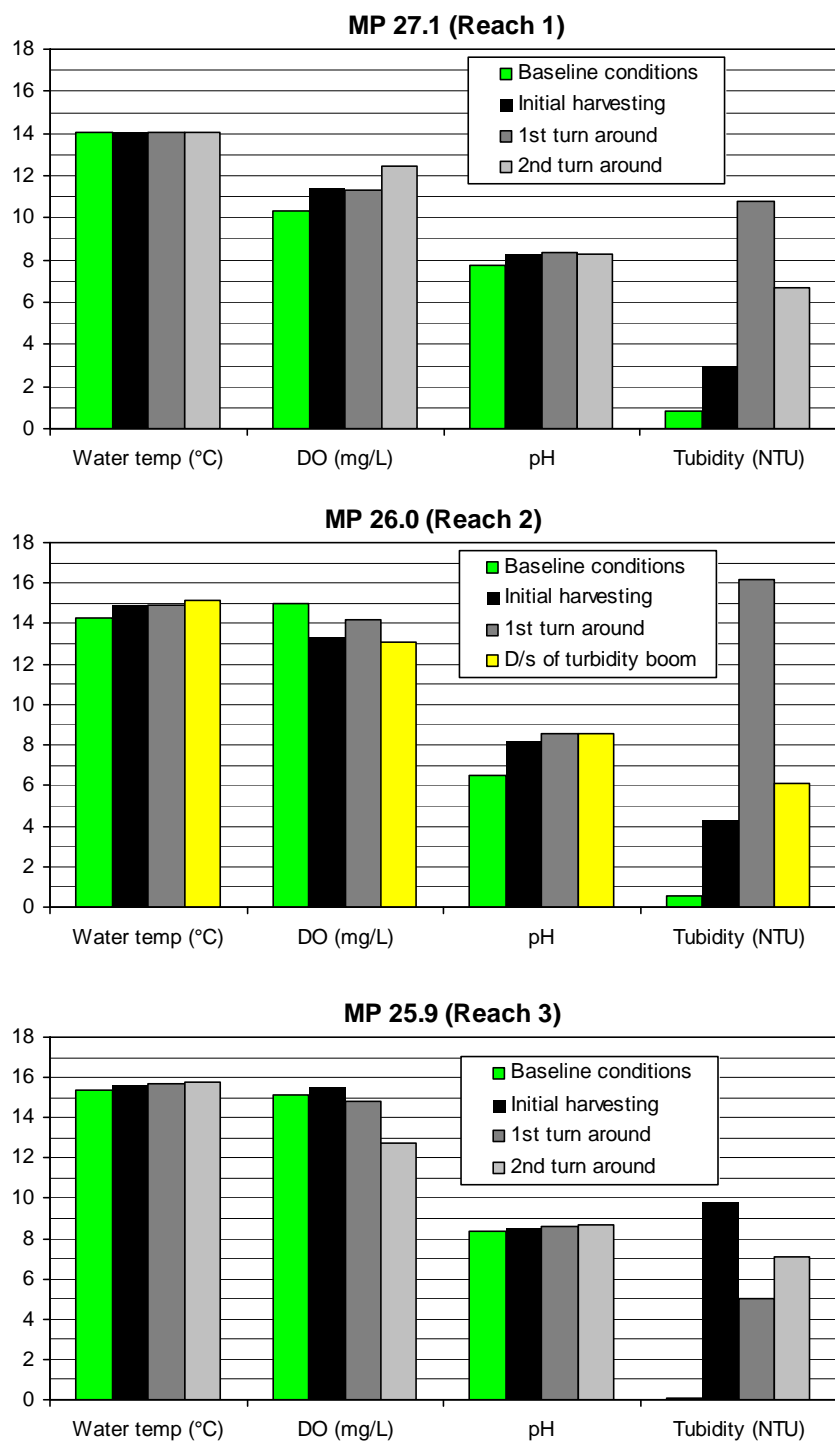
Figure 9.39. Average water quality data measured with YSI 650MDS multimeter during vegetation harvesting pilot test on October 16, 2008.

- Turbidity and selected water quality characteristics were measured at the downstream end of each harvesting reach (upstream of fragment/turbidity booms). The measurements were made using a hand-held YSI 650MDS multimeter (Figure 9.38) prior to harvesting (baseline conditions) and during harvesting. In Reach 2, an additional measurement was made downstream of the turbidity boom to determine its trapping efficiency. Depth-average multimeter data are presented in Table 9.2 and Figure 9.39.

According to the multimeter data (Table 9.2, Figure 9.39), water temperature was constant in Reach 1 and increased in Reaches 2 and 3. The observed changes in water temperature were due to sunlight effect and were not related to harvesting. Dissolved Oxygen (DO) increased in Reach 1 and decreased in Reaches 2 and 3, while pH slightly increased in all the test reaches. However, the observed changes in DO and pH were insignificant. The most noticeable effect of harvesting was the increased level of water turbidity. Measured turbidity increased from less than 1 NTU before harvesting up to 10-11 NTU during harvesting in Reaches 1 and 3 (where sediment layer was left intact) and up to 16 NTU during harvesting in Reach 2 (where sediment layer was

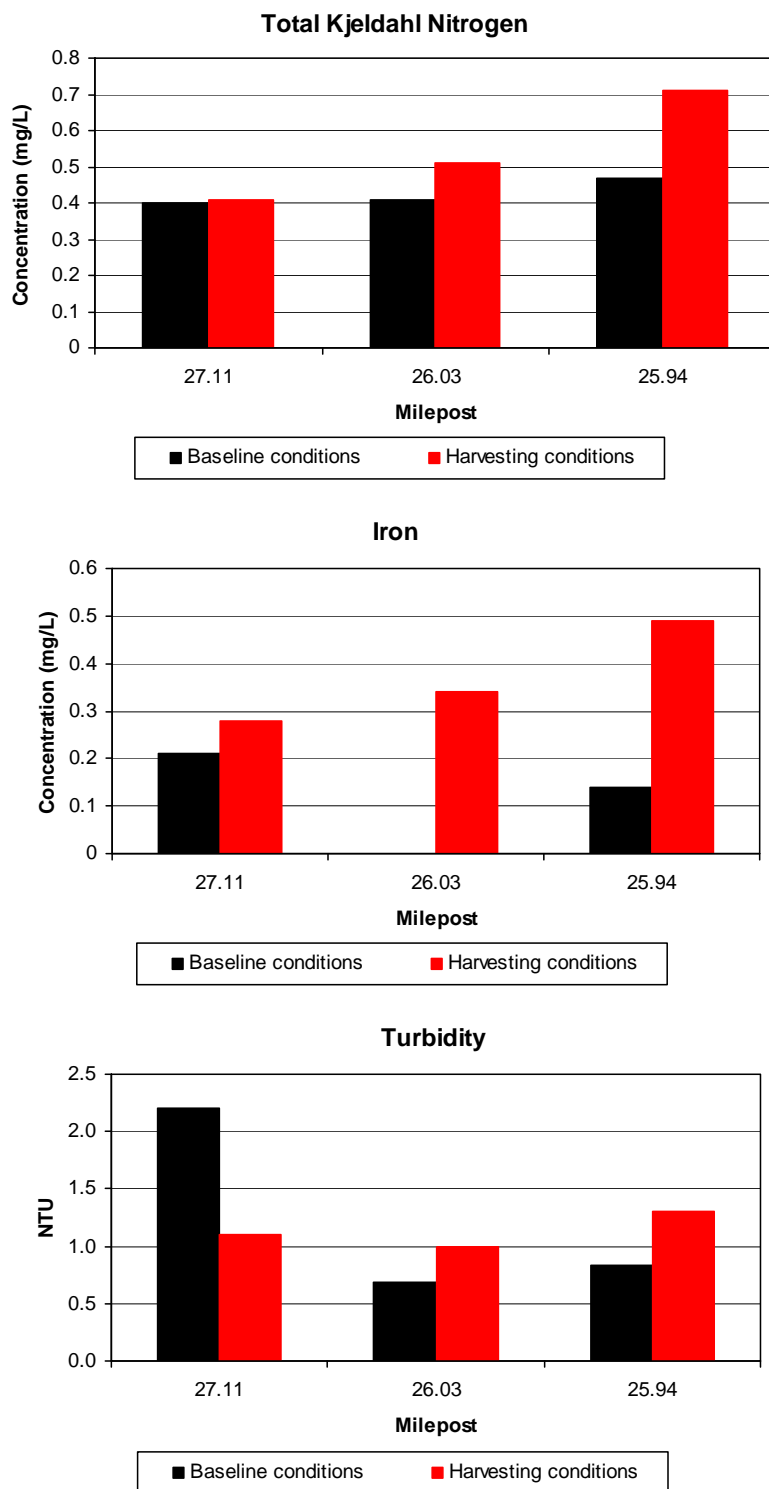
Figure 9.40. Water quality laboratory results for samples collected during vegetation harvesting pilot test on October 16, 2008.

Results of laboratory analysis of water samples (Table 9.3 and Figure 9.40) also indicated that harvesting did not produce any significant impact on water quality characteristics. Most constituents were either non-detectable or found in very small quantities. The only parameters that slightly exceeded existing drinking water standards were turbidity and iron.

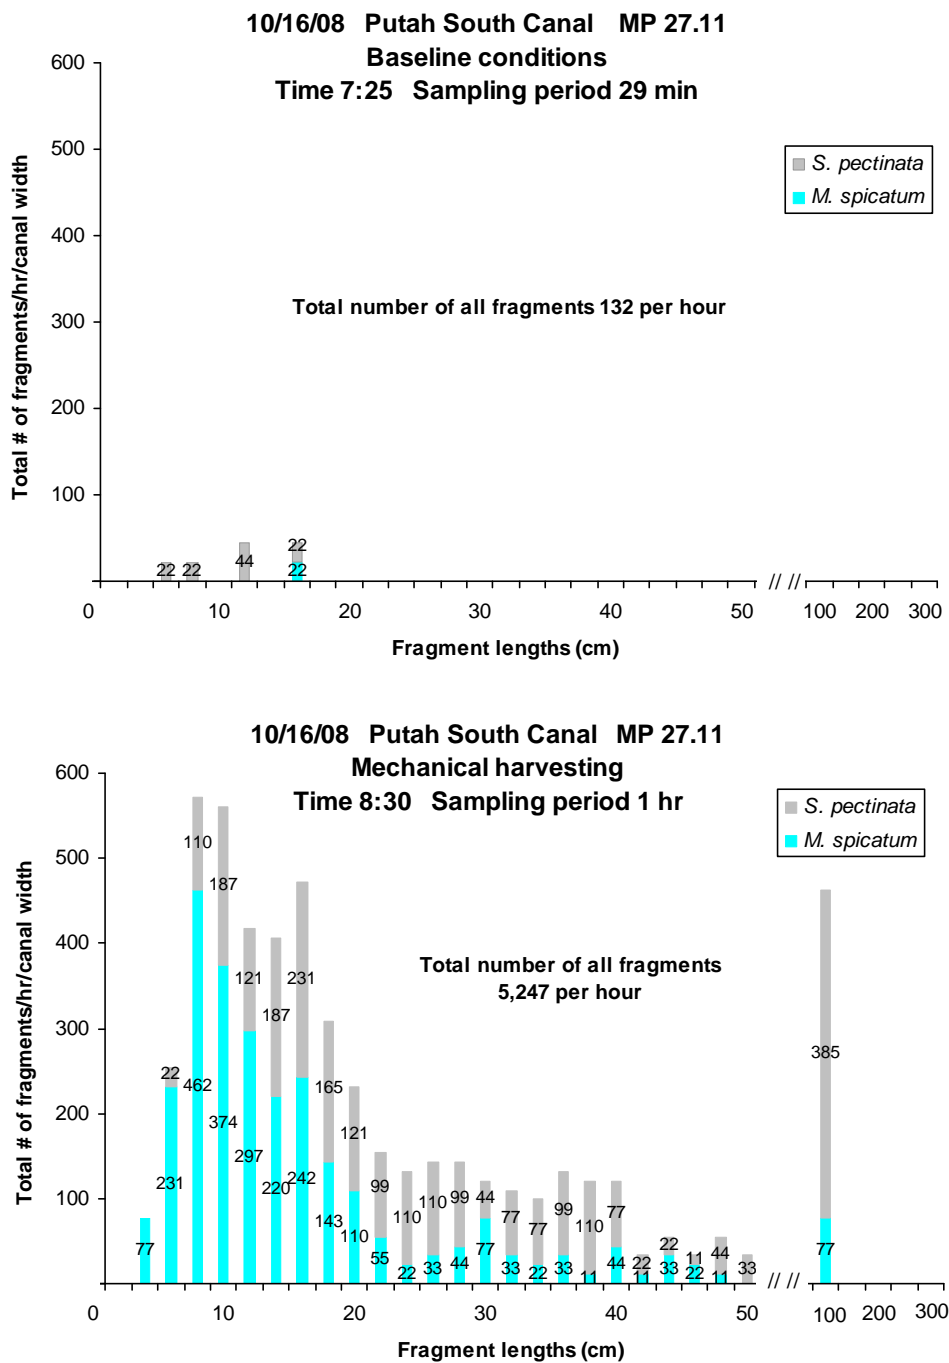
Figure 9.43. Total vegetation influx measured at MP 27.11 (Reach 1) on October 16, 2008 before and during vegetation harvesting.

Monitoring of vegetation flux revealed that harvesting did increase the amount of floating weed fragments in the canal (Figures 9.43-9.45). Measured total number of fragments increased by an order of magnitude from 132 to 550 fragments per hour during baseline conditions to 2,376 to 5,247 per hour during harvesting operations. Prevailing species in the test reaches were *S. pectinata* and *M. spicatum*. To prevent plant material dispersal to the downstream reaches, the fragments need to be contained by means of fragment and turbidity booms. The pilot test demonstrated insufficient trapping efficiency of the presently available booms. However, the design and implementation of the booms can be improved specifically for the PSC.

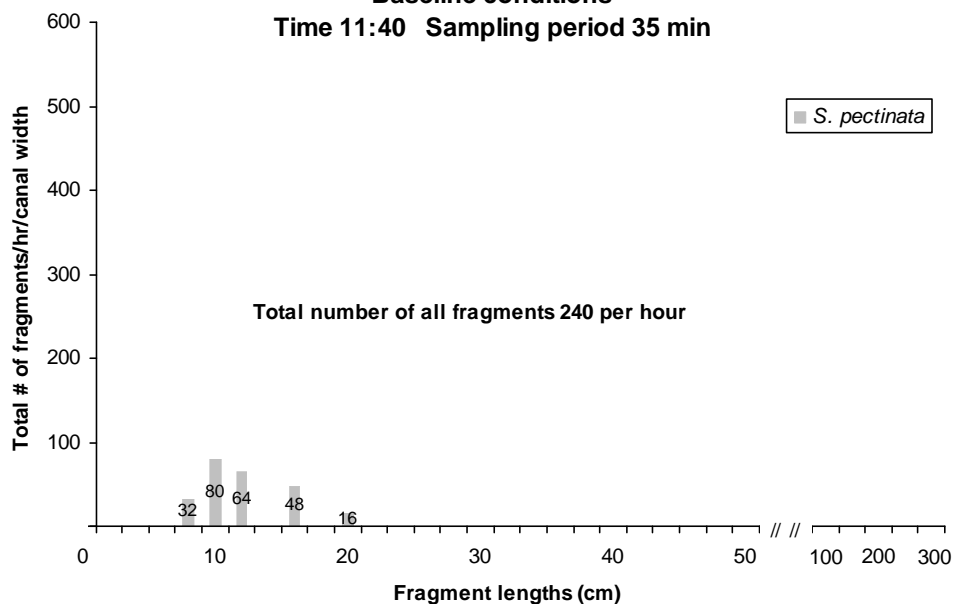
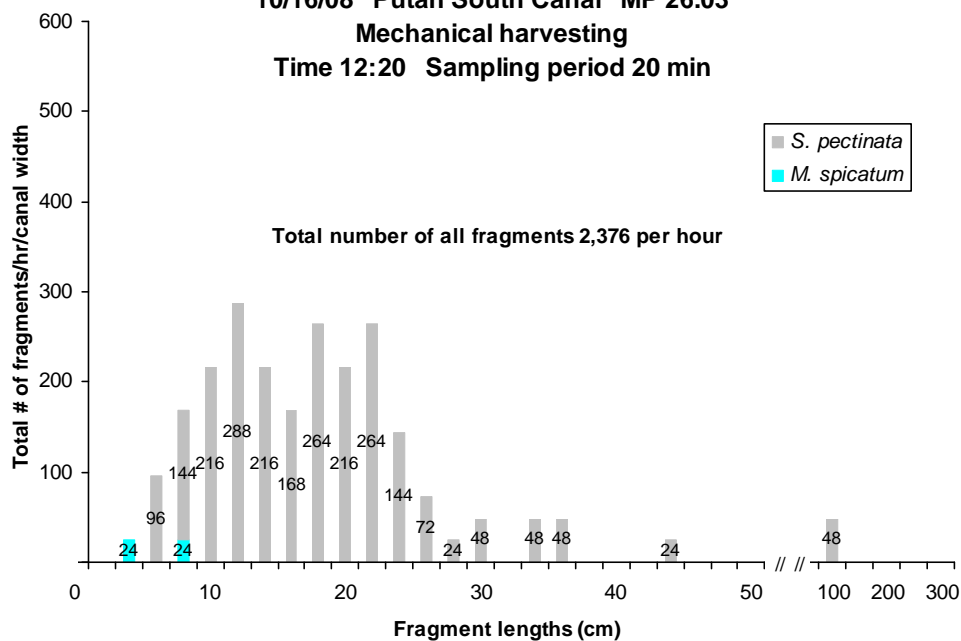
Figure 9.44. Total vegetation influx measured at MP 26.03 (Reach 2) on October 16, 2008 before and during vegetation harvesting.

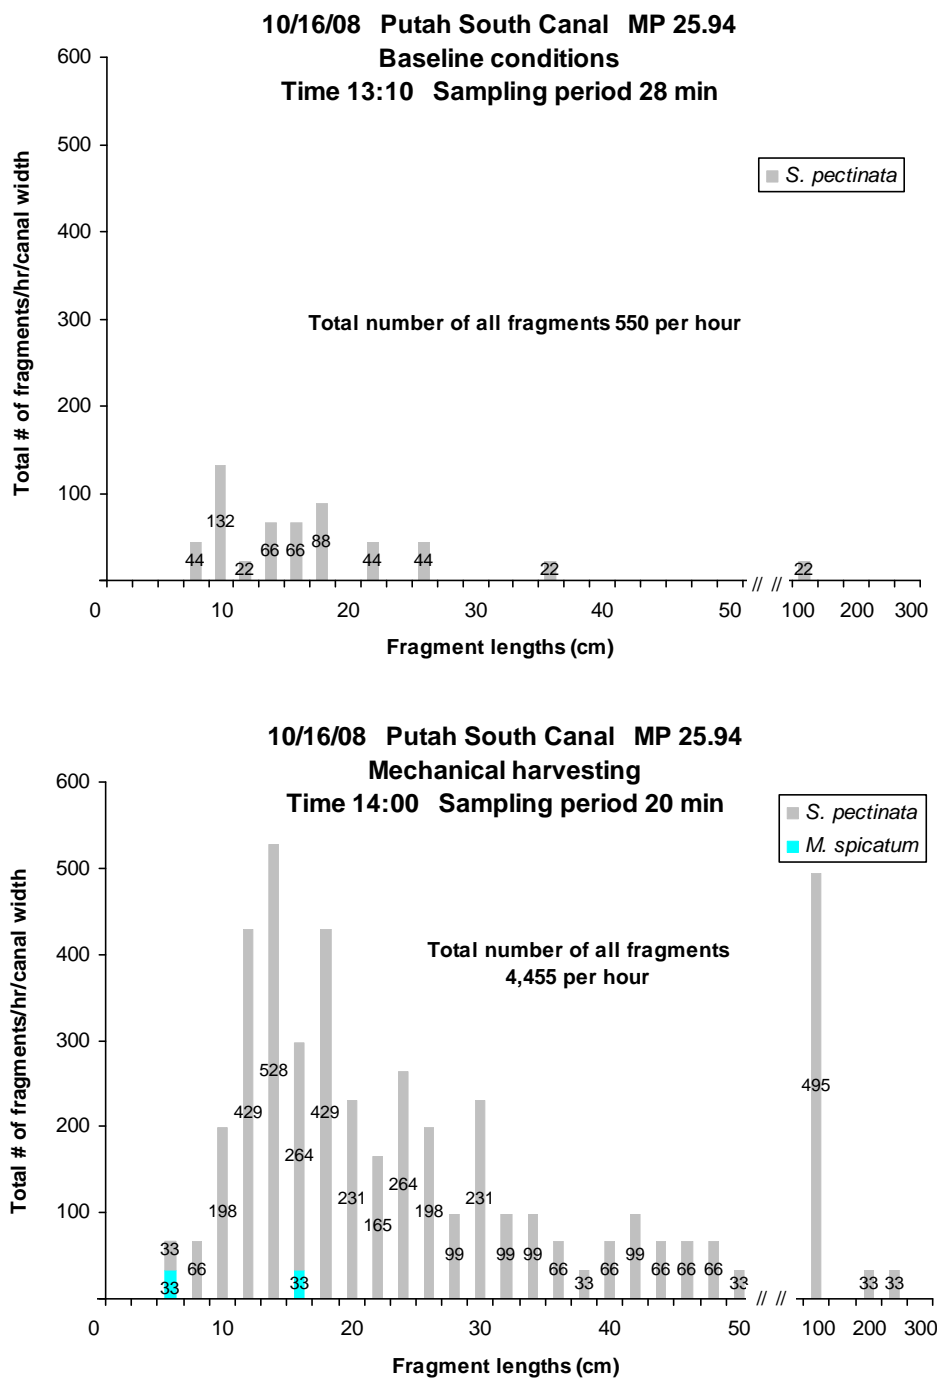
Figure 9.45. Total vegetation influx measured at MP 25.94 (Reach 3) on October 16, 2008 before and during vegetation harvesting.

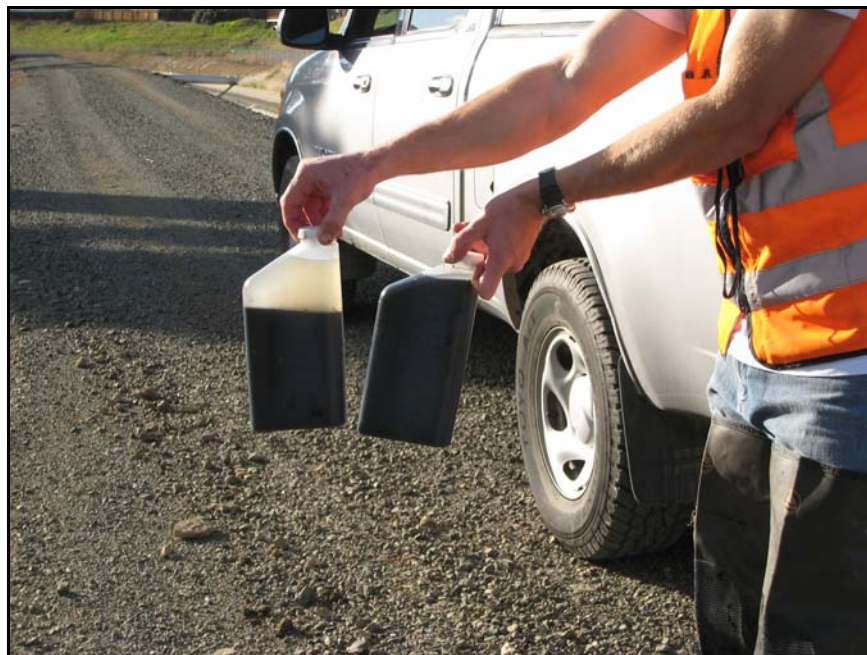
Figure 10.1. Water samples from Putah South Canal collected near water surface during 2007 cleanout. Sample on the right was just collected; sample on the left had settled for about 30 minutes. Both samples contain high concentrations of organic materials with little or no mineral sediment.

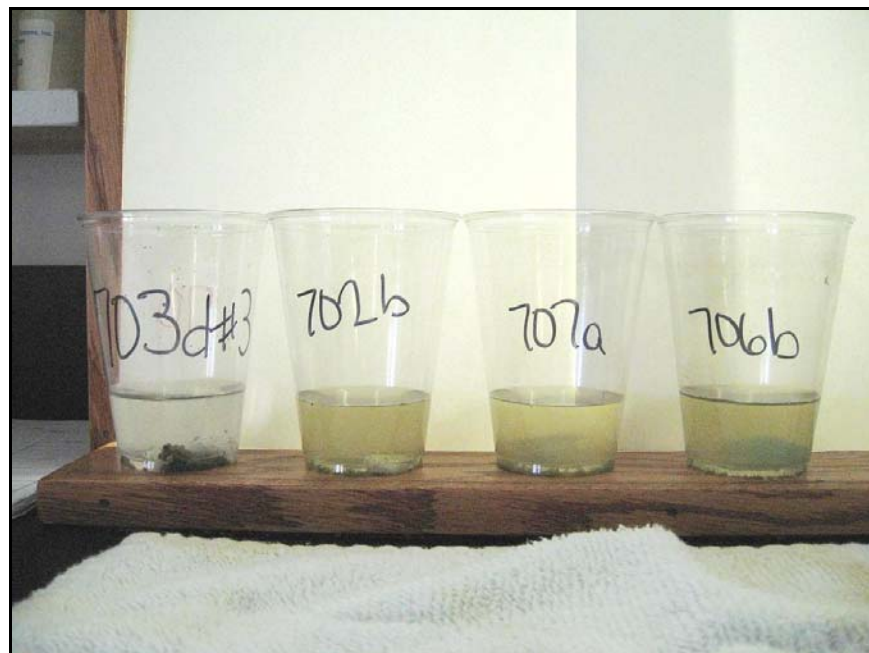
Figure 10.5. Composite water-sediment mixture from Pleasants Creek and Putah South Canal after application of four polymer mixtures. Results from formula 703d#3 are shown in the far left of photo.

These results indicate that proper application of the 703d#3 Floc Log formula in the PSC has potential significant benefits. First, reduction in turbidity would reduce the needs for WTPs shut downs during winter storms and canal cleanout activities. Second, the reduction in phosphates could create phosphorus starved conditions. Since phosphorus is an essential nutrient used by plants to convert light energy to chemical energy during photosynthesis and is important for plant growth, starving (or stripping) the system of phosphorus may reduce the growth of aquatic weeds in the canal.

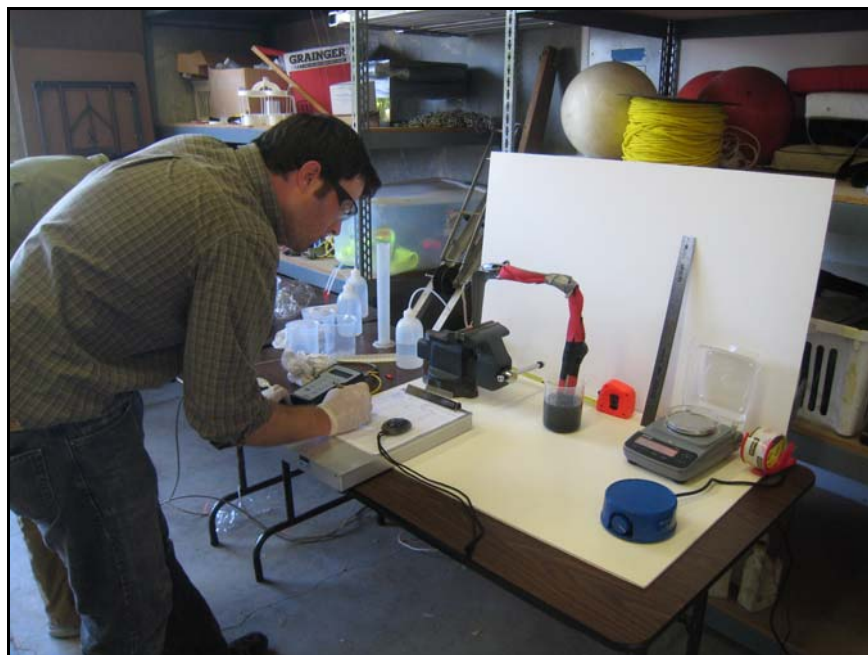
Figure 10.7. Laboratory set-up for NHC bench scale polymer tests.

NHC prepared laboratory equipment and apparatus to test the effects that the polymer would have on PSC sediment settling rates and water clarification (Figure 10.7). A total of seven sediment settling tests were conducted. For each of the seven tests, 30 grams of PSC bottom materials were added to seven 500 mL beakers which were then filled with PSC water to a total volume of 350 mL in each beaker. One beaker sample was used as a control (no polymers added) and the remaining six beakers were used to test the effectiveness of adding the prescribed dose of polymer compound 703d#3 as recommended by APS. The prepared samples were thoroughly mixed on a laboratory mixing table until all of the sludge and sediments materials were in suspension. Initial turbidity readings were recorded at half the depth for each sample. For each of the samples in the polymer test group, 2 grams of the 703d#3 Floc Log material were then added and the contents were remixed. The control and polymer test mixtures were then set aside and allowed to settle. During the settling period, turbidity was recorded every 30 seconds for the control sample and every 10 seconds for the polymer test samples. After the settling tests were completed, the water and materials in the control beaker and the supernatant from each of the polymer test samples were bottled and delivered to Sunland Analytical Lab in Rancho Cordova, CA for suspended sediment analyses.
