9. ASSESSMENT OF ISSUES AND CONCERNS REGARDING AQUATIC VEGETATION IN PUTAH SOUTH CANAL

9.3. Issues and Observations

11. RECOMMENDATIONS FOR MANAGING SEDIMENT AND VEGETATION

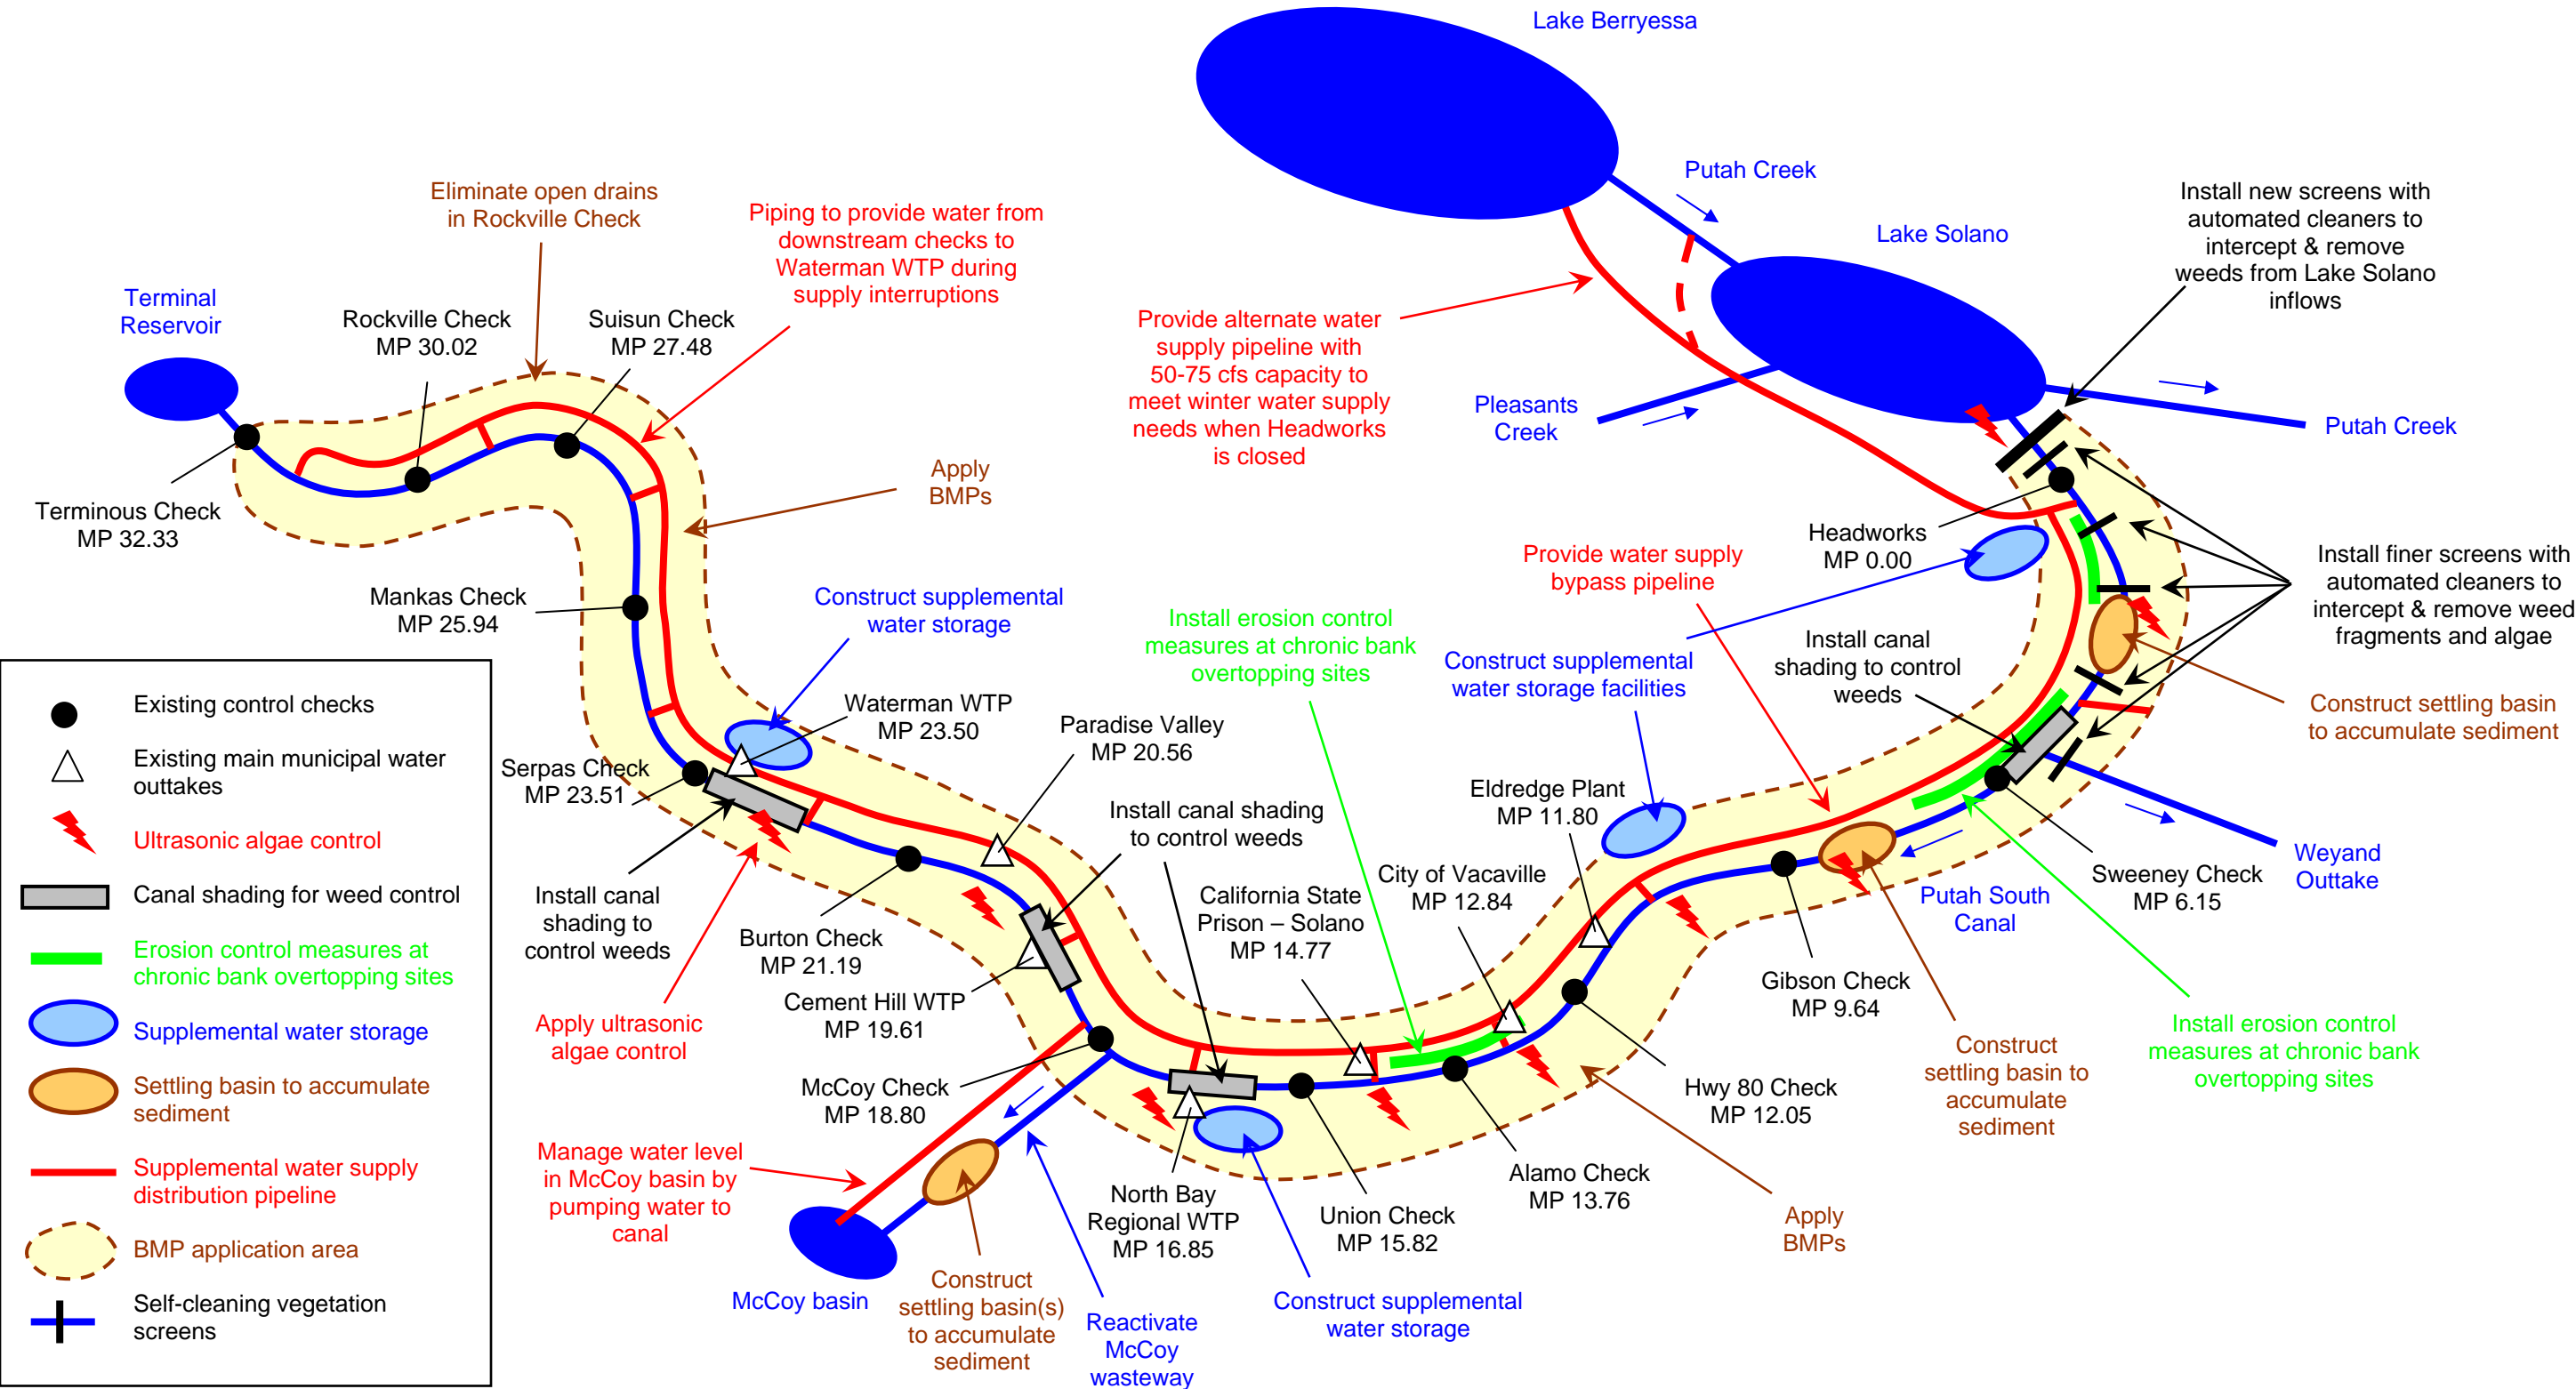
Figure 11.1. Conceptual schematic showing locations of recommended capital improvements to Putah South Canal for sediment, weed, and algae control.

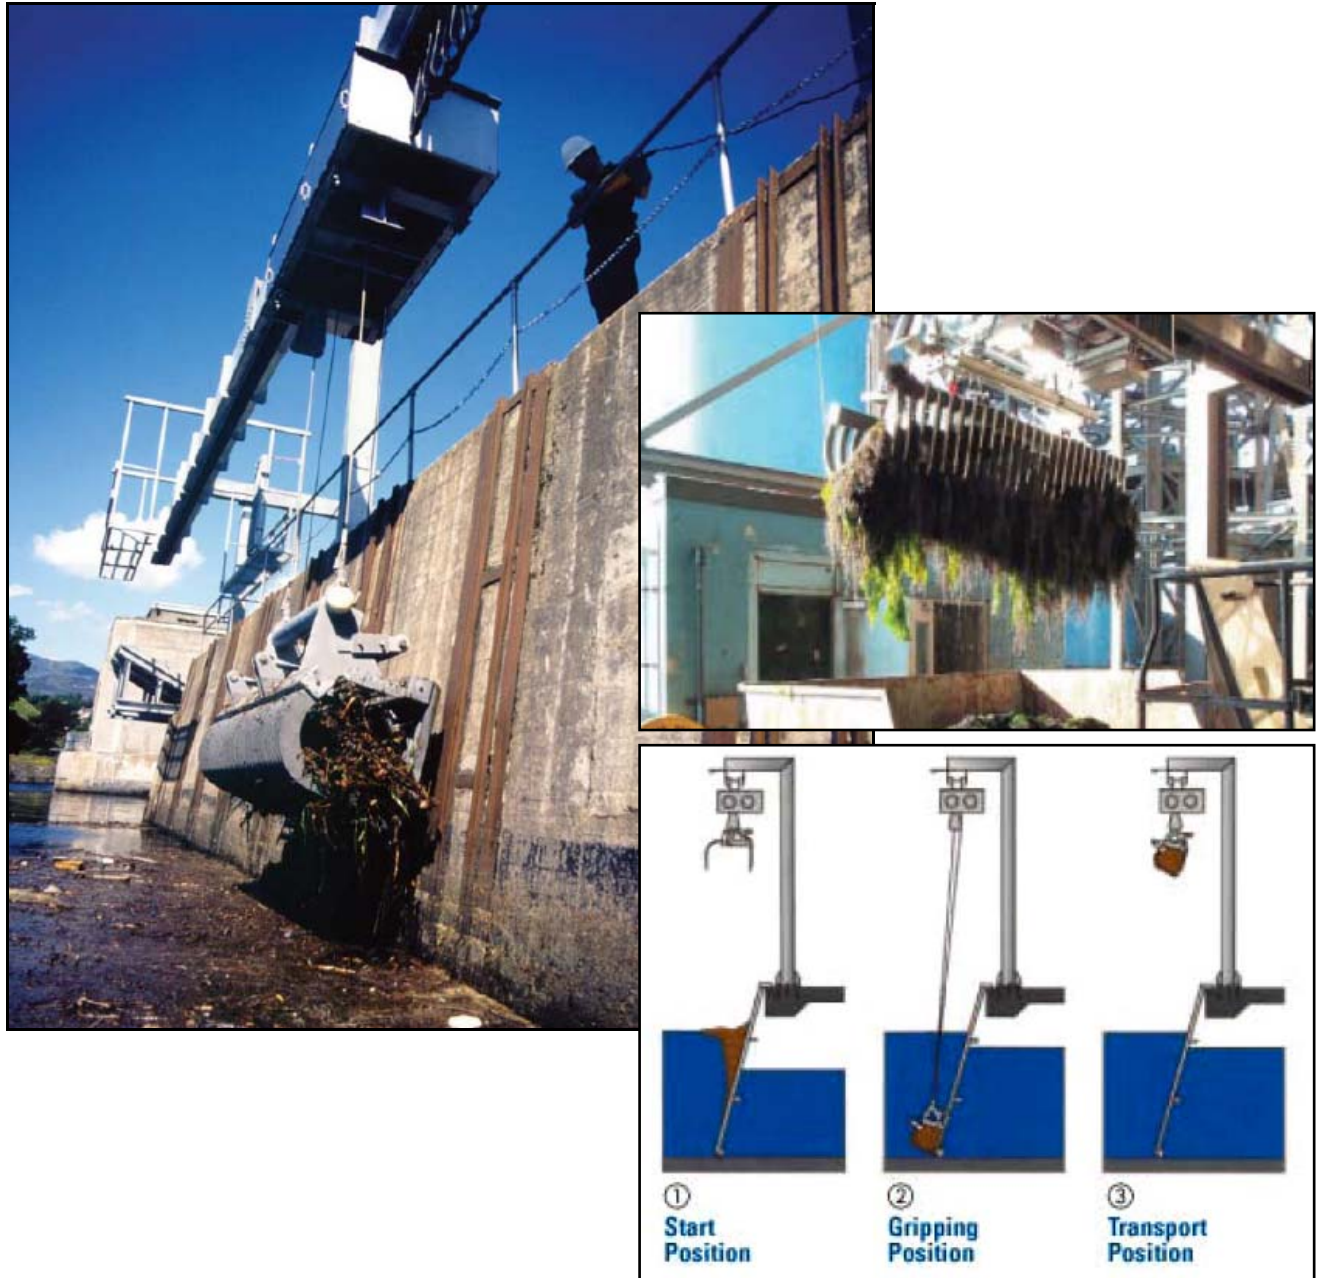
Figure 11.3. Brackett Bosker Raking Machine. Images by Eimco Water Technologies (<http://www.glv.com>).

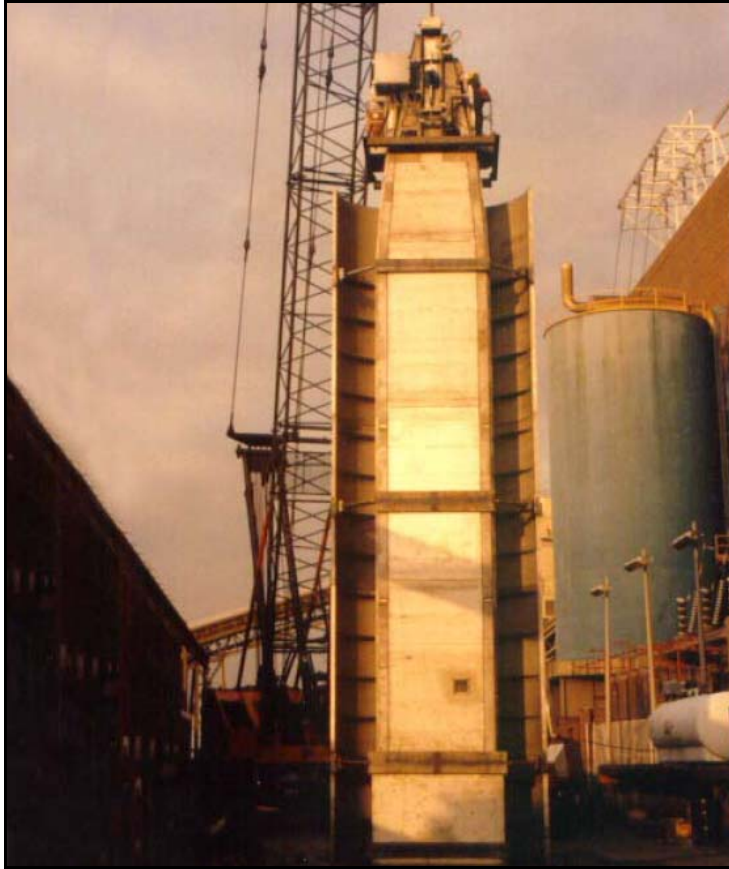
Figure 11.4. Brackett Green Dual Flow Band Screen. Images by Eimco Water Technologies (<http://www.glv.com>).

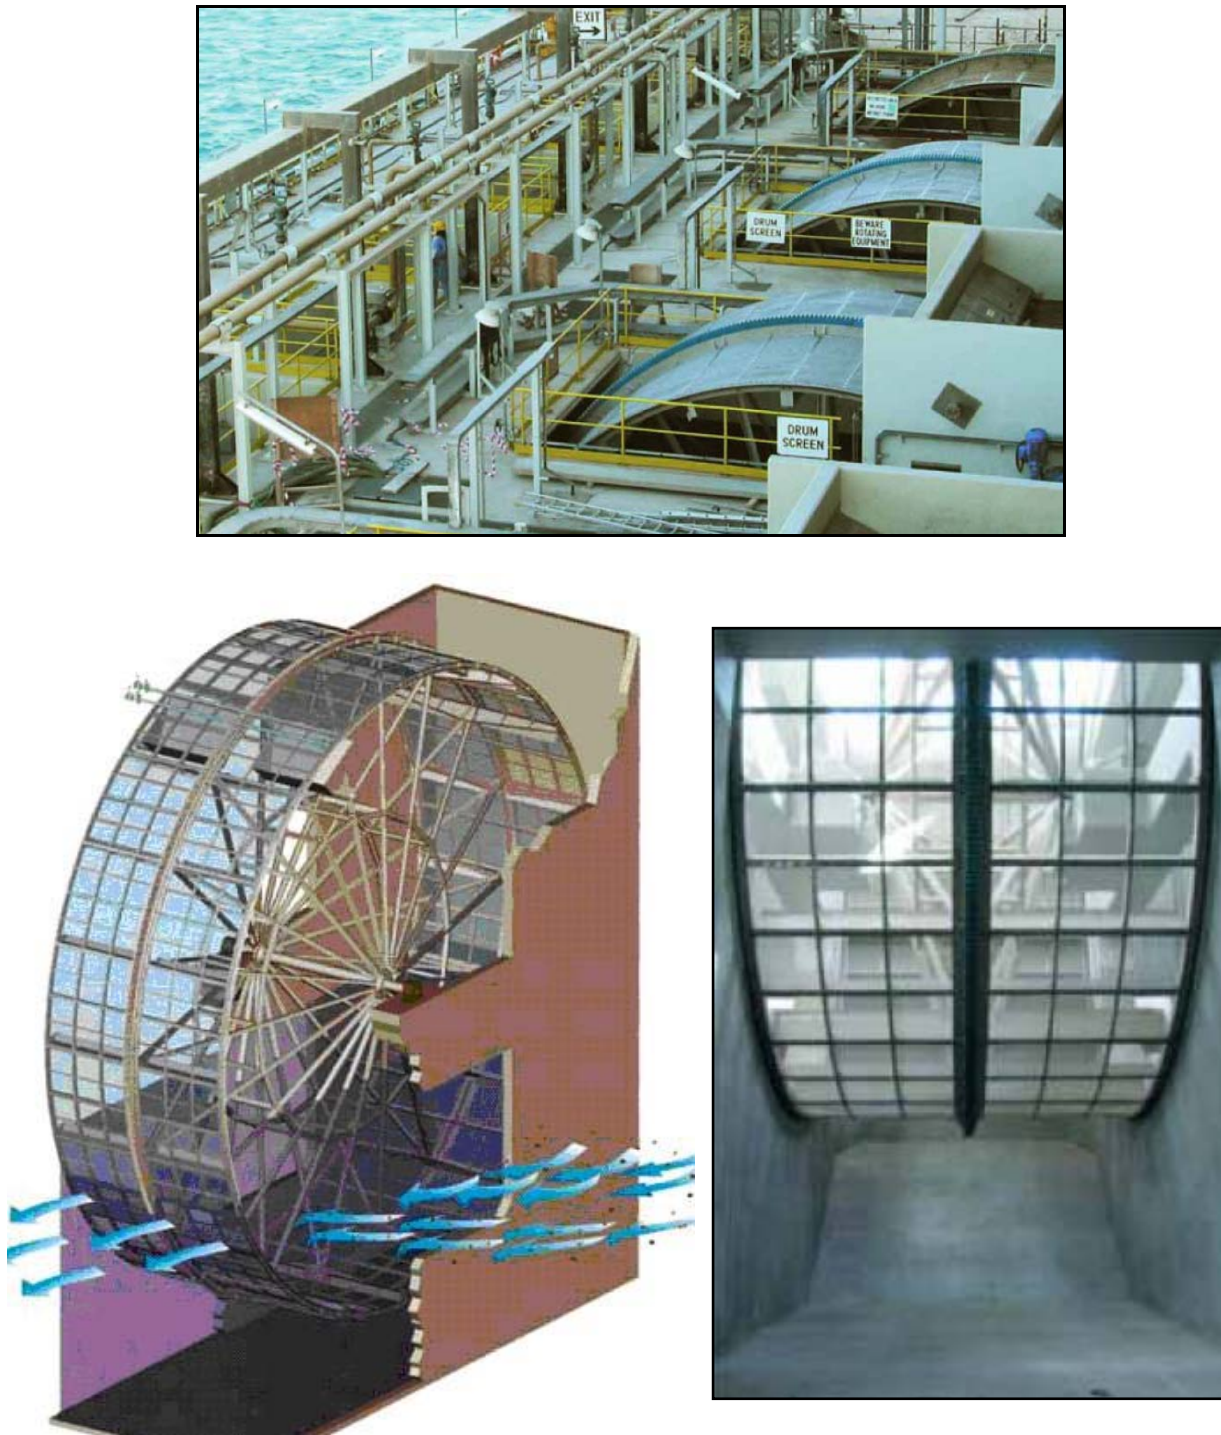
Figure 11.6. Brackett Green Double Entry Drum Screen. Images by Eimco Water Technologies (<http://www.glv.com>).

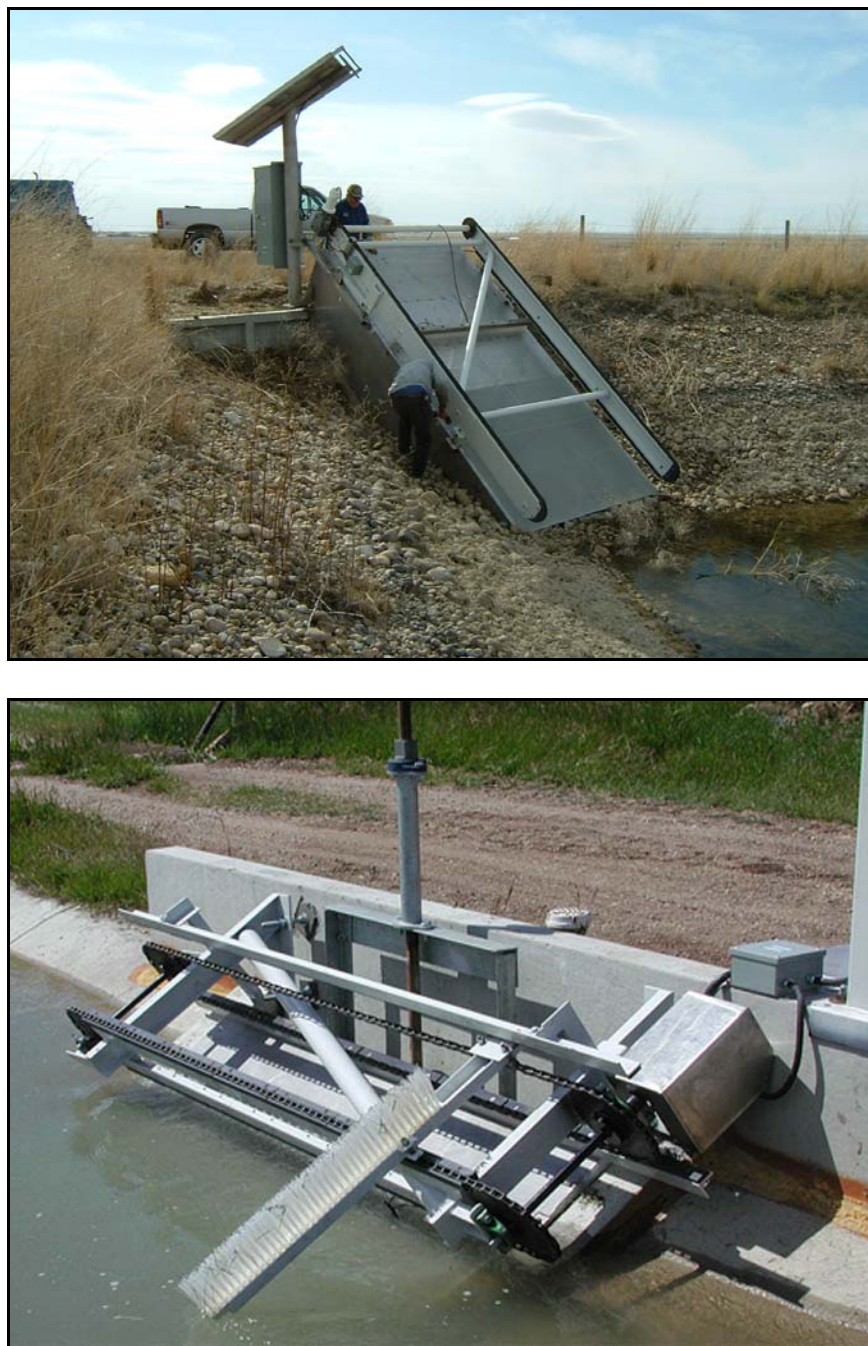
Figure 11.7. Aqua System 2000 Inc. Inline Screen Cleaner (top) and Side Screen Cleaner (bottom). Photos provided by Aqua System 2000 Inc (<http://www.aquasystems2000.com>).

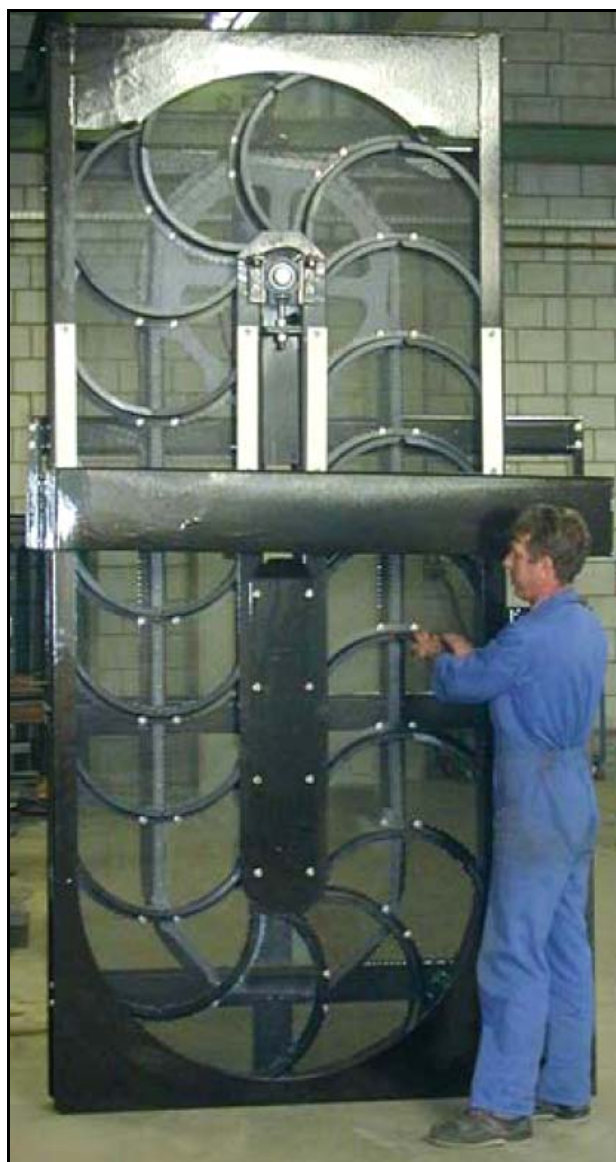
Figure 11.8. MultiDisc Fine Screen. Images by Infilco Degremont Inc. (<http://www.degremont-technologies.com/>).

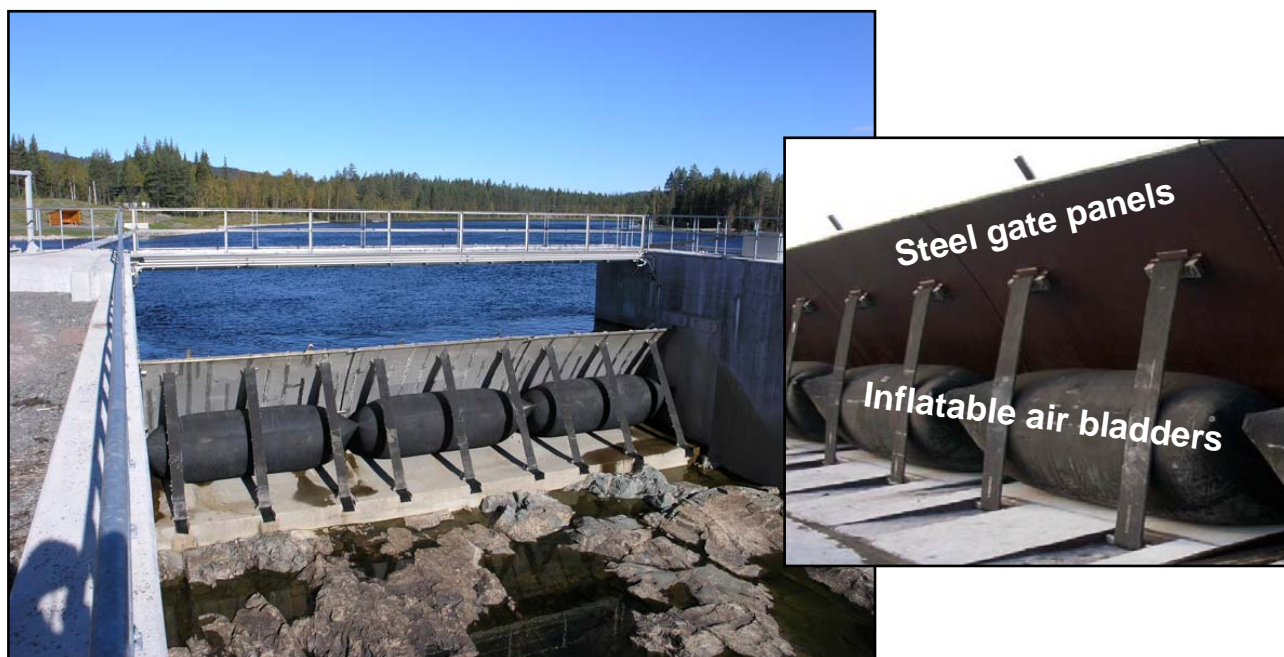
Figure 11.13. Obermeyer spillway gates. Photos from <http://www.obermeyerhydro.com> and <http://www.dyrhoff.co.uk>.

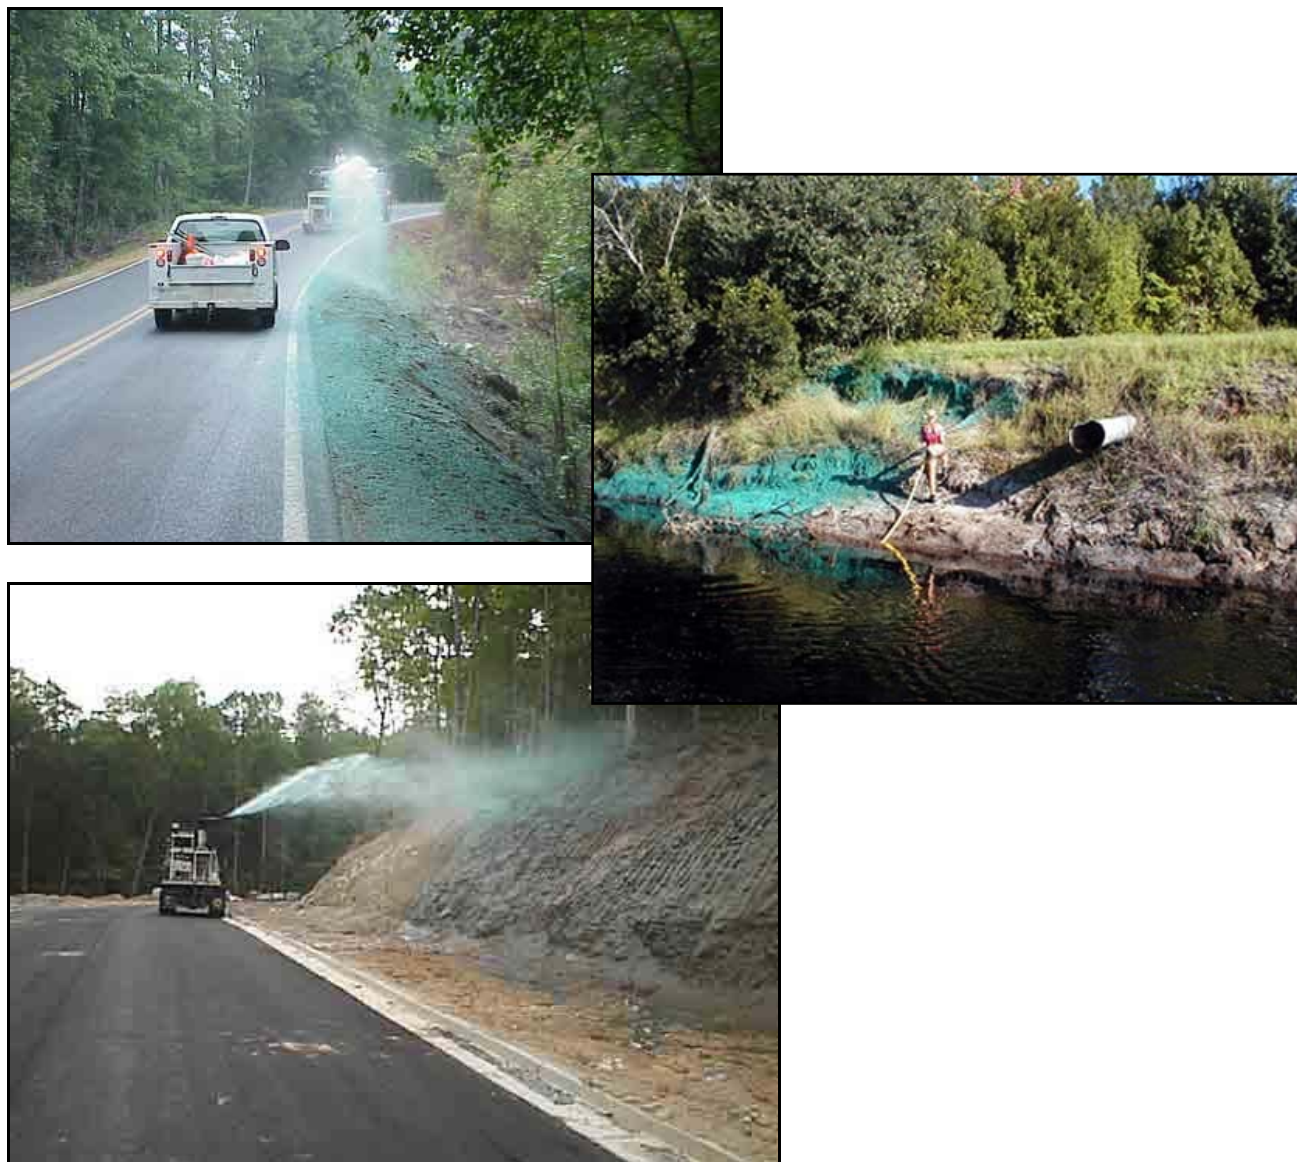
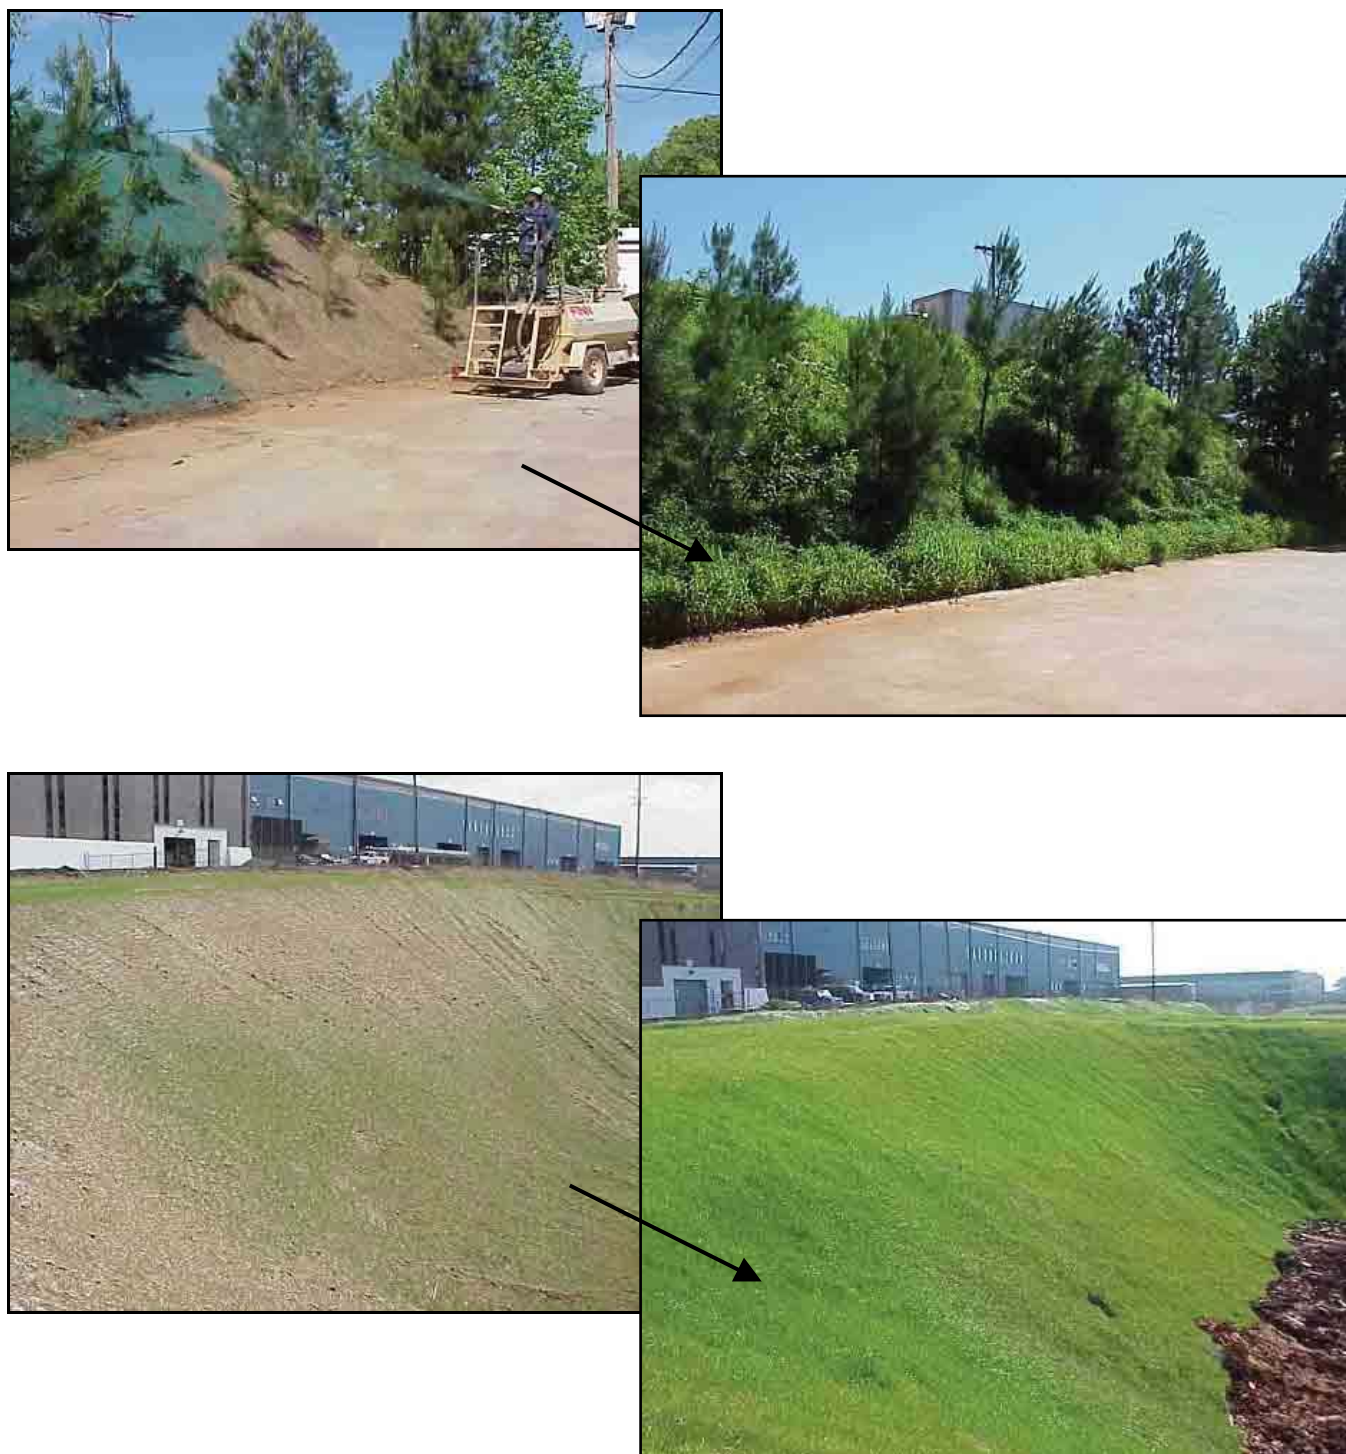
Figure 11.18. Application of polymers for erosion control. Photos from <http://www.siltstop.com>.

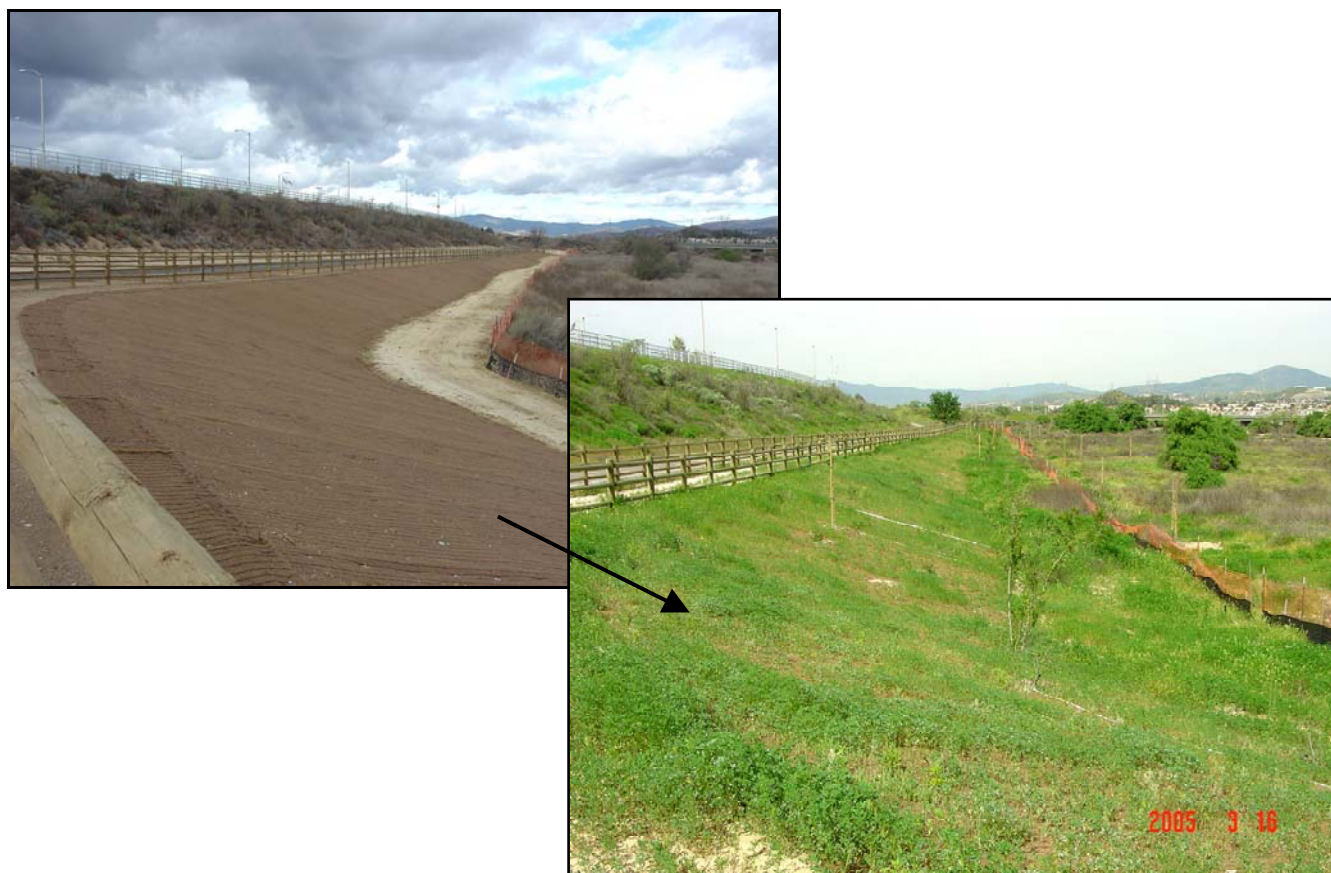
Figure 11.19. Turf Reinforcement Mats applications. Images provided by Propex Geosynthetics (<http://www.propexinc.com>)

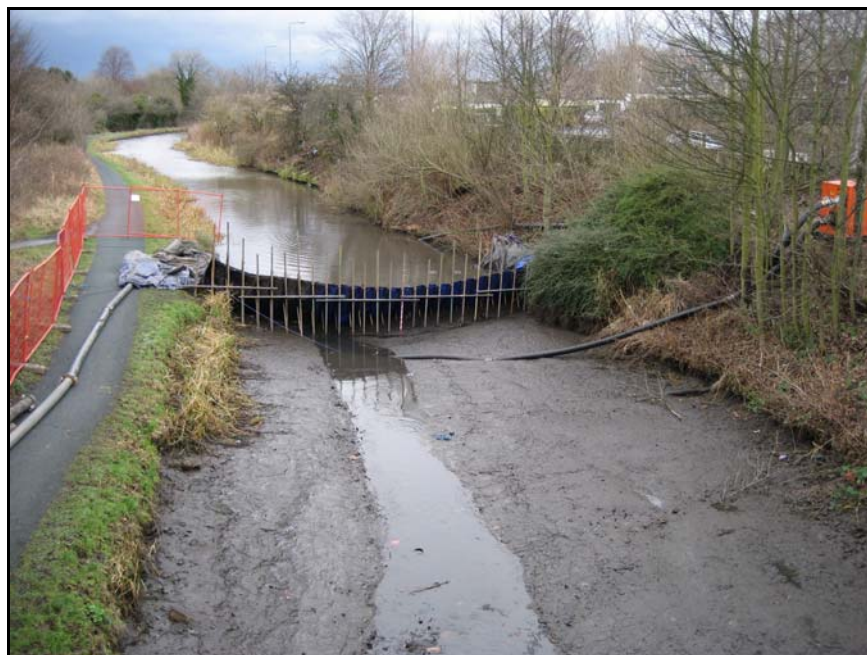
Figure 11.21. De-watering of isolated section of Union Canal, Edinburgh, Scotland. Photo of January 13, 2008. Water is pumped around isolated section. View downstream.

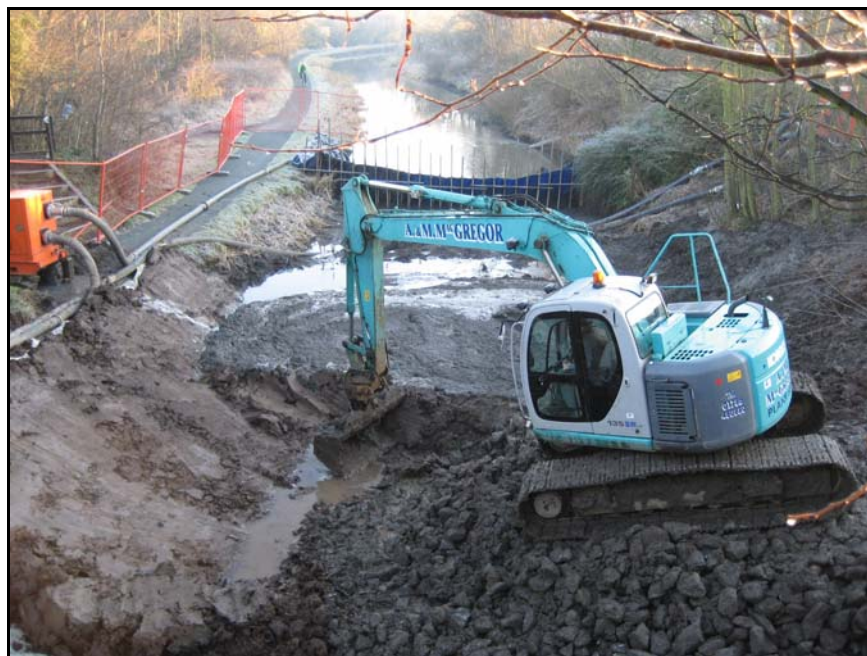
Figure 11.22. Mechanical removal of sediment from isolated section of Union Canal, Edinburgh, Scotland. View downstream. Photo of February 12, 2008.
