APPENDIX B

RE: Task 3.1a Deliverable. BMP Evaluation Matrix

RE: Status of BMPs Recommended for Application in August 22, 2008 Letter

Interim Protocol for Reducing Suspended Sediment into the PSC from the Headworks during Large Storm Events

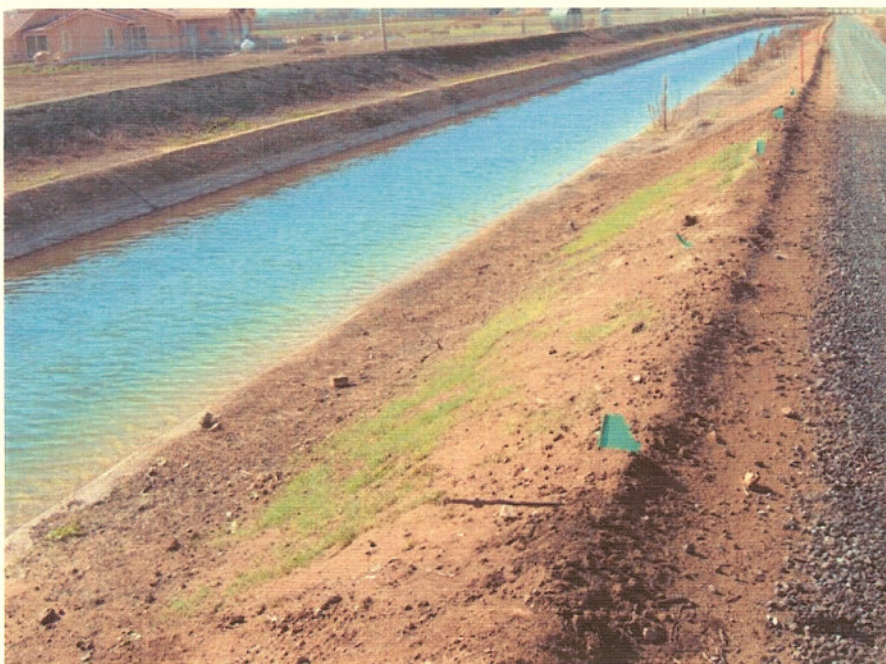
**Mankas Drain (east side of Suisun Valley), February 2, 2009.
Preliminary Results of Seed Mix Trials. February 2, 2009.**

Currently, a pilot study is being conducted by Hydro Science and **nbc** to assess which of five grass mixes gives the best results. Nine test sites have been seeded. Each site consists of five 10 foot-wide plots, each seeded to a different grass mix. Because of the severely dry winter, the germination rates have been lower than normal. Pending the outcome of the trials, some consideration for extending the trials another year might be advantageous if it appears that the results are biased by the early dry conditions which may have suppressed germination of species that might otherwise offer good results. The plots were briefly watered by pumping out of the canal the on February 2. Current results and some selected photographs are attached.

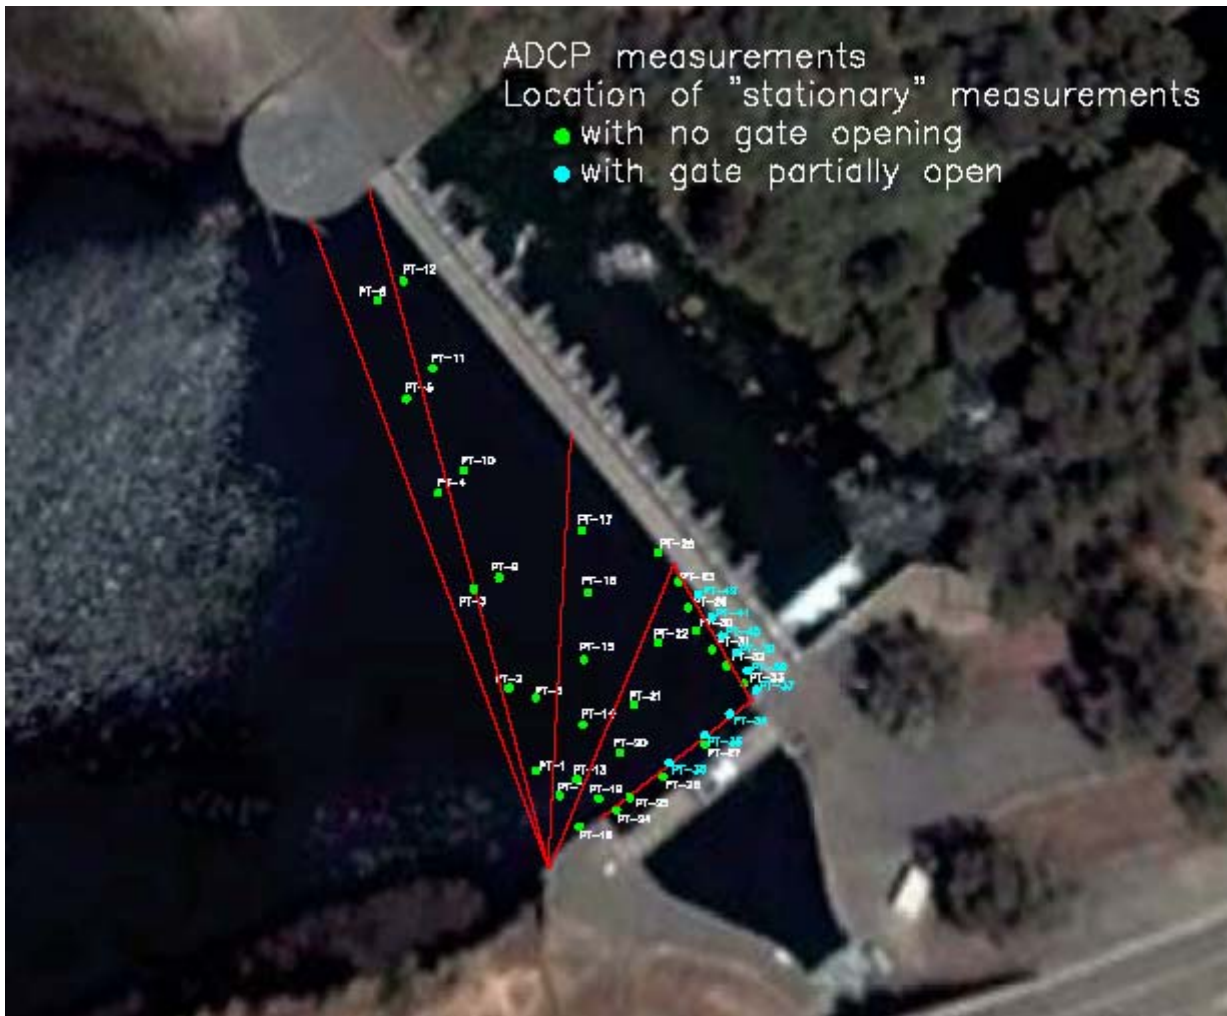
Figure C-6.1.1 showing locations along the six in-lake transects where stationary velocity profile measurements were measured with the ADCP.

The following pages contain plots, for each transect, the velocity magnitude profiles extracted from the collection software (WinRiver) and the vertical distribution plots. The profiles have been generated with 3 Ensembles averaged.

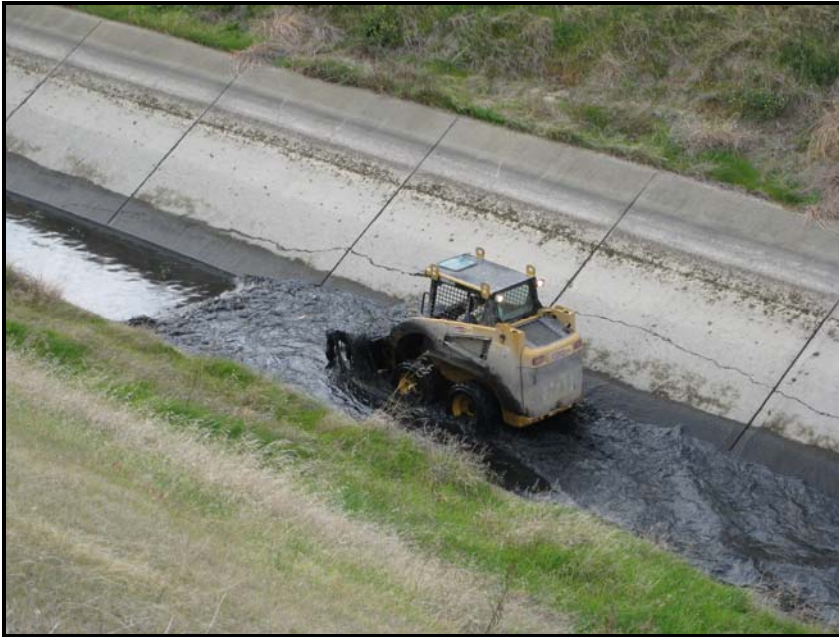
Figure E-10.3.1 Photo of Bobcat scooping up vegetation and settled materials in PSC during 2007 cleanout operations.

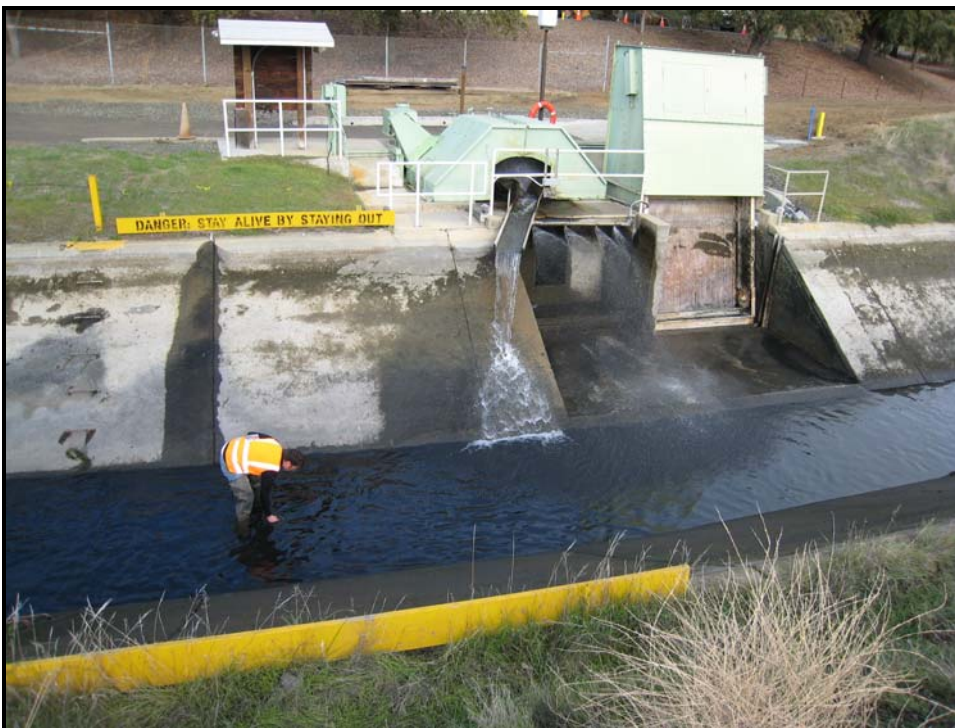
Figure E-10.3.4 Water sample being collected next to Waterman Treatment Plant Intake on November 19, 2007.

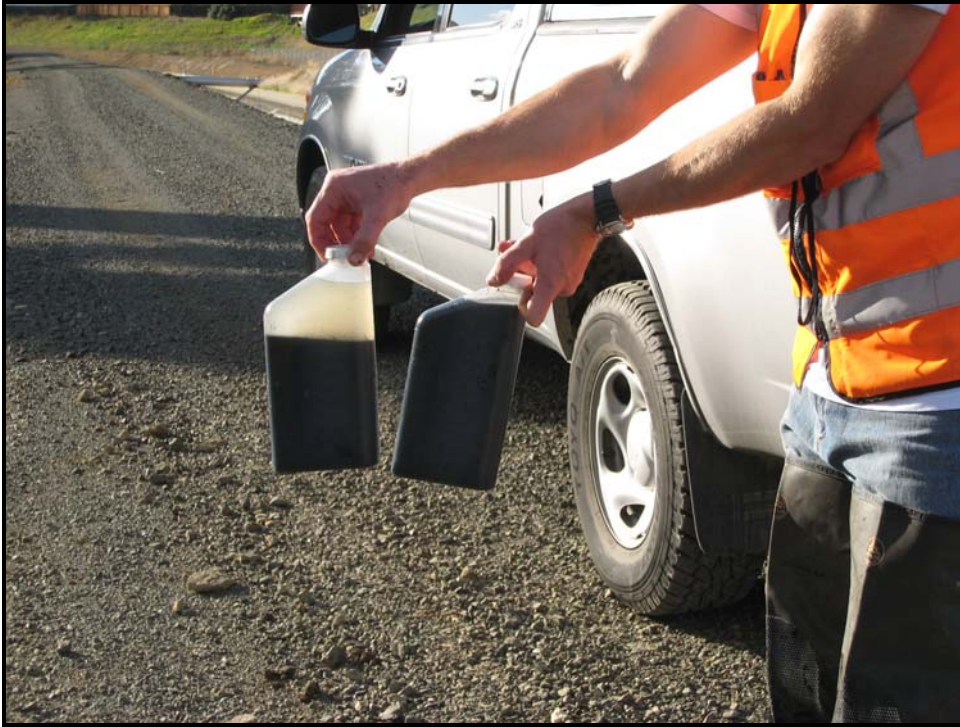
Figure E-10.3.5 Water samples from canal during cleanout. Bottle on the right was just collected; sample on the left had settled for about 30 minutes. Both contain high concentrations of organic materials with little or no sediment.
