Pleasant Creek Rock Vane Stabilization/Revegetation Project

Final Report: G/L Account #: 6140SC

May 28, 2021

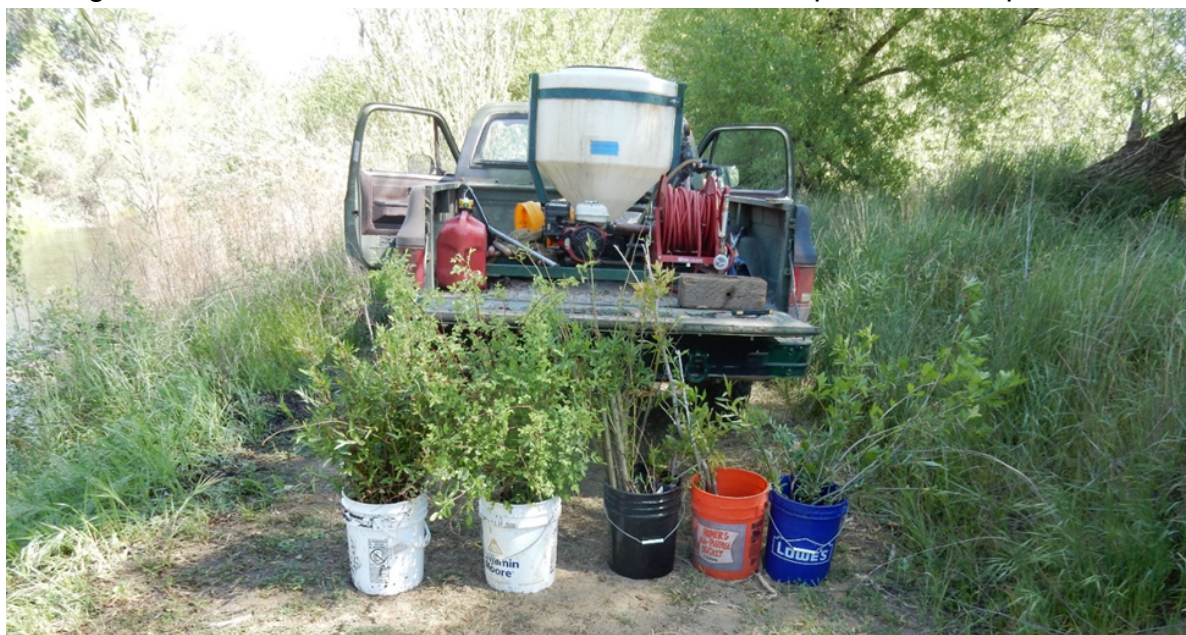
Figure 3. Special techniques enabled planting of 295 plants into 8 vanes on the Lopez property in one afternoon.

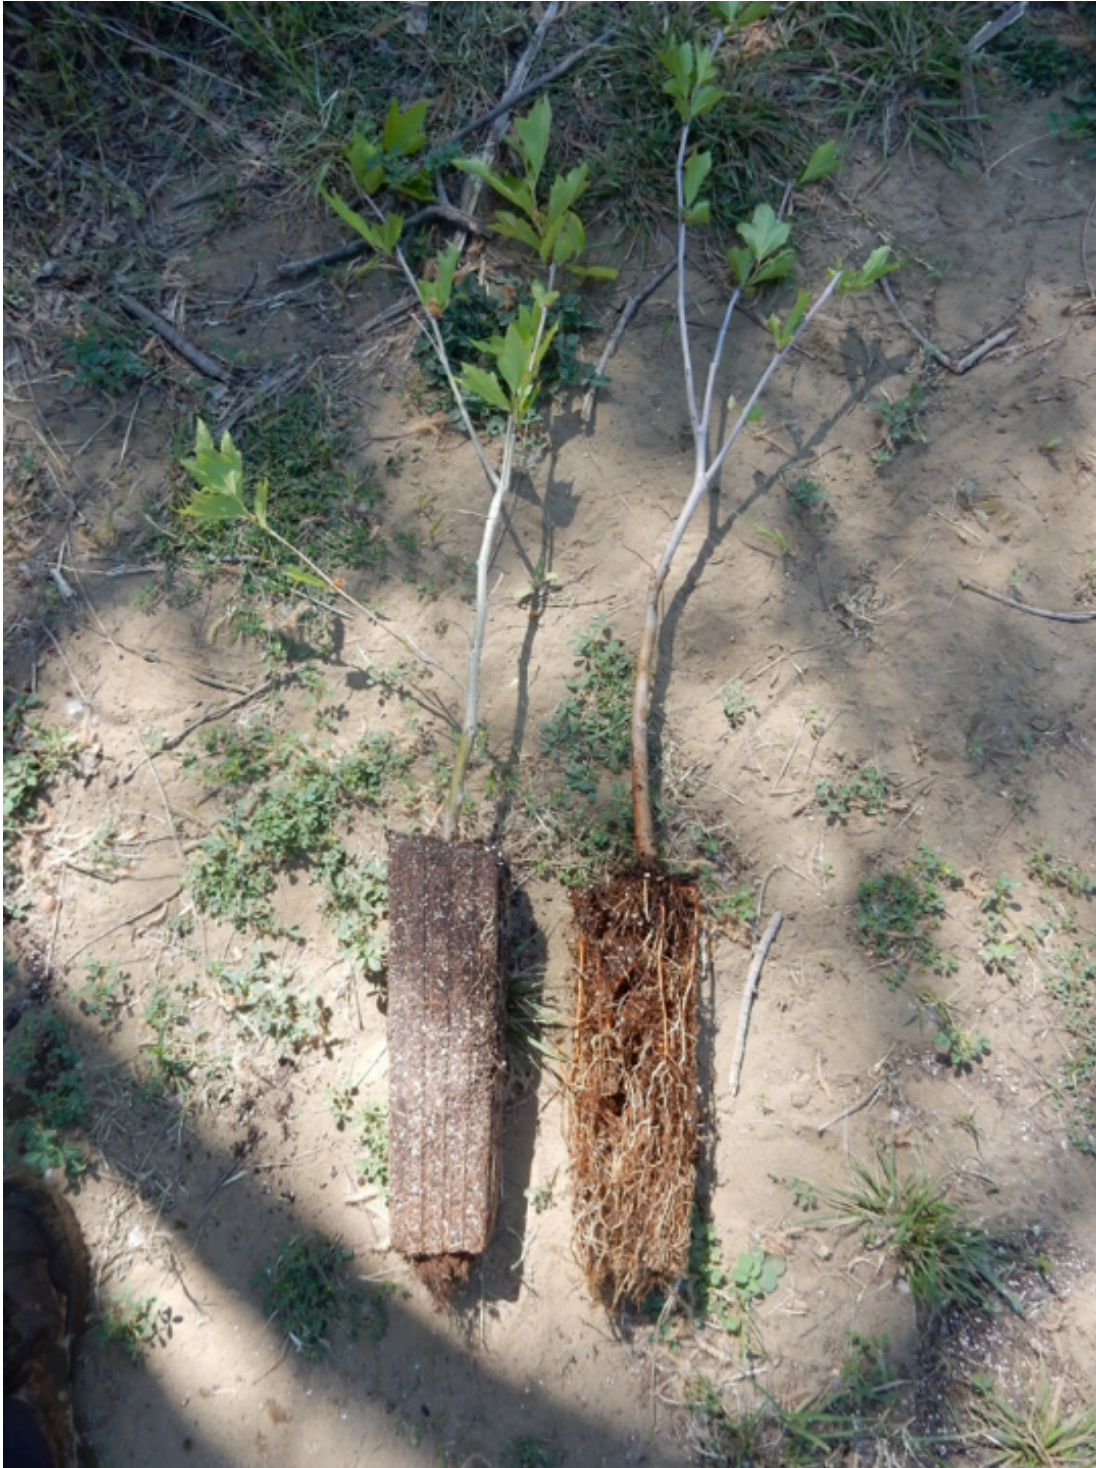
Figure 4. Rinsing the soil from the roots substantially reduces the weight which improves planting efficiency and makes the root ball more malleable when planting among rocks.

There are many advantages to using the root-rinsing technique as it allows the ability to densely pack a bucket with an entire series of plants for efficiently transporting the day's materials needed for multiple vanes. Another benefit is that when the root ball is free of soil it is more malleable which made it easier to fit into the many irregular shaped holes that needed to fit between boulders. Removing the soil also helps to reduce introduction of unintended weed species that are sometimes growing in the pots. In the nursery, potting mixes are designed to be well drained but

potting mix around the roots is somewhat of a liability in the field due to the sudden transition from potting mix to native soil. Bare root plants are immediately in contact with native soil with no soil-texture barriers to delay rooting. Virtually all forestry plantings are established with bare-root seedlings likely for all of these reasons.

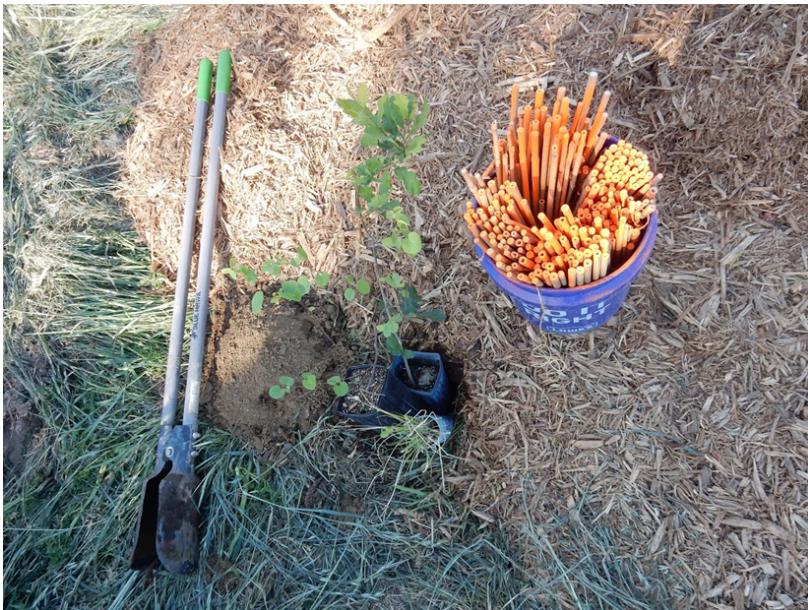
Figure 5. These orange bamboo stakes were used to mark where plants are installed in the vanes. Post hole diggers are NOT recommended for planting in the channel.

After the planting effort was completed in early May, the post-planting follow up evaluation was used to assess plant survival to determine the effectiveness of the plantings. It is a good sign if a plant survives the first few weeks after it is transferred from nursery care into the ground. It means that there was sufficient moisture to ensure it can begin the process of establishing its roots. Each live plant was marked with a short bamboo stake painted with non-toxic orange paint so that it may be possible to revisit the sites and assess survival at a later date (Fig 5).

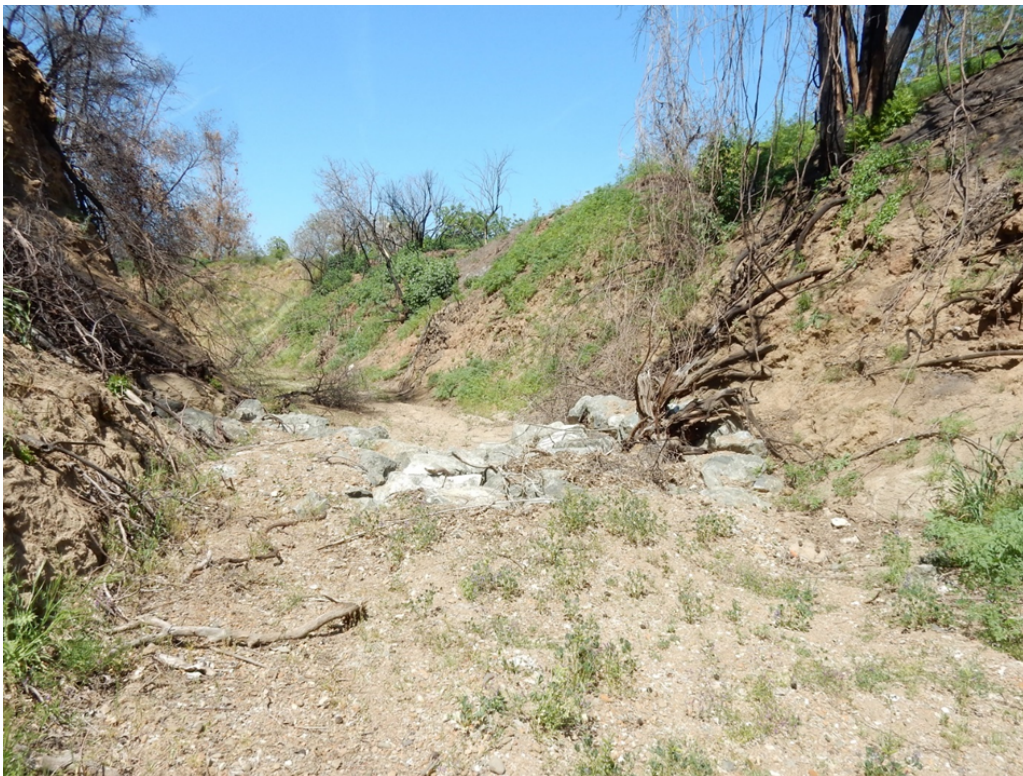
Figure 6. An example of a dry rock vane on the Flaherty property that did not have enough moisture to support rooted plants, especially considering there is no ability to water the plants. 10 dry vanes received only native grass seed at this time of year.

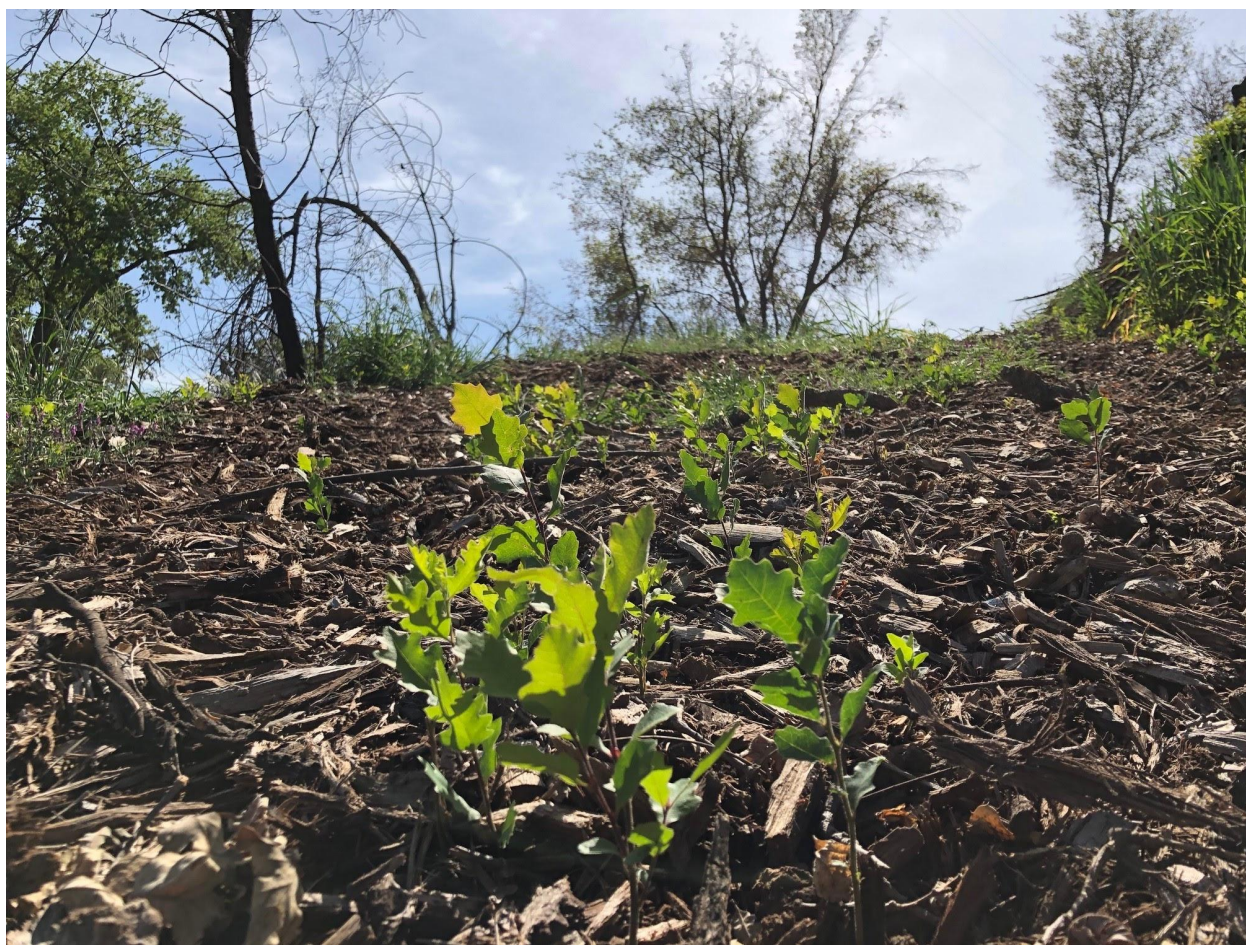
Figure 8. Woodchips promote plant growth. Oak seedlings found emerging from woodchips that were placed under an oak on what was a pulverized road surface.

The use of woodchips has many benefits. Spreading chips during or after construction will help to reduce soil movement and can promote plant growth (Fig 8). Chips help to retain soil moisture, promote biological activity, reduce the soil temperature, and improve the soil as they break down through the years. Under certain conditions chips have the ability to reduce erosion by binding the chips and soil together by promoting fungal growth.
