December 16, 2014

From: Ken W. Davis, Aquatic biologist

Re: Lower Putah Creek Scarification - Observations and Images

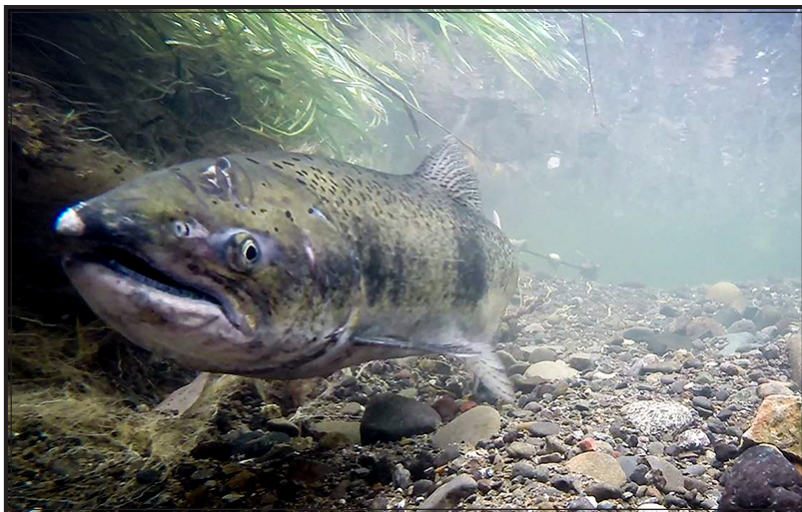
Female salmon moving under the cover of a riparian sedge. Image from video taken 12/8/2014.

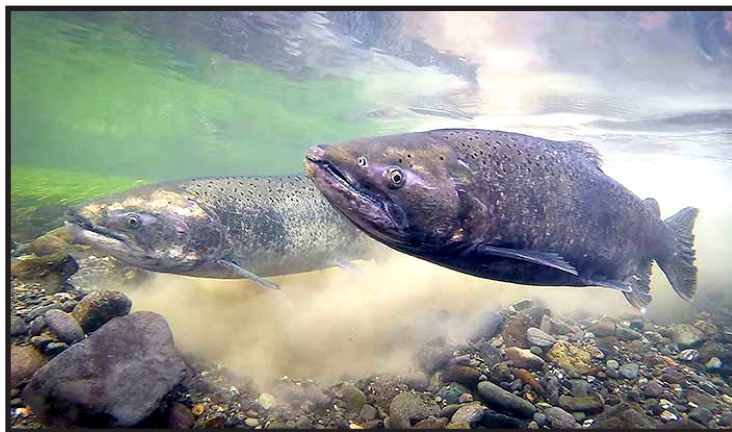
Chinook salmon spawning on 12/7/14

Invasive aquatic vegetation control: To my knowledge of the scarification sites which I routinely visit, there was no removal of aquatic vegetation from Lower Putah Creek. Section 1 (control site with no scour) does have a significant population of aquatic vegetation which remains. Aquatic vegetation is visible in the background (middle left) of the image. The spawning salmon did dislodge some vegetation during the redd-building process.
