Re: **Mertz Dam and Potential “New” Spawning Sections in Lower Putah Creek**

## REPORT 5478

### Lower Putah Creek

Mertz Dam & Exposed Gravelbeds

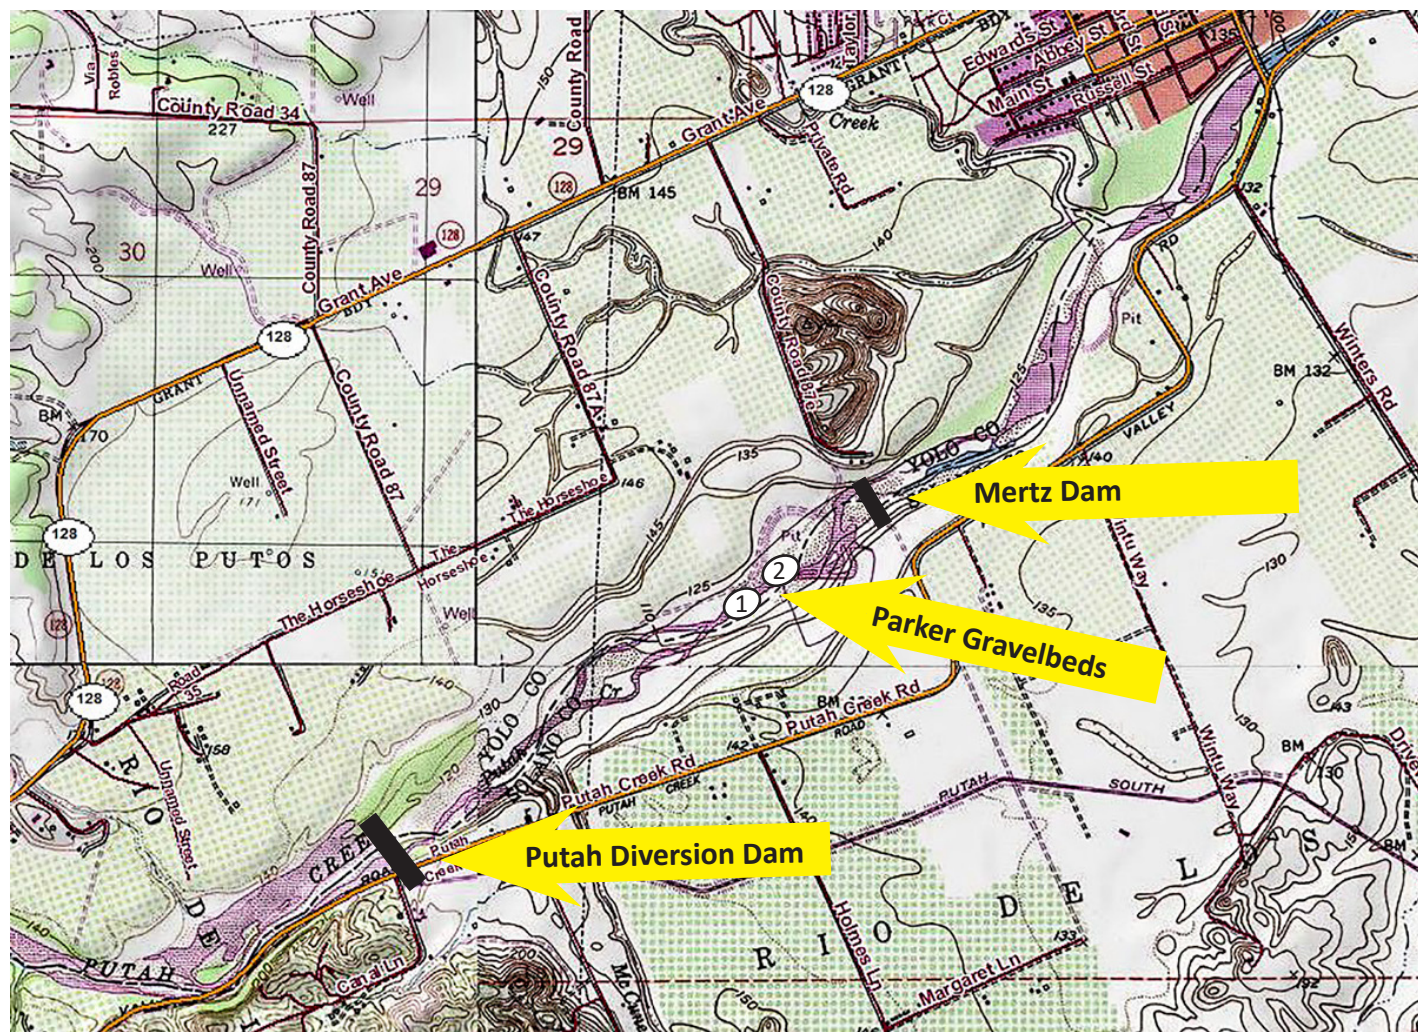
#### Low Water Exposed Gravel Beds at Parker - GPS Data (WGS-84)

See Page 4 for information and an image showing one of two sites that are now visible due to the apparent breach of the Mertz Dam. Both sites deserve consideration for gravelbed scarification in 2017.

Parker 1	N	38° 30' 07"	W	121° 59' 23"
Parker 2	N	38° 30' 9.3"	W	121° 59' 20.5"
