February 24, 2015

Subject: Putah Creek Fish Video Project - 2014 Salmon Run

REPORT 4963 2014 Putah Salmon Run

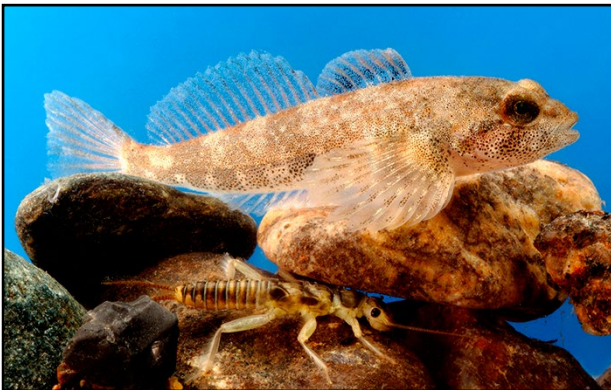
Benthic invertebrate (stonefly) hiding under rock.

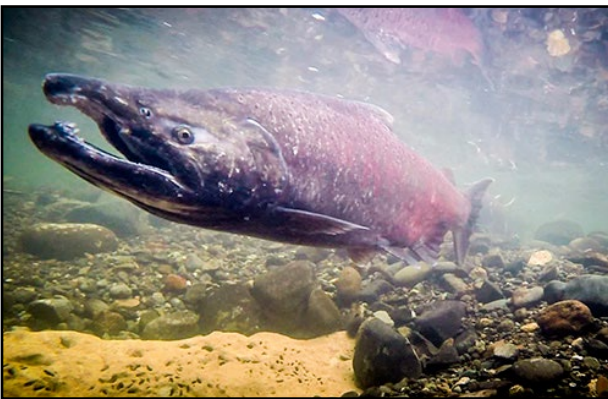
Magnificent male that courted females in the Scarification Control Section.

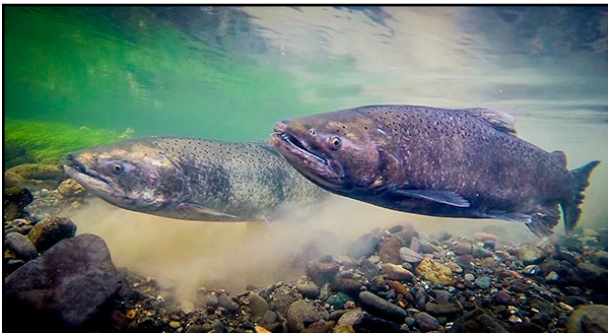
Chinooks paired on Scarification Control Section

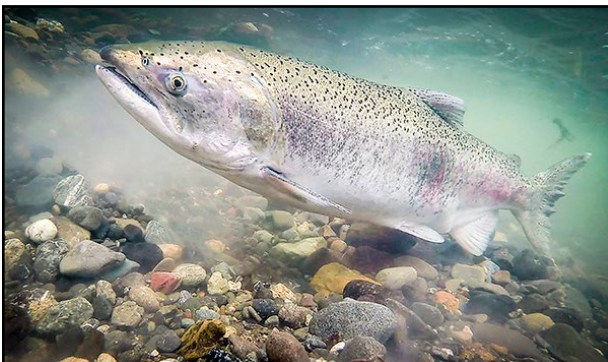
Female Chinook resting after digging a deep redd on Scarification Section No. 5.

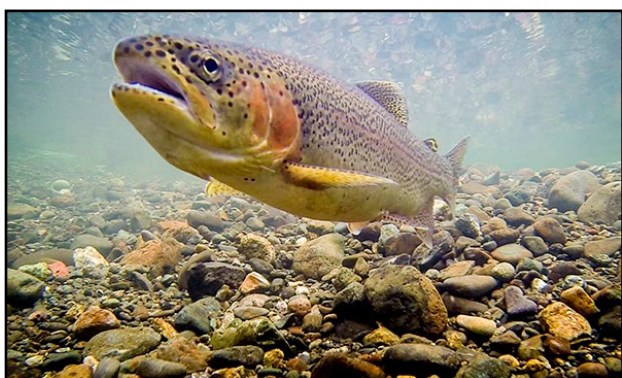
Female rainbow trout above her redd near the Harris property line.

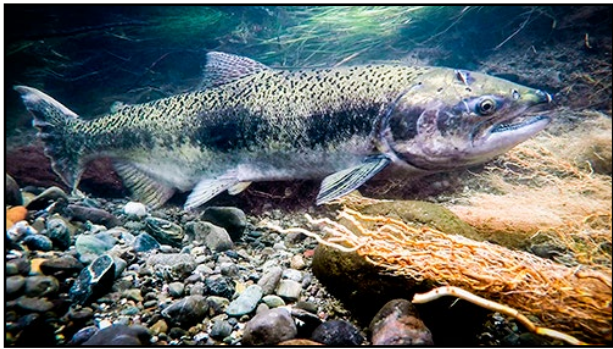
Salmon moving under overhanging vegetation in North Pickerel side channel. 12/10/14

Of particular interest is that behavior used by the fish when they moved upstream near the banks and under the overhanging vegetation. The upper canopy is rather sparse in this area.

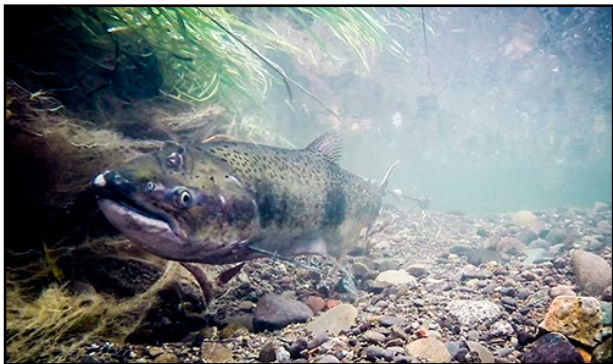
Female Chinook resting in area underneath overhanging vegetation in Pickerel North Side Channel.

The female on the left would rest in a section immediately below her redd and appeared to dig into the bank to enlarge her hiding site. She favored the section which had over-hanging vegetation.

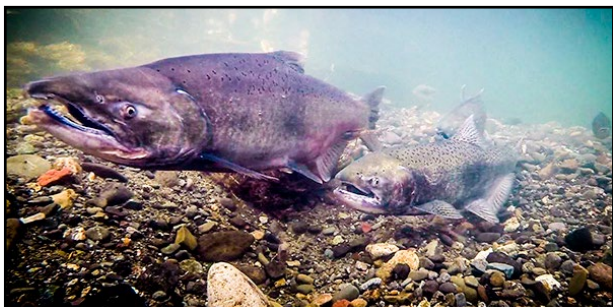
Paired salmon on Scarification Section No 6. Additional case showing large (normal size) male and 18 inch female

The salmon heavily favored the sections that were scarified. That includes the pair on the left that successfully spawning in Scarified Section # 6. Note the size differential between the sexes. Male on left, female on right.

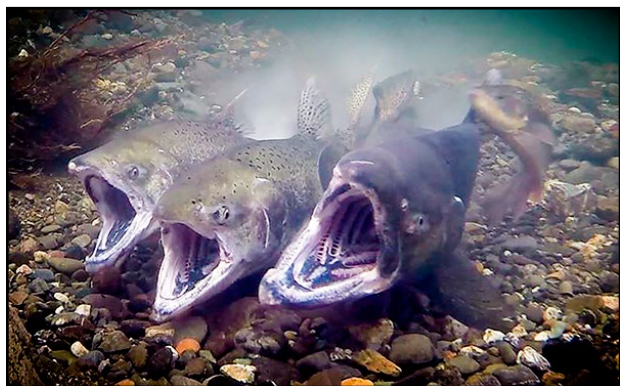
Salmon spawning in Scarification Section Number 6.

Salmon spawned on every Scarified Section. This video was captured on Scarification Section 6.

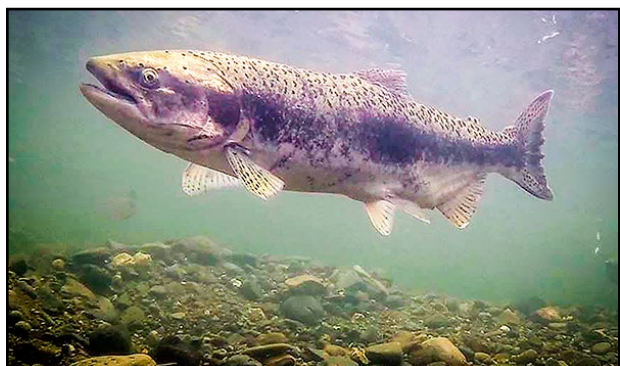
18 inch female Chinook at Scarification Section 3.

Small salmon, 15 to 18 inches in length, were common in some areas of the scarified sections. Typically, these small fish are 1-2 year males. I asked Peter Moyle to look at this situation and comment on the observation that these small females were digging redds (only female action) and being courted by normal size males. Dr. Moyle witnessed this occurrence.

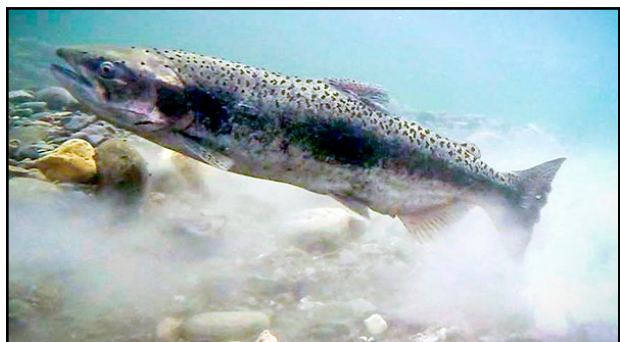
18 inch female Chinook after digging redd at Section 3.

The small females actively dug redds in the Scarified Sections of the creek.

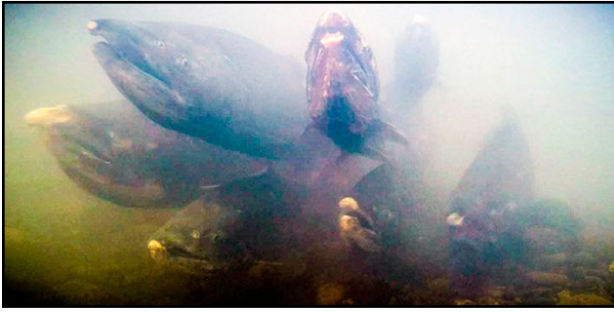
Gang of Seven. Beat-up, highly scarred salmon that were part of a run that came up the creek after the second storm. They settled on Scarification Section 4 on 12/ xxx/14.

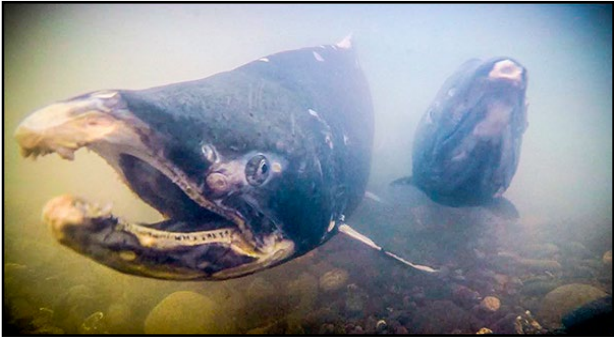
Beat-up, highly scarred salmon that were part of a run that came up the creek after the second storm.
