Watershed Emergency Response Team Evaluation
LNU LIGHTNING COMPLEX
HENNESSEY FIRE

CA-LNU-013407

October 8, 2020

LNU LIGHTNING COMPLEX (HENNESSEY FIRE)
Watershed Emergency Response Team EVALUATION
October 8, 2020

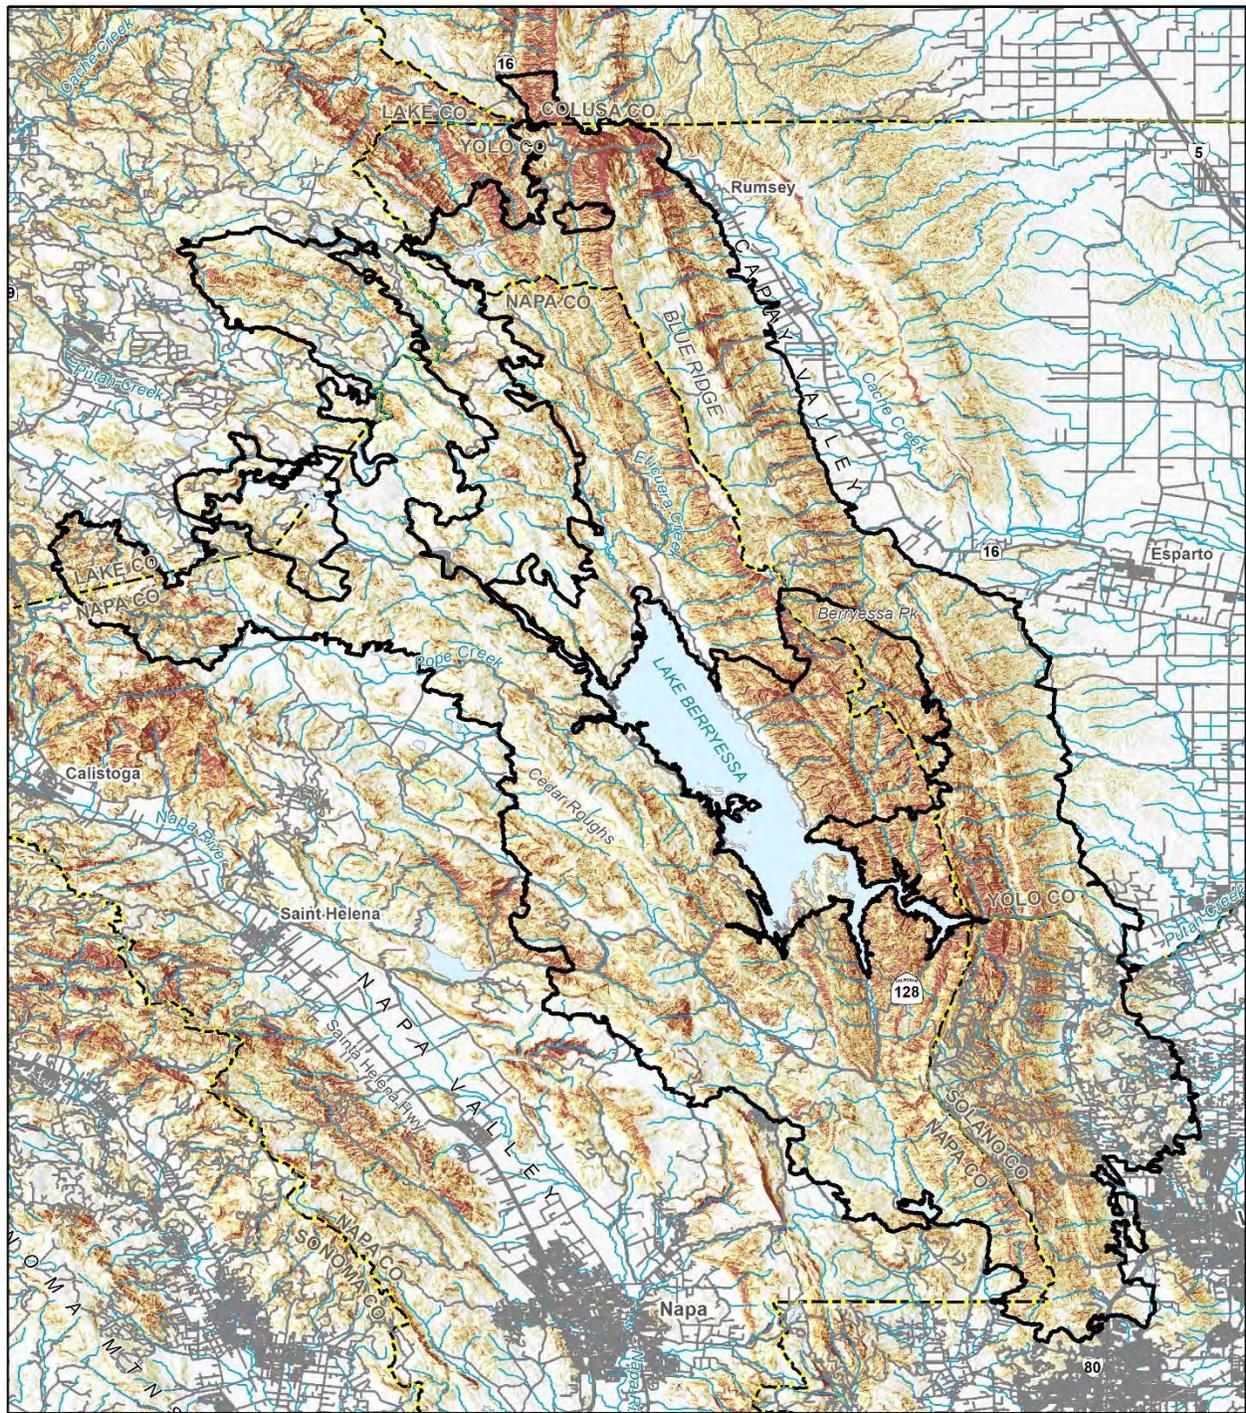
Figure 3. Shaded relief map for the Hennessey Fire. Areas over 60 percent slope (i.e., red shading) have a higher likelihood of landsliding, erosion, and dry ravel.

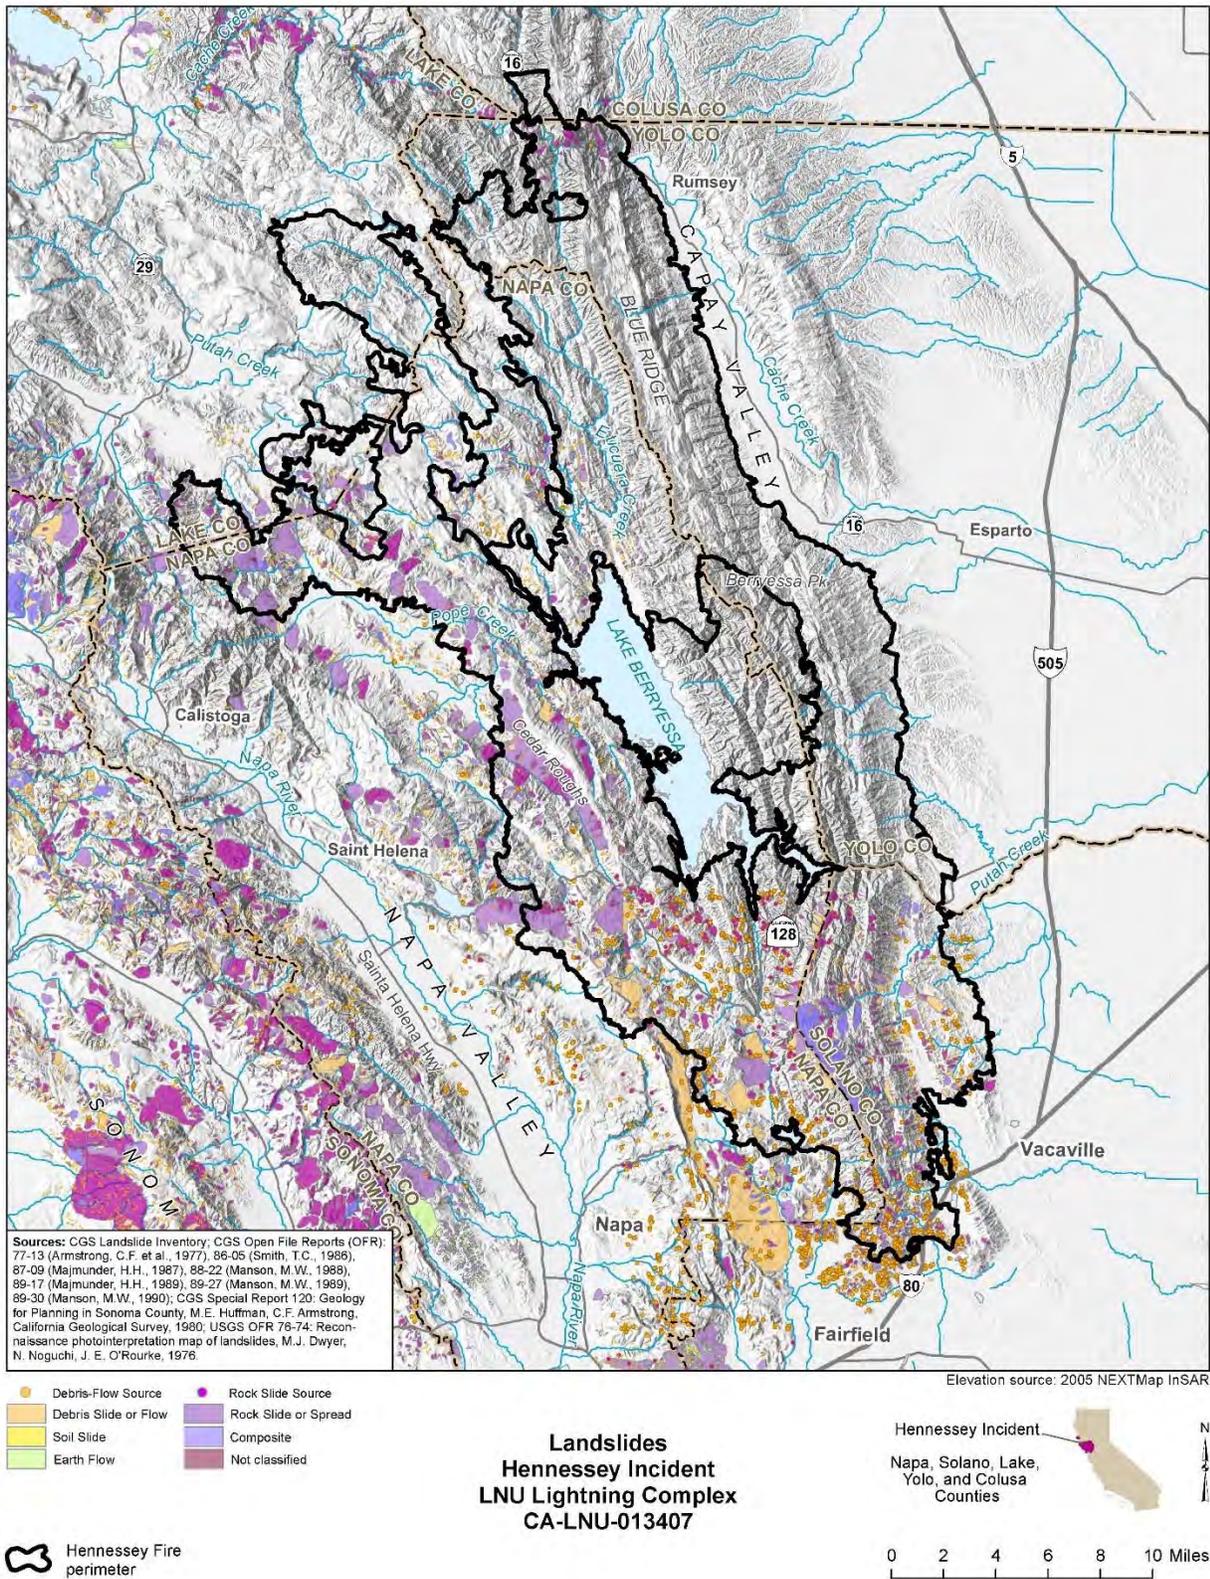
Figure 6. Landslide map for the Hennessey Fire.

The deep-seated landslides mapped as Quaternary landslide deposits in the geology map (Figure 5) represent a small portion of mapped large, deep-seated landslides within the burned areas. The landslide map of the burned areas (Figure 6) consists of numerous sources compiled within the California Geological Survey internal landslide inventory (Wills et al., 2011). The inventory includes regional mapping by Dwyer et al. (1976) within the southern and western portions of the map, by Manson (1989) within the Highway 16 corridor in the northeastern portion of the map, and by Majmunder (1987, 1989) within the southernmost edge of the burned area. It should be noted that regional landslide mapping is not available for the north-northeastern portion of the burned area; however, this does not imply that landslides are not present within these areas. As part of our evaluation of the burned area, we did not validate the landslide mapping but used it as a tool to help guide our evaluation of the burned area and focus on areas of potential hazard. The absence of landslides in the eastern portion of the map is representative of the absence of mapping in

the area, rather than the absence of landslide activity. Generally based on field observations and review of available LiDAR imagery, landsliding appears to be prevalent across the burned area, primarily as shallow debris flows or rock slides. Extreme short-term and long-term rainfall events are a primary trigger for initiating both shallow and deep-seated landslides, respectively, in the area, while ground shaking from nearby active faults is an important process in preparing slopes for landsliding and initiating landslides (Keefer, 1984). These landslide prone materials can add to the increased erosion and runoff expected because of post-fire soil hydrology changes.

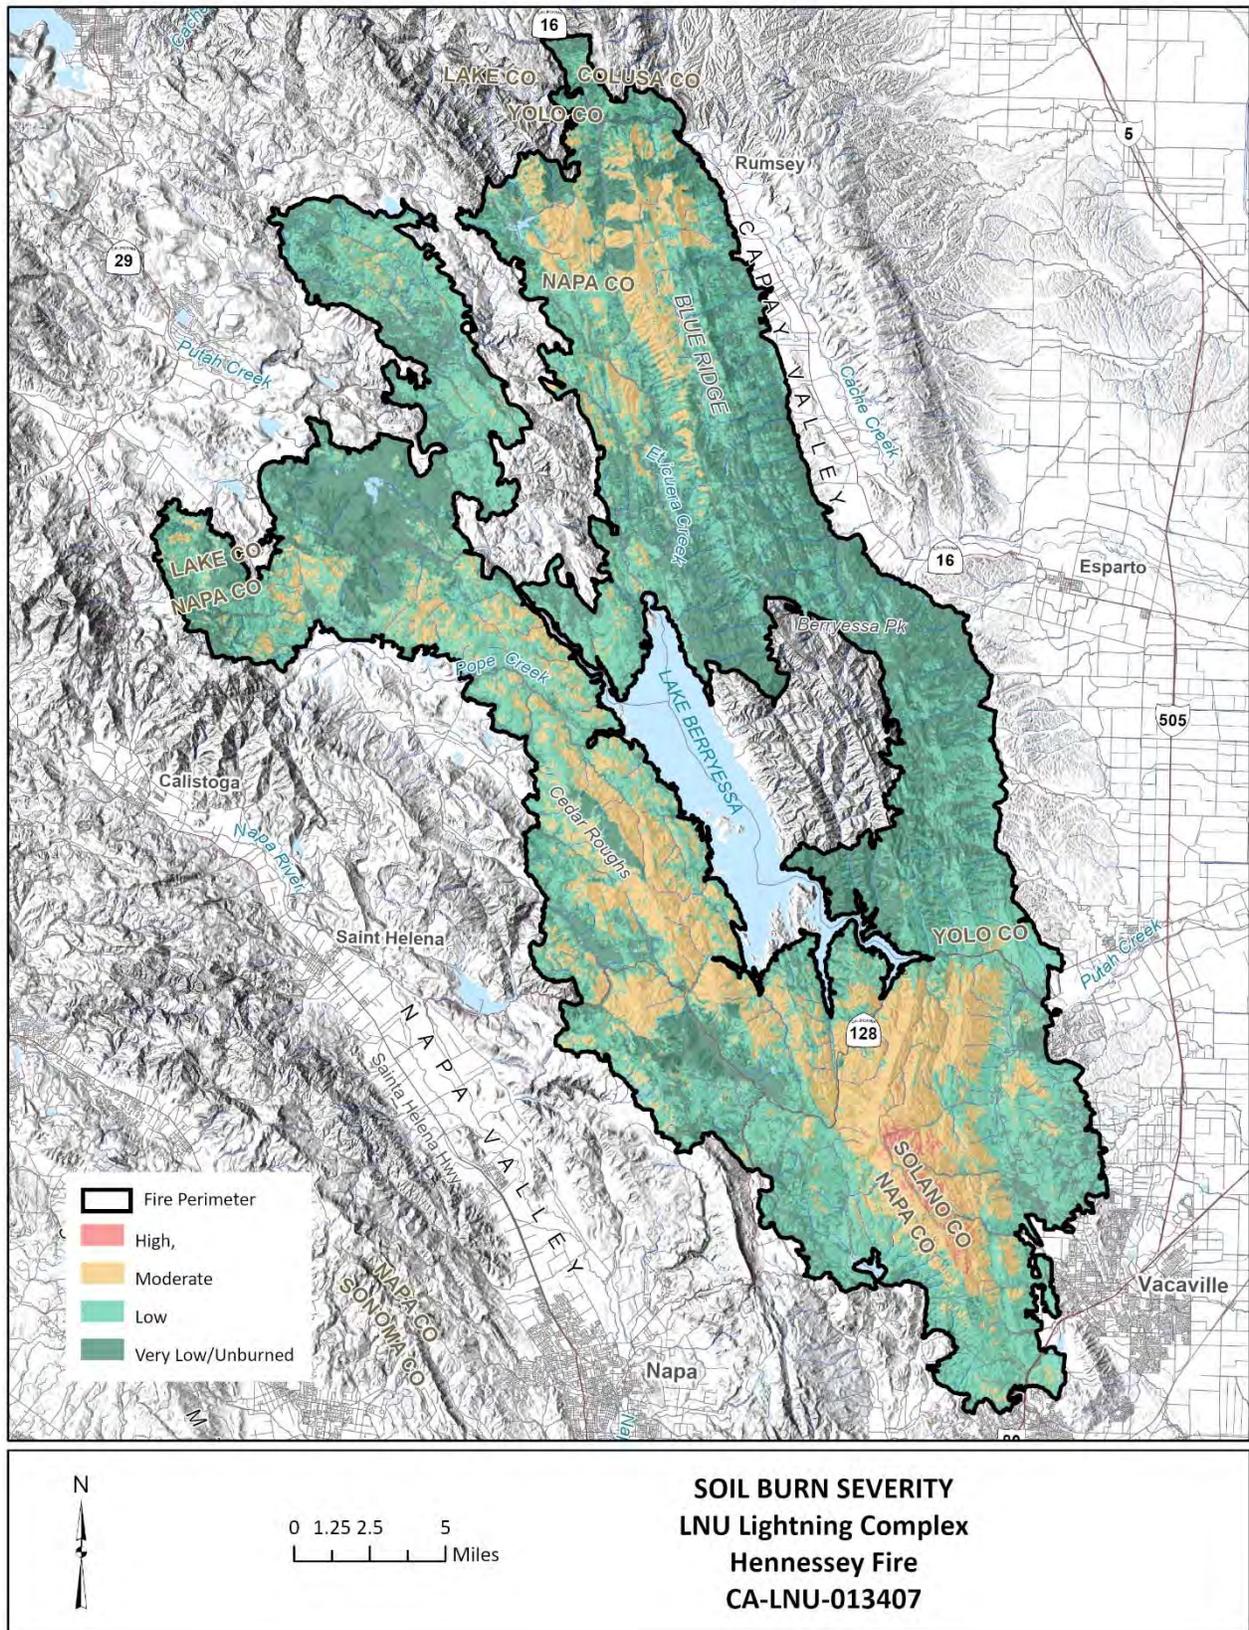
Figure 8. Soil burn severity map for the Hennessey Fire.

The Hennessey Fire burned area is characterized by a high proportion of very low to low soil burn severity (Table 4, Figure 8). Forty-three percent (43%) of the Hennessey burned area is composed of low soil burn severity, and thirty-six percent (36%) is very low/unburned. Twenty-one percent (21%) of the area burned at moderate severity and less than one percent (<1%) burned at high severity. Moderate and high soil burn severities indicate a high potential for post-fire watershed response. The highest portion of high and moderate soil burn severity is within the steep terrane of the Vaca Mountains in the southern portion of the burned area. Concentrations of moderate soil burn severity are in the northeastern and western portions of the burned area. The lowest soil burn severity, with virtually no identifiable moderate soil burn severity, is in the slopes above the southern Capay Valley and Lamb Valley on the eastern side of the burned area. Past discussions with Soil Scientists from the United States Forest Service have indicated that soils with higher clay content tend to have less heat penetration than sandier soils (*personal communication*, Brad Rust and Dave Young, USFS Soil Scientists). This may play a part in the lower soil burn severities observed in the Hennessey Fire, as soils in these areas generally have a relatively high clay content.

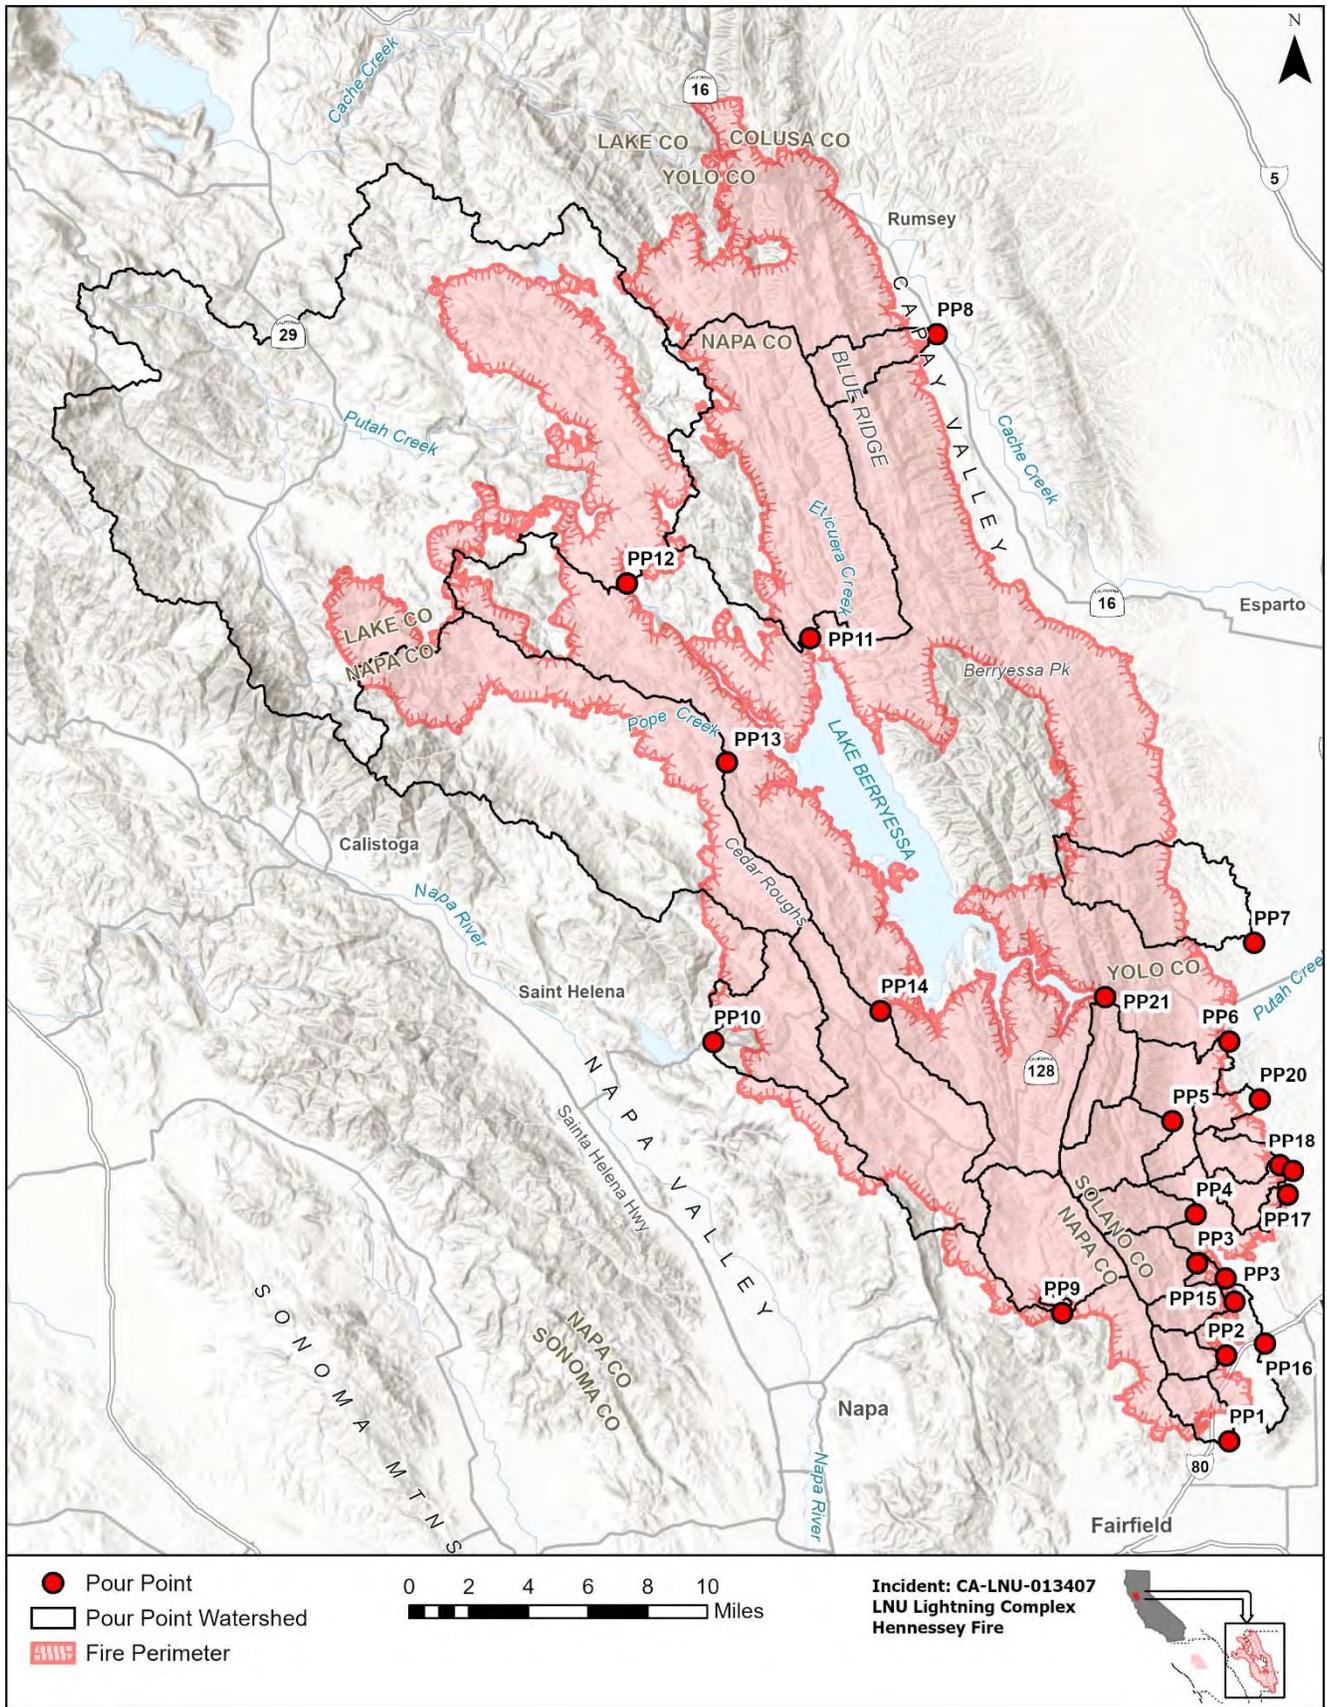
Figure 9. Hennessey Fire pour point watersheds.

Table 5. Estimated bulked post-fire flow multipliers and peak flow return interval based on a 2-year and 10-year recurrence interval storm for pour point watersheds shown in Figure 9.

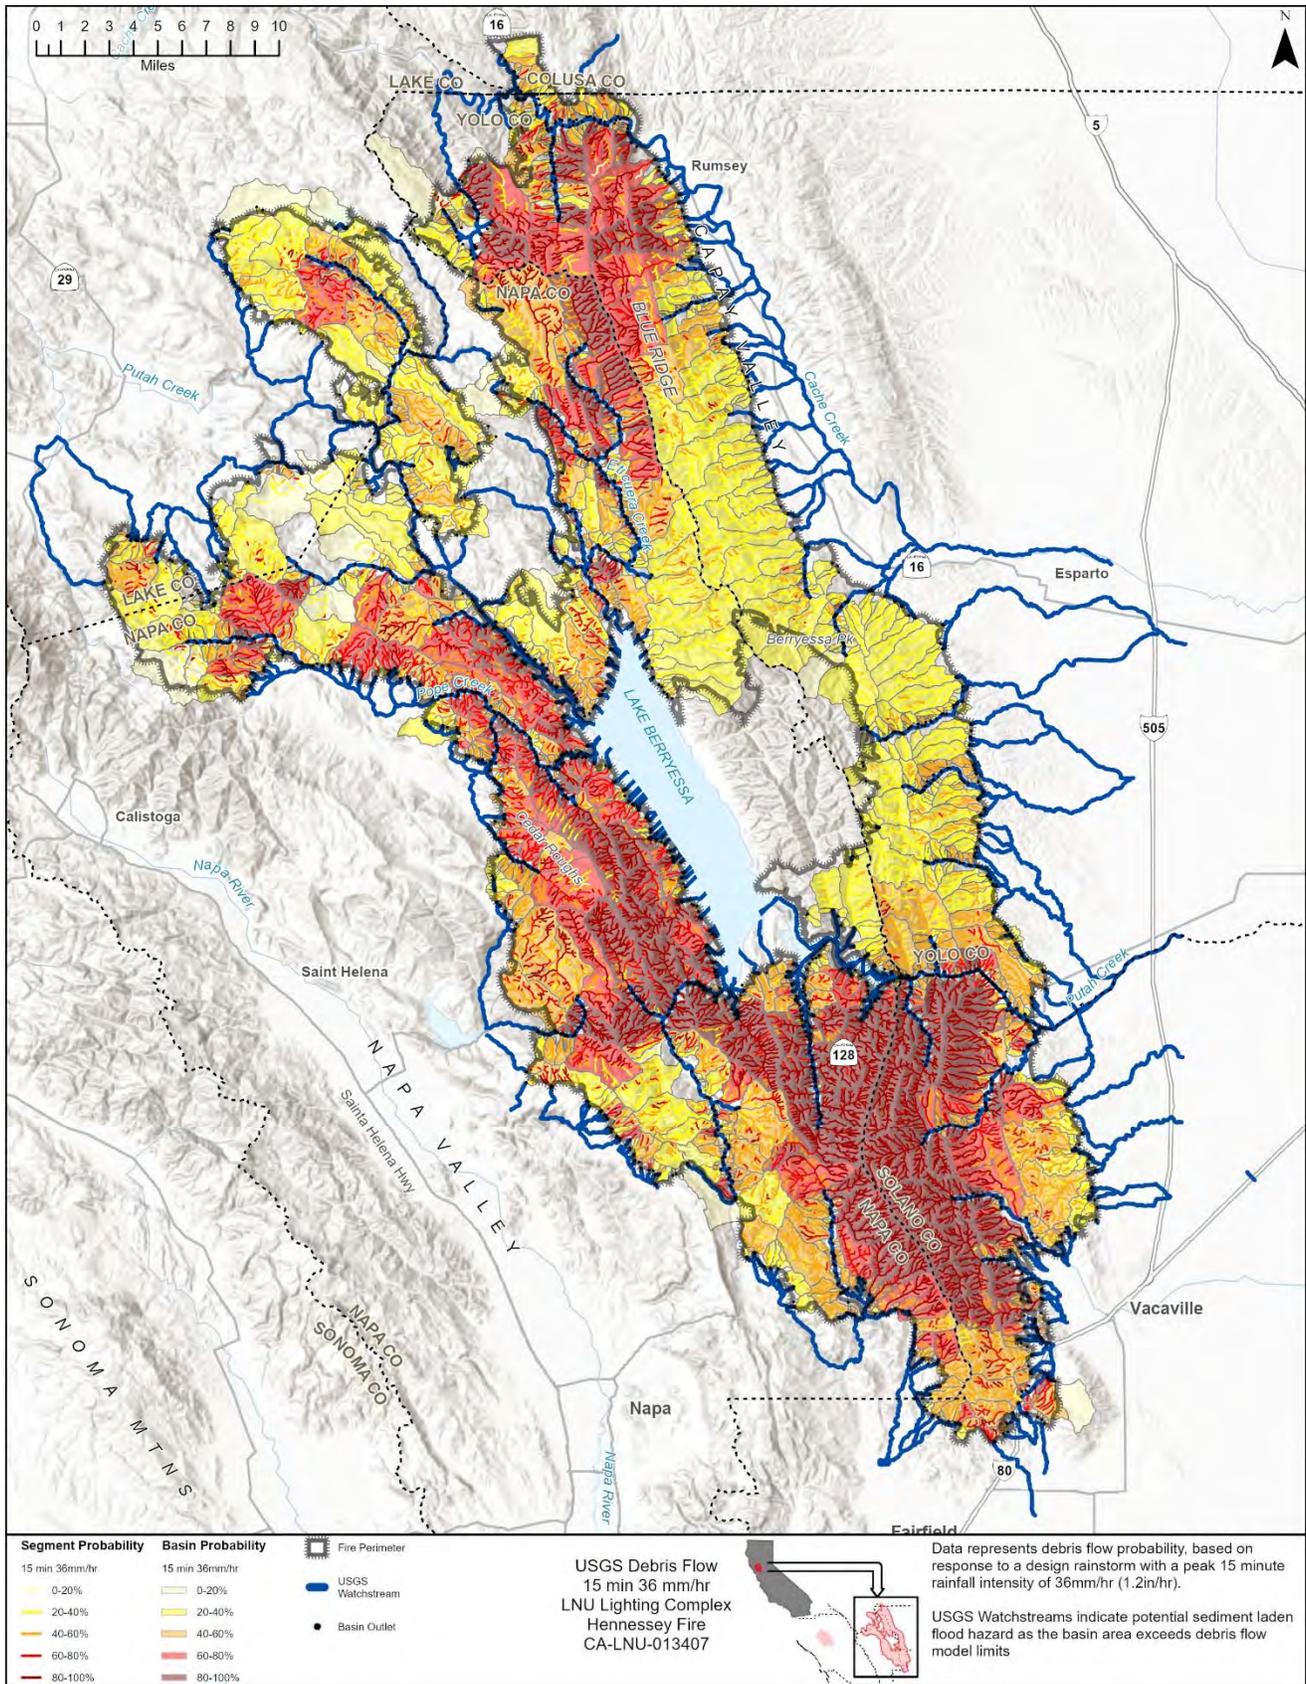
Figures 11, 12, and 13 show the estimated likelihood, potential volume, and combined debris flow hazard for the 36 mm hr⁻¹ (1.46 in hr⁻¹) storm, respectively. These maps indicate that the combined debris flow hazard is primarily moderate to high for the selected rainfall intensity along Blue Ridge in the northernmost and southern portions of the burned area, near Wragg Ridge in the southern burned area, and the Cedar Roughs in the western portion of the burned area. Elsewhere, these maps generally show that the combined debris flow hazard is moderate to low for the selected rainfall intensity. The VAR maps in Appendix C show combined debris flow hazard in response to the 36 mm hr⁻¹ (1.46 in hr⁻¹) storm event.

Figure 11. USGS debris flow model results for the Hennessey Fire. Debris flow probability, 36 mm/hr storm event.

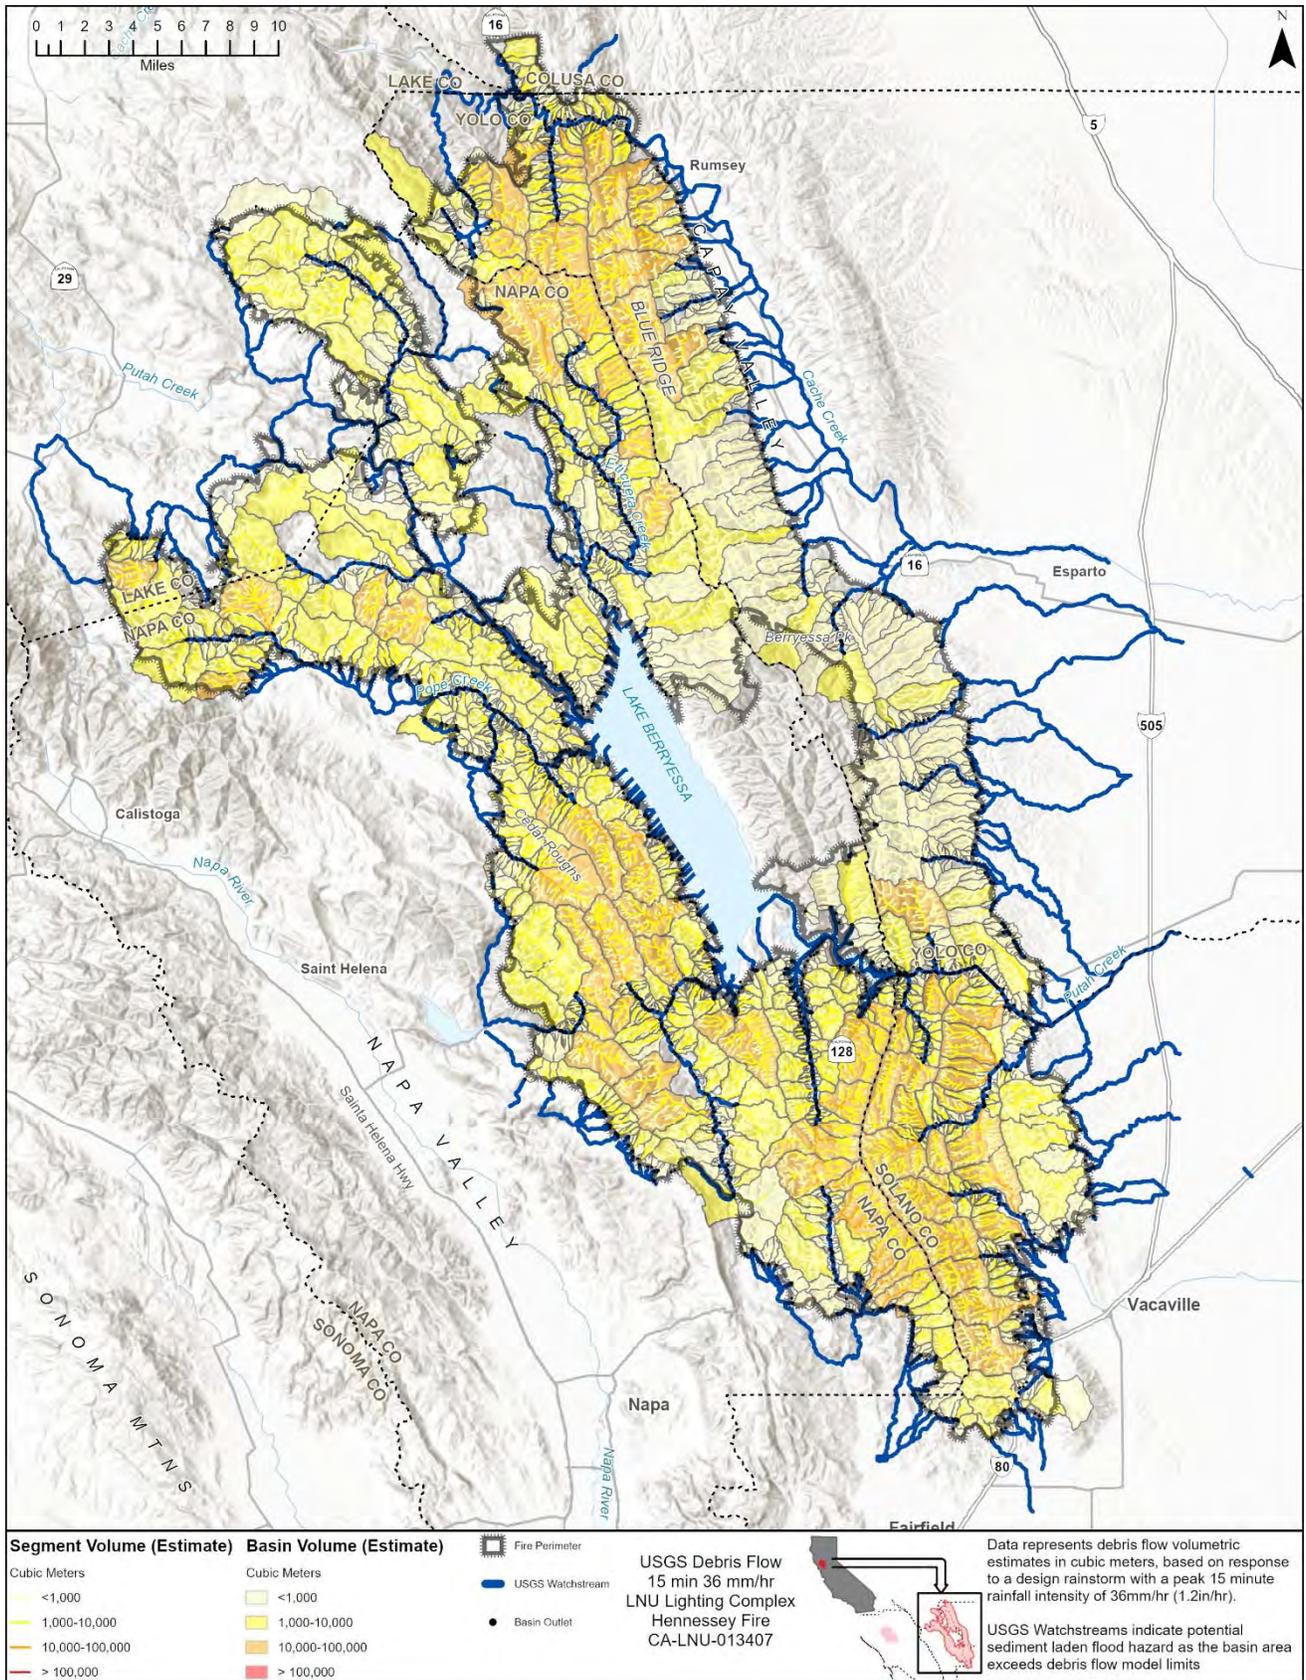
Figure 12. USGS debris flow model results for the Hennessey Fire. Debris flow volume, 36 mm/hr storm event.

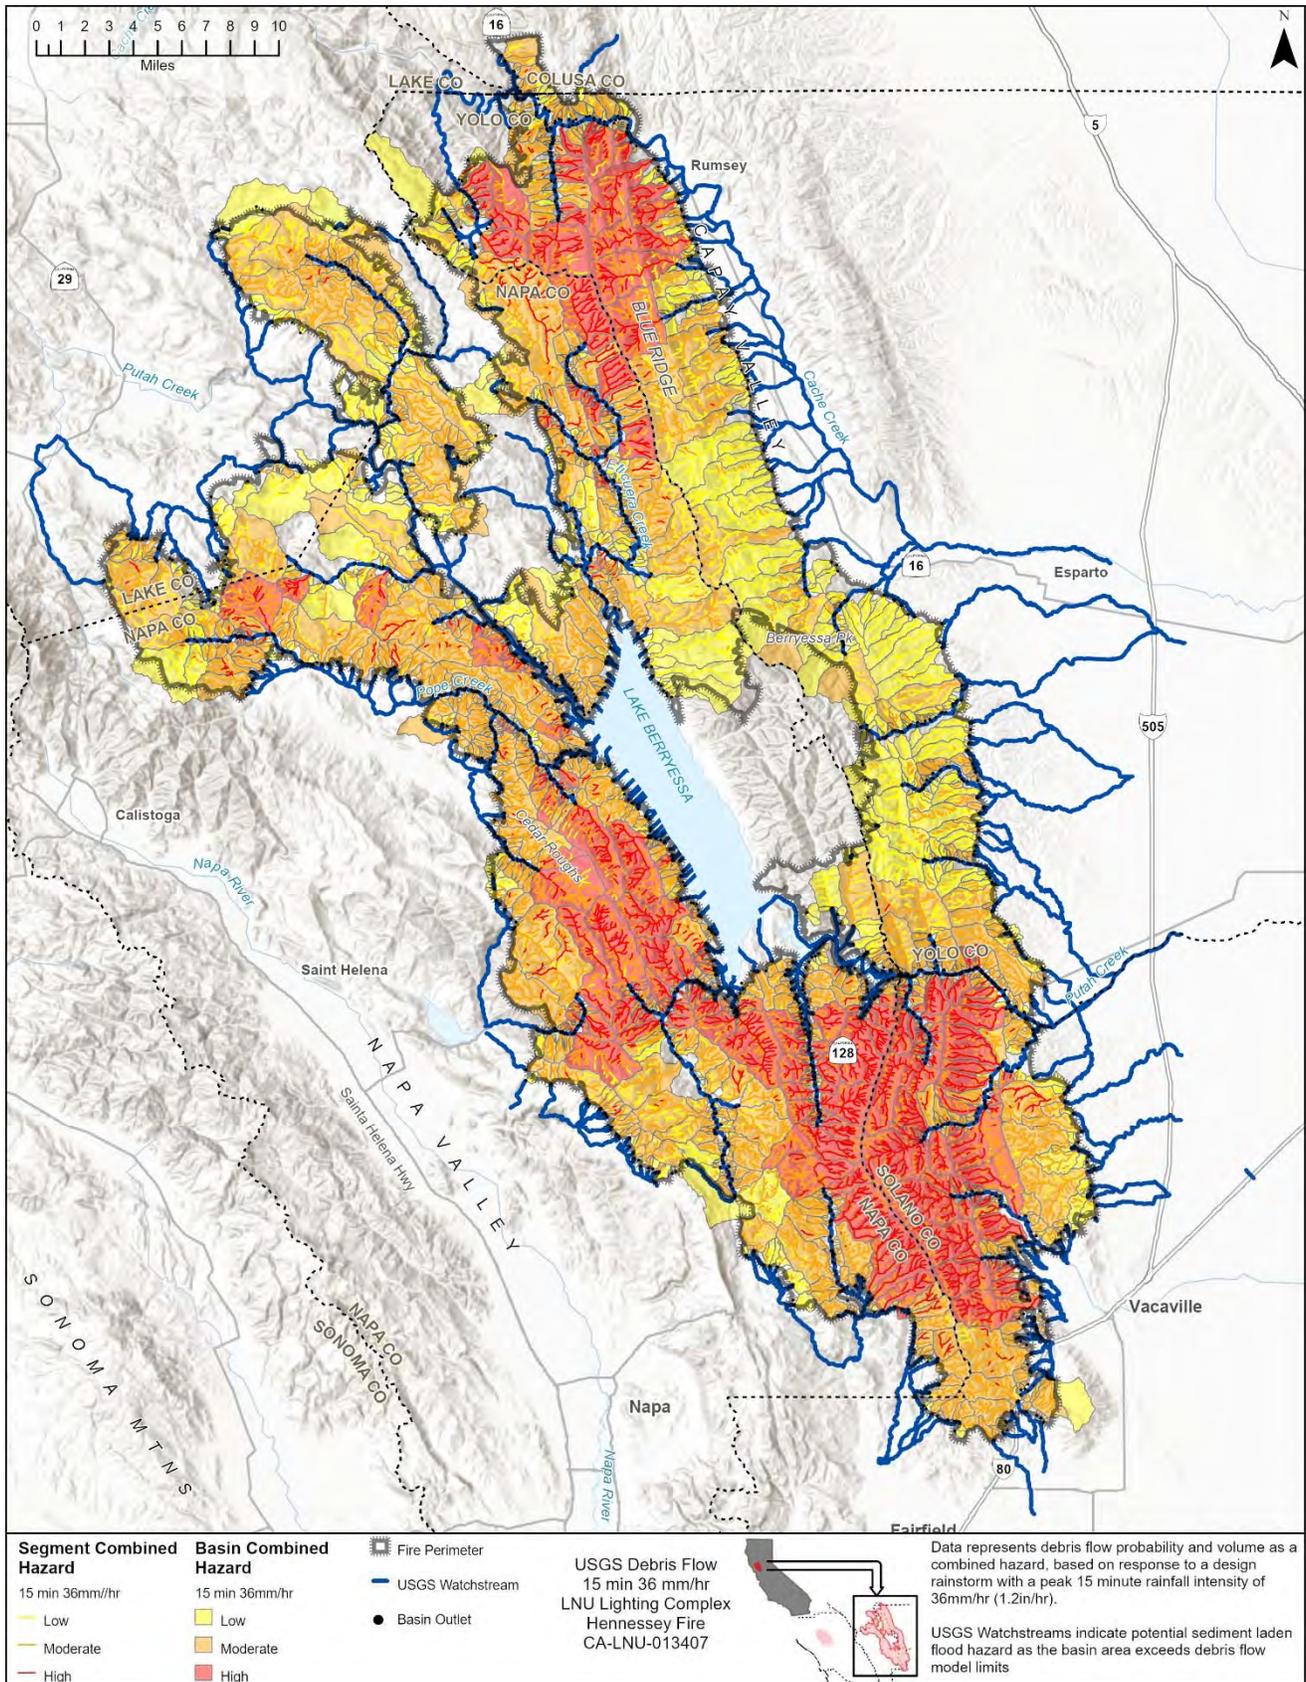
Figure 13. USGS debris flow model results for the Hennessey Fire. Combined hazard, 36 mm/hr storm event.

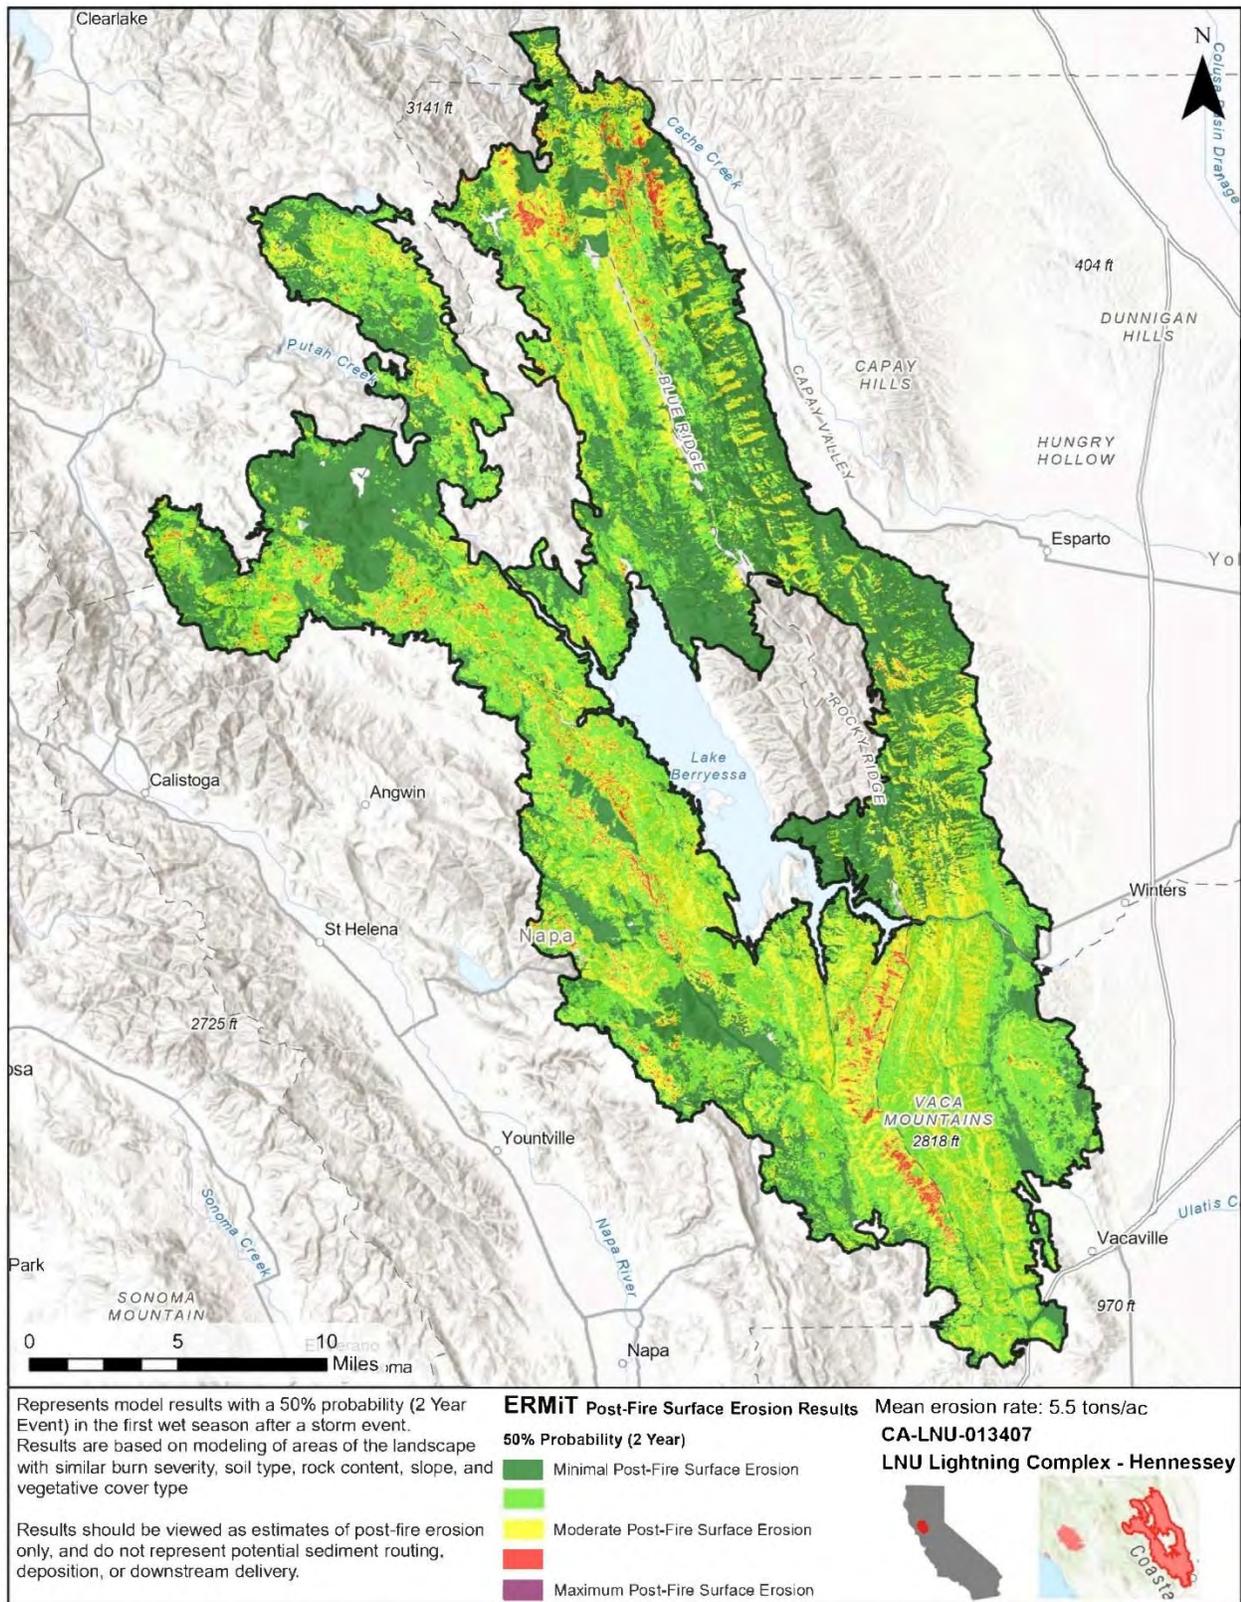
- The ERMiT post-fire surface erosion model predicts mostly a minimal to moderate increase in the rate of surface erosion across the burned area due to the preponderance of low and very low soil burn severity.

Figure 14. Hennessey Fire predicted surface erosion rates for the 2-year recurrence interval storm event using the Erosion Risk Management Tool (ERMIT).

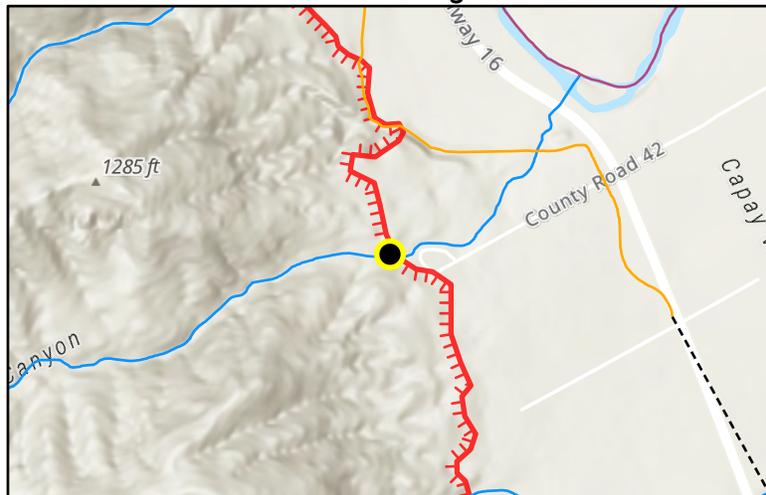
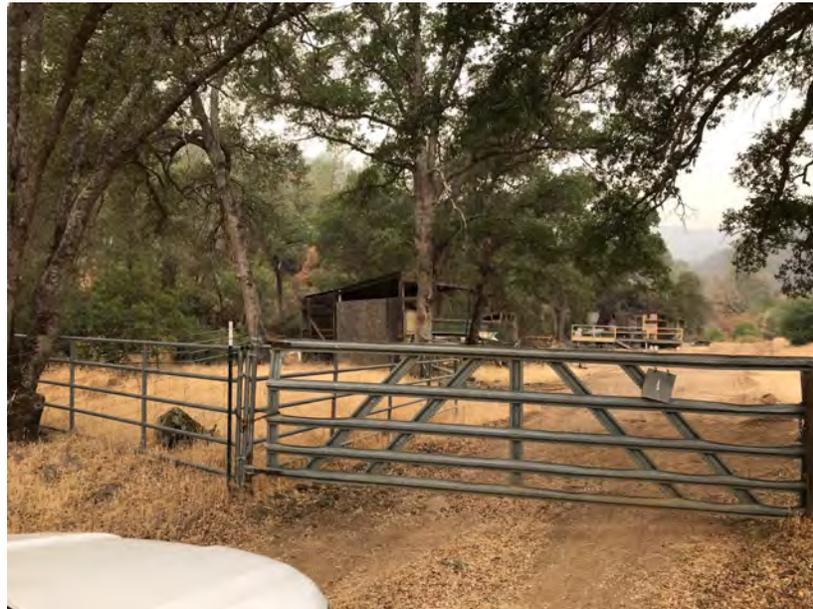
Field Observation Potential debris flow from large drainage, watercourse is narrow and house is adjacent to it.
Potential Hazard: adjacent to it.

Potential Hazard to Life: moderate

Potential Hazard to Property: moderate

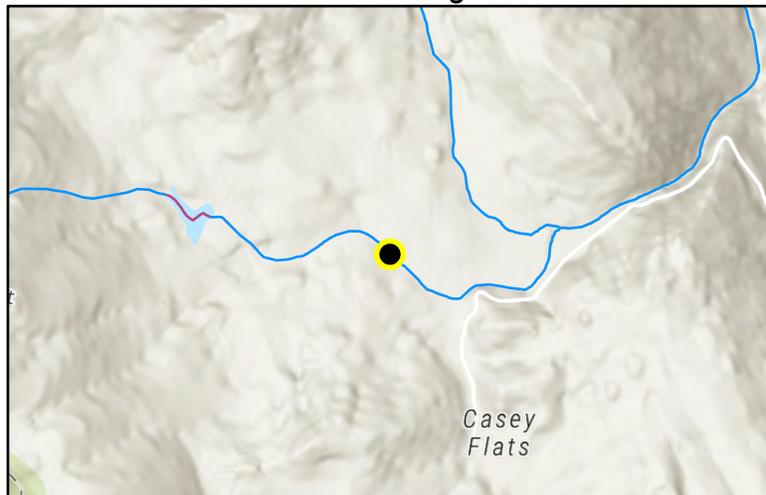
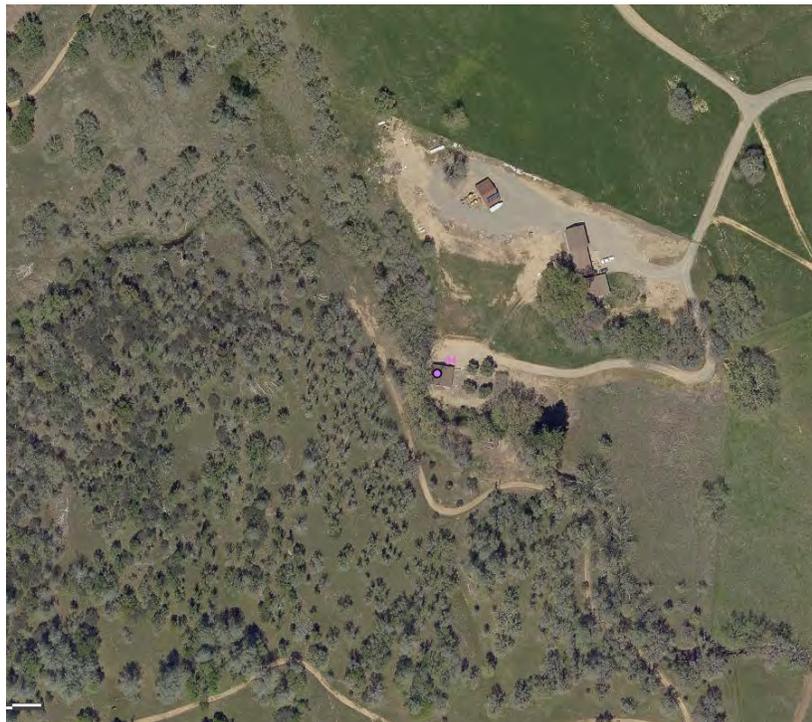
Field Observation Access limited. Based on large drainage area above, house identified as VAR.
or Potential Hazard:

Potential Hazard to Life: **moderate**

Potential Hazard to Property: **moderate**

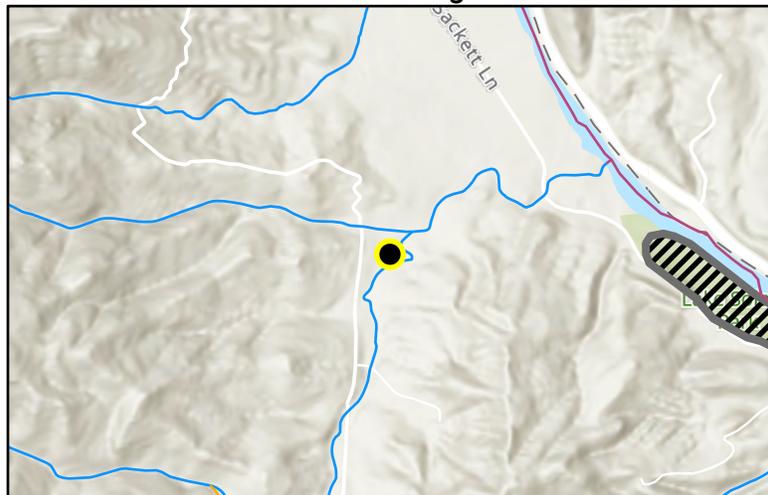
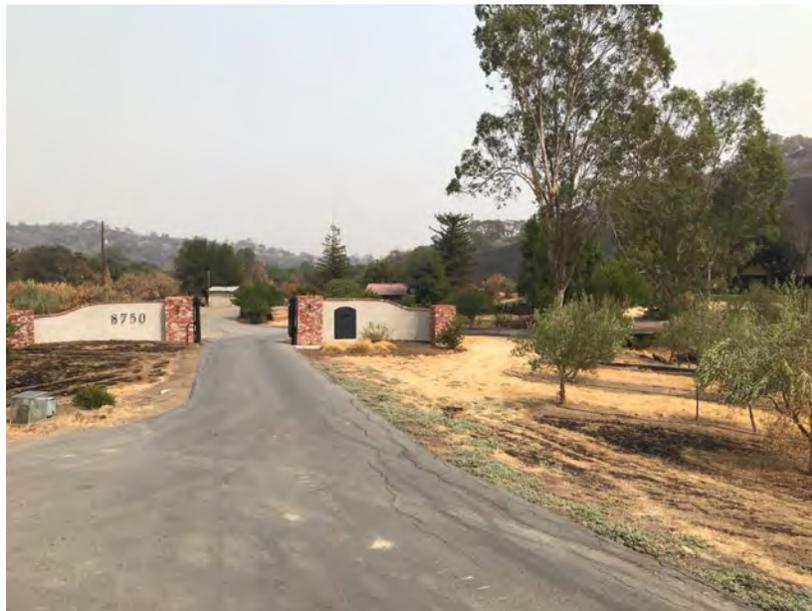
Field Observation Outbuilding and playground equipment in path of watercourse.
or Potential Hazard:

Potential Hazard to Life: moderate

Potential Hazard to Property: low

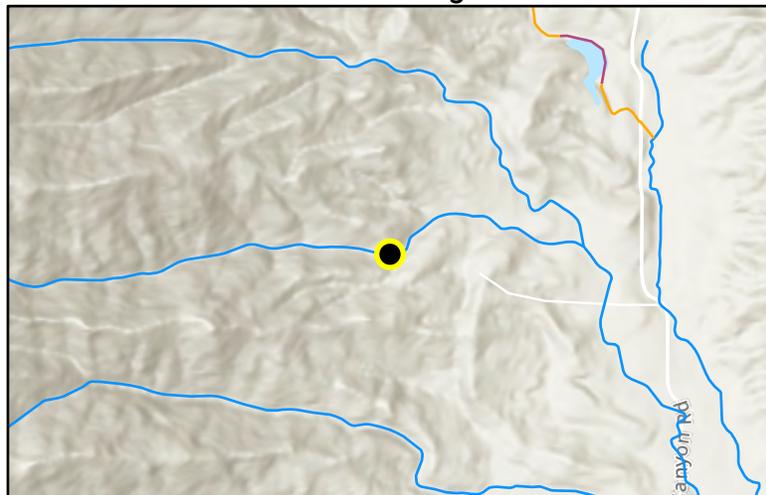
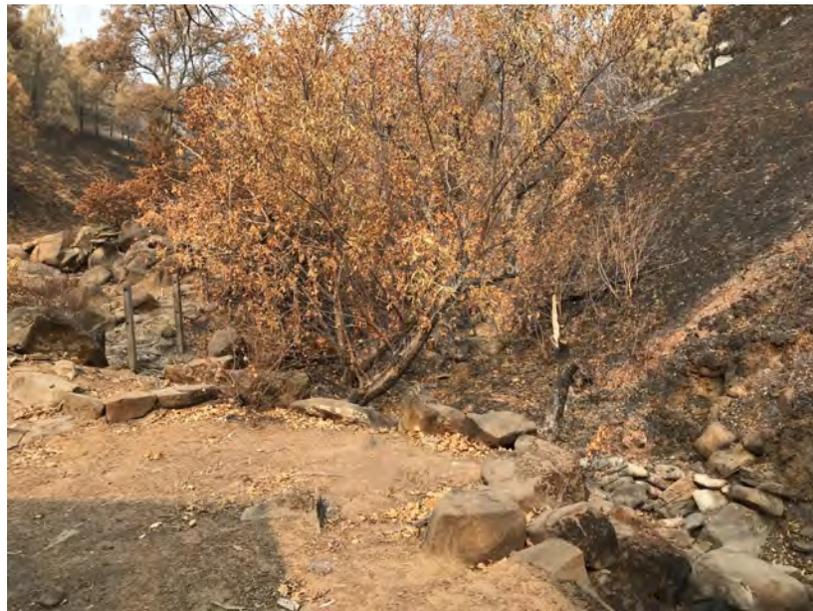
Field Observation Garage sitting at junction of two watercourses loaded with large boulders.
or Potential Hazard: Potential for debris flow to damage structure. Informed landowner of hazards to garage.

Potential Hazard to Life: **low**

Potential Hazard to Property: **moderate**

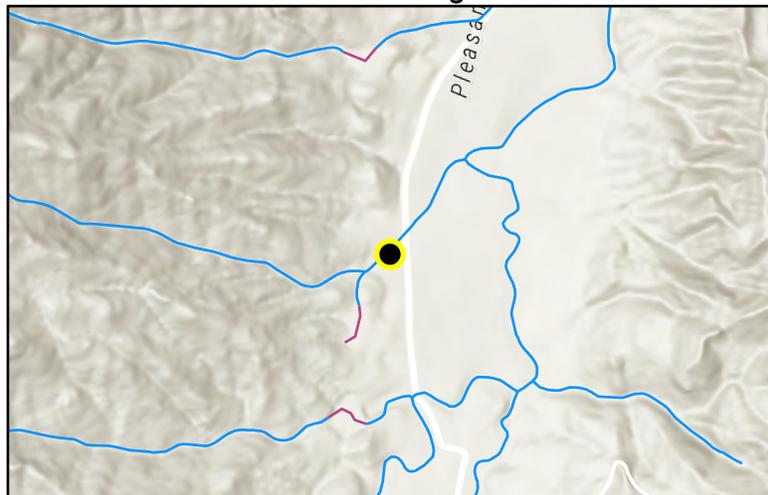
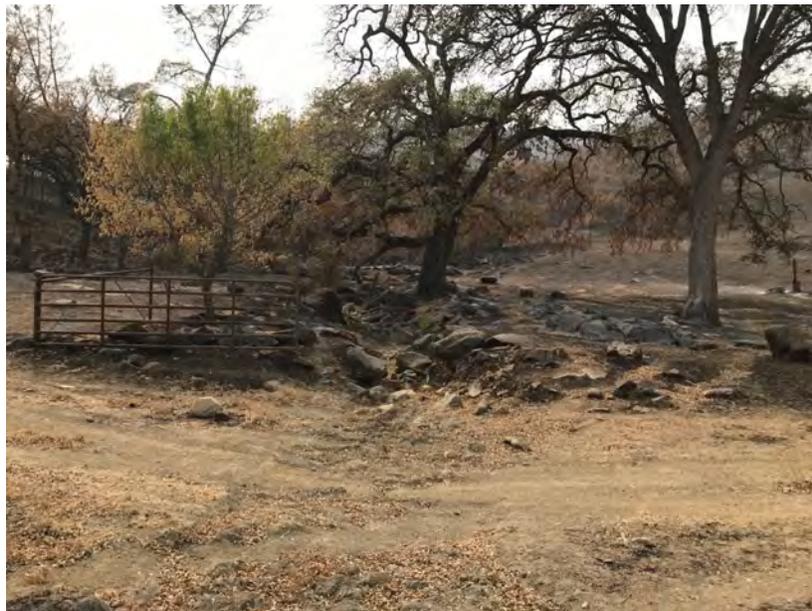
Field Observation Barn in flow path of watercourse. Debris flow and flooding hazards.
or Potential Hazard:

Potential Hazard to Life: low

Potential Hazard to Property: moderate
