Watershed Emergency Response Team Evaluation
LNU LIGHTNING COMPLEX
HENNESSEY FIRE

CA-LNU-013407

October 8, 2020

LNU LIGHTNING COMPLEX (HENNESSEY FIRE)
Watershed Emergency Response Team EVALUATION
October 8, 2020

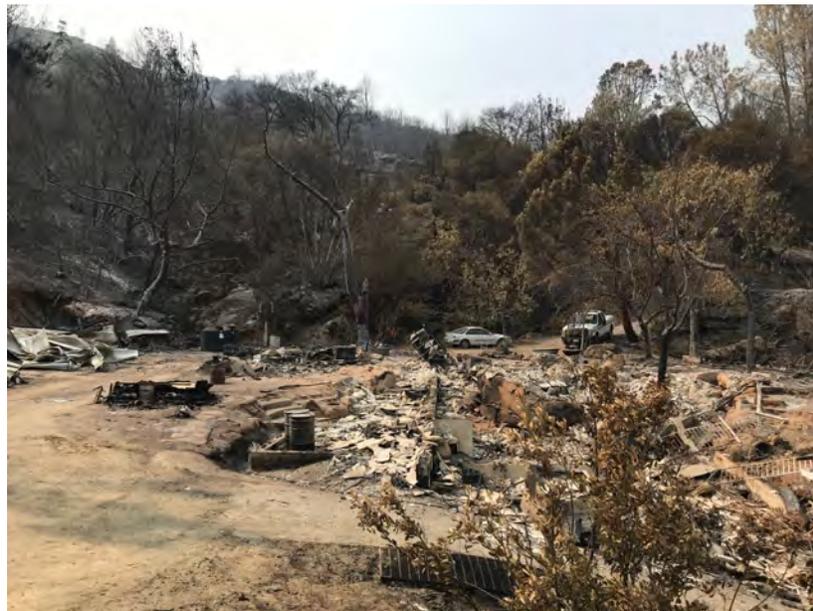
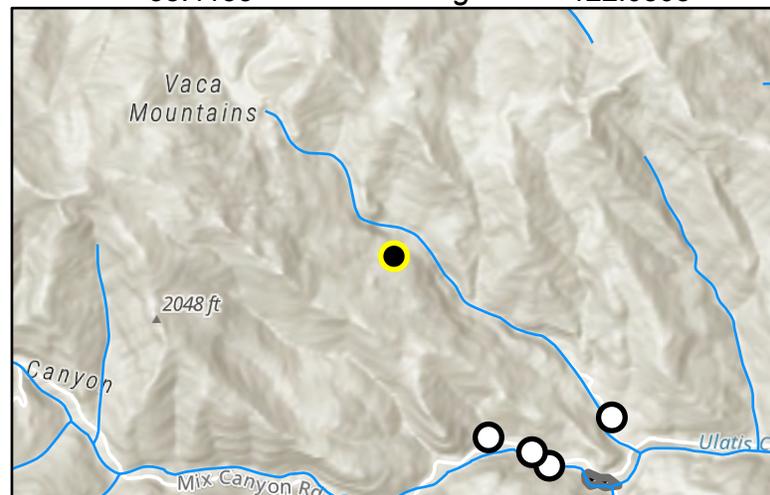
Field Observation Burned House pad built on cut/fill bench in axis of relatively small watercourse.
or Potential Hazard: Watercourse is diverted in trench around house. Potential for flooding or debris flow.

Potential Hazard to Life: moderate

Potential Hazard to Property: moderate

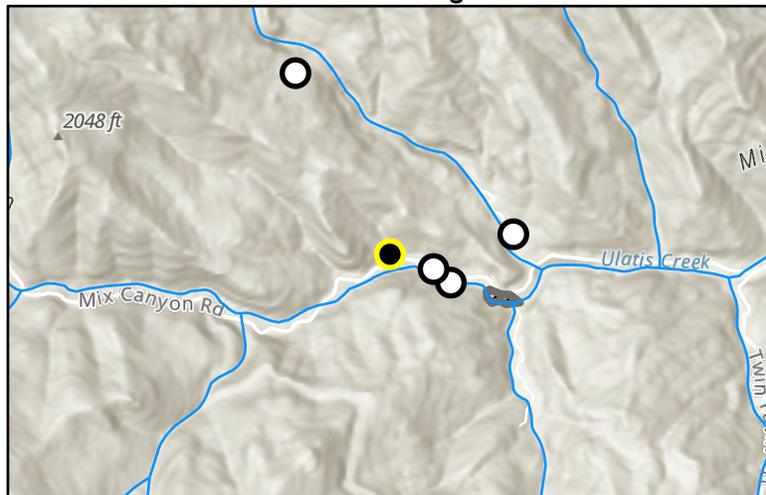
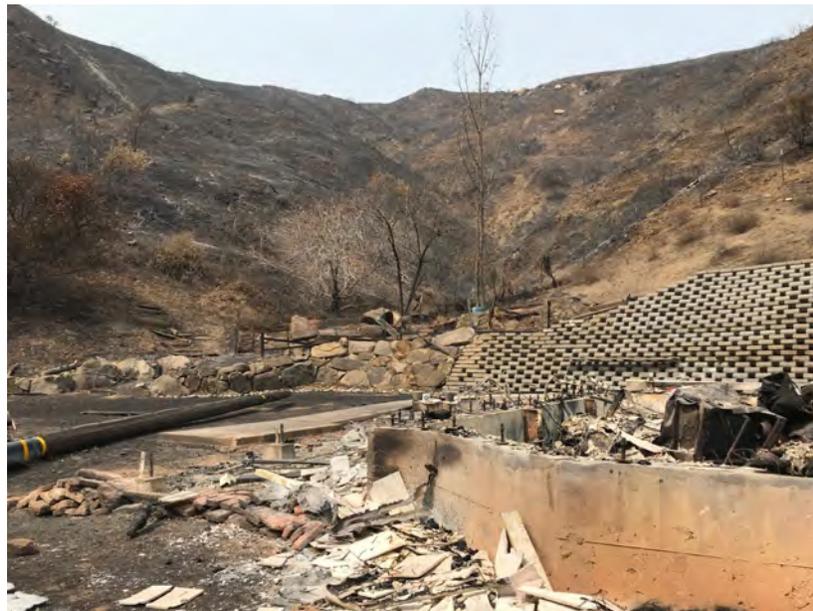
Field Observation Burned house pad on alluvial fan at mouth of potential debris flow channel.
or Potential Hazard: House site. Somewhat setback from channel but could potentially be impacted.
Possible trailer site in direct impact location.

Potential Hazard to Life: high

Potential Hazard to Property: high

Description: Place possible trailer site at east end of lot.

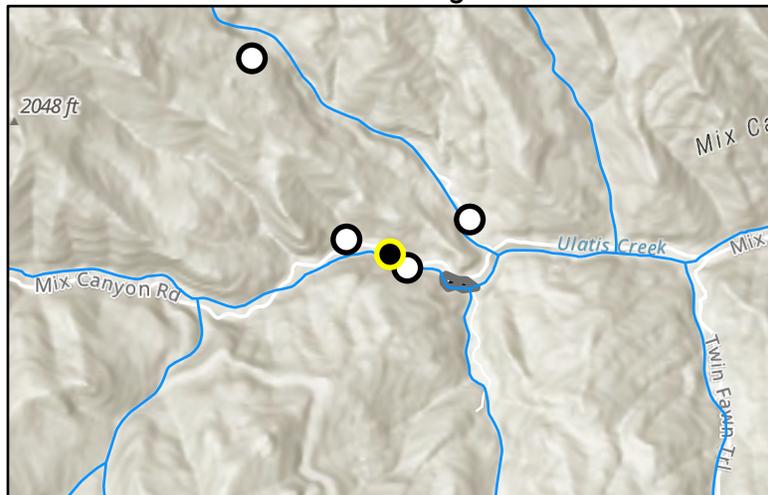
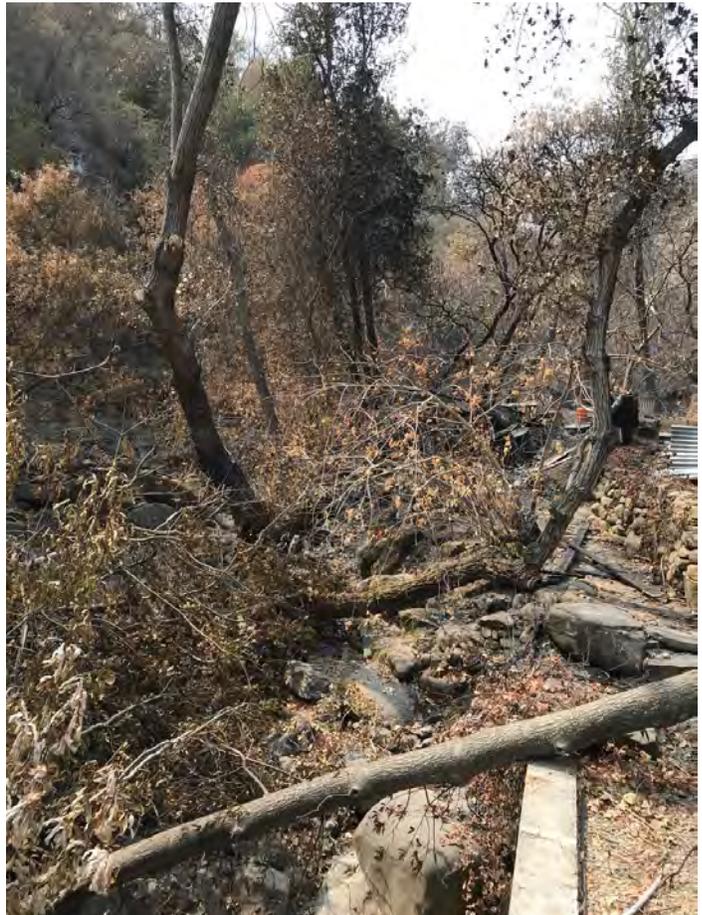
Field Observation Wide area near watercourse that could be used as possible trailer site.
or Potential Hazard:

Potential Hazard to Life: moderate

Potential Hazard to Property: moderate

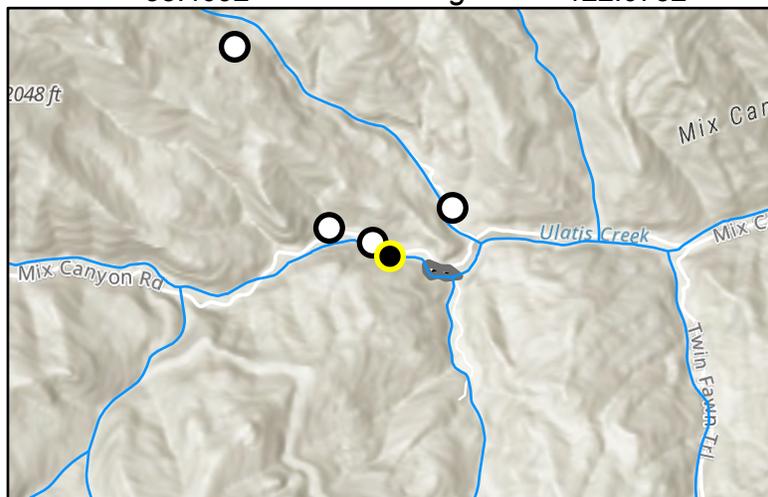
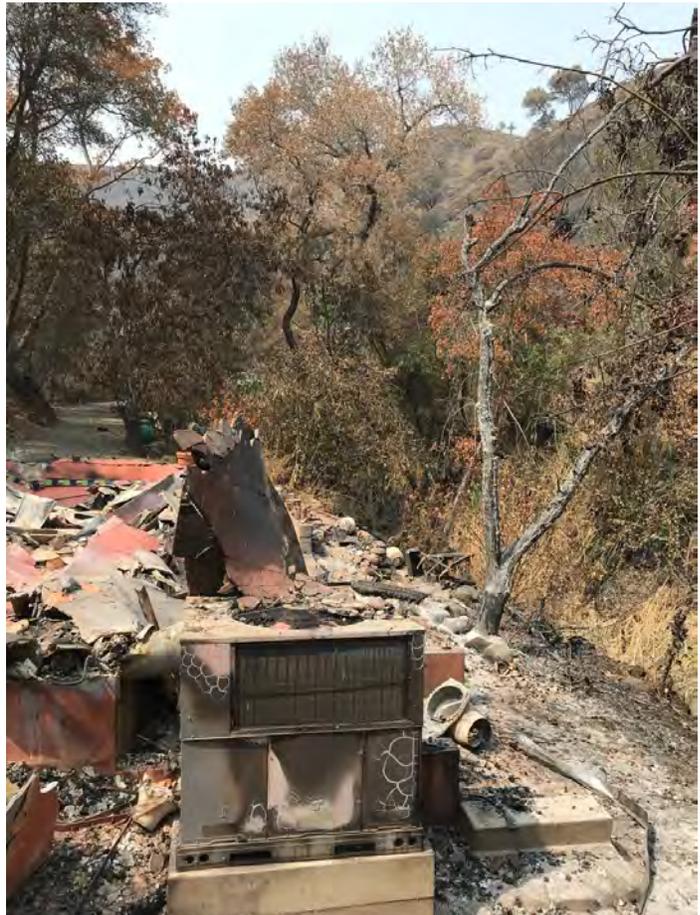
Field Observation House site near watercourse. Potential for debris flow and flood.
or Potential Hazard:

Potential Hazard to Life: moderate

Potential Hazard to Property: moderate

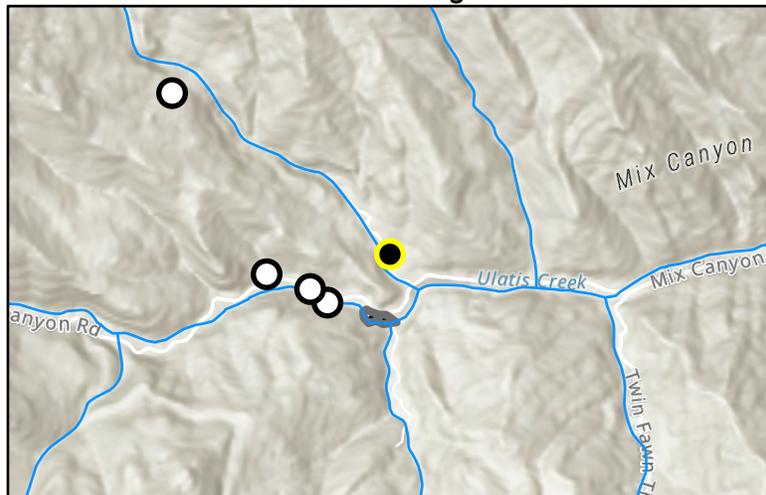
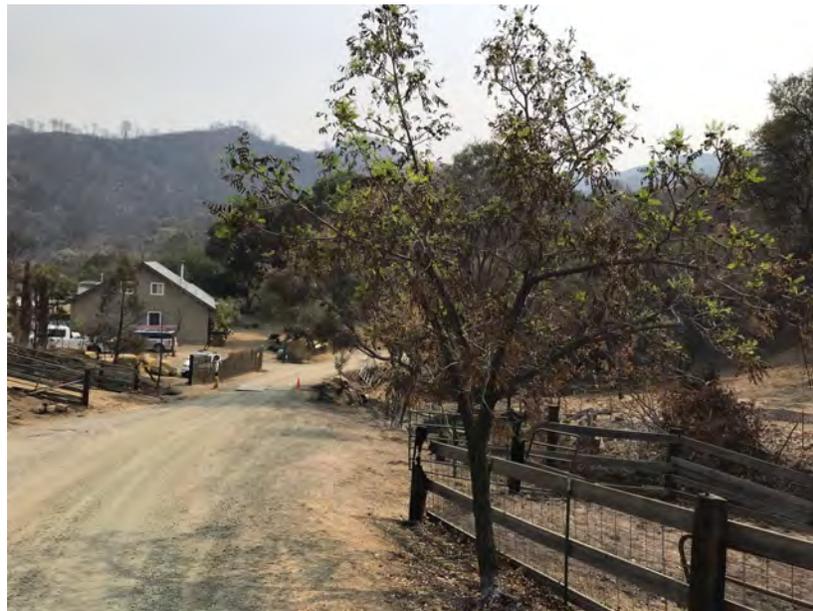
Field Observation Potential for debris flow to escape watercourse channel at livestock paddock or **Potential Hazard:** upstream and flow toward residence.

Potential Hazard to Life: moderate

Potential Hazard to Property: moderate

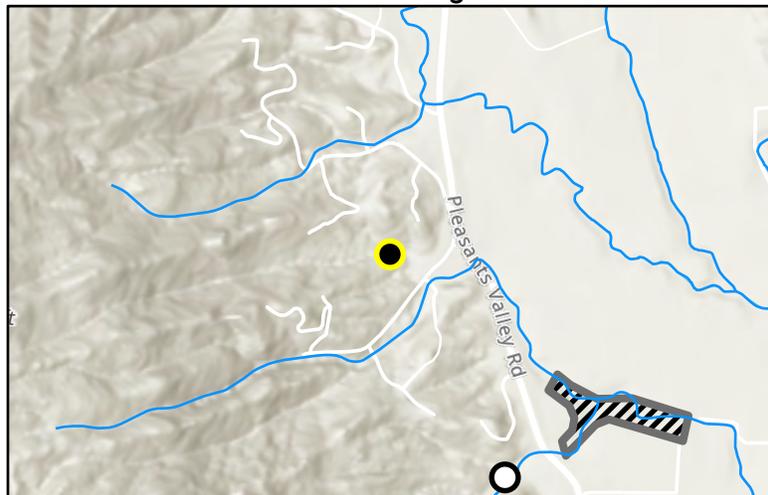
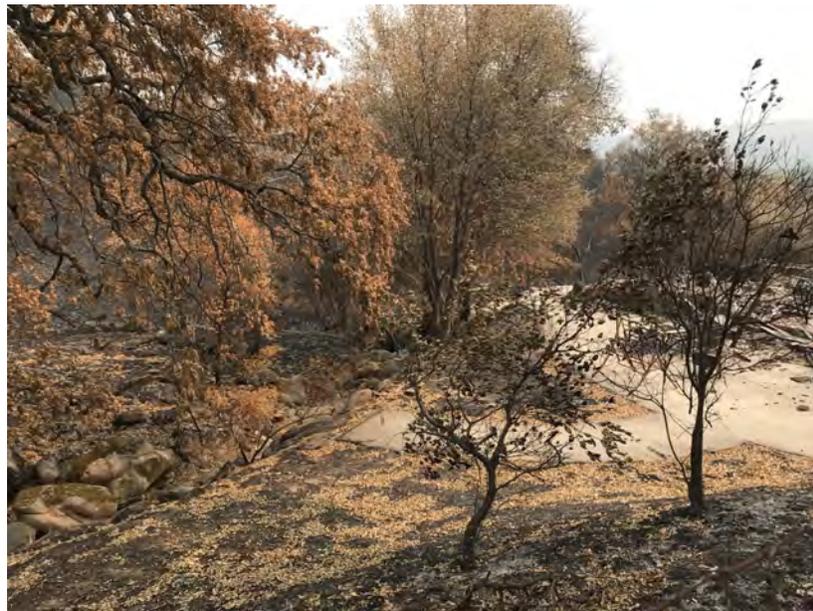
Field Observation or Potential Hazard: Small fan with numerous boulders upslope of burned residence. Watercourse channel is shallow and there is potential for debris flow to overflow and impact house site.

Potential Hazard to Life: moderate

Potential Hazard to Property: moderate

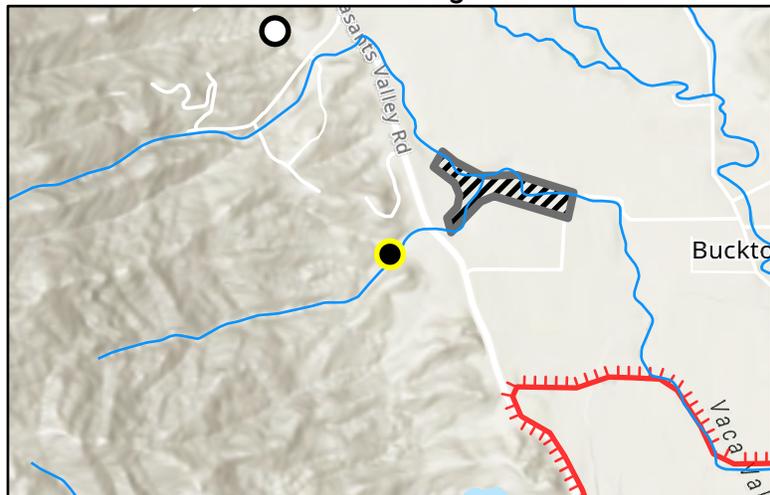
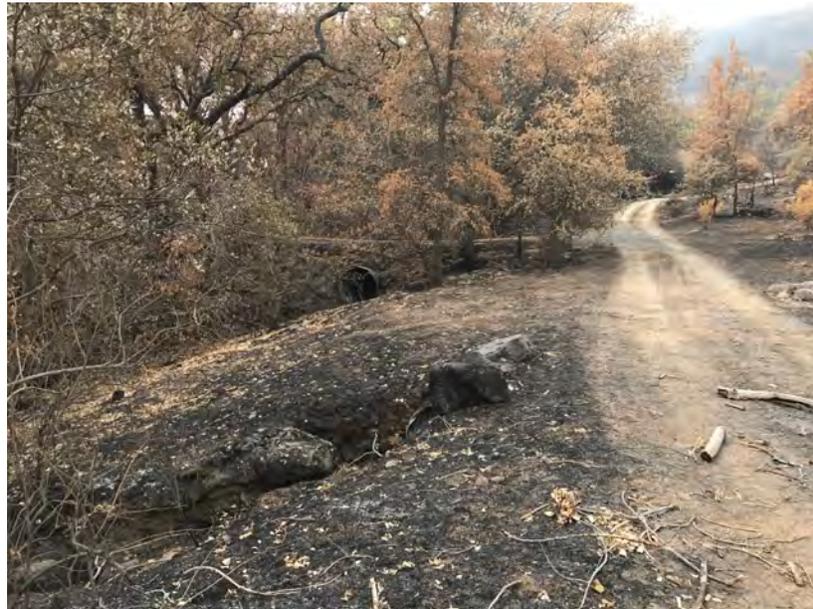
Field Observation Burned house at confluence of tributary and main watercourse. Dam/pond at
or Potential Hazard: tributary upslope of house. Potential for debris flow or flooding on main
watercourse with potential for diversion toward house at crossings upslope.

Potential Hazard to Life: moderate

Potential Hazard to Property: moderate

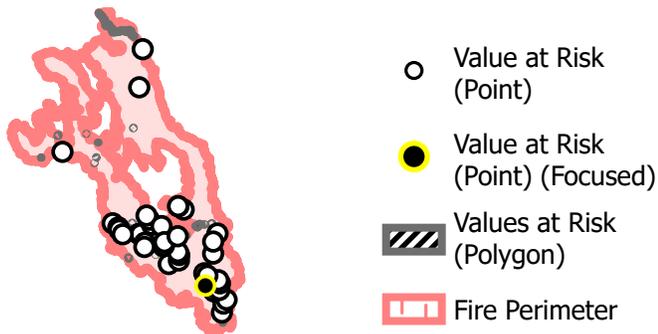
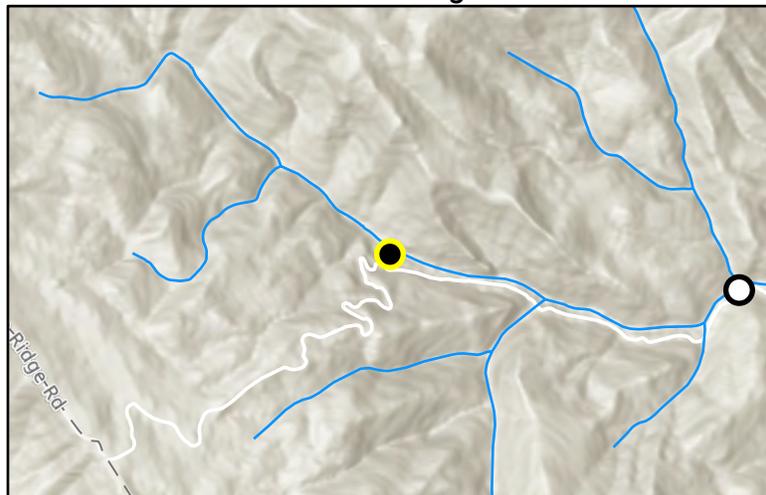
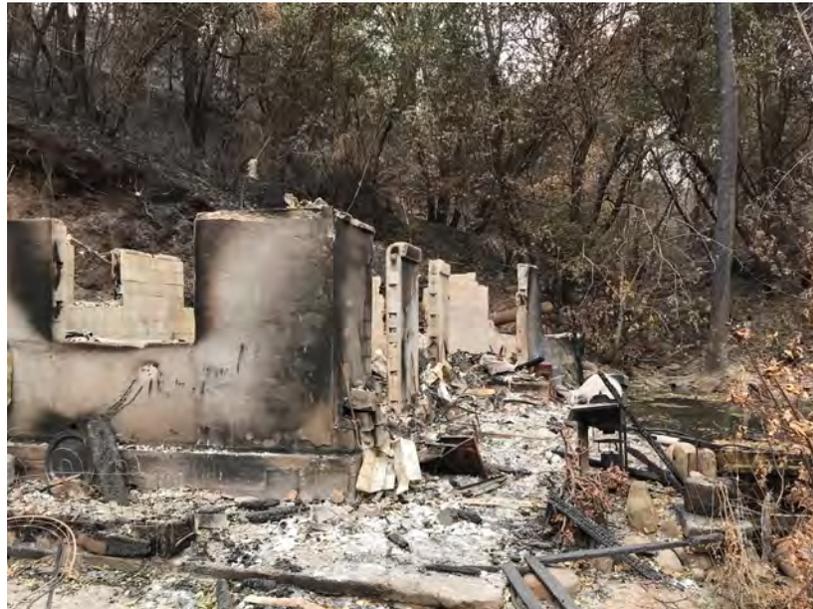
Field Observation Burned house immediately adjacent to watercourse. Many large boulders in
or Potential Hazard: watercourse channel. Debris flow and flooding potential.

Potential Hazard to Life: high

Potential Hazard to Property: high

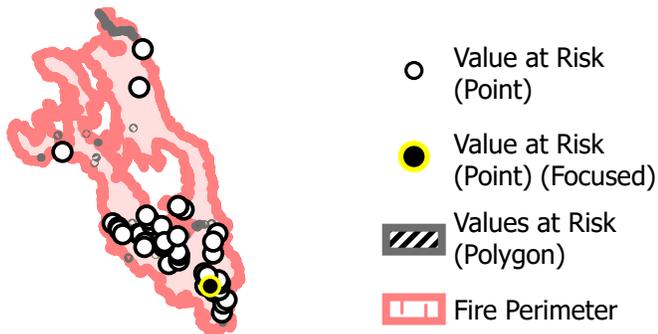
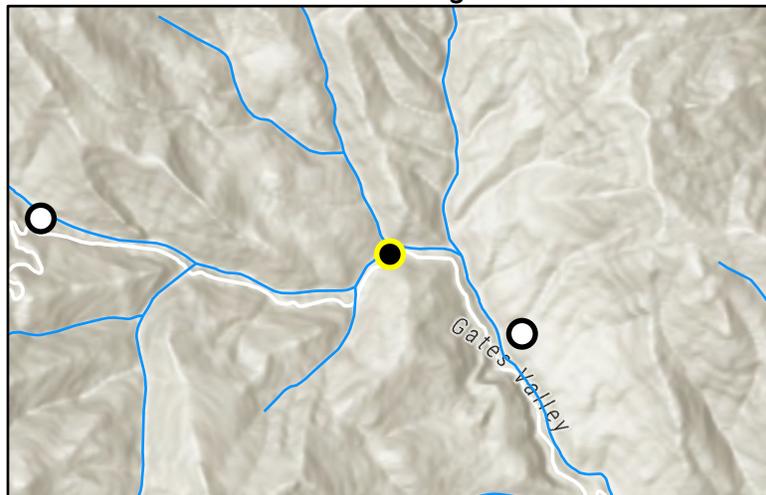
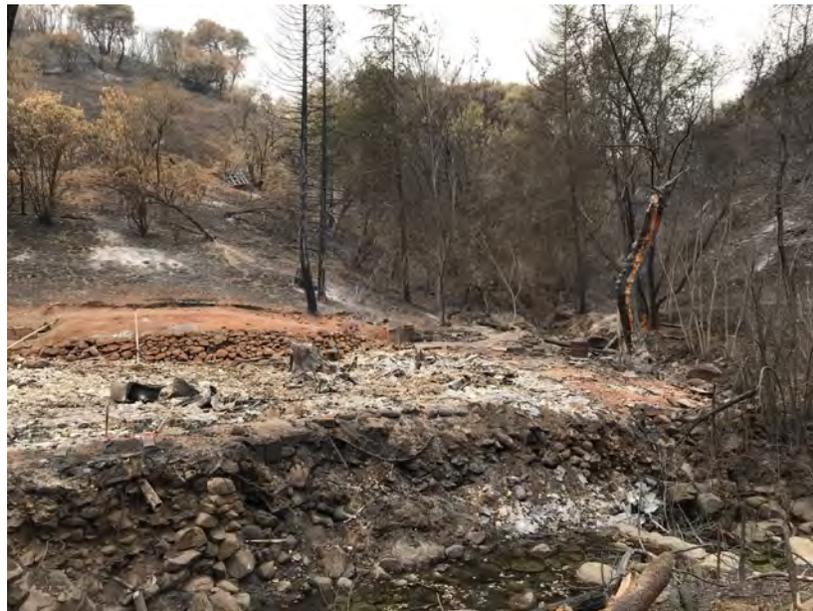
Field Observation Burned house in floodplain. House pad at confluence of Alamo Creek and side
or Potential Hazard: tributary. Possible trailer site with potential for flooding and debris flow.

Potential Hazard to Life: high

Potential Hazard to Property: high

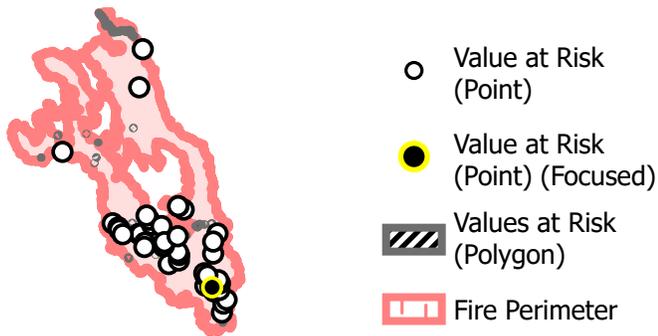
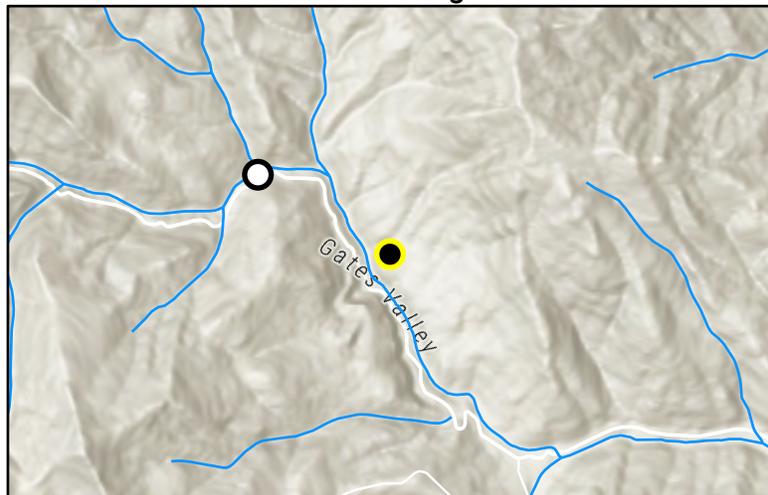
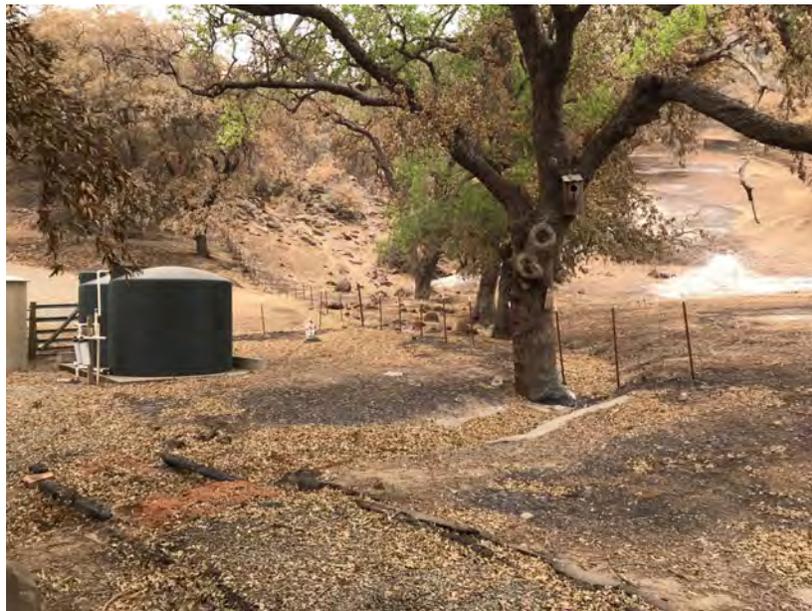
Field Observation House built on fan with very small poorly defined watercourse channel.
or Potential Hazard: Potential debris flow impact to burned house site or trailer.

Potential Hazard to Life: high

Potential Hazard to Property: high

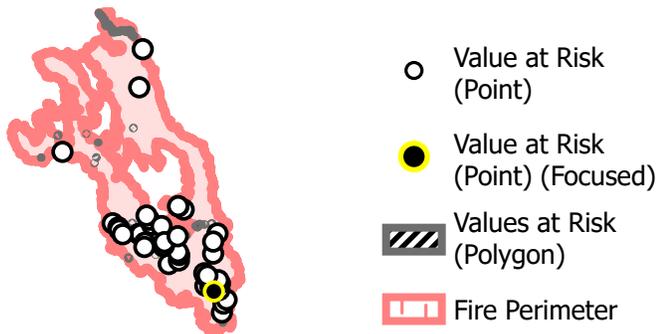
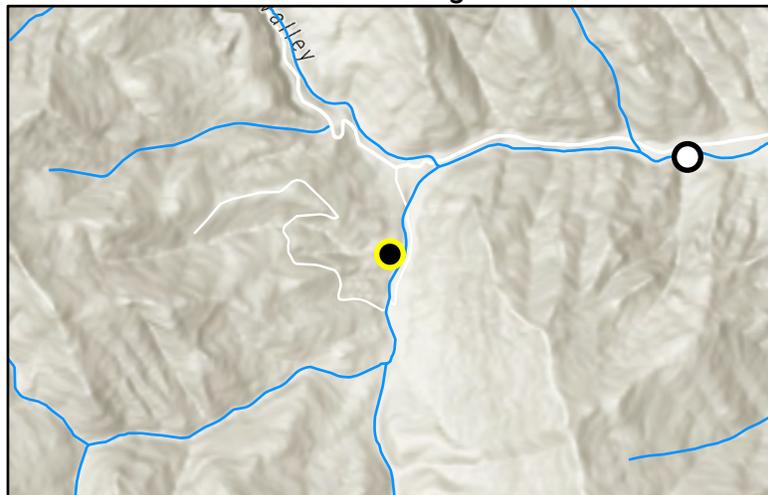
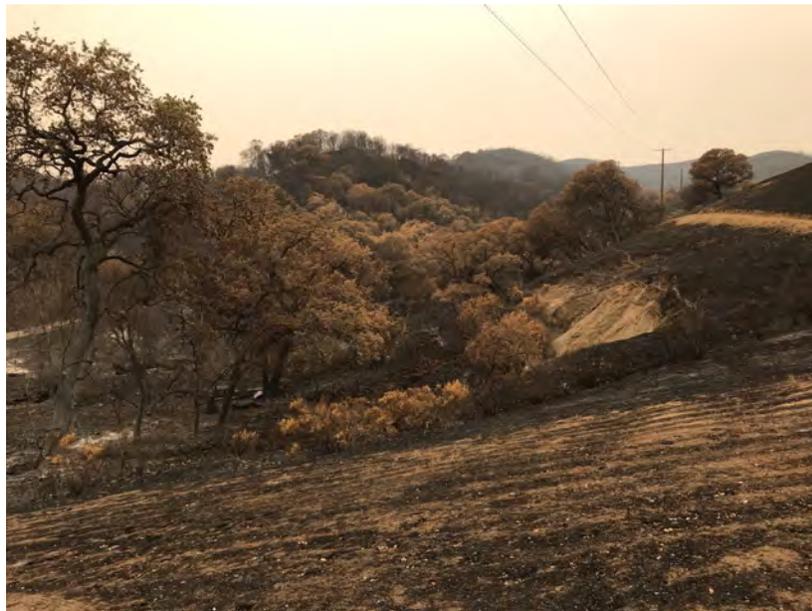
Field Observation or Potential Hazard: House next to watercourse in potential floodplain. Steep side tributary with boulders descends to house. Dam upslope likely to act as debris basin. Dam spillway is severely eroded and flooding downstream appears possible. Spillway channel flows to house.

Potential Hazard to Life: moderate

Potential Hazard to Property: moderate

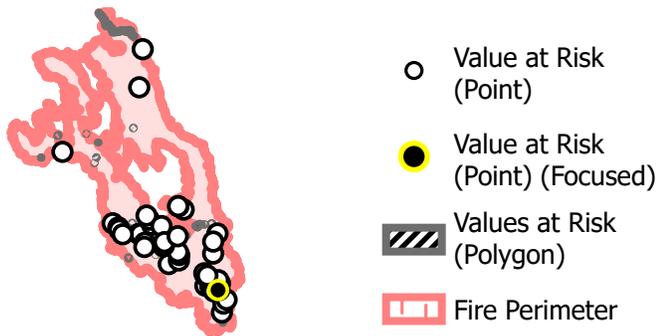
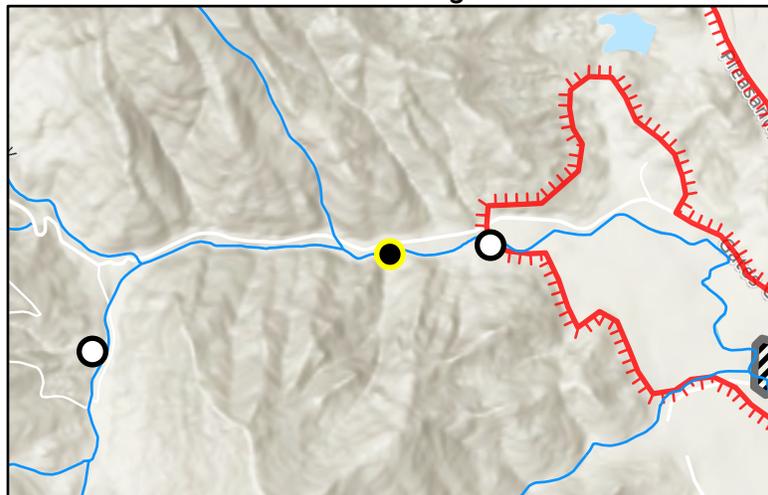
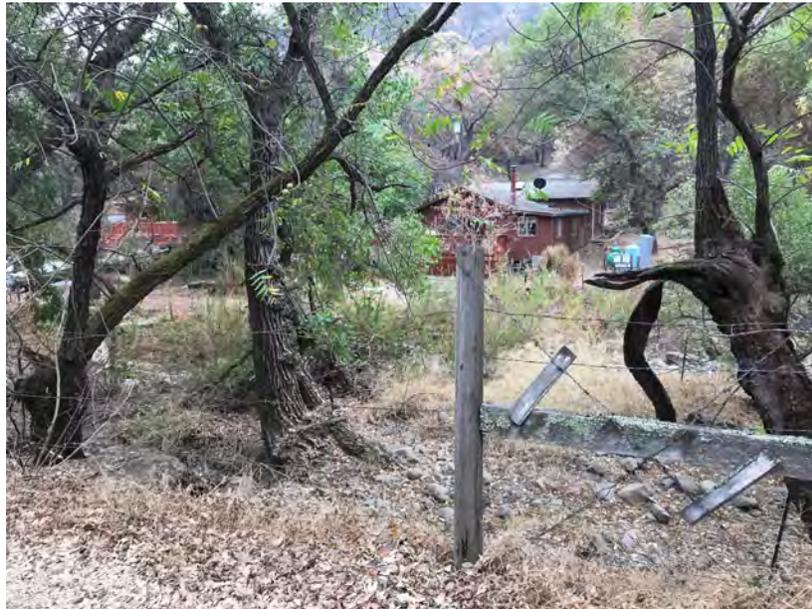
Field Observation House in potential floodplain.
or Potential Hazard:

Potential Hazard to Life: low

Potential Hazard to Property: moderate

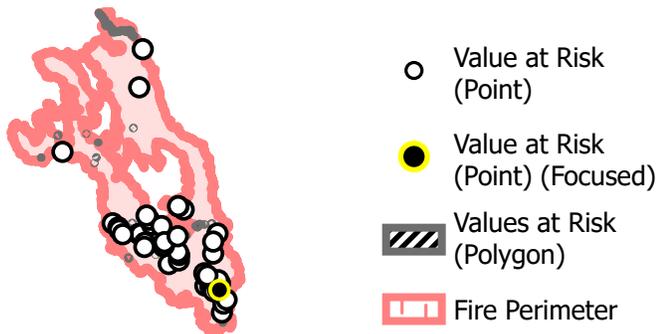
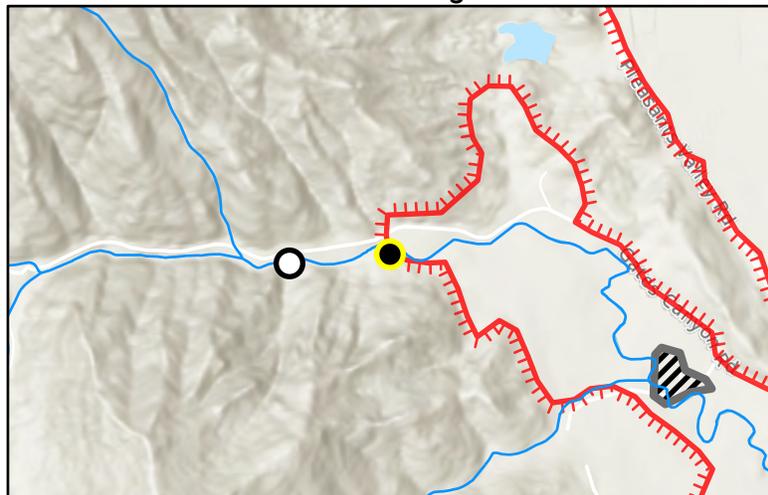
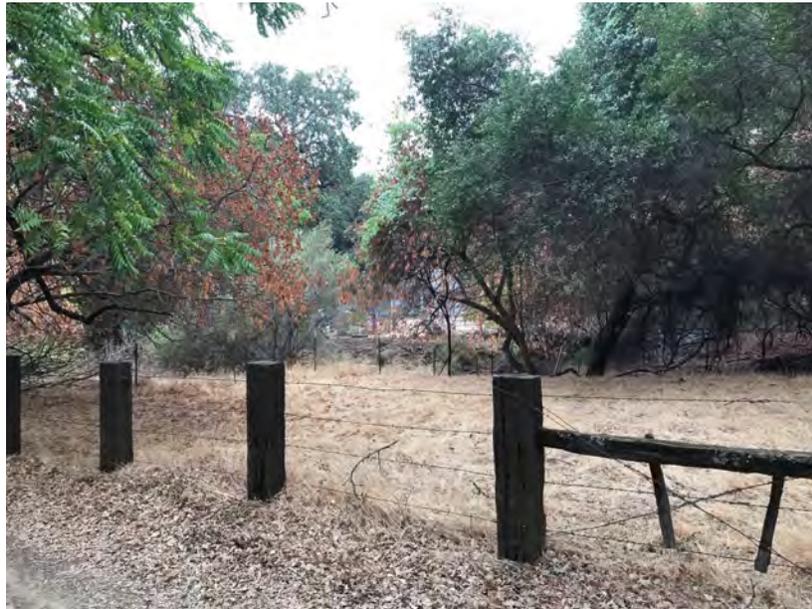
Field Observation Flooding potential. House is somewhat setback from watercourse but is on
or Potential Hazard: edge of mapped floodplain.

Potential Hazard to Life: low

Potential Hazard to Property: moderate

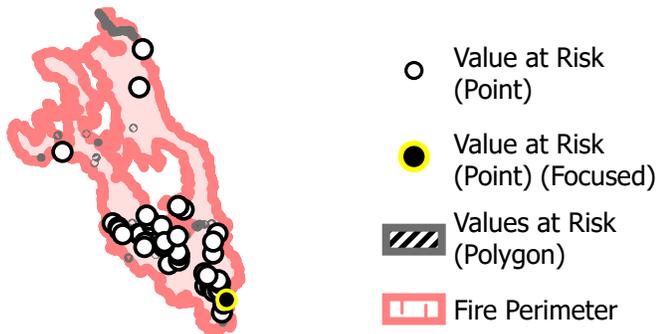
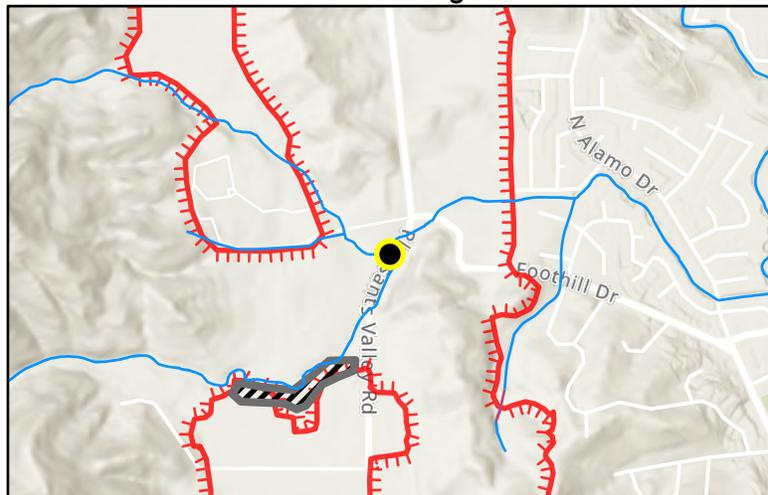
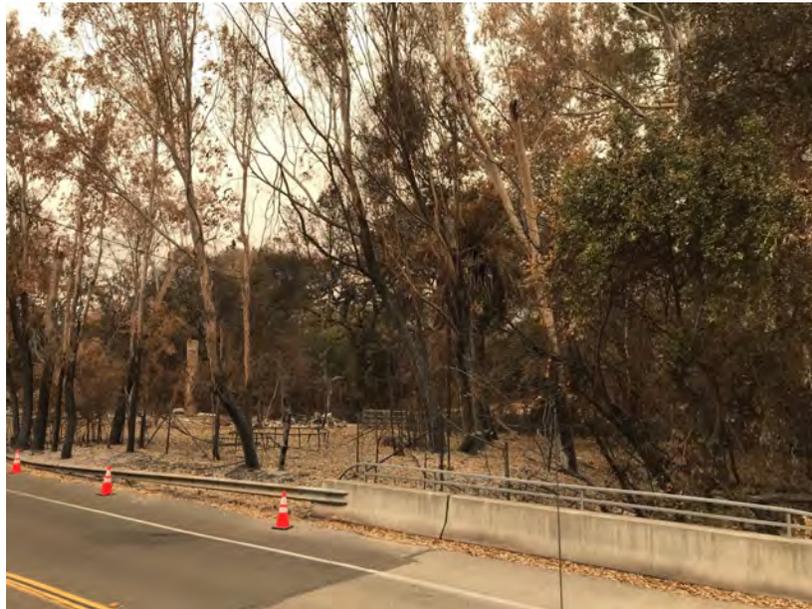
Field Observation Burned house in potential floodplain at confluence of watercourses.
or Potential Hazard:

Potential Hazard to Life: low

Potential Hazard to Property: moderate

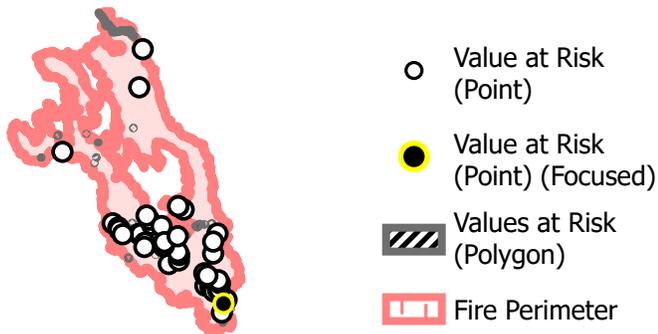
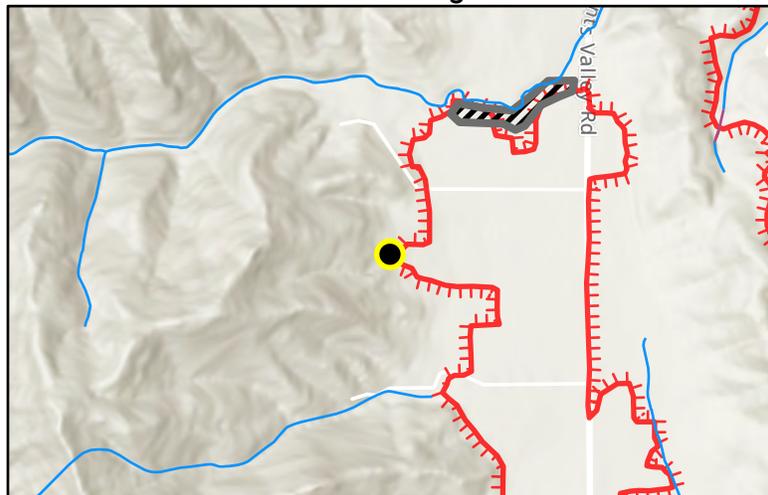
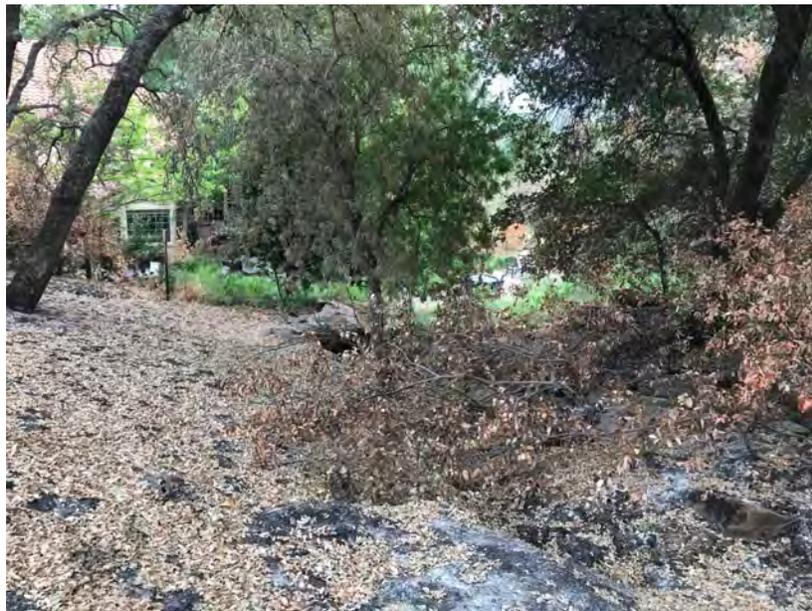
Field Observation House built on fan. Channel directed to right, around house. 3 ft and larger
or Potential Hazard: boulders in watercourse. Potential for debris flow.

Potential Hazard to Life: moderate

Potential Hazard to Property: moderate

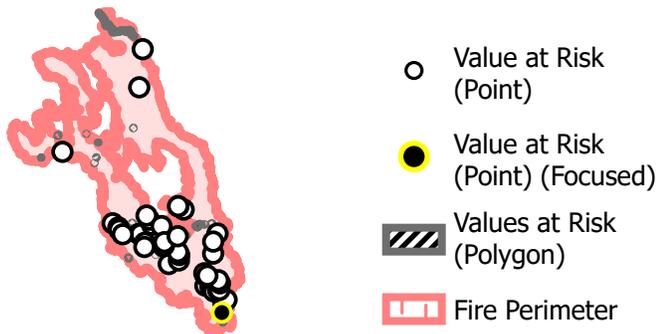
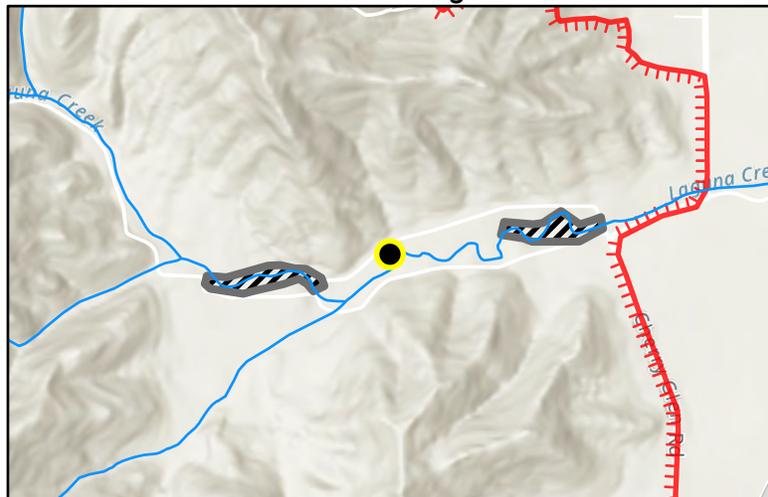
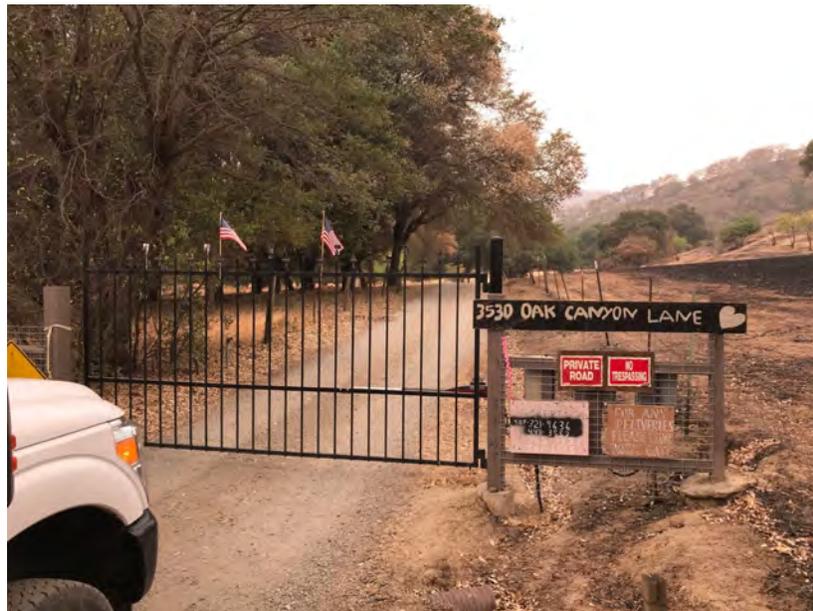
Field Observation Locked gate, not able to access. House is potentially in floodplain.
or Potential Hazard:

Potential Hazard to Life: low

Potential Hazard to Property: moderate

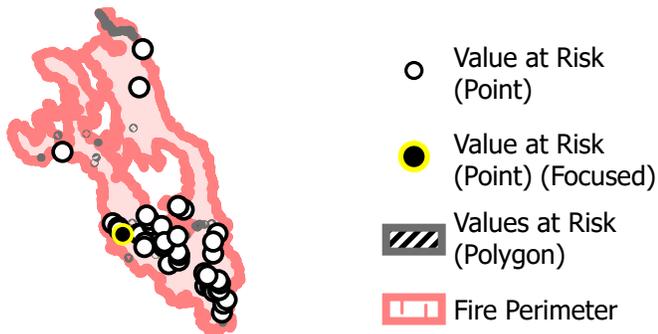
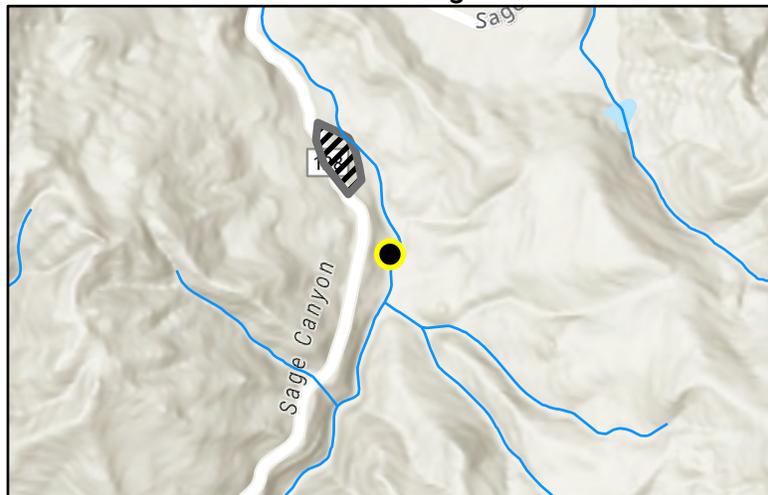
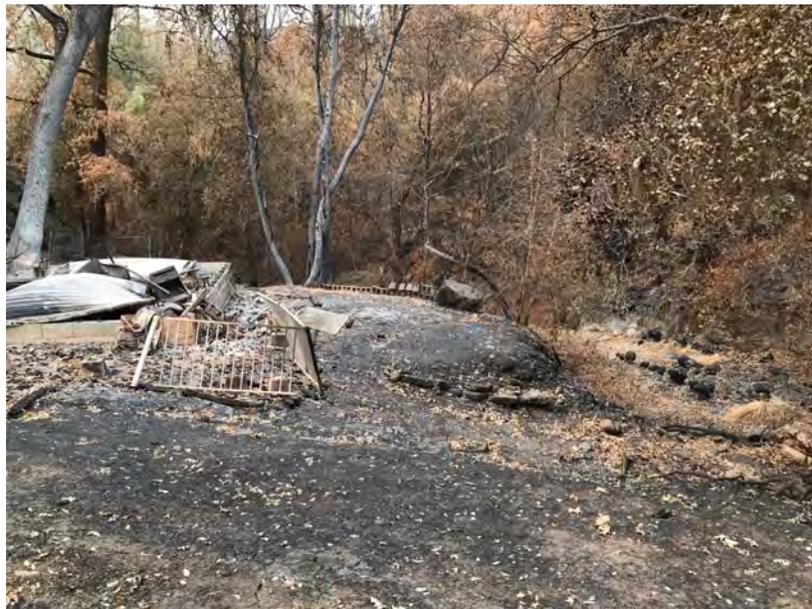
Field Observation: Burned structure next to watercourse in Sage Canyon. Flooding hazard.
or Potential Hazard:

Potential Hazard to Life: **moderate**

Potential Hazard to Property: **moderate**

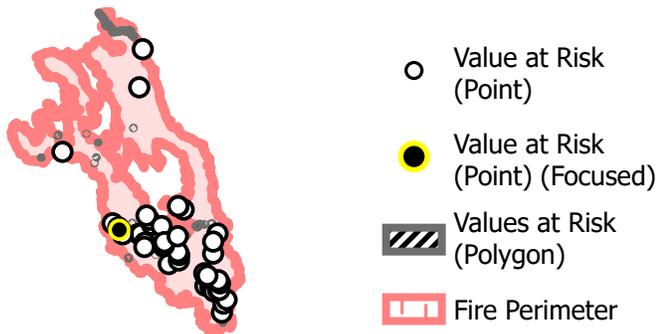
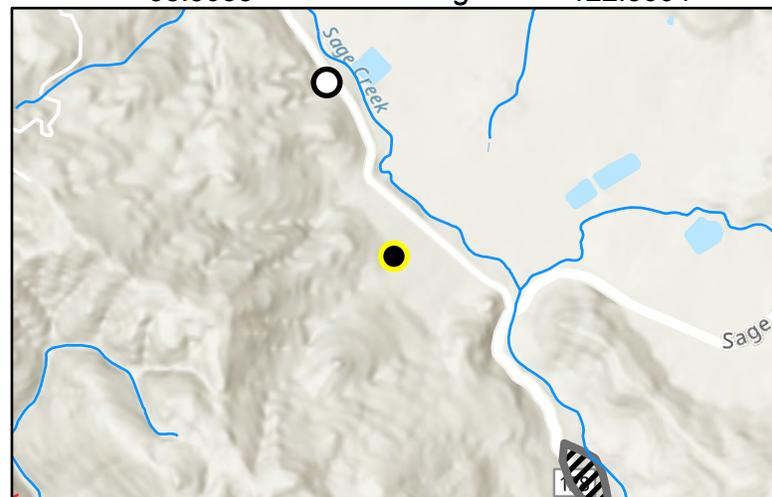
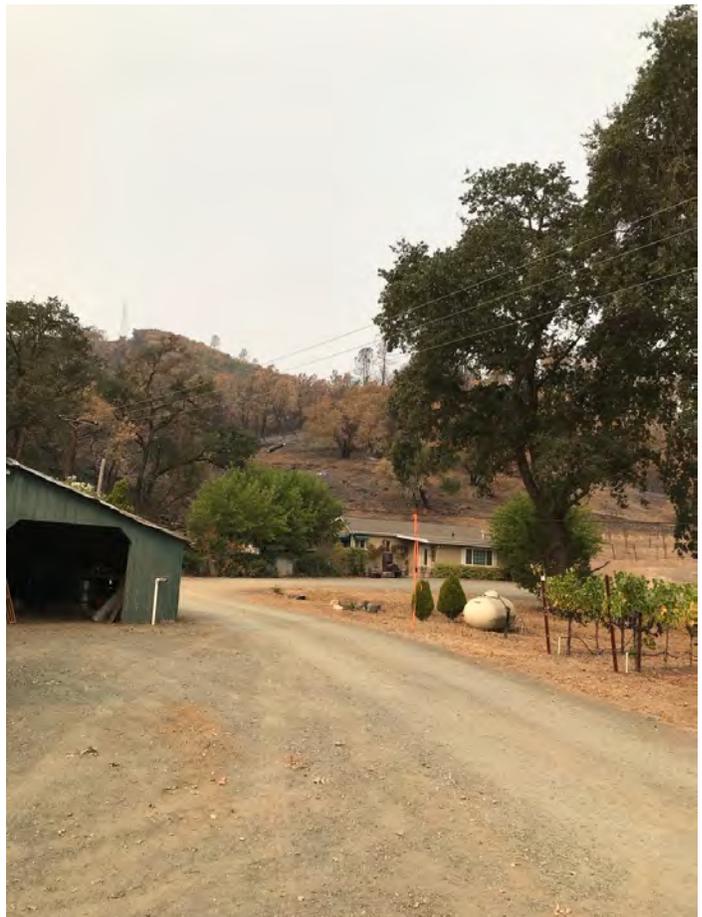
Field Observation House is in path of watercourse. Debris flow and flooding.
or Potential Hazard:

Potential Hazard to Life: **high**

Potential Hazard to Property: **high**

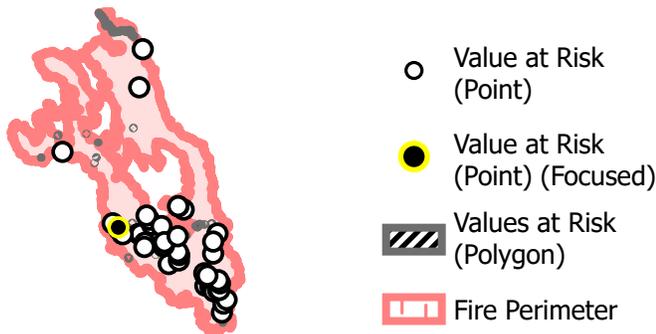
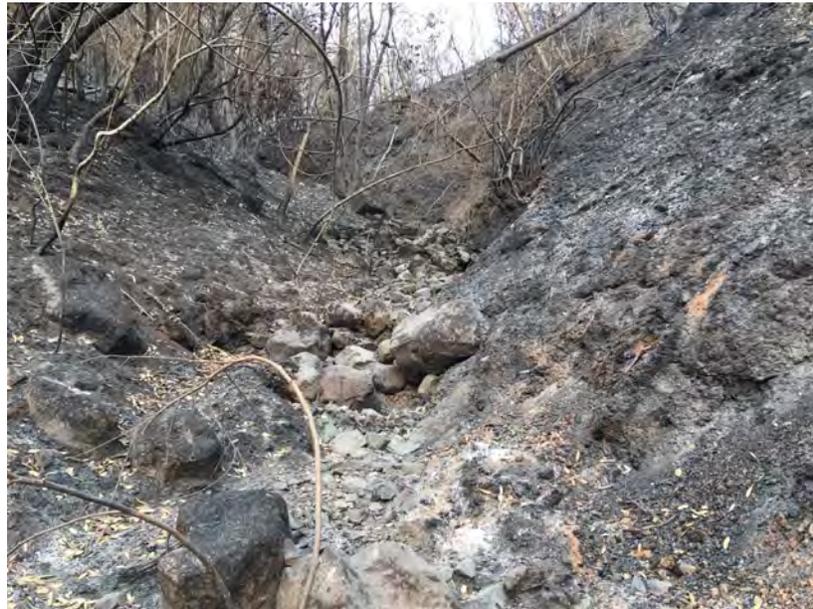
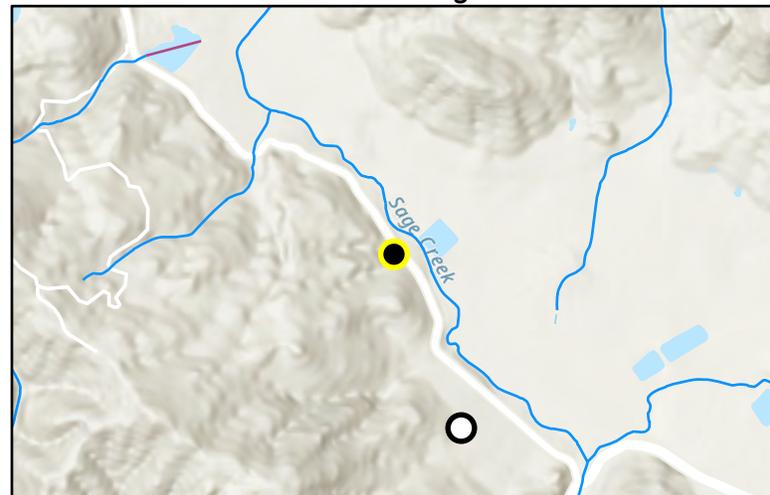
Field Observation Burned structure in path of two smaller watercourses in moderate burn. Barn
or Potential Hazard: across the road is also at risk. Debris flow and flooding hazards.

Potential Hazard to Life: **high**

Potential Hazard to Property: **high**

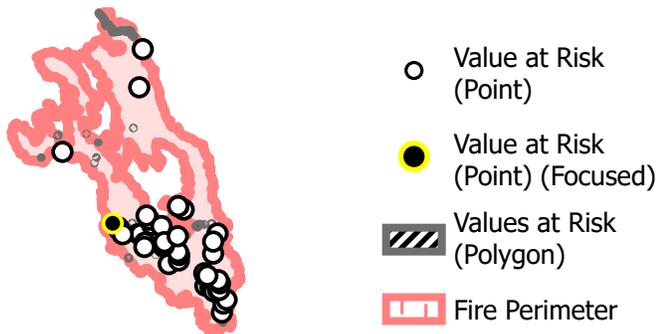
Field Observation House sits next to watercourse. Debris flow and flooding.
or Potential Hazard:

Potential Hazard to Life: **moderate**

Potential Hazard to Property: **moderate**

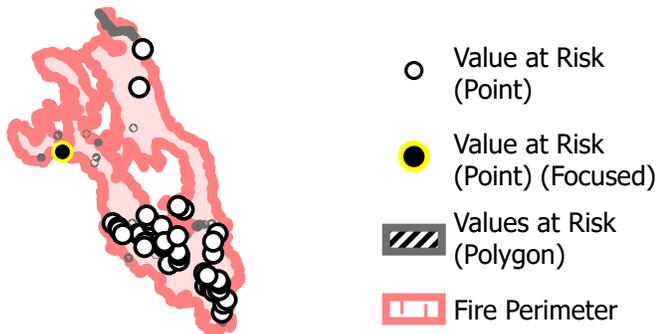
Field Observation or Potential Hazard: Potential for flooding from main channel, appears outside of mapped flood zone.

Potential Hazard to Life: **low**

Potential Hazard to Property: **moderate**

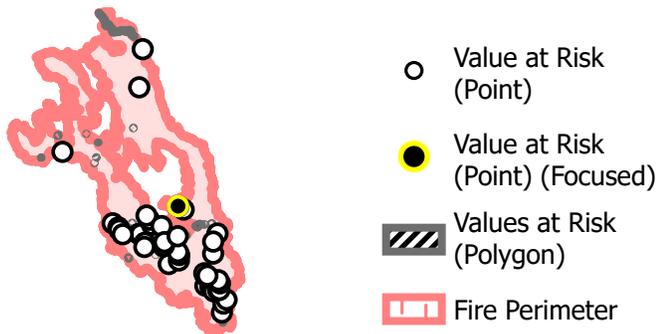
Field Observation Debris flow hazard at location of house, identified by damage inspection, based on **Potential Hazard:** on proximity to channel on hillshade. Not able to access.

Potential Hazard to Life: moderate

Potential Hazard to Property: moderate

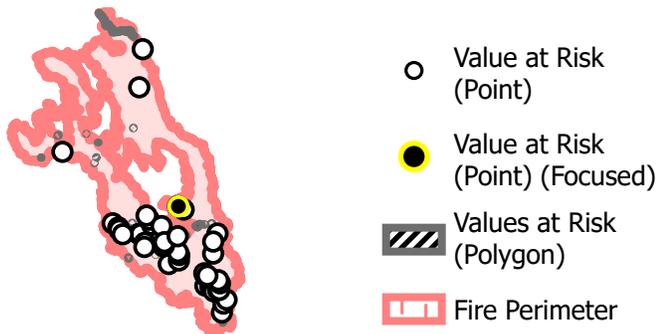
Field Observation Debris flow hazard at location of house, identified by damage inspection, based on **Potential Hazard:** on proximity to channel on hillshade. Not able to access.

Potential Hazard to Life: moderate

Potential Hazard to Property: moderate

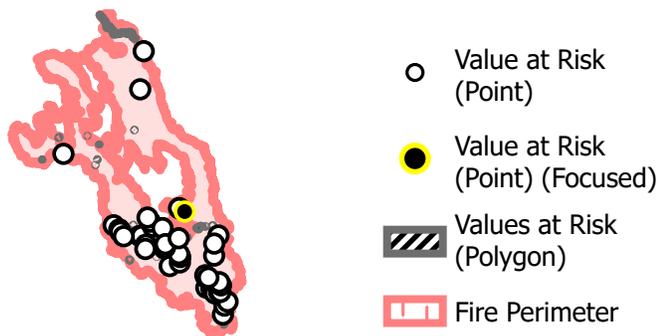
Field Observation Debris flow hazard at location of house, identified by damage inspection, based on **Potential Hazard:** on proximity to channel on hillshade. Not able to access.

Potential Hazard to Life: moderate

Potential Hazard to Property: moderate

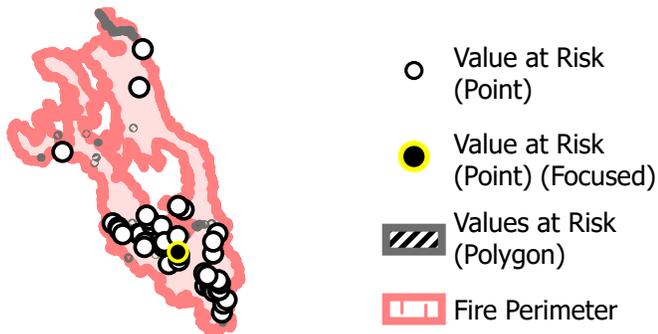
Field Observation Burned house along edge of potential debris flow drainage. Culvert at upstream
or Potential Hazard: edge of house pad has potential to plug and divert flows to house.

Potential Hazard to Life: moderate

Potential Hazard to Property: moderate

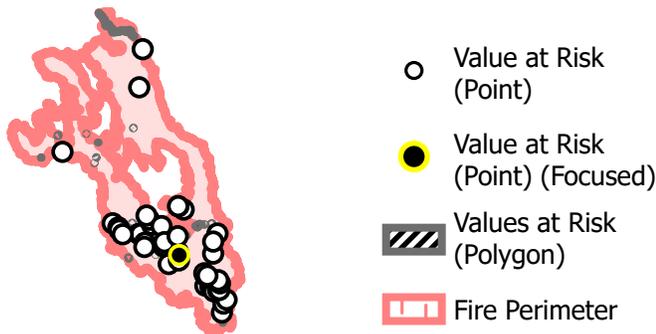
Field Observation or Potential Hazard: Burned house along edge of potential debris flow drainage. 1 to 4-foot diameter boulders in channel. Culvert at upstream edge of house pad has potential to plug and divert flows to house.

Potential Hazard to Life: moderate

Potential Hazard to Property: moderate
