Watershed Emergency Response Team Evaluation
LNU LIGHTNING COMPLEX
HENNESSEY FIRE

CA-LNU-013407

October 8, 2020

LNU LIGHTNING COMPLEX (HENNESSEY FIRE)
Watershed Emergency Response Team EVALUATION
October 8, 2020

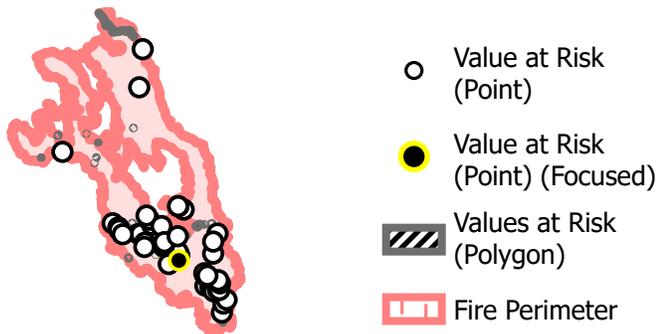
Field Observation Burned house within potential debris flow drainage. Channel diverted around
or Potential Hazard: house pad. Large boulders in channel.

Potential Hazard to Life: high

Potential Hazard to Property: high

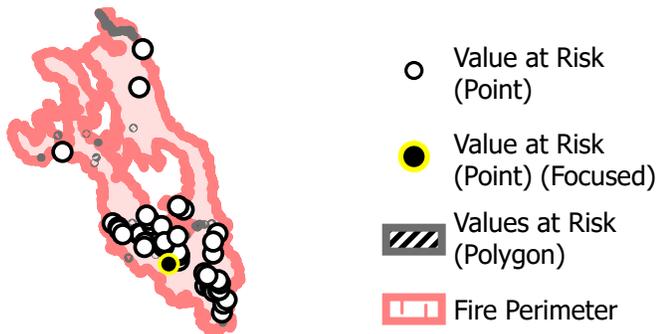
Field Observation Debris flow and flood hazard. Not able to access due to locked gate.
or Potential Hazard:

Potential Hazard to Life: moderate

Potential Hazard to Property: moderate

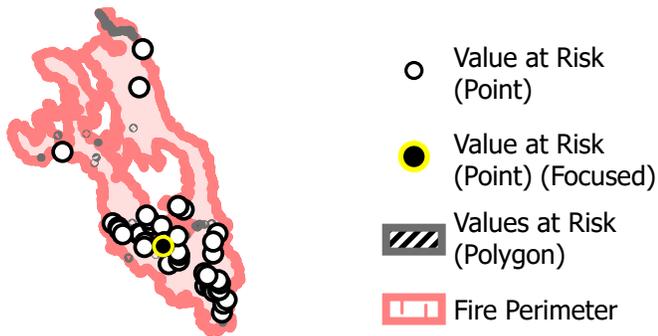
Field Observation House near watercourse. Locked gate, not able to access. Debris flow and
or Potential Hazard: flooding potential.

Potential Hazard to Life: moderate

Potential Hazard to Property: moderate

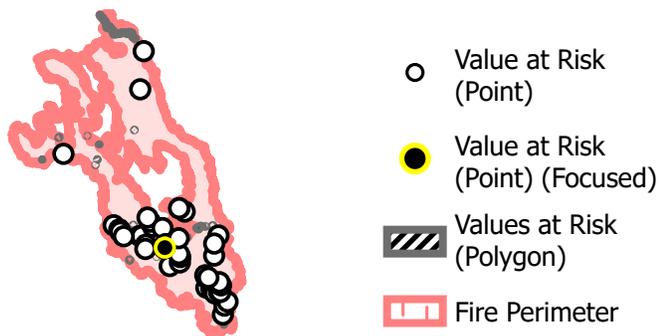
Field Observation House built on low terrace next to watercourse.
or Potential Hazard:

Potential Hazard to Life: moderate

Potential Hazard to Property: moderate

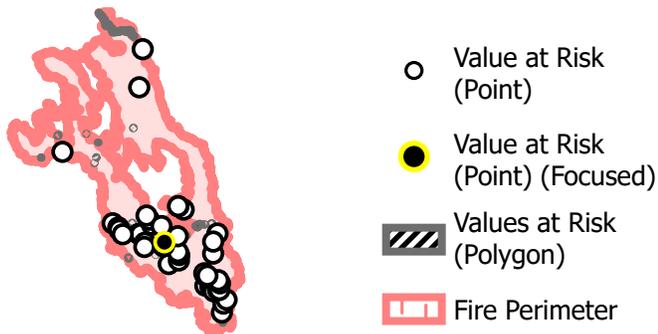
Field Observation Burned mobile home next to watercourse.
or Potential Hazard:

Potential Hazard to Life: moderate

Potential Hazard to Property: low

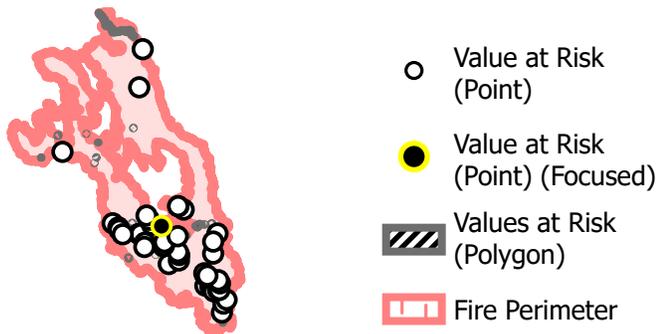
Field Observation House built at mouth of potential debris flow channel.
or Potential Hazard:

Potential Hazard to Life: moderate

Potential Hazard to Property: moderate

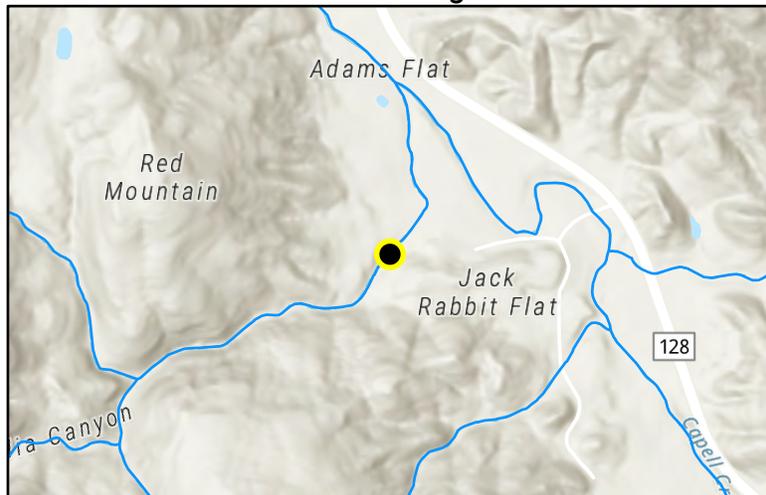
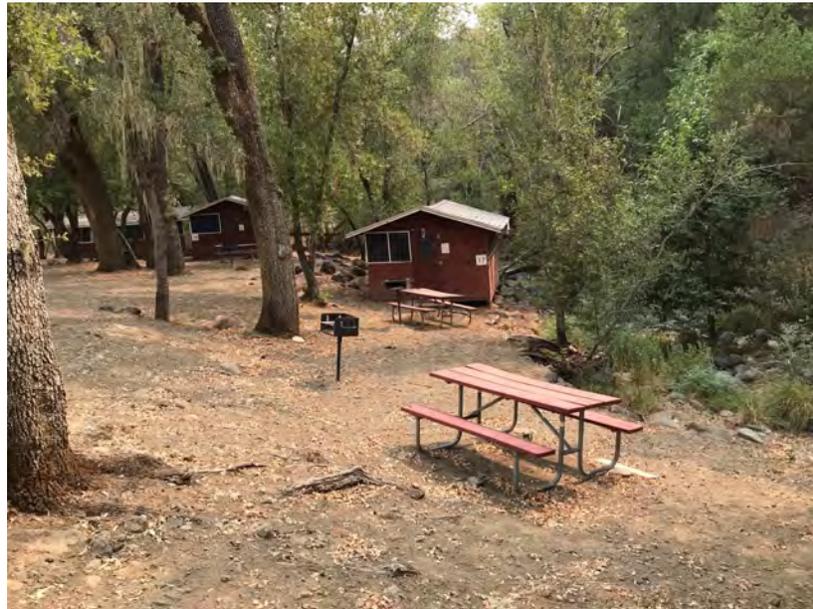
Field Observation Teen Center with lots of cabins in path of watercourse. Low soil burn severity.
or Potential Hazard:

Potential Hazard to Life: moderate

Potential Hazard to Property: low

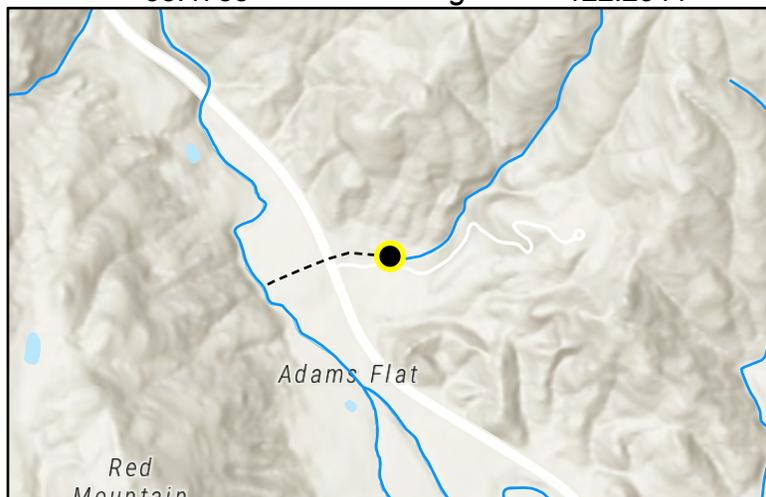
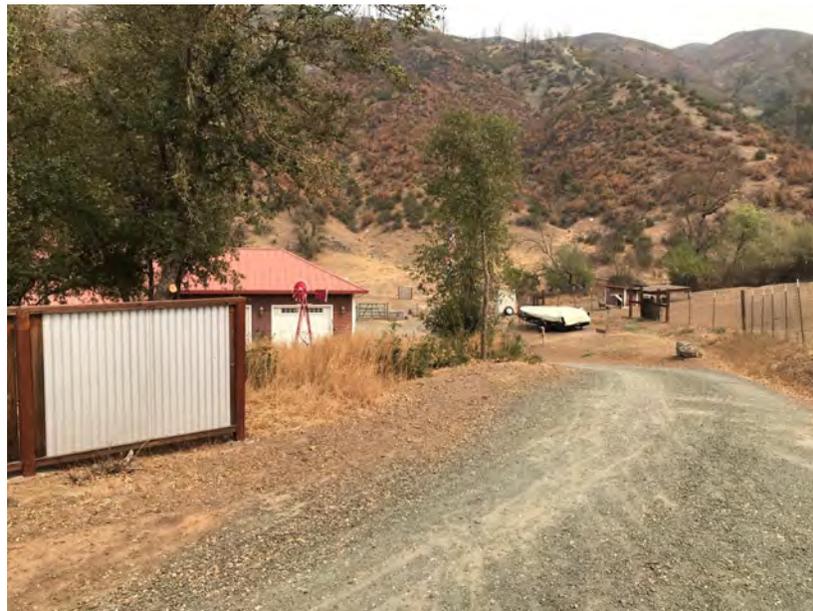
Field Observation House in drainage path.
or Potential Hazard:

Potential Hazard to Life: moderate

Potential Hazard to Property: moderate

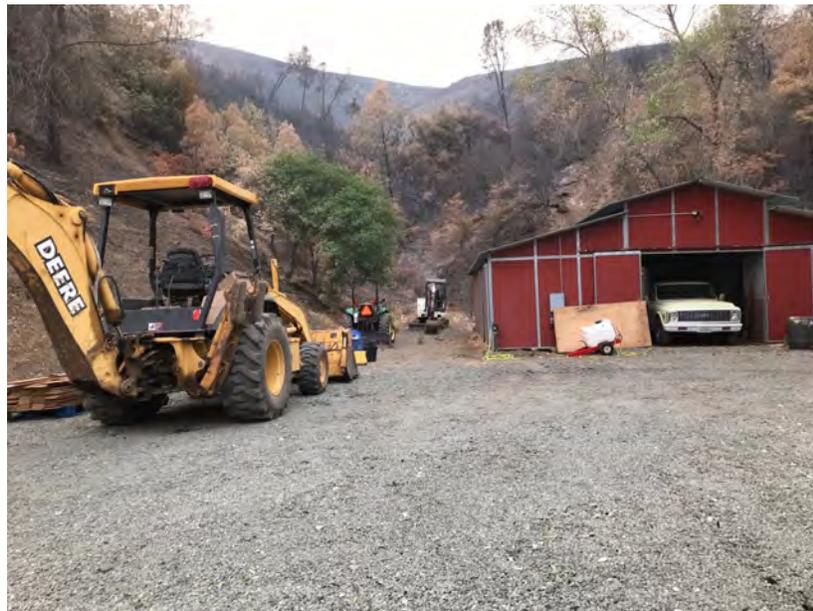
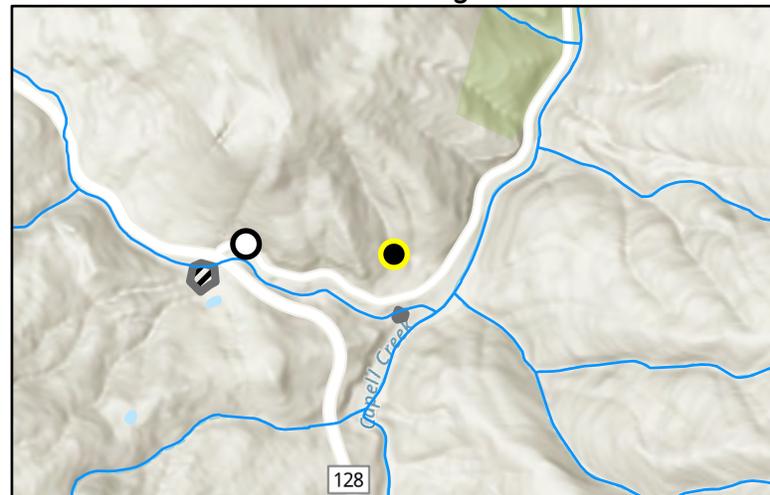
Field Observation Debris flow outlet where garage/stable is currently sitting. House offset from
Potential Hazard: debris flow path.

Potential Hazard to Life: moderate

Potential Hazard to Property: high

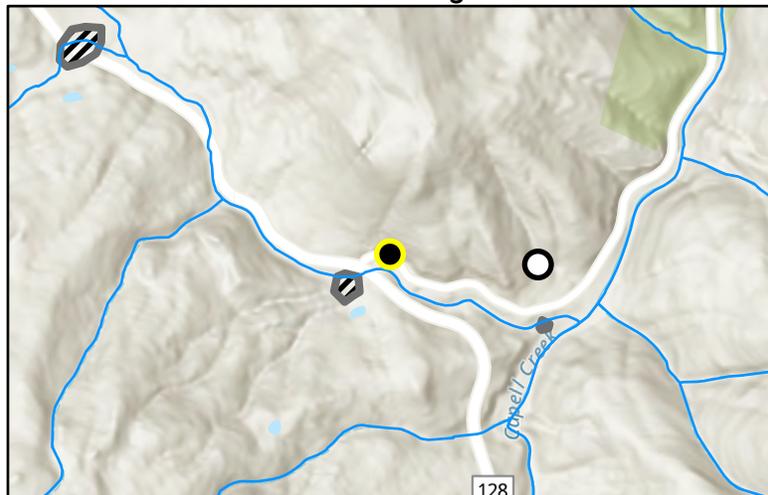
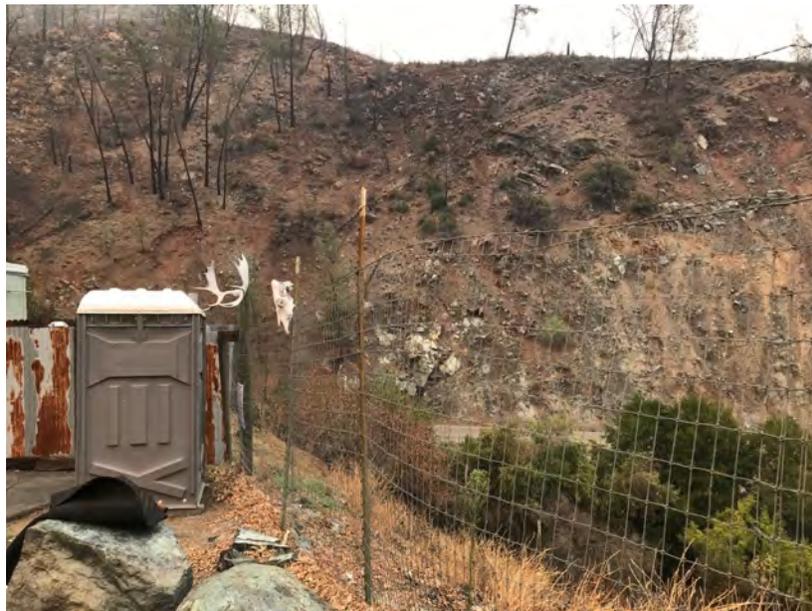
Field Observation Potential rock fall hazards, owner confirms existing nuisance of rock fall
or Potential Hazard: hazards (yearly issues) onto road.

Potential Hazard to Life: high

Potential Hazard to Property: moderate

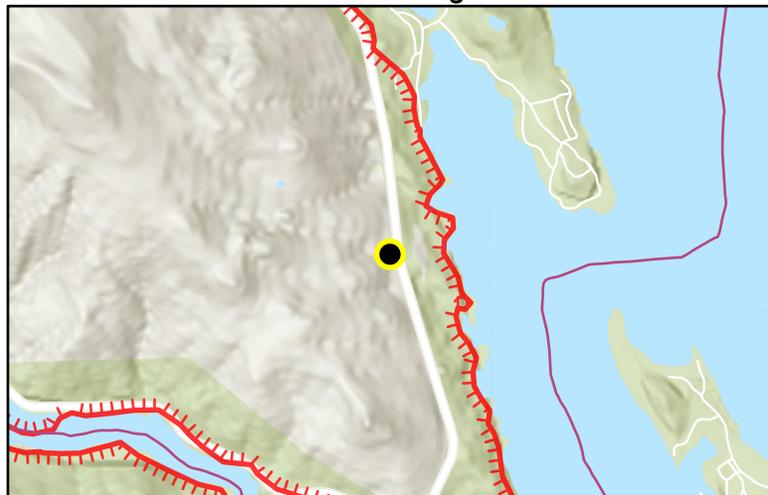
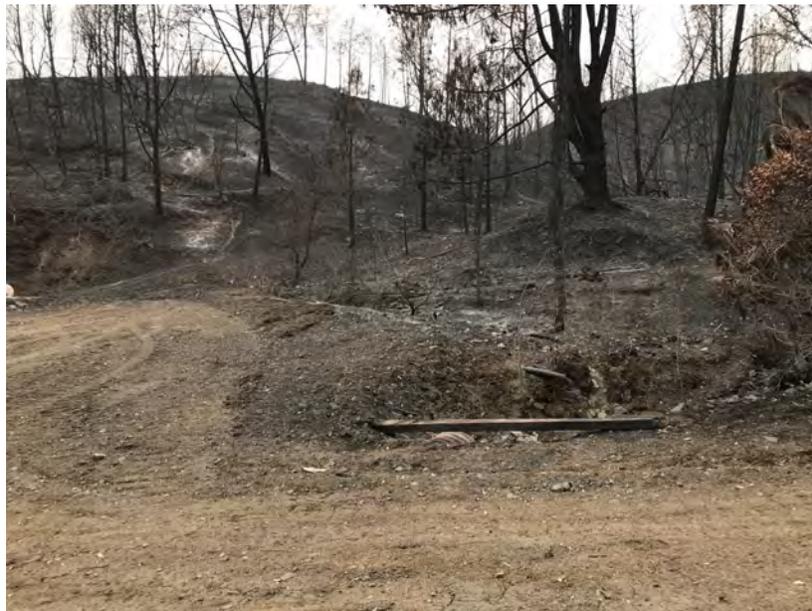
Field Observation Small bank protecting house but potential for debris flow to plug small culvert
or Potential Hazard: and divert towards house or overtop bank towards house.

Potential Hazard to Life: **moderate**

Potential Hazard to Property: **moderate**

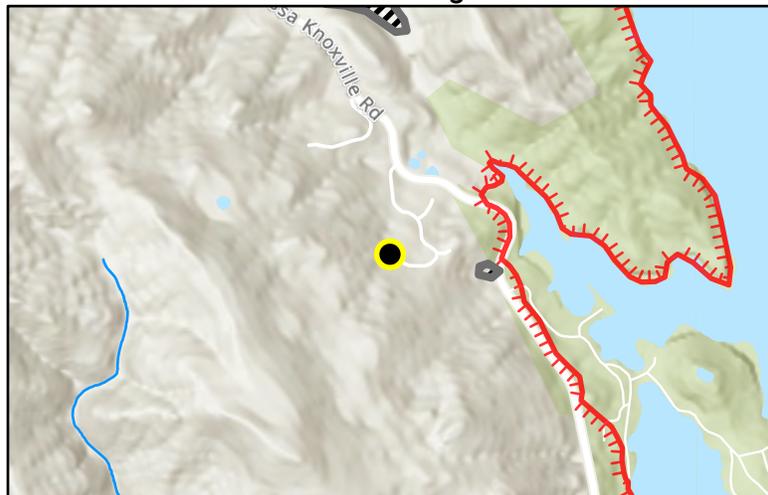
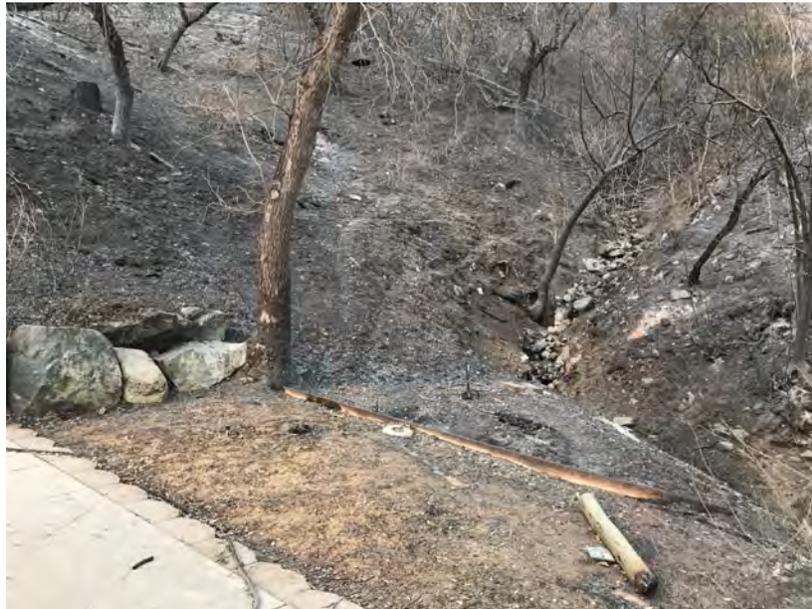
Field Observation Potential debris flow avulsion from steep watercourse adjacent to house.
or Potential Hazard:

Potential Hazard to Life: moderate

Potential Hazard to Property: moderate

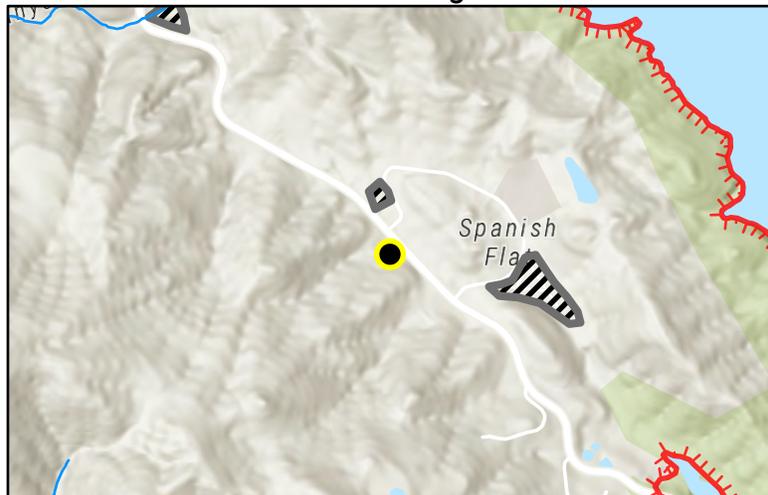
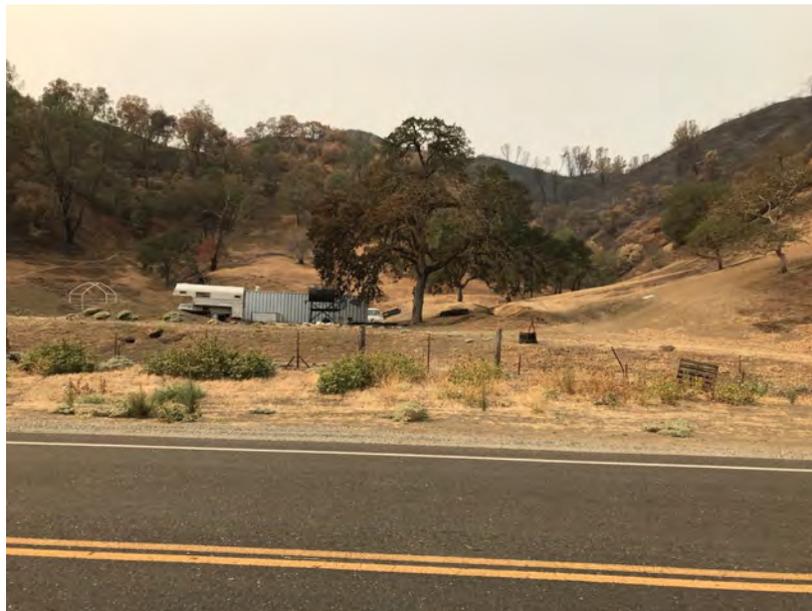
Field Observation Potential for flooding or sediment laden flow to enter property. Small source
or Potential Hazard: material (gravel, sand).

Potential Hazard to Life: moderate

Potential Hazard to Property: moderate

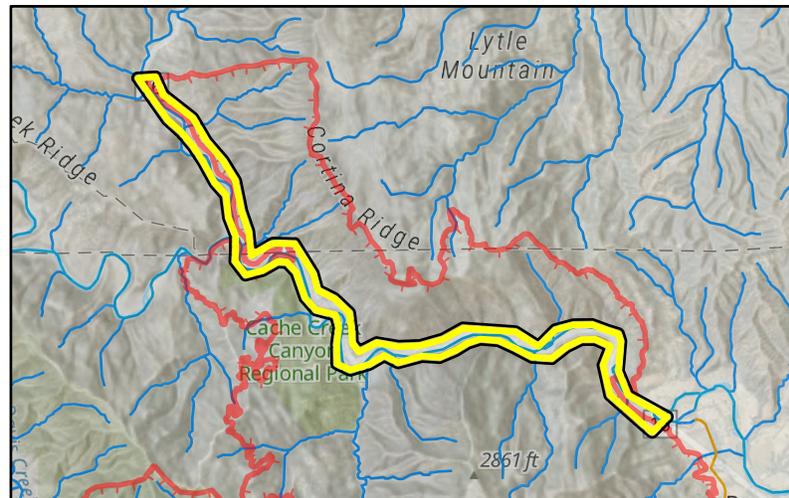
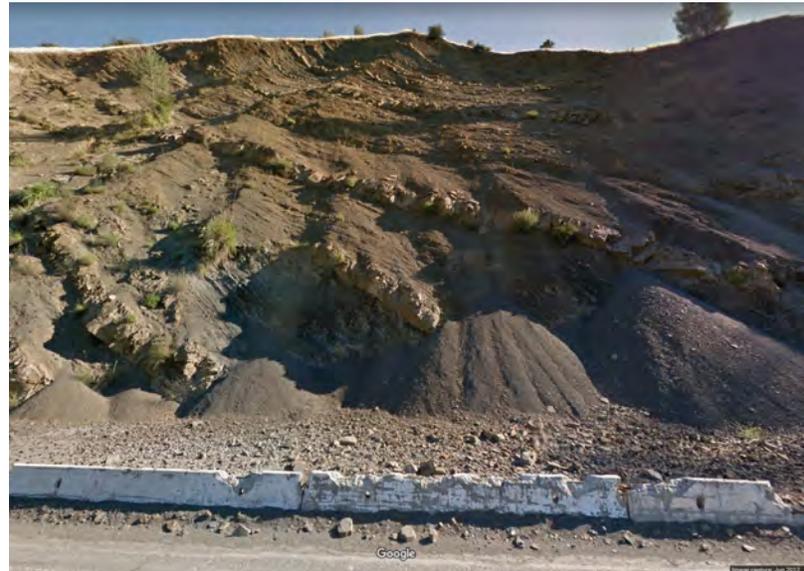
Field Observation Rock fall, debris flow onto State Highway 16.
or Potential Hazard:

Potential Hazard to Life: high

Potential Hazard to Property: low

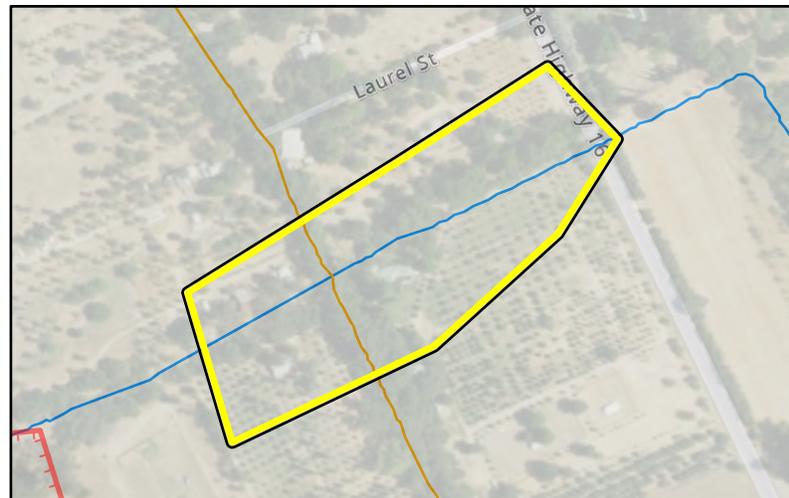
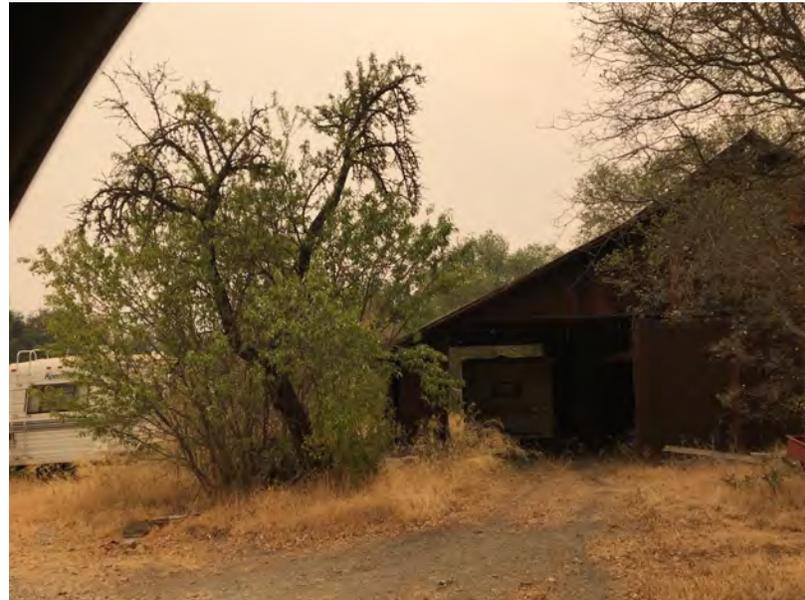
Field Observation Lots of structures near canal with little room for conveyance. Damage to
Potential Hazard: drainage canal.

Potential Hazard to Life: low

Potential Hazard to Property: moderate

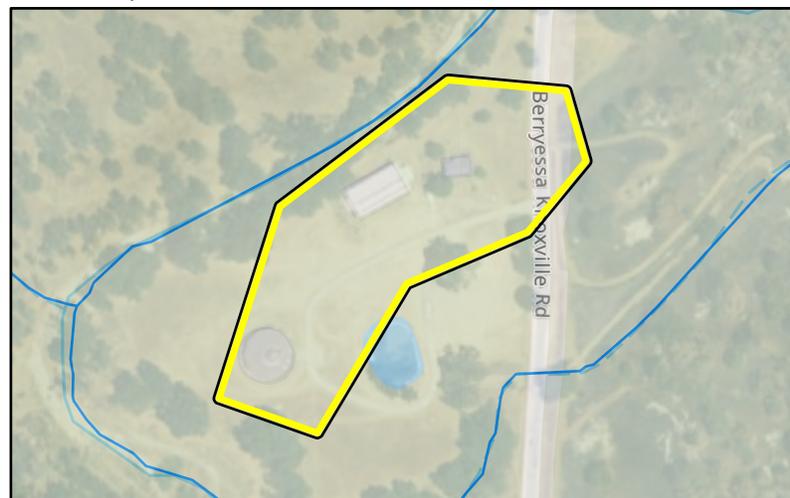
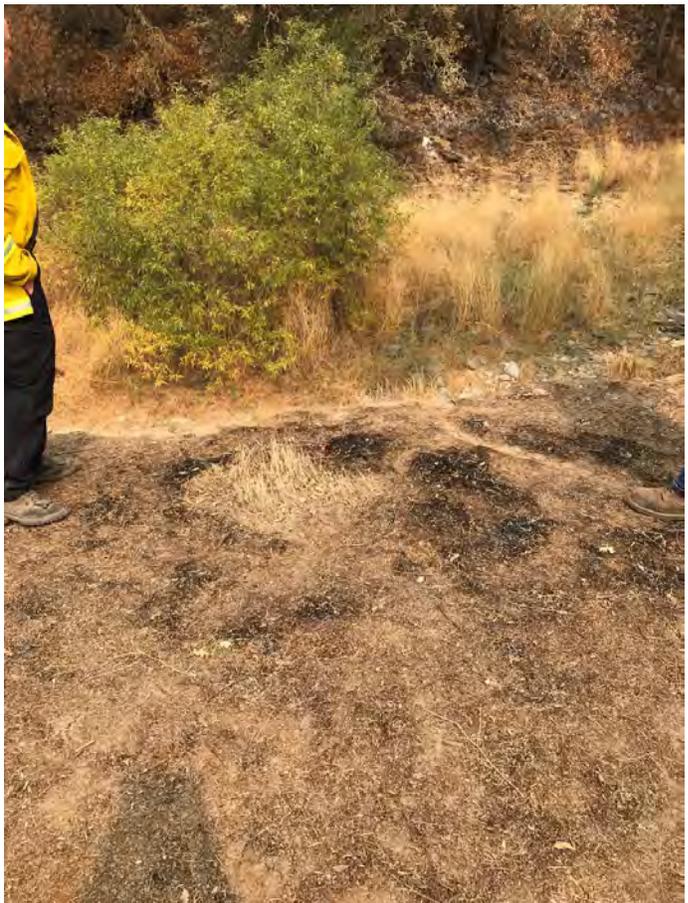
Field Observation or Potential Hazard: Structures at risk of potential flooding from main watercourse. Worker said stream eroded large part of bank a few years ago. House next to main watercourse is currently vacant. Knoxville Wildlife headquarters.

Potential Hazard to Life: low

Potential Hazard to Property: moderate

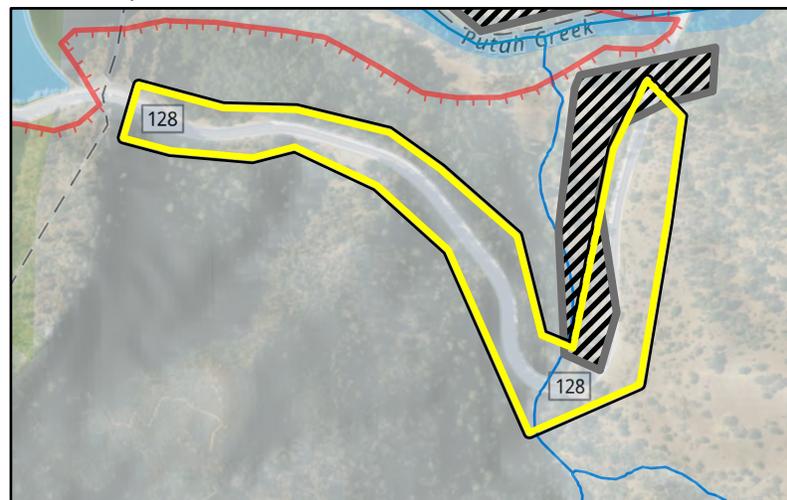
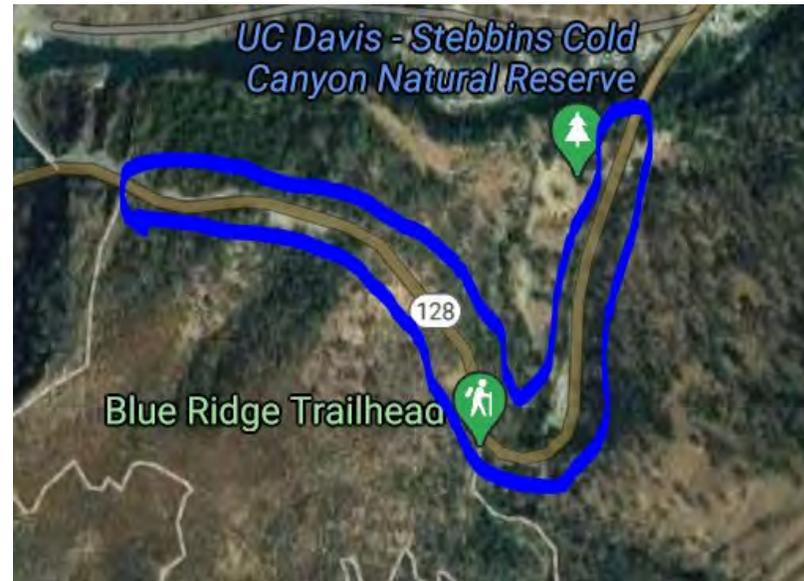
Field Observation **Rock fall onto Highway.**
or Potential Hazard:

Potential Hazard to Life: **moderate**

Potential Hazard to Property: **low**

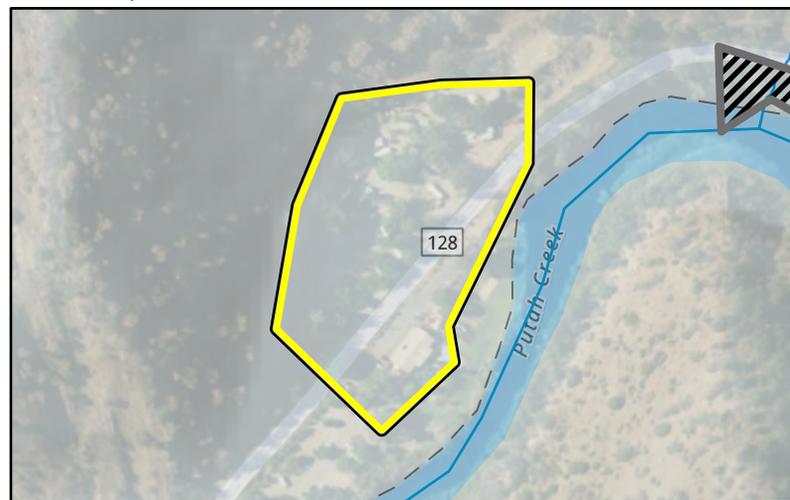
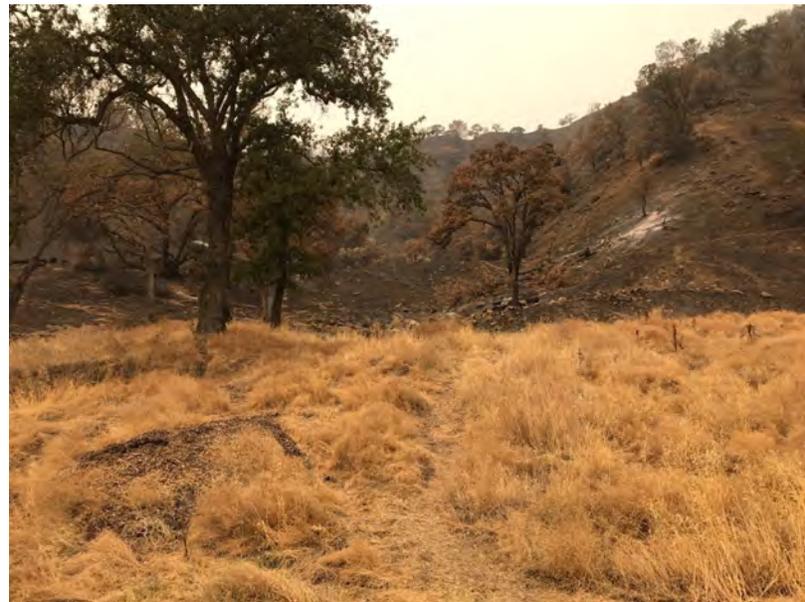
Field Observation or Potential Hazard: Potential rock fall hazards. Have had a boulder, a few feet across, land on office. Potential debris flows from basins directed at yurt and trailer. Debris retention basin upstream.

Potential Hazard to Life: high

Potential Hazard to Property: high

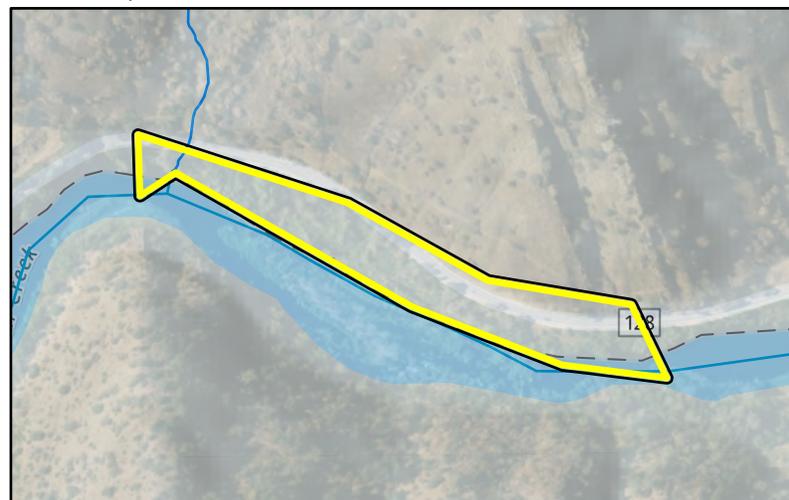
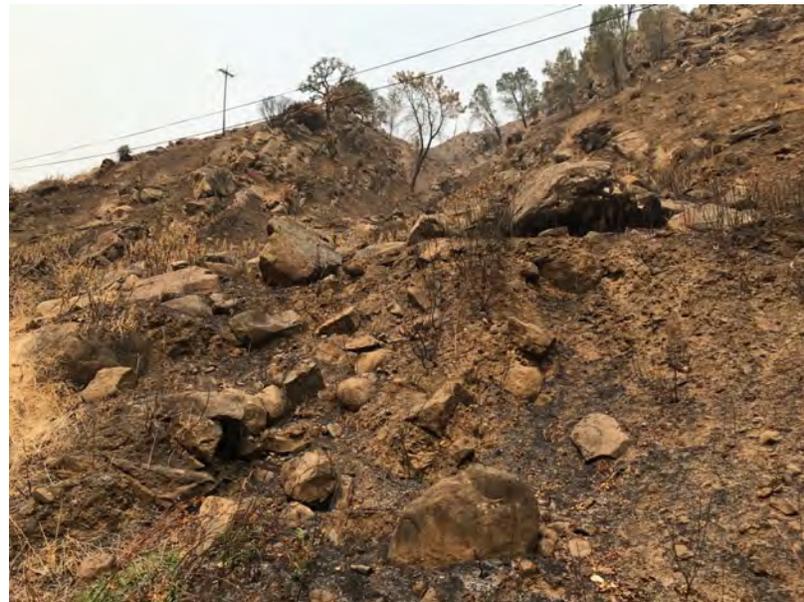
Field Observation **Rock fall hazards.**
or Potential Hazard:

Potential Hazard to Life: **moderate**

Potential Hazard to Property: **low**

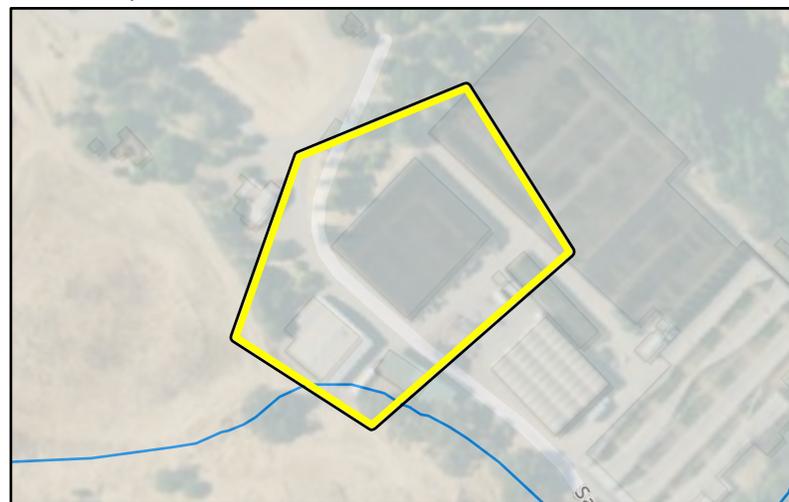
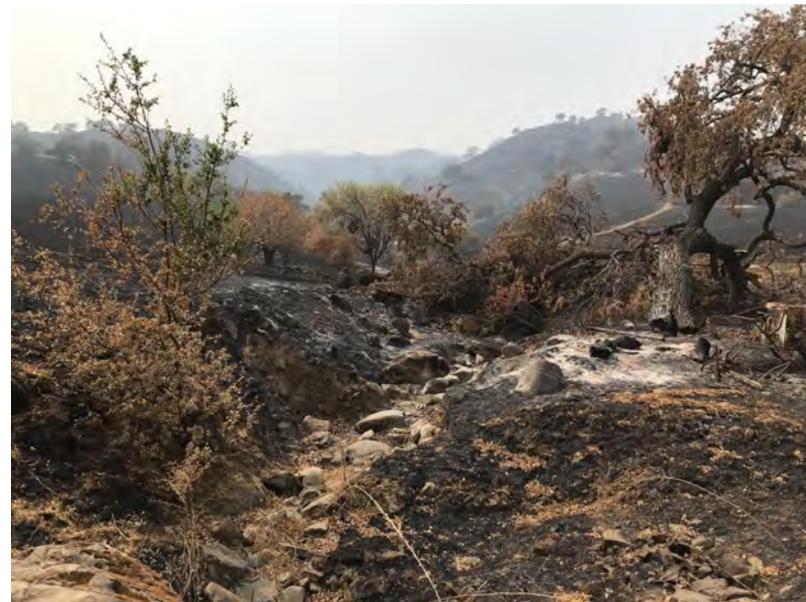
Field Observation Ag buildings in flow path of watercourse. Debris flow and flooding hazards.
Potential Hazard:

Potential Hazard to Life: moderate

Potential Hazard to Property: moderate

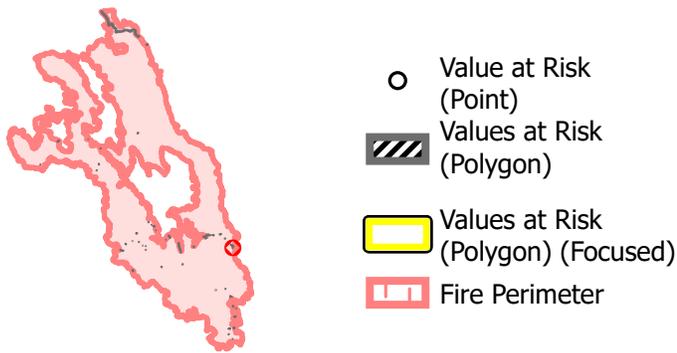
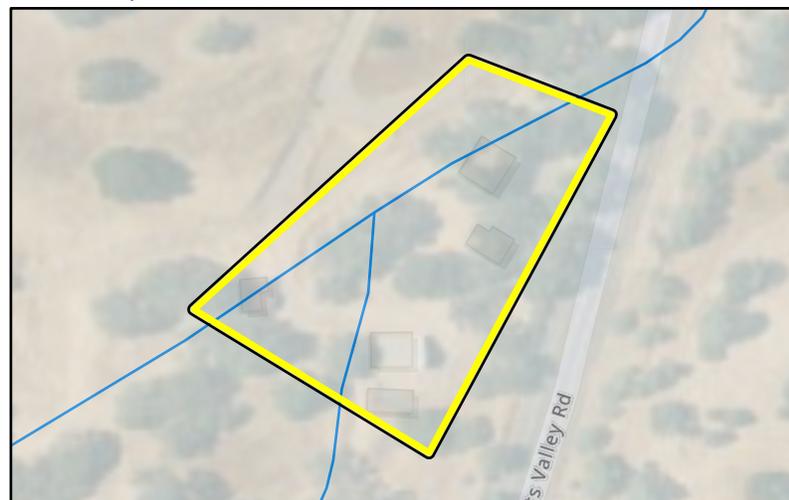
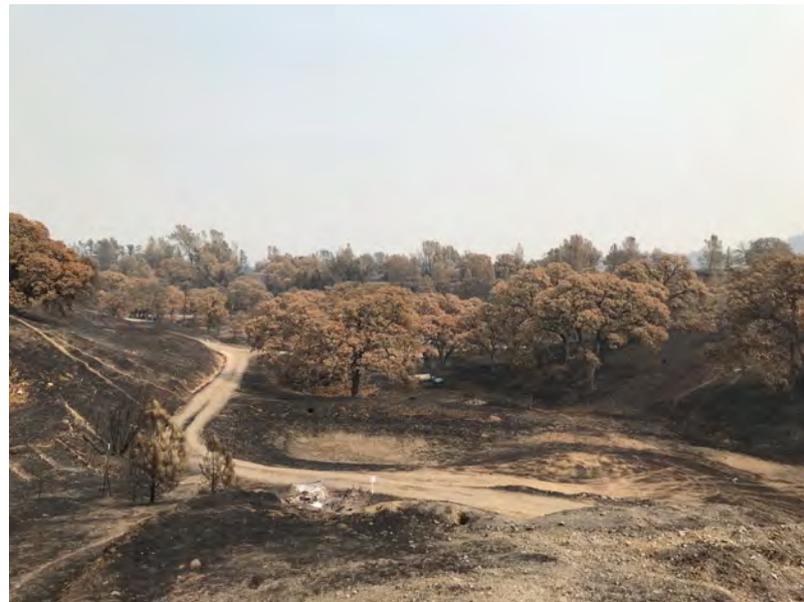
Field Observation Burned structures in the confluence of two watercourses. Potential flood risk.
or Potential Hazard:

Potential Hazard to Life: moderate

Potential Hazard to Property: moderate

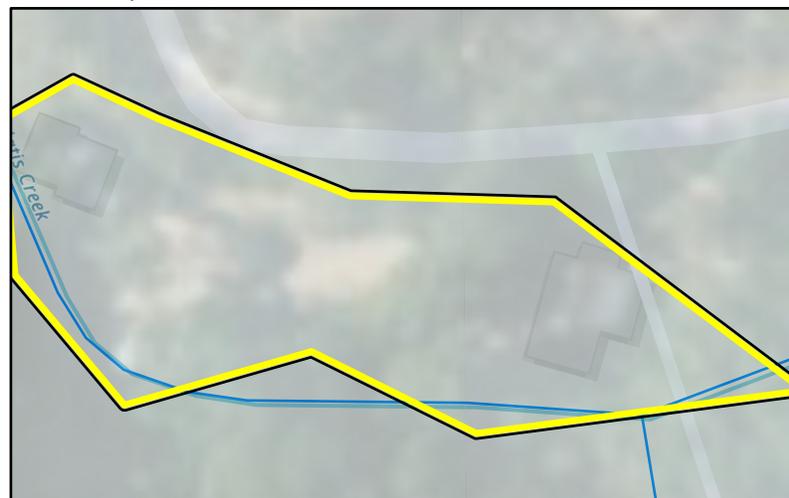
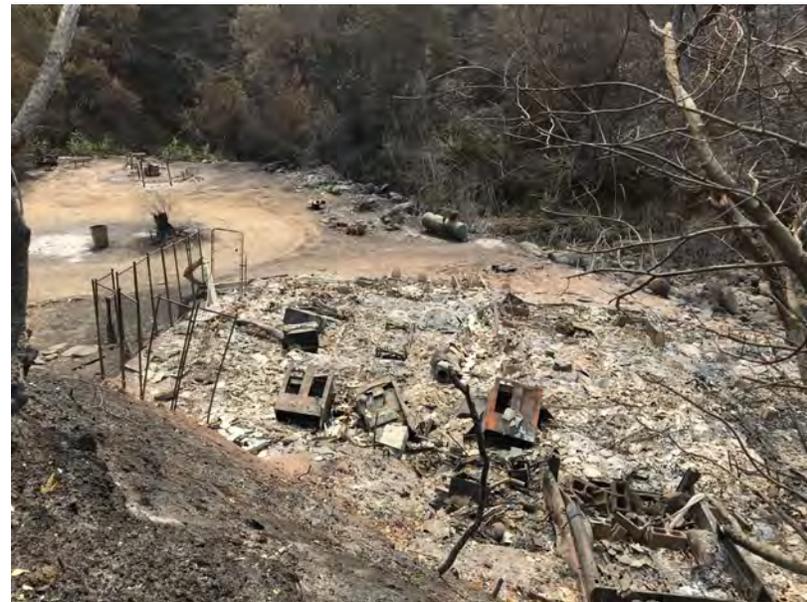
Field Observation House pads next to watercourse.
or Potential Hazard:

Potential Hazard to Life: high

Potential Hazard to Property: high

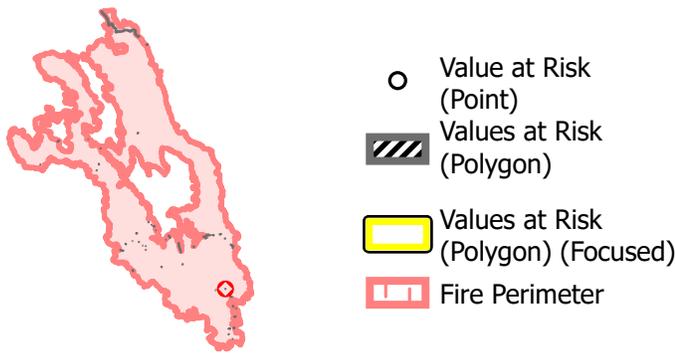
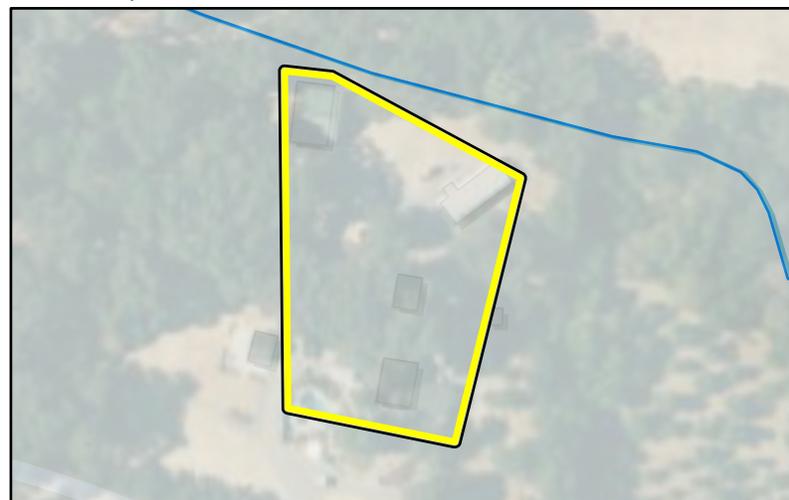
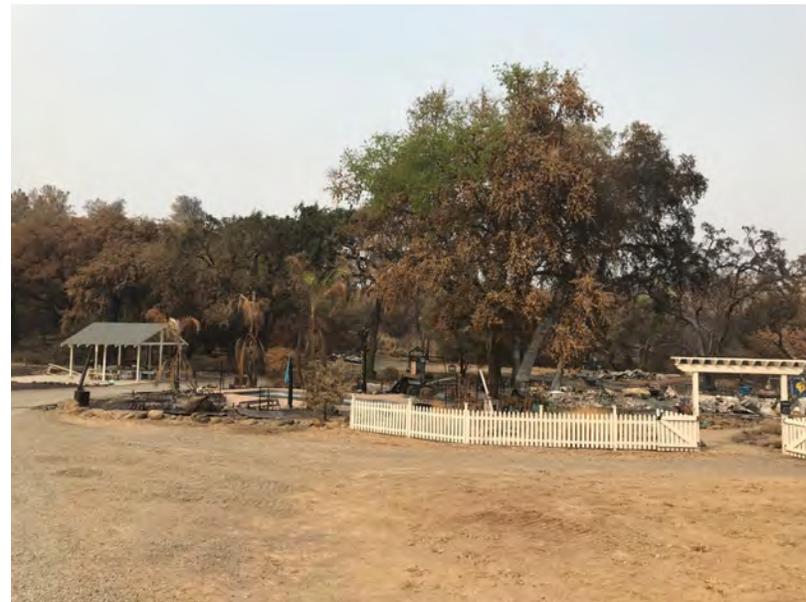
Field Observation Ulatis Creek opens from confined channel into braided network on fan like area.
Potential Hazard: Houses constructed here. Potential for debris flow and flooding.

Potential Hazard to Life: high

Potential Hazard to Property: high

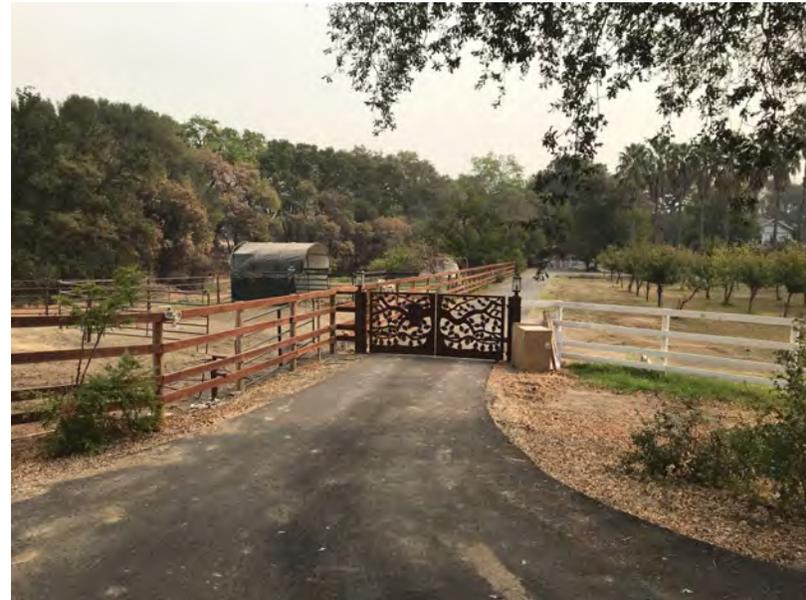
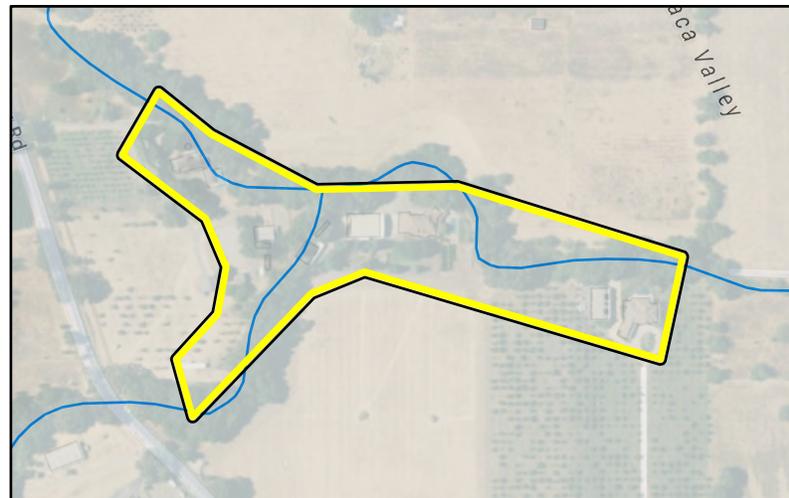
Field Observation or Potential Hazard: Houses and miscellaneous non-inhabited structures in potential floodplain adjacent to watercourse. Resident reports no major flooding out of incised banks of watercourse in memory. Not able to access.

Potential Hazard to Life: low

Potential Hazard to Property: moderate

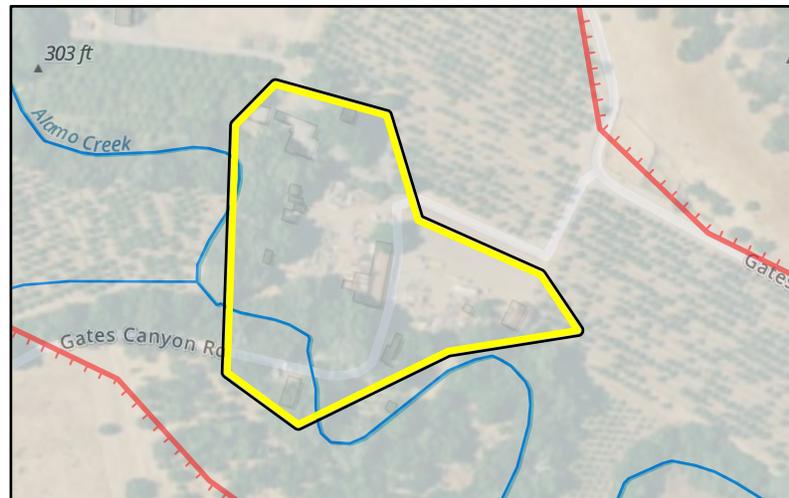
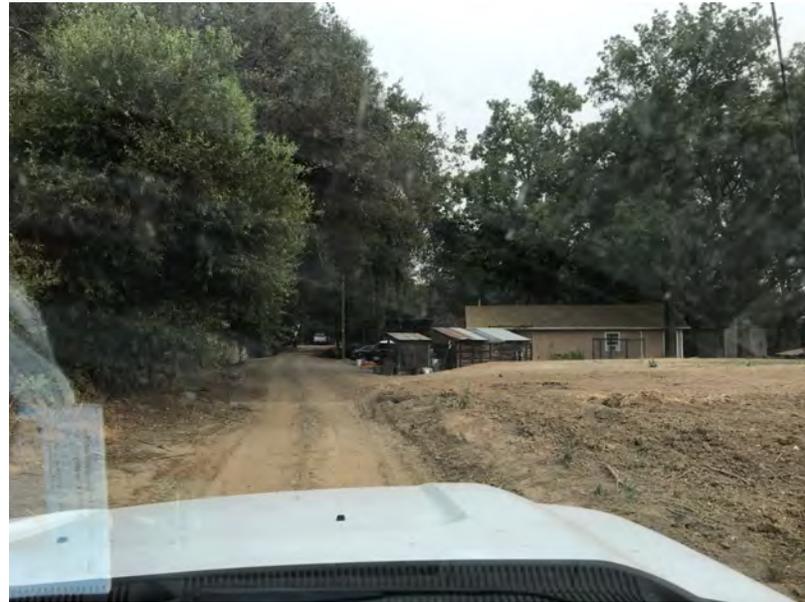
Field Observation Houses in potential floodplain. Resident reports past floods close to house, but
Potential Hazard: not to house. Limited to orchard flooding.

Potential Hazard to Life: low

Potential Hazard to Property: moderate

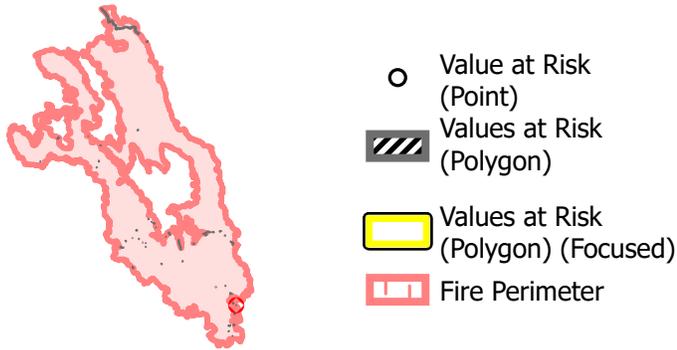
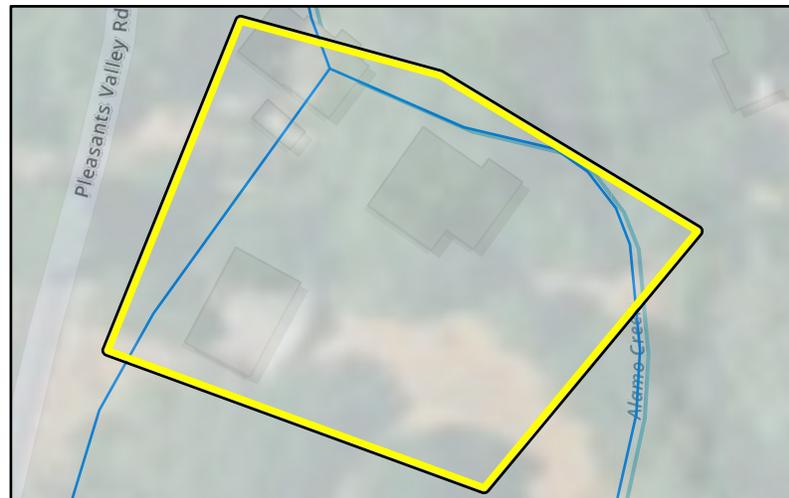
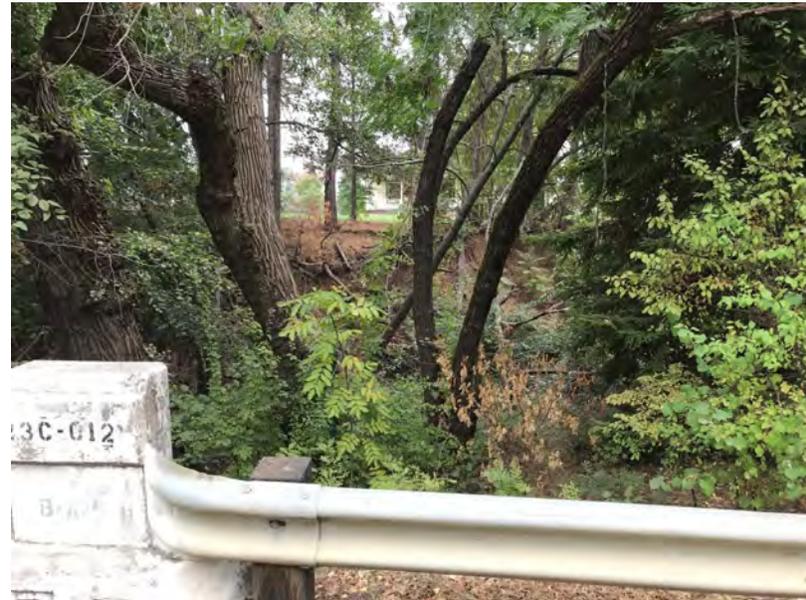
Field Observation House in potential floodplain.
or Potential Hazard:

Potential Hazard to Life: low

Potential Hazard to Property: moderate

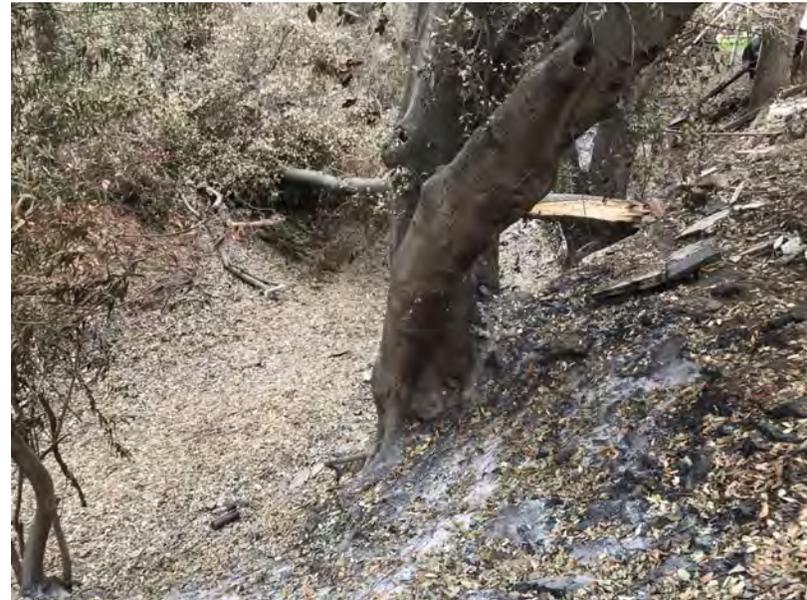
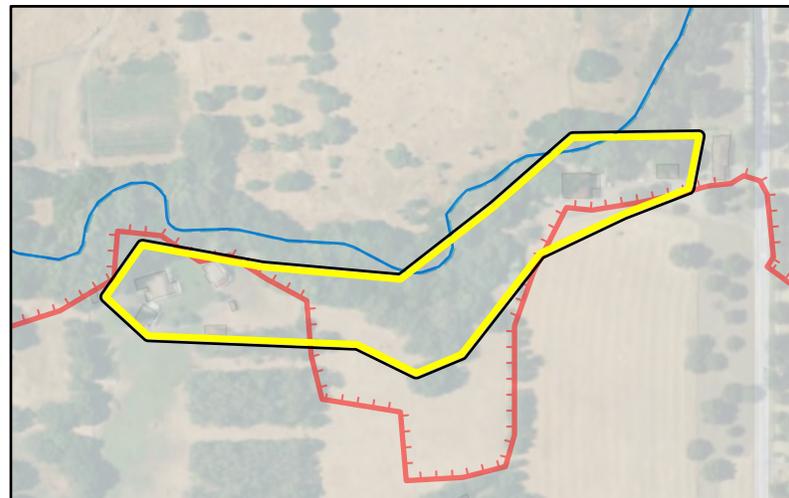
Field Observation Houses close to watercourse in potential floodplain. Local resident reports high or **Potential Hazard:** flows have nearly overtopped watercourse channel in past and flooding post fire is expected. Burned trees observed fallen into the channel.

Potential Hazard to Life: low

Potential Hazard to Property: moderate

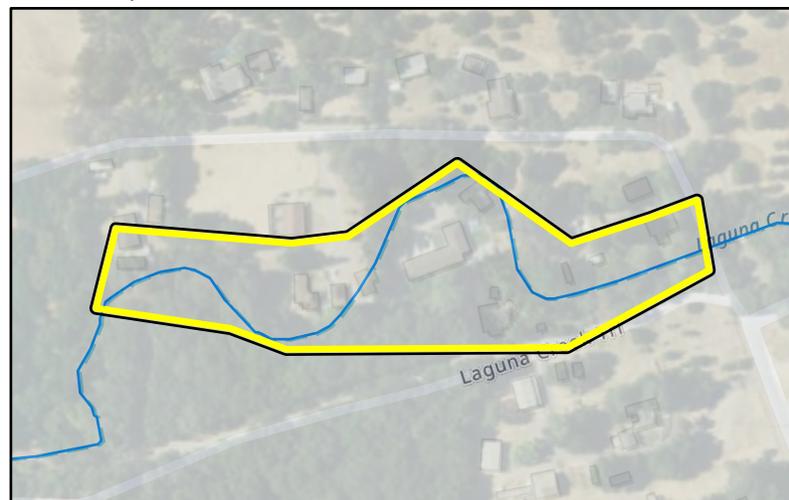
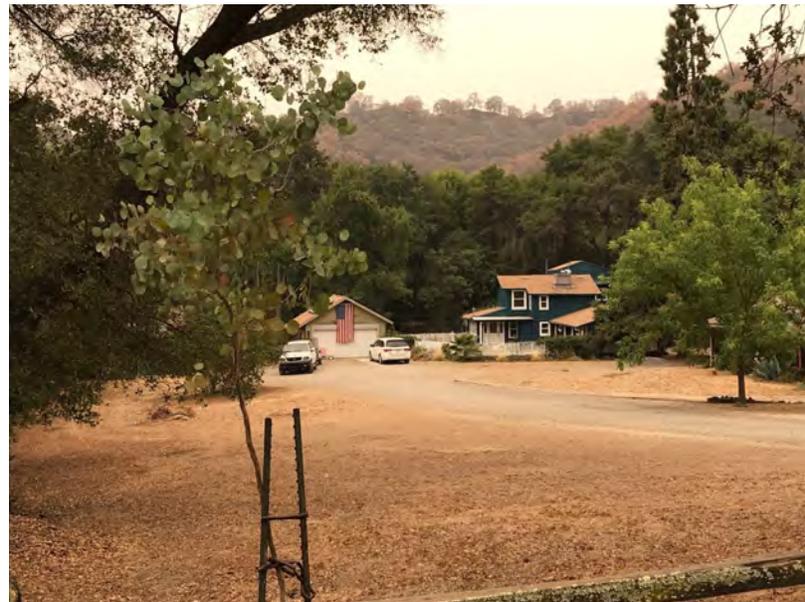
Field Observation Houses and structures located in potential floodplain.
or Potential Hazard:

Potential Hazard to Life: low

Potential Hazard to Property: moderate
