Watershed Emergency Response Team Evaluation
LNU LIGHTNING COMPLEX
HENNESSEY FIRE

CA-LNU-013407

October 8, 2020

LNU LIGHTNING COMPLEX (HENNESSEY FIRE)
Watershed Emergency Response Team EVALUATION
October 8, 2020

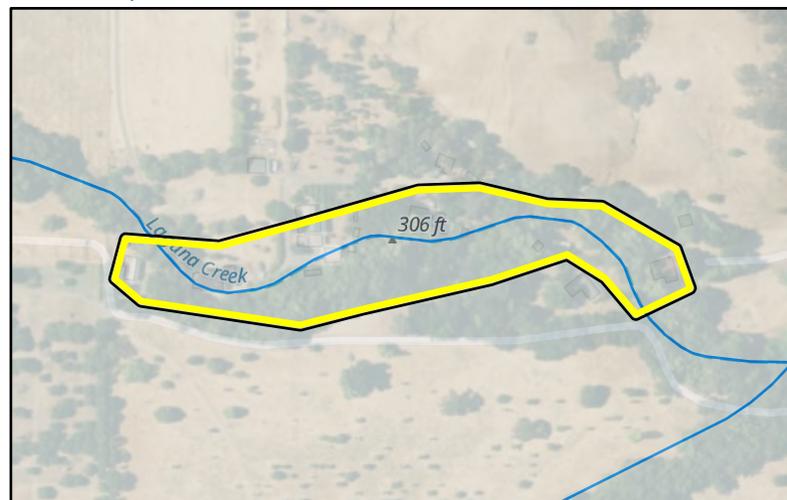
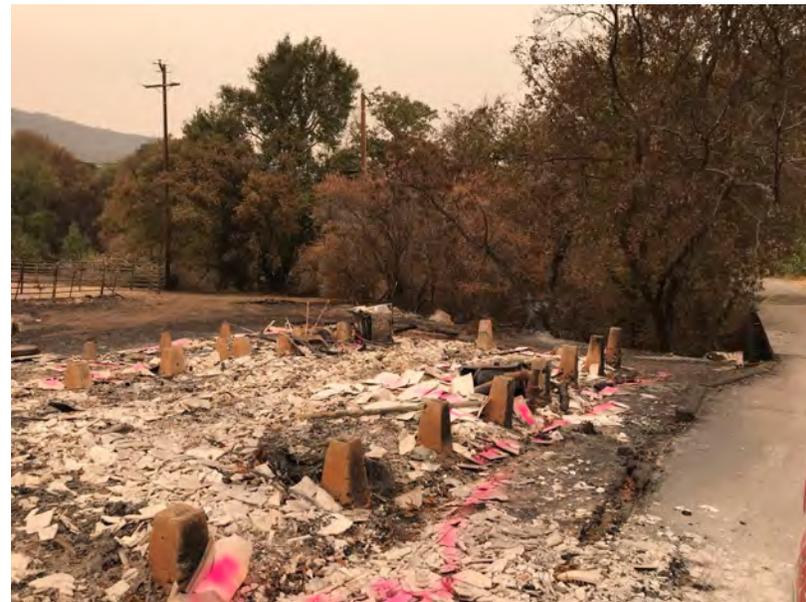
Field Observation Houses and structures along edge of channel in potential floodplain.
or Potential Hazard:

Potential Hazard to Life: low

Potential Hazard to Property: moderate

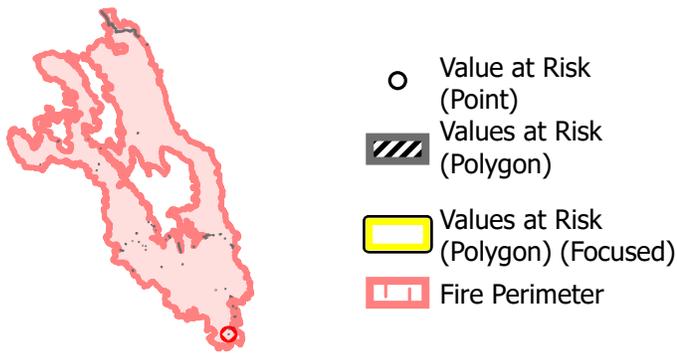
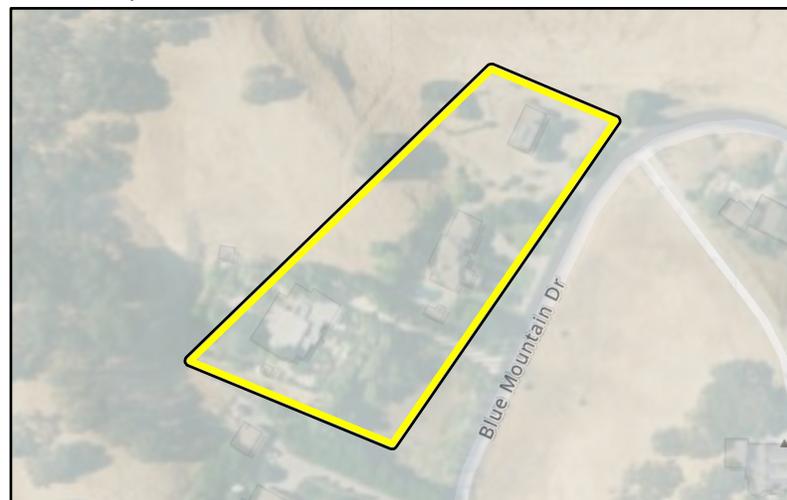
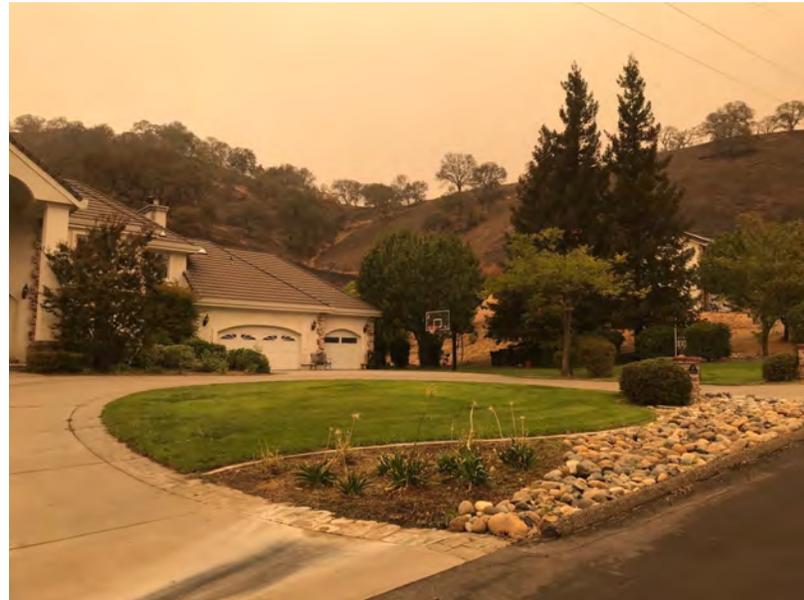
Field Observation Houses at outlet of debris flow channels.
or Potential Hazard:

Potential Hazard to Life: **low**

Potential Hazard to Property: **moderate**

Description: Evacuate during large rain events, evaluate potential for deflection structure.

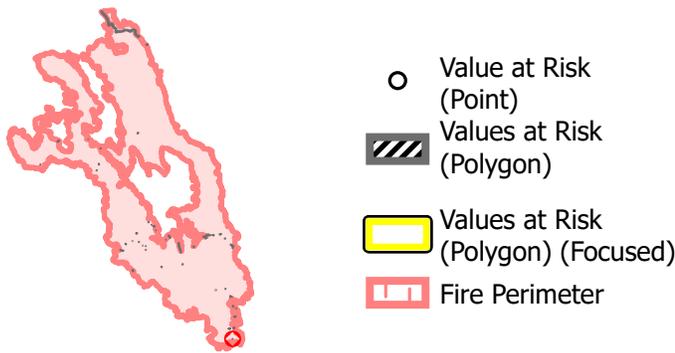
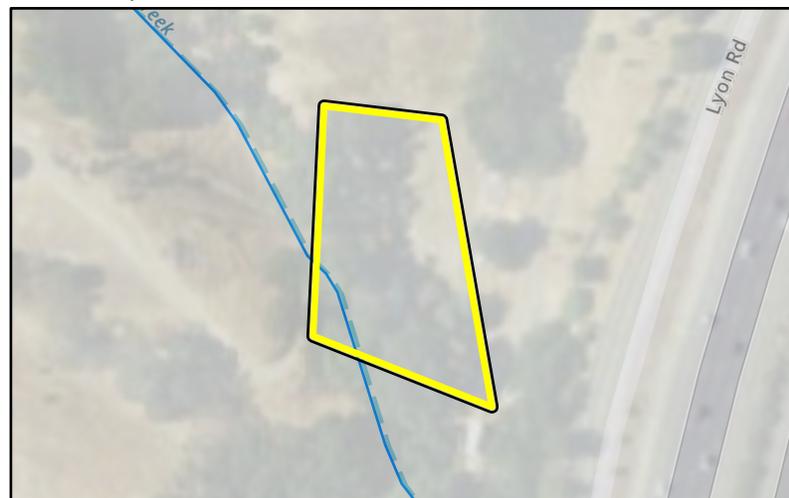
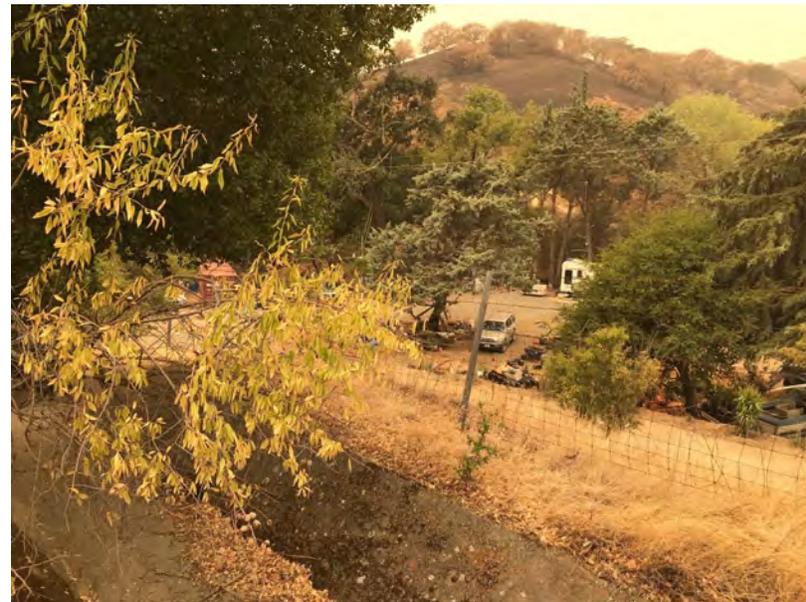
Field Observation Trailers along low terrace near watercourse.
or Potential Hazard:

Potential Hazard to Life: **low**

Potential Hazard to Property: **moderate**

Description: Move trailers prior to predicted large rain event.

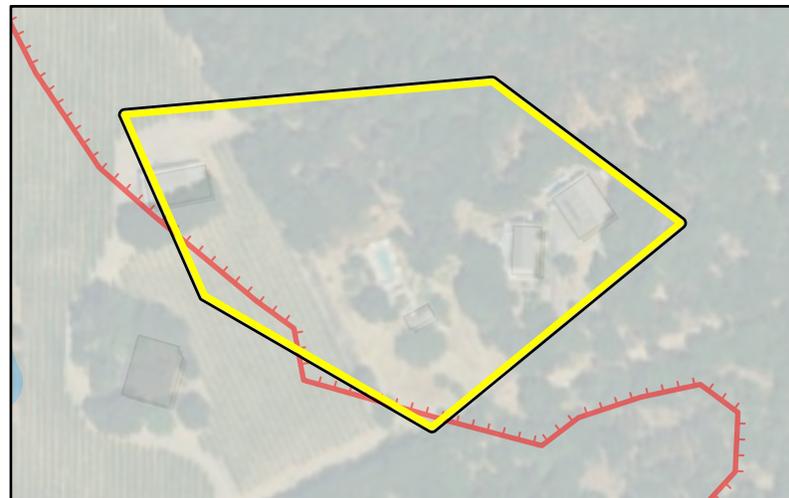
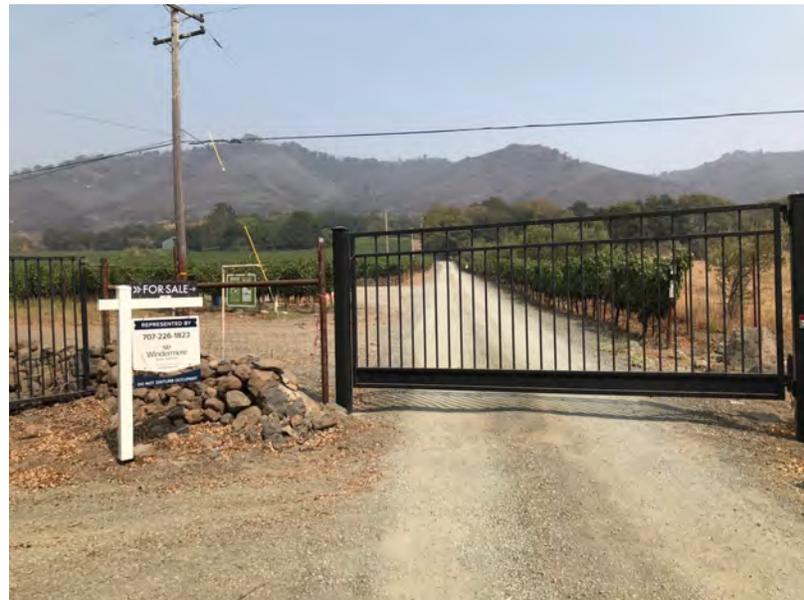
Field Observation Houses on toe/fan of landslide. Not able to access.
or Potential Hazard:

Potential Hazard to Life: **moderate**

Potential Hazard to Property: **moderate**

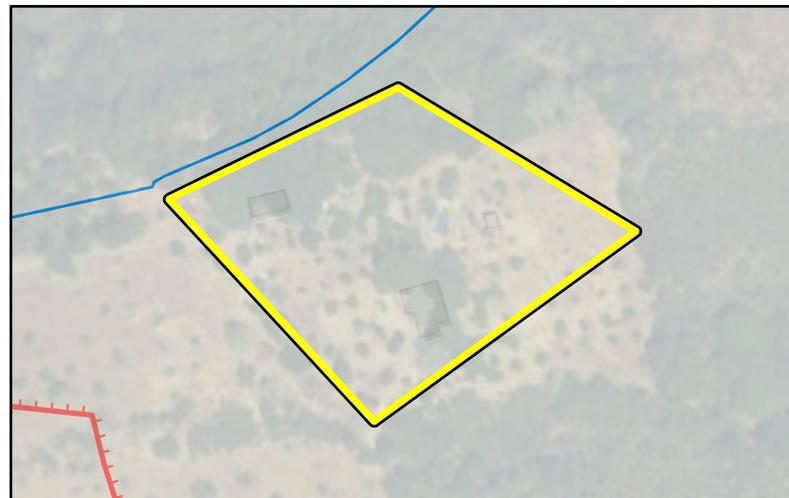
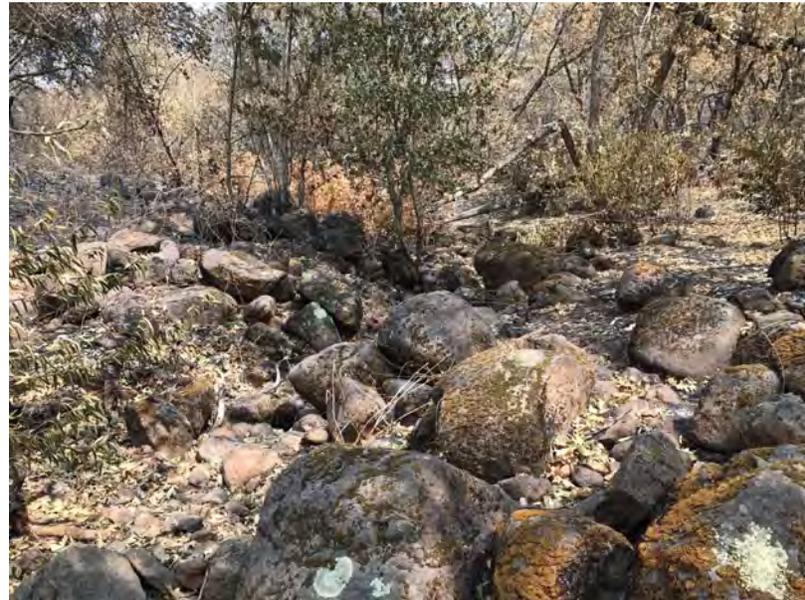
Field Observation Houses on toe/fan of landslide between three drainages. Large boulders in
Potential Hazard: creeks. Owner says lower house has flooded recently.

Potential Hazard to Life: **moderate**

Potential Hazard to Property: **moderate**

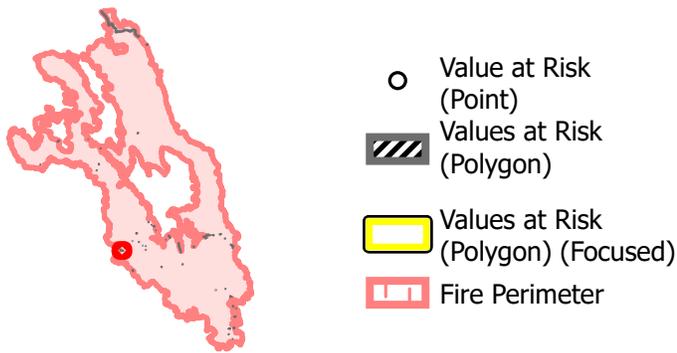
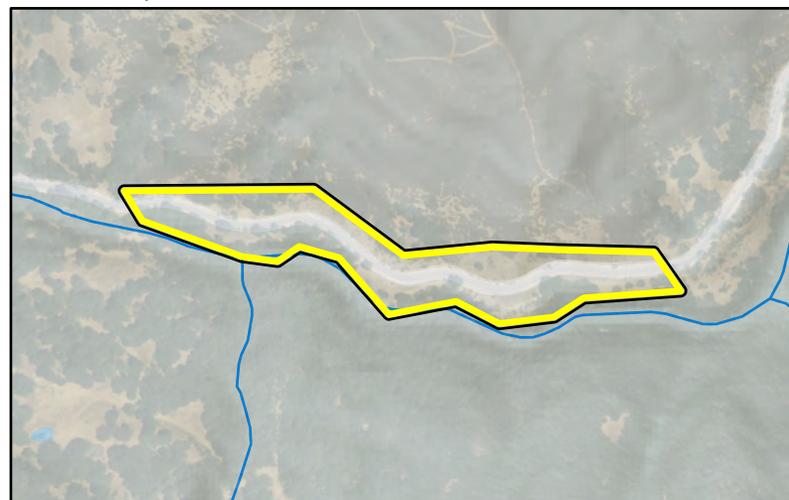
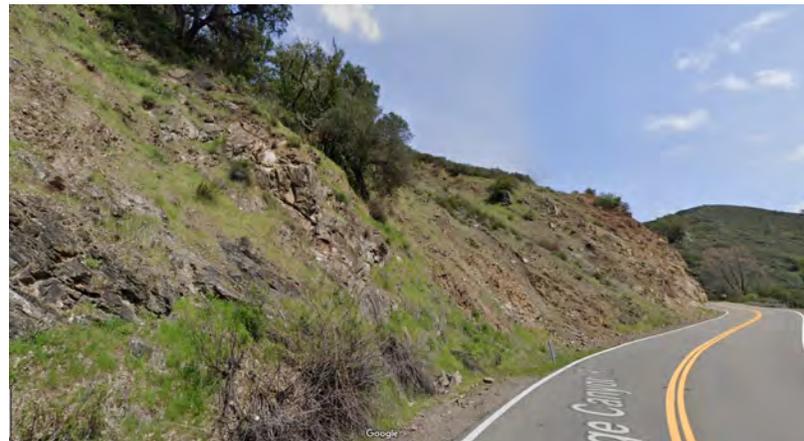
Field Observation **Rock fall onto road.**
or Potential Hazard:

Potential Hazard to Life: **moderate**

Potential Hazard to Property: **low**

Description: Consider closing road segment during lage rain events.

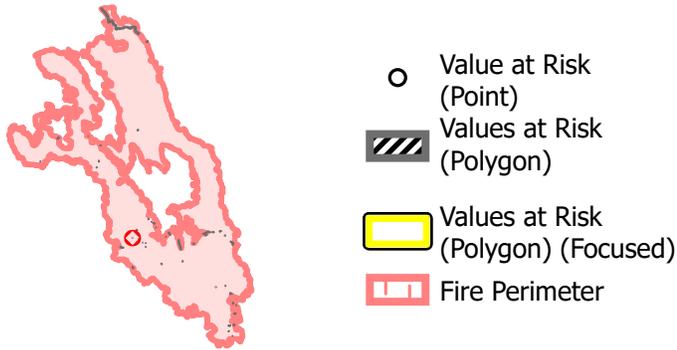
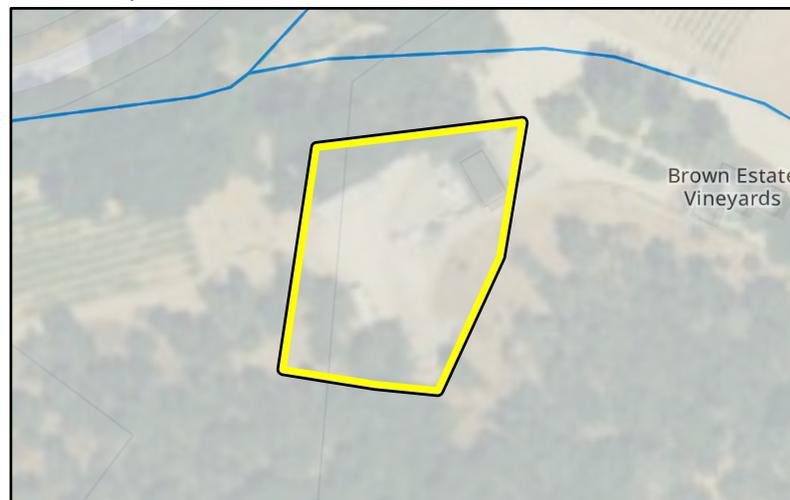
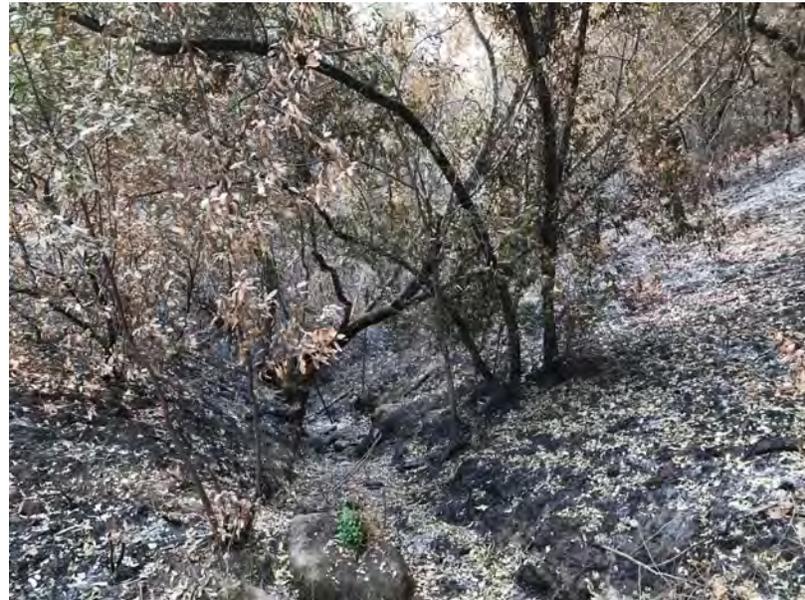
Field Observation Trailers, barn, and winery infrastructure in path of watercourse. Debris flow and
Potential Hazard: flooding hazards.

Potential Hazard to Life: moderate

Potential Hazard to Property: moderate

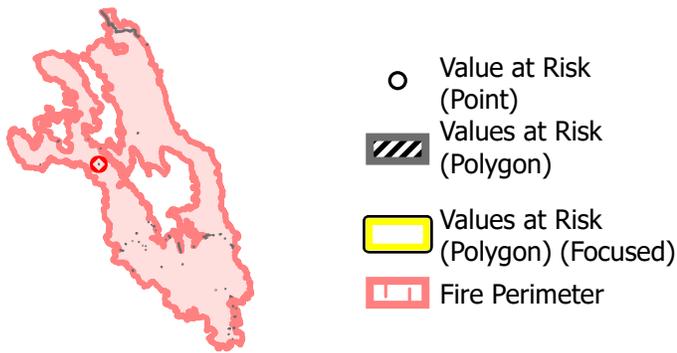
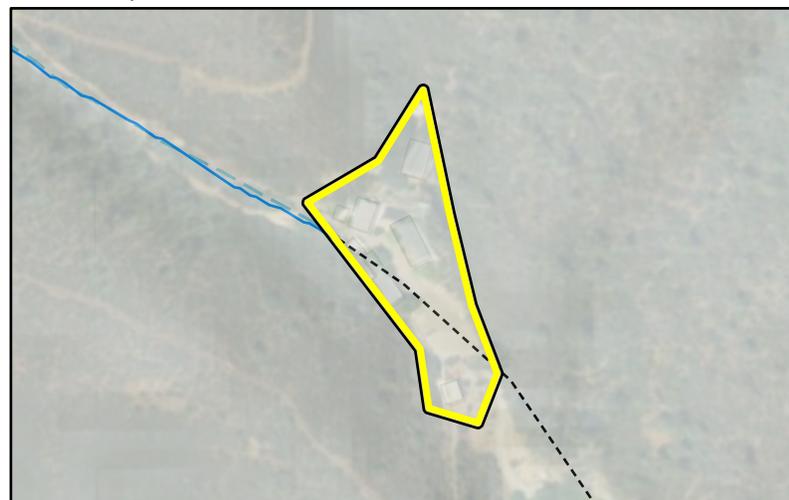
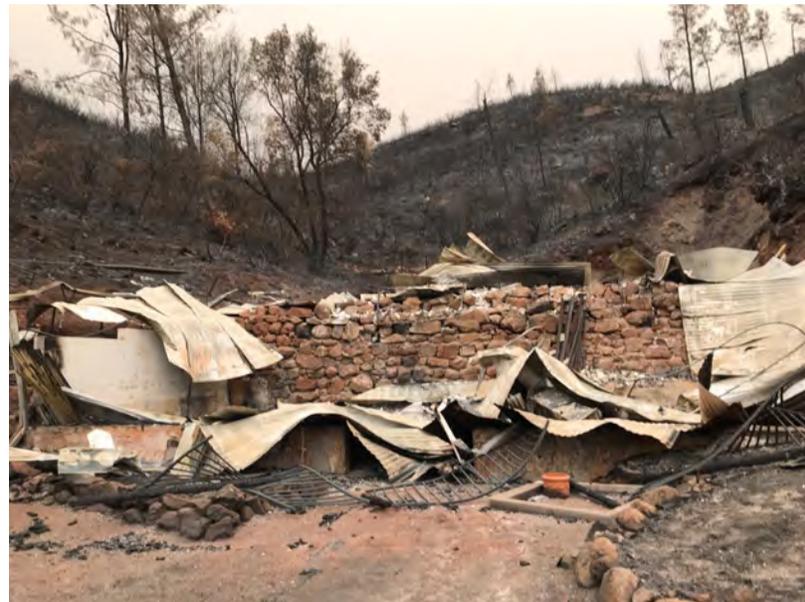
Field Observation Debris flow and rock fall hazards for buildings at Center.
or Potential Hazard:

Potential Hazard to Life: **high**

Potential Hazard to Property: **high**

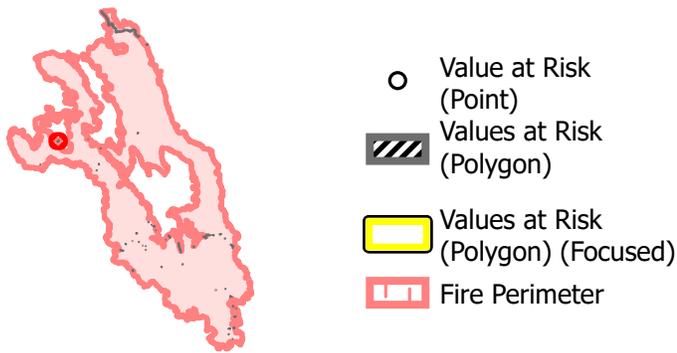
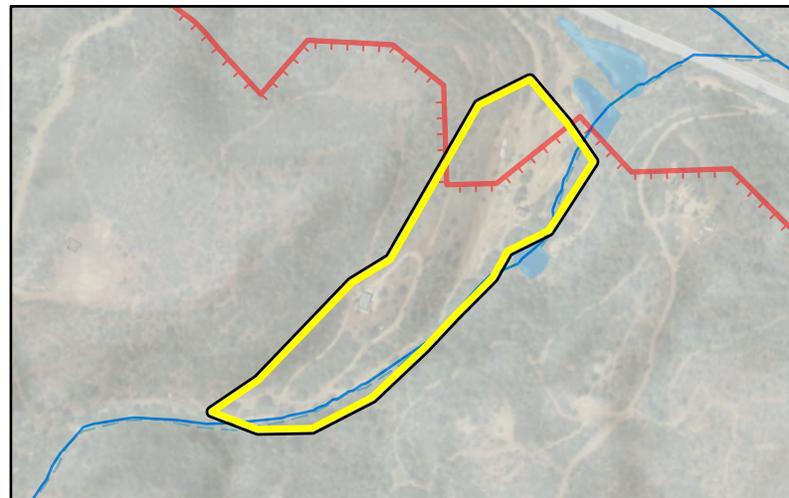
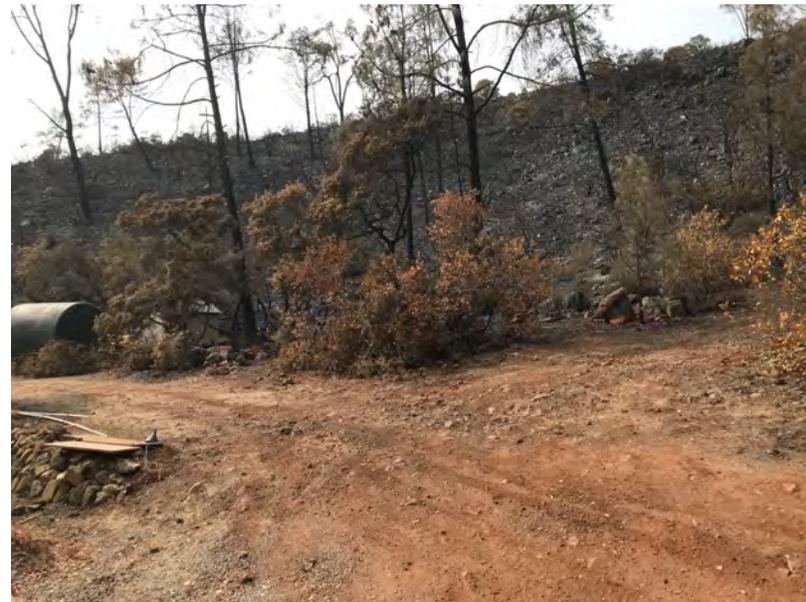
Field Observation Potential debris flow may impact shop/barn. Houses at risk for rock fall hazards.
or Potential Hazard:

Potential Hazard to Life: moderate

Potential Hazard to Property: moderate

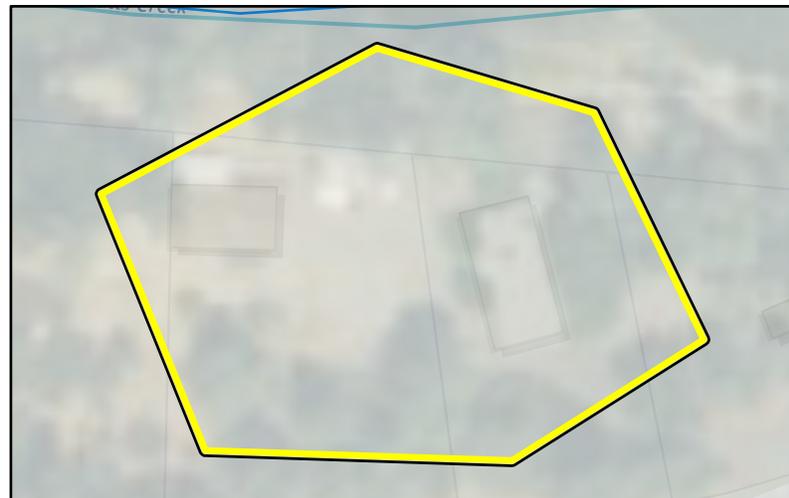
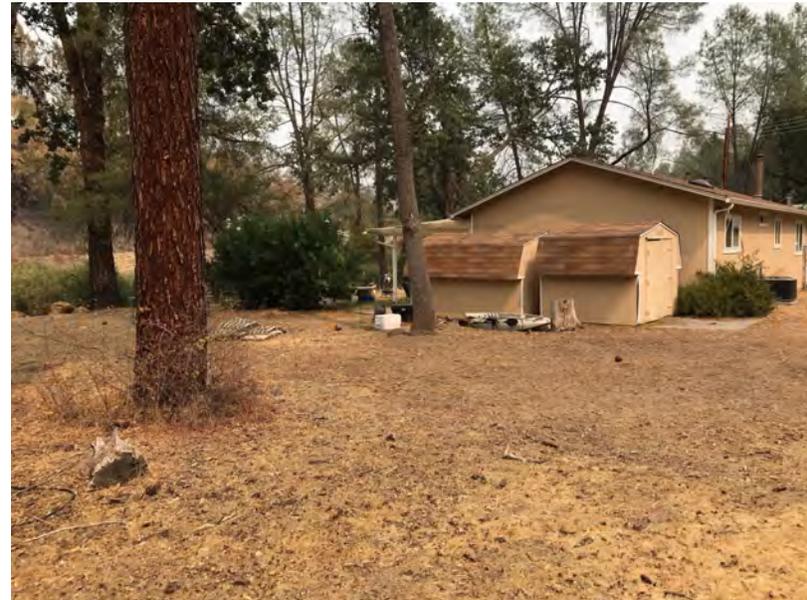
Field Observation Potential flooding from road toward houses.
or Potential Hazard:

Potential Hazard to Life: low

Potential Hazard to Property: moderate

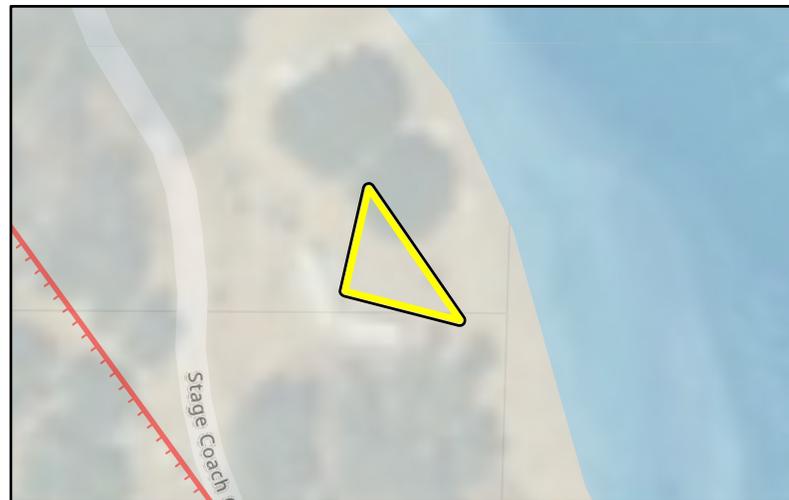
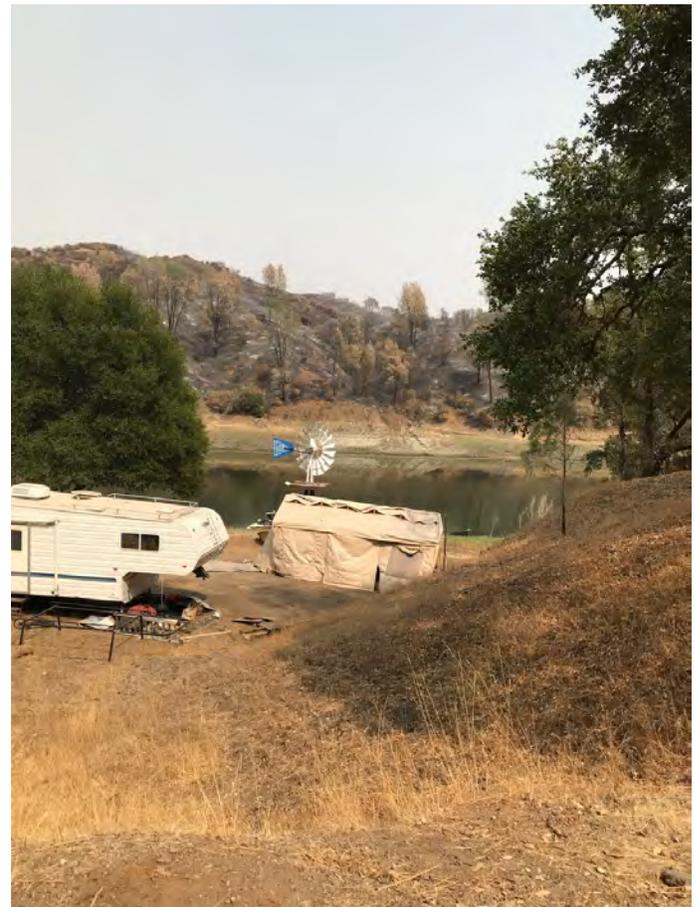
Field Observation Potential for debris flow from watercourse, low burn severity.
or Potential Hazard:

Potential Hazard to Life: low

Potential Hazard to Property: moderate

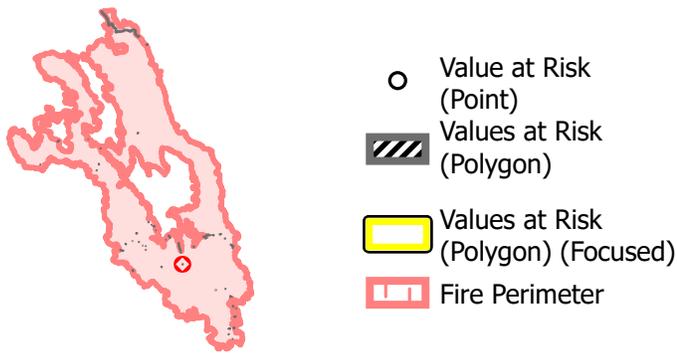
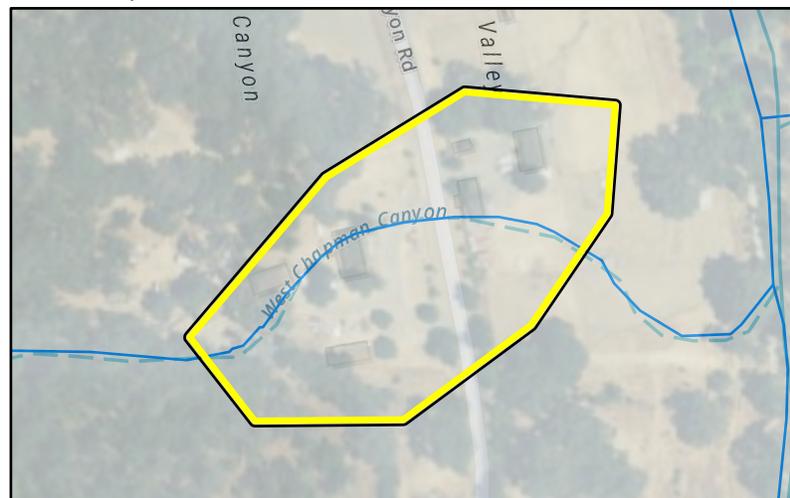
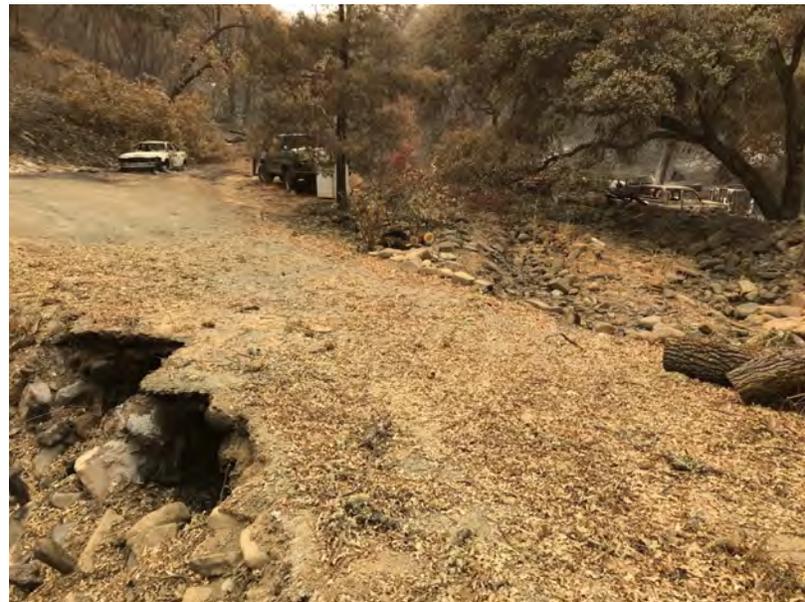
Field Observation Houses adjacent to watercourses, creek filled with small to large boulders.
Potential Hazard: Culvert could plug and watercourse could avulse.

Potential Hazard to Life: high

Potential Hazard to Property: high

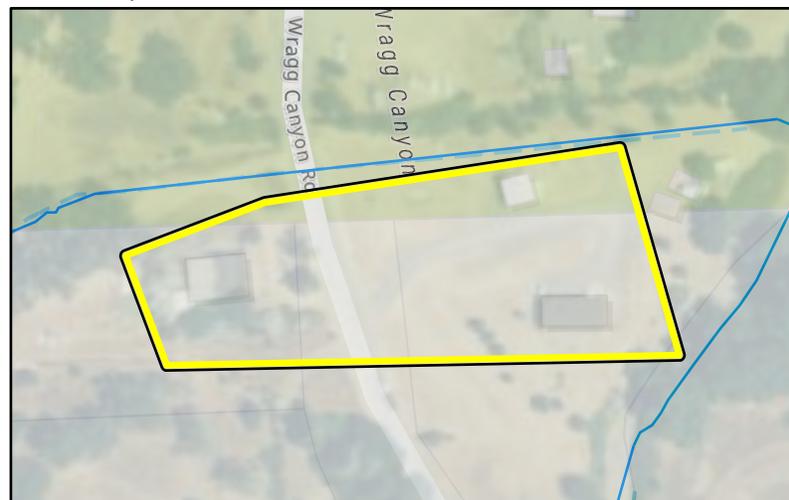
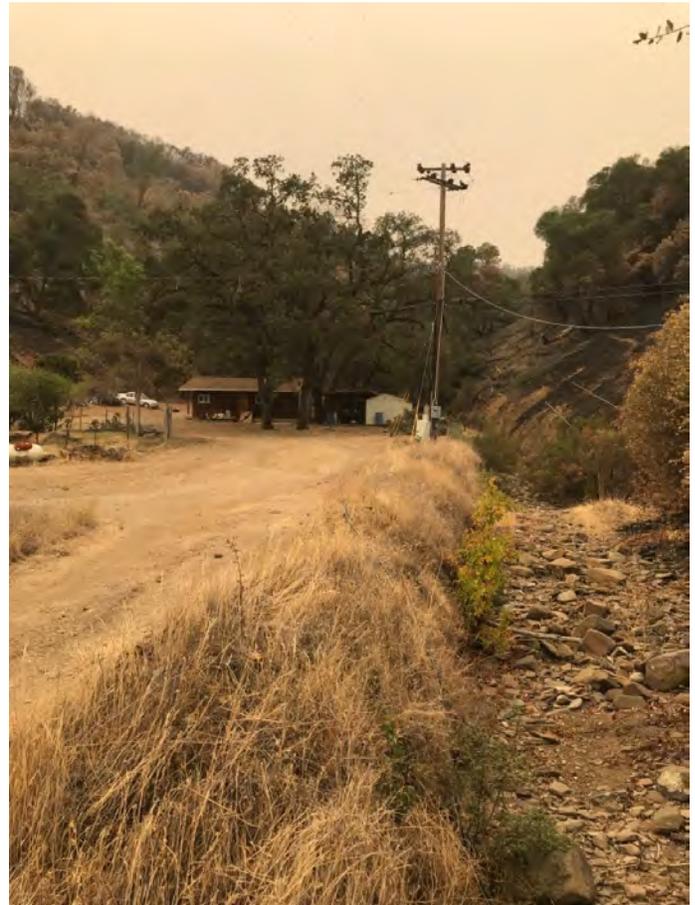
Field Observation House built next to watercourse. Debris flow and flooding potential.
or Potential Hazard:

Potential Hazard to Life: **high**

Potential Hazard to Property: **high**

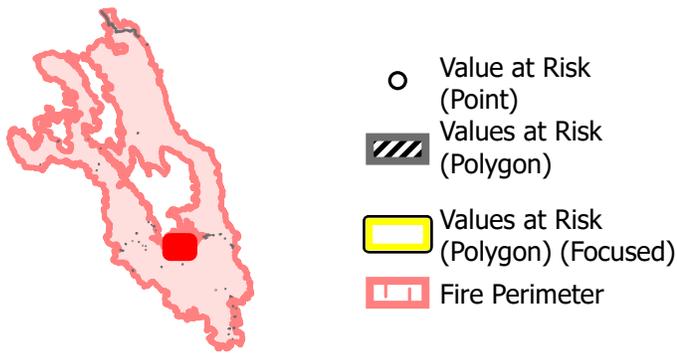
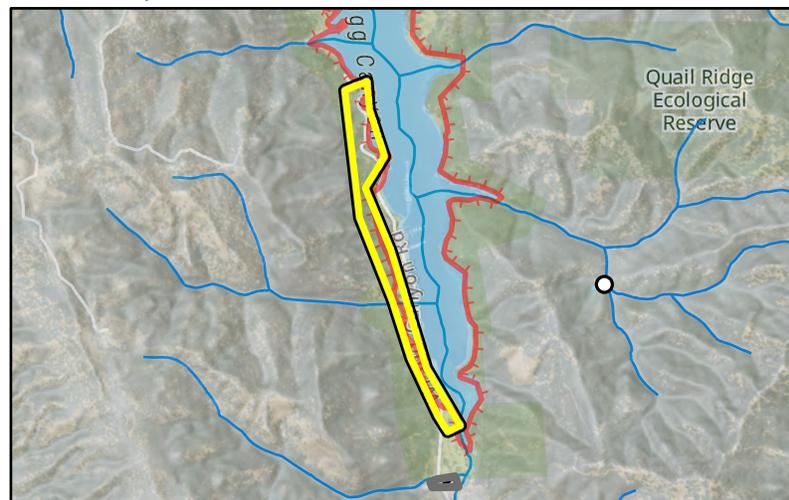
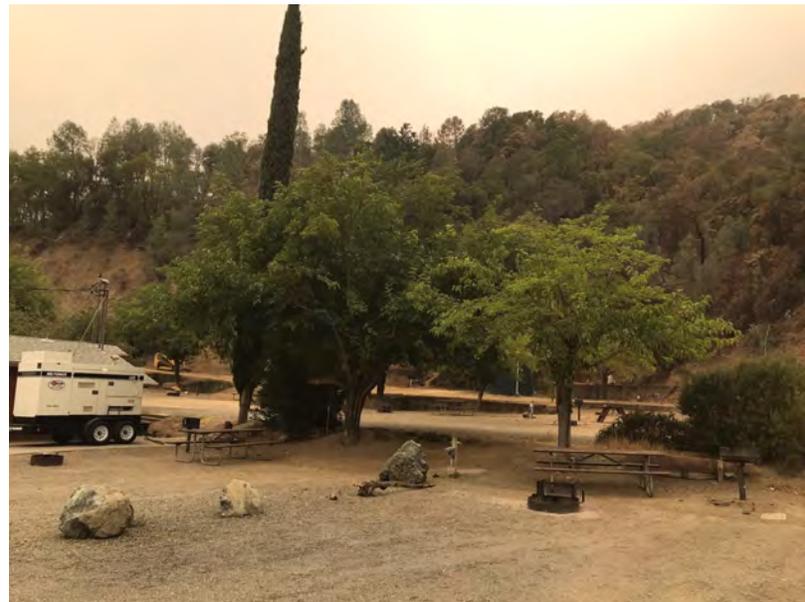
Field Observation Campsites and cabins in debris flow and flooding path.
or Potential Hazard:

Potential Hazard to Life: moderate

Potential Hazard to Property: moderate

Description: Close campground during rain events.

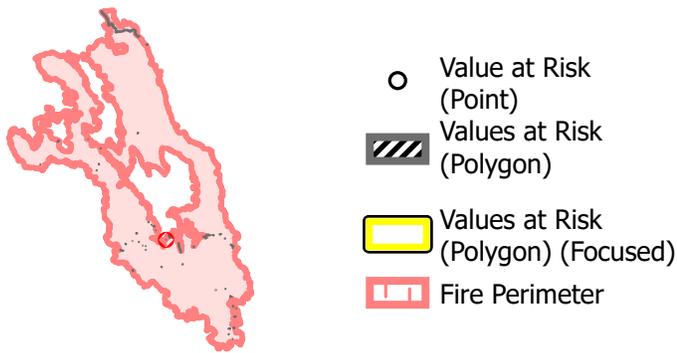
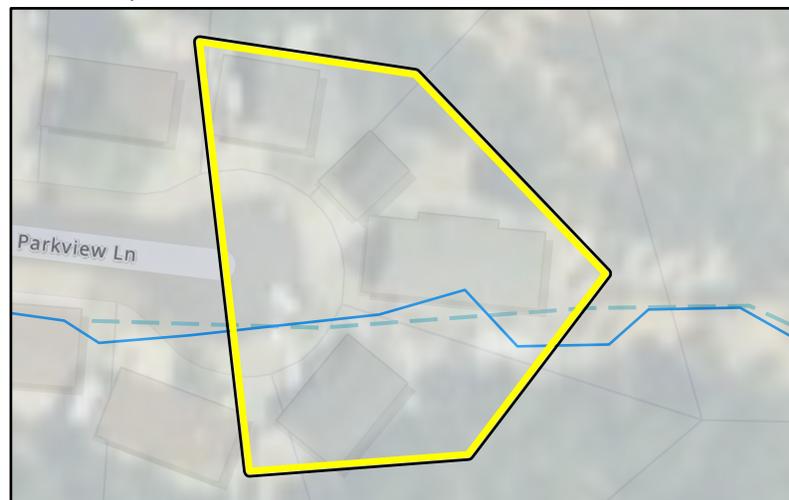
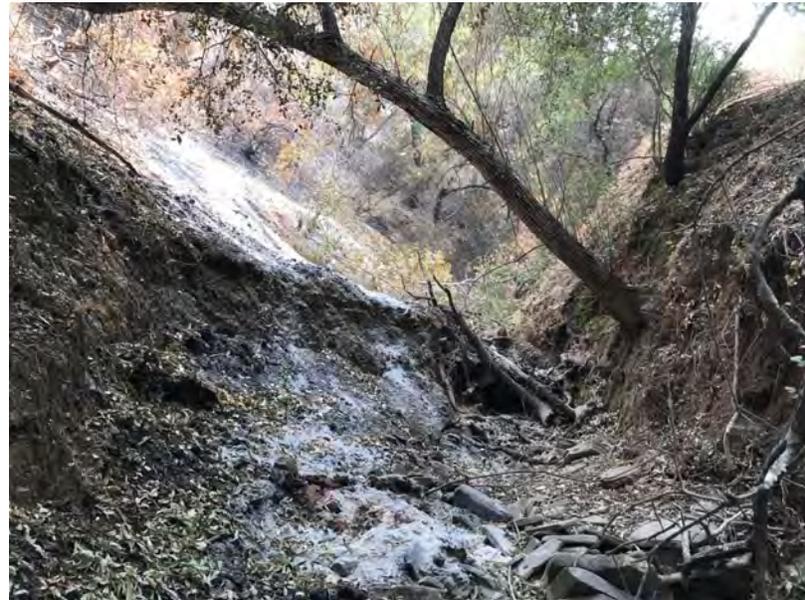
Field Observation or Potential Hazard: Houses and drainage structures at mouth of potential debris flow canyon. Home owner says drainage structure aggrades and plugs. Flow has been directed through his driveway before.

Potential Hazard to Life: moderate

Potential Hazard to Property: moderate

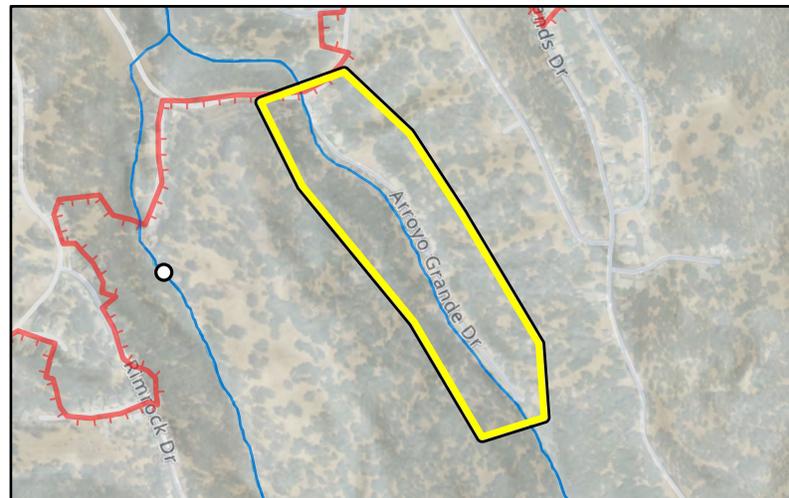
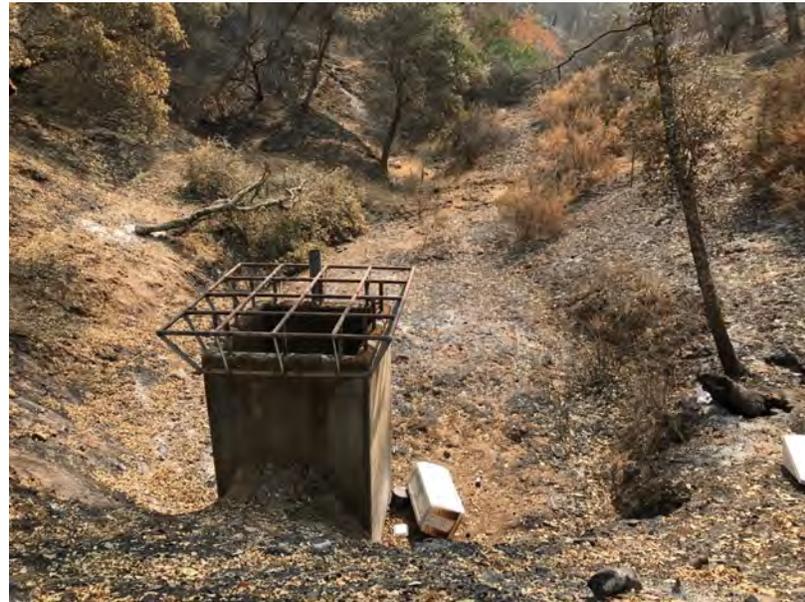
Field Observation House pads in watercourse channels and below steep rocky side tributaries.
Potential Hazard: Small debris basin at top of road.

Potential Hazard to Life: moderate

Potential Hazard to Property: moderate

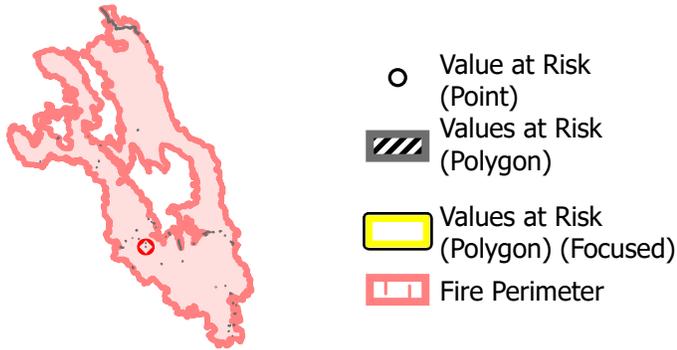
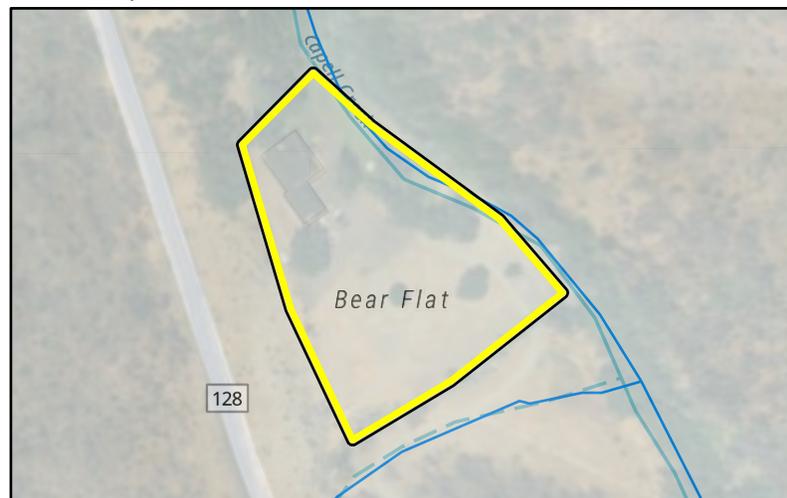
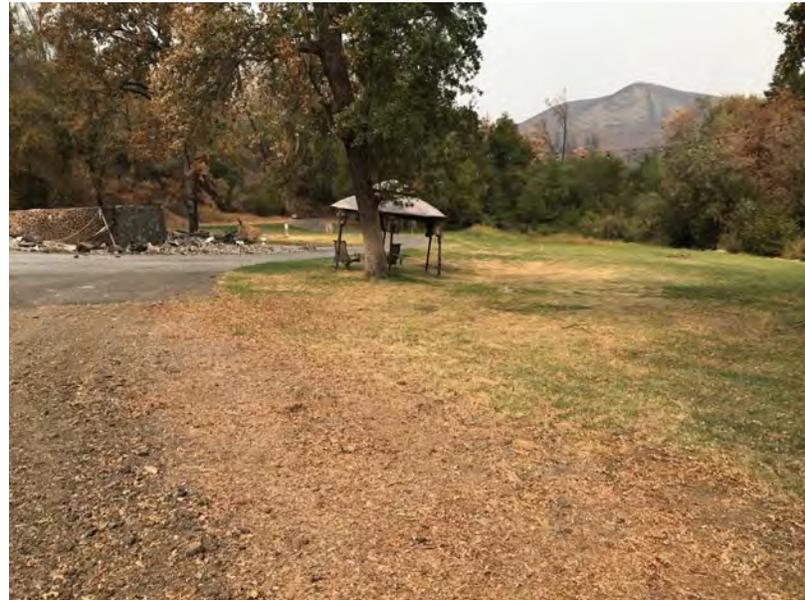
Field Observation Burned structure and outbuilding in a floodway. Flood hazards.
or Potential Hazard:

Potential Hazard to Life: low

Potential Hazard to Property: moderate

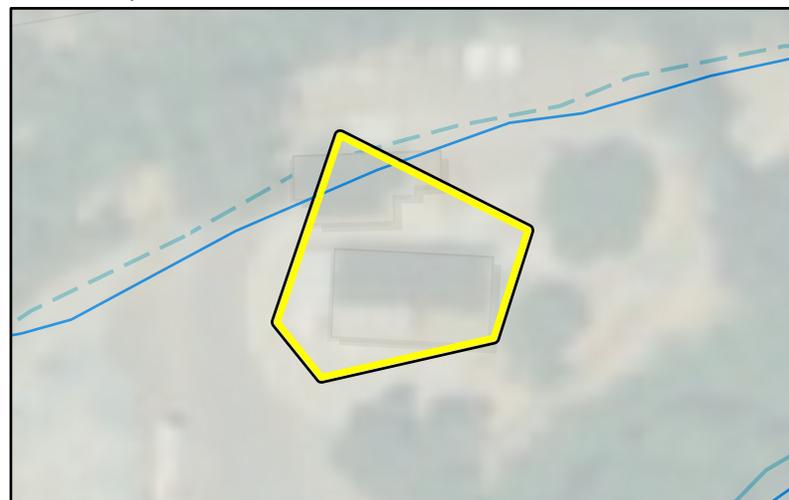
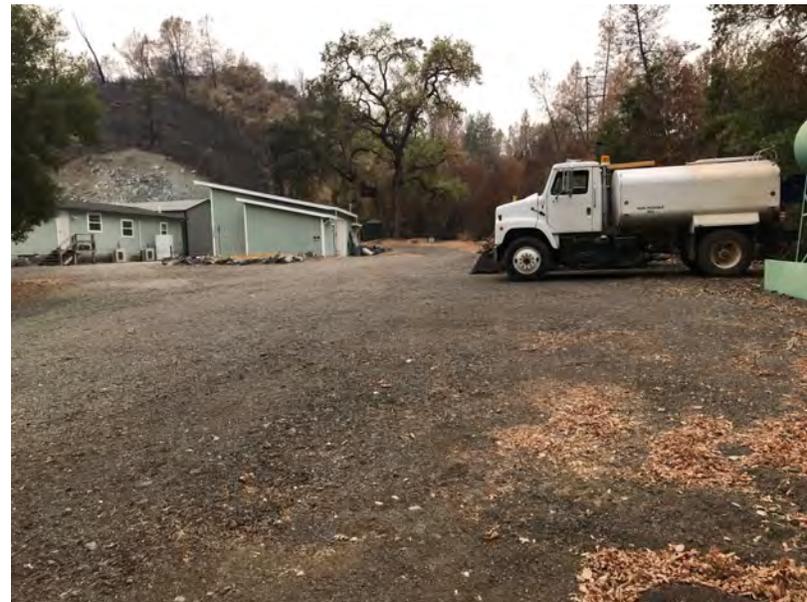
Field Observation Potential for northern watercourse to overtop (bends towards house), will likely
Potential Hazard: be directed towards driveway.

Potential Hazard to Life: moderate

Potential Hazard to Property: moderate

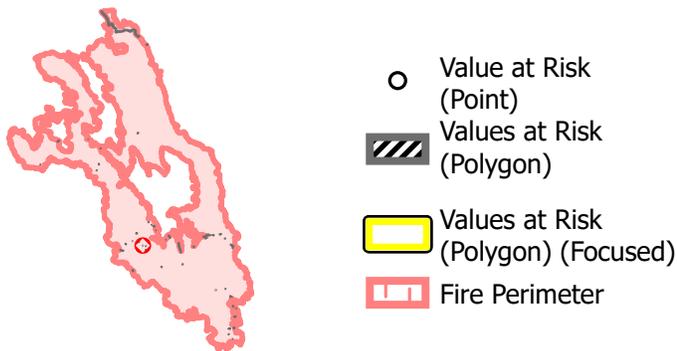
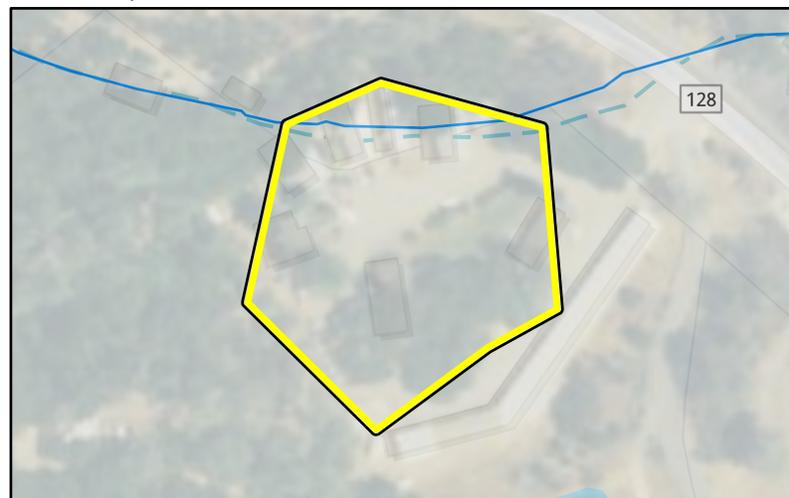
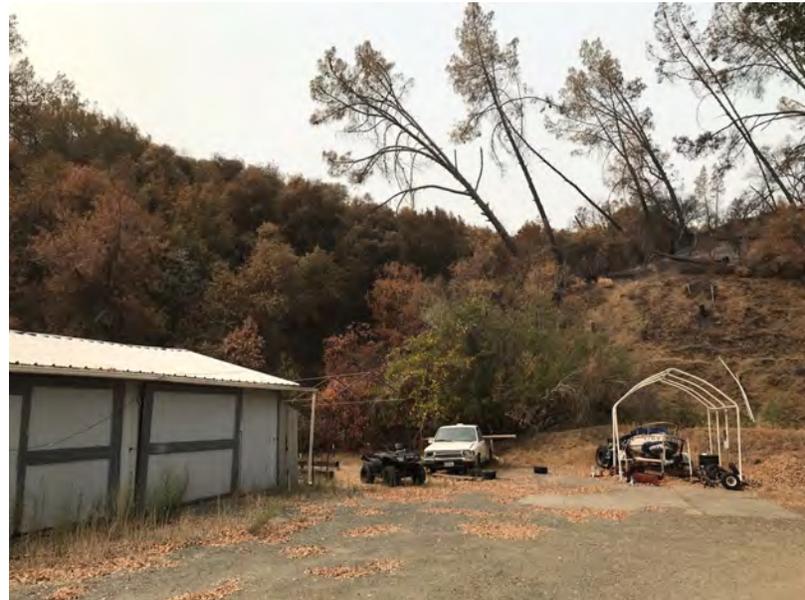
Field Observation Complex of trailers and storage structures in path of drainage. Debris flow and
Potential Hazard: flooding hazards.

Potential Hazard to Life: high

Potential Hazard to Property: high

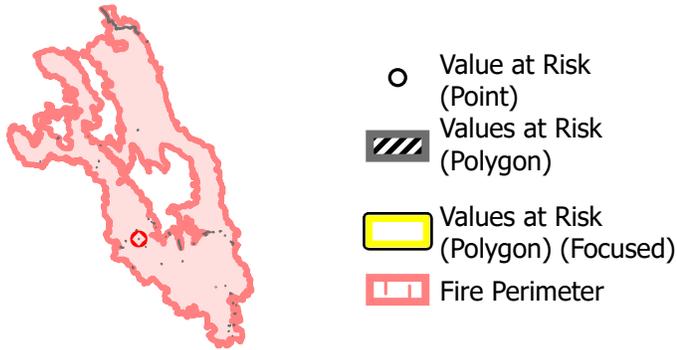
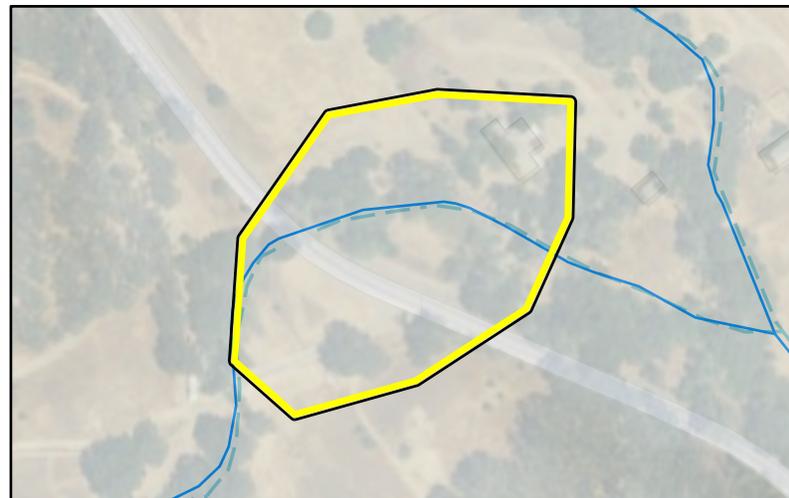
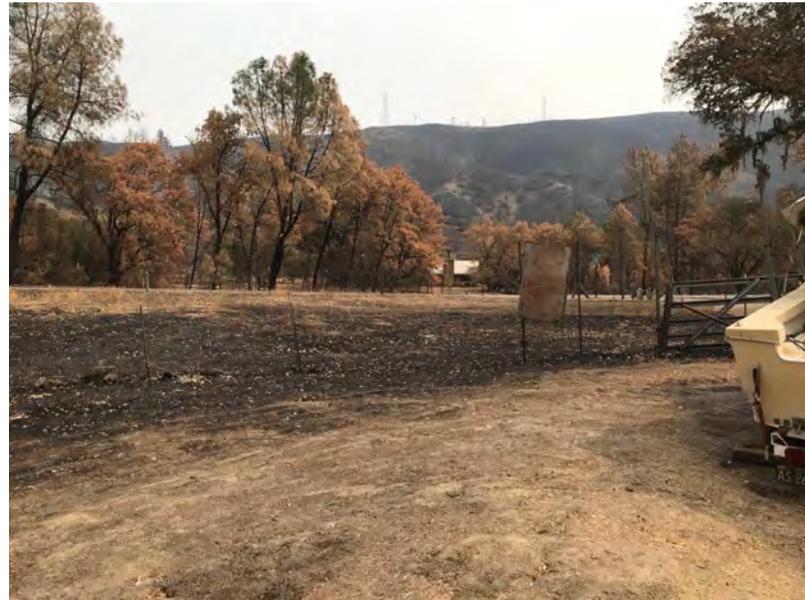
Field Observation House is built below mouth of watercourse channel. House is across highway
or Potential Hazard: but drainage includes moderate and high soil burn severity.

Potential Hazard to Life: **moderate**

Potential Hazard to Property: **moderate**

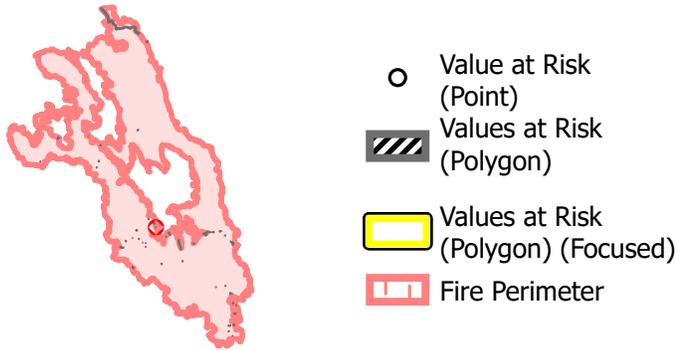
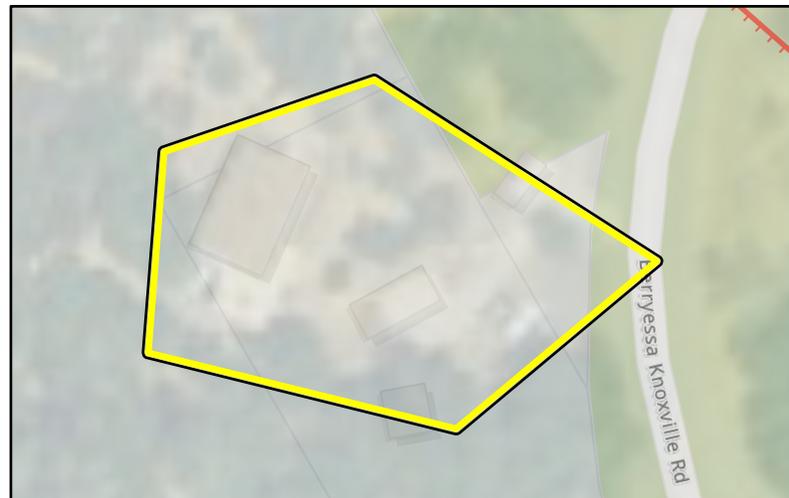
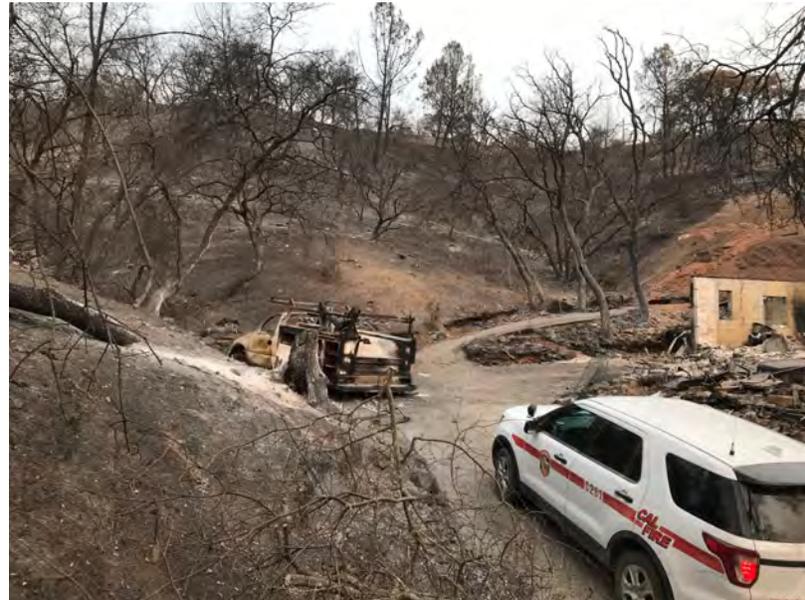
Field Observation House between downstream small watercourse channel with cobble and small or **Potential Hazard:** boulders. Larger watercourse is likely to travel down road and avoid house, with exception of nuisance debris. Garage is downstream of road.

Potential Hazard to Life: moderate

Potential Hazard to Property: moderate
