Watershed Emergency Response Team Evaluation
LNU LIGHTNING COMPLEX
HENNESSEY FIRE

CA-LNU-013407

October 8, 2020

LNU LIGHTNING COMPLEX (HENNESSEY FIRE)
Watershed Emergency Response Team EVALUATION
October 8, 2020

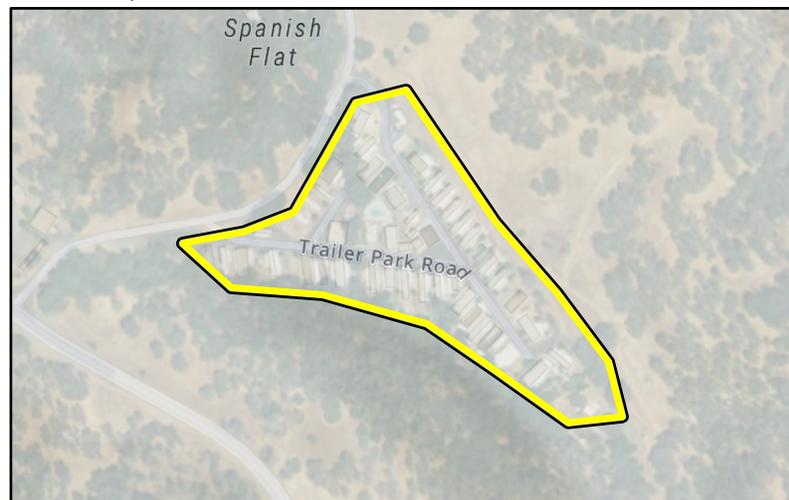
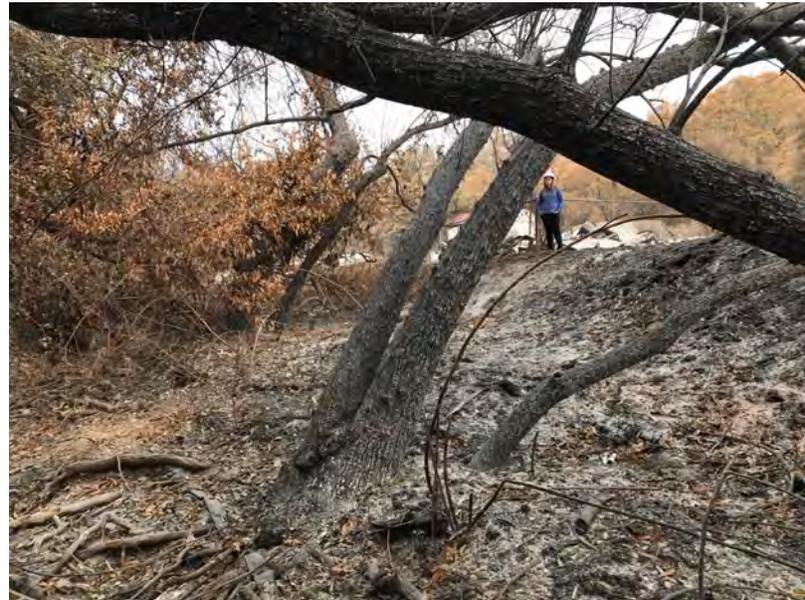
Field Observation Potential flooding and hyper concentrated flows from watercourse adjacent to
Potential Hazard: mobile home facility.

Potential Hazard to Life: low

Potential Hazard to Property: moderate

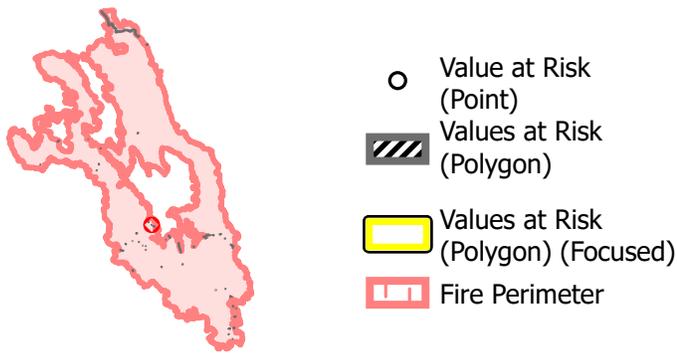
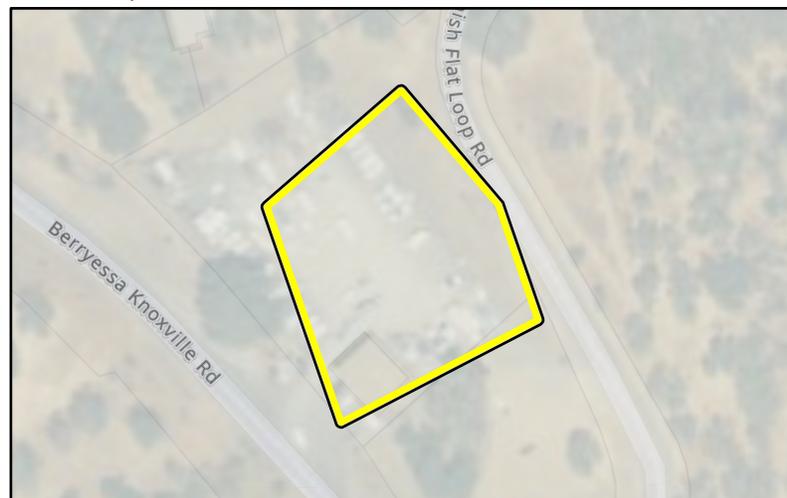
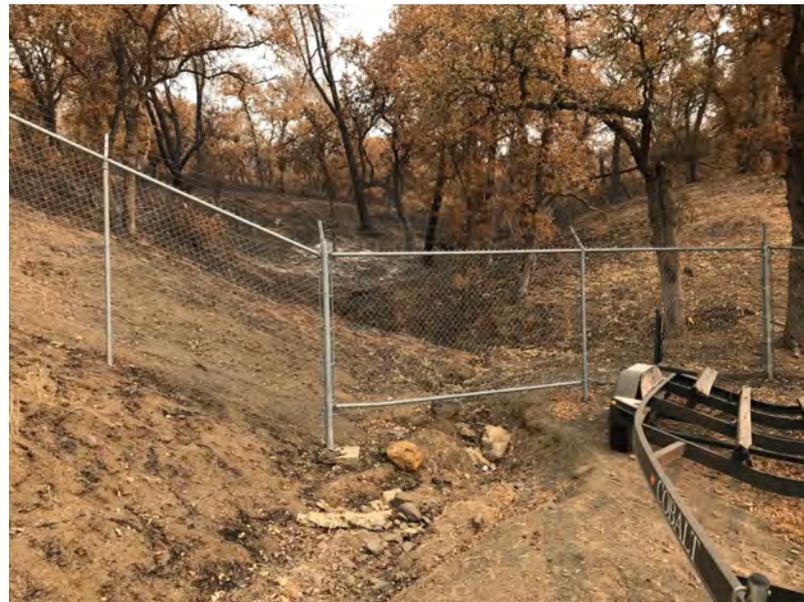
Field Observation Repair yard and shop has potential for debris flow or flood to enter yard, mostly
Potential Hazard: small material but a few large cobbles were noted. No capacity for water flow in channel.

Potential Hazard to Life: low

Potential Hazard to Property: moderate

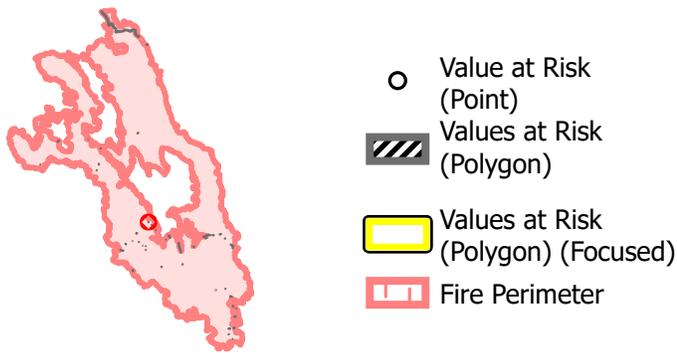
Field Observation Mobile home and storage area downstream of active watercourse containing
or Potential Hazard: large material, at risk for debris flows.

Potential Hazard to Life: moderate

Potential Hazard to Property: moderate

Description: Move trailer to higher ground to mitigate risk.

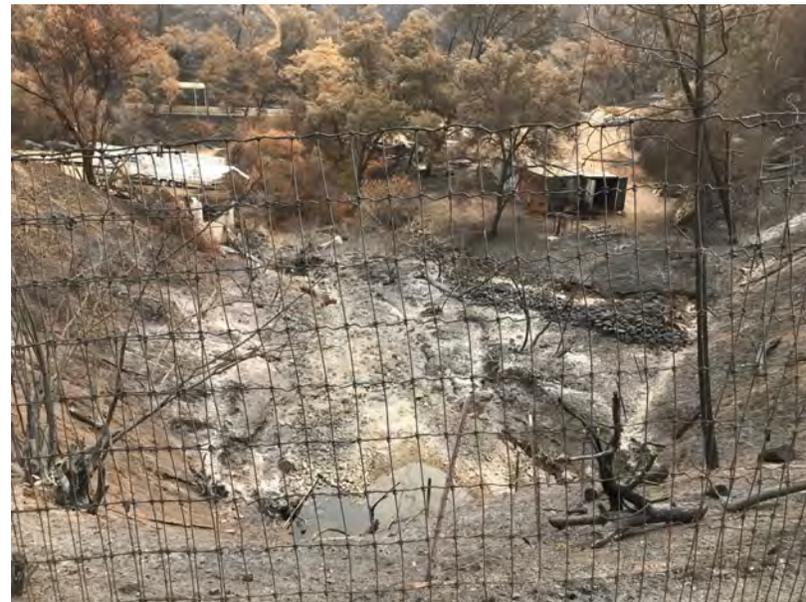
Field Observation Day use area and parking. Potential for debris flow and/or flooding from Cold
or Potential Hazard: Canyon.

Potential Hazard to Life: high

Potential Hazard to Property: low

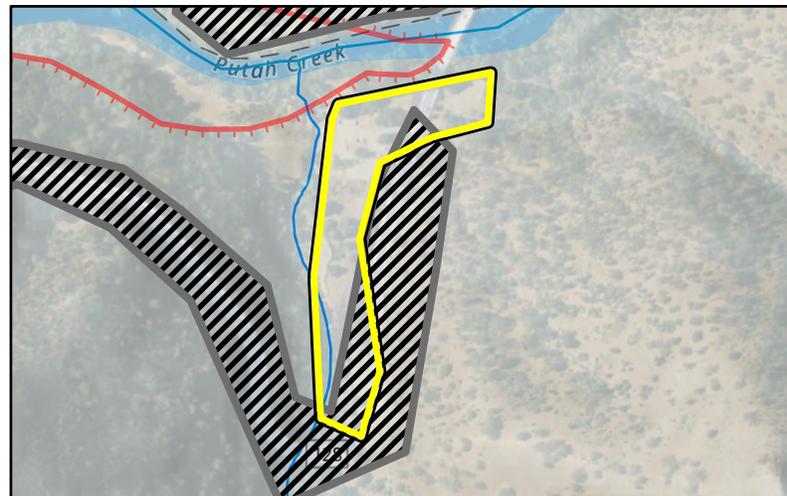
Field Observation Resort and RV parking in floodplain of Putah Creek opposite mouth of Cold
or Potential Hazard: Canyon. Potential for debris flow and flooding.

Potential Hazard to Life: high

Potential Hazard to Property: moderate

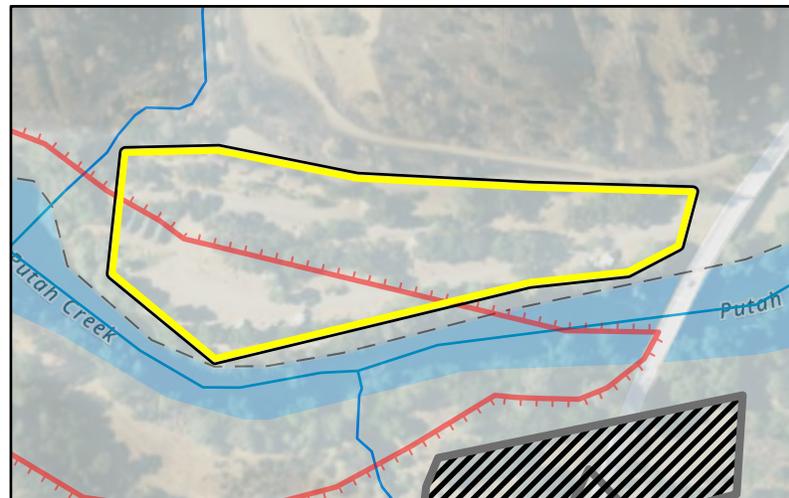
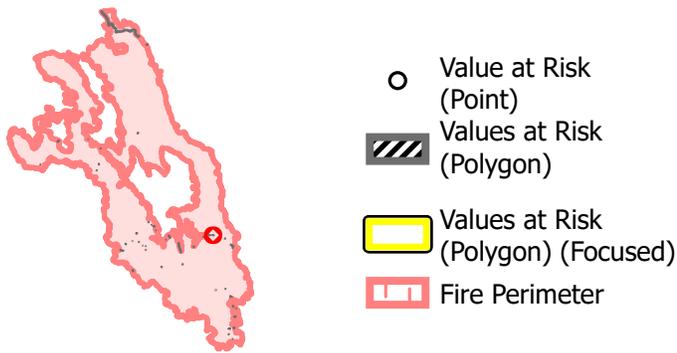
Field Observation Day use area and facilities downslope of Bray Canyon and other steep tributary
or Potential Hazard: canyon. Potential for debris flow or flooding.

Potential Hazard to Life: moderate

Potential Hazard to Property: low

Description: close site prior to and during large storm events

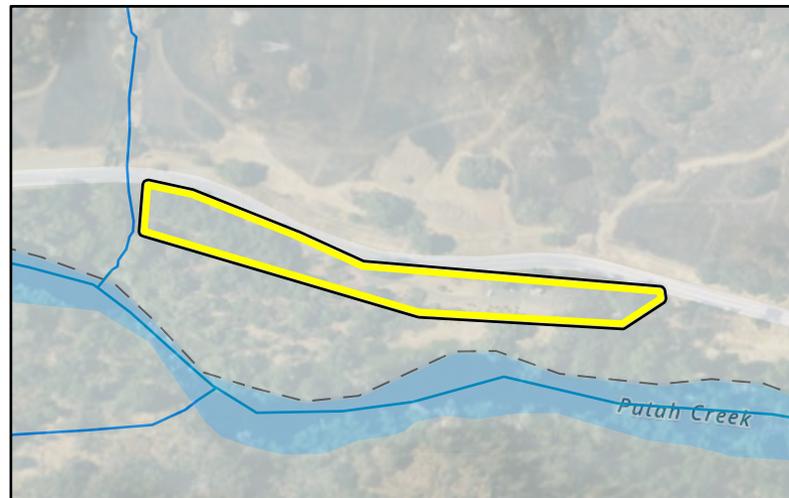
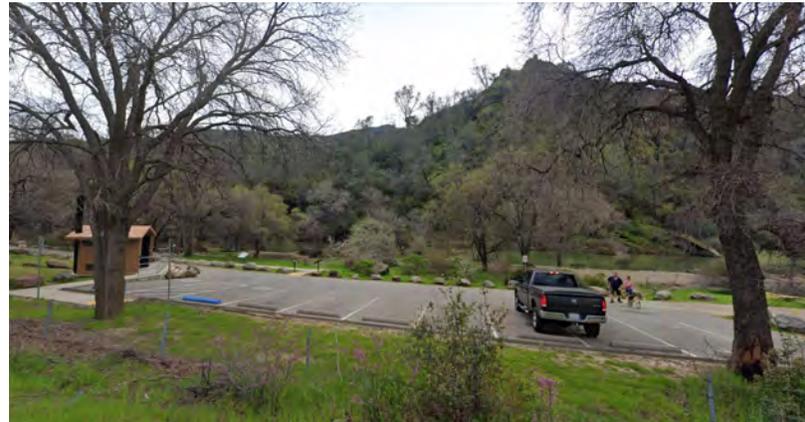
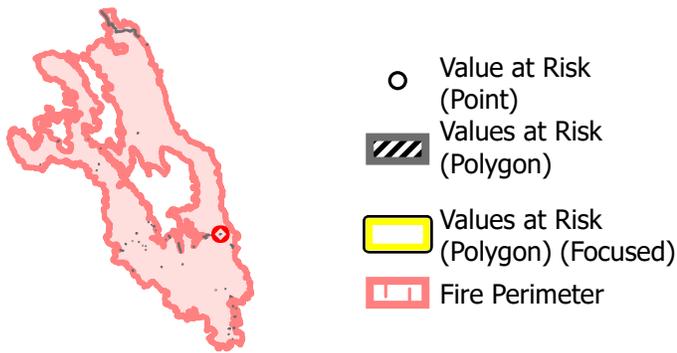
Field Observation Day use area parking located downslope of several potential debris flow or **Potential Hazard:** channels.

Potential Hazard to Life: moderate

Potential Hazard to Property: low

Description: close area prior to and during large storm events

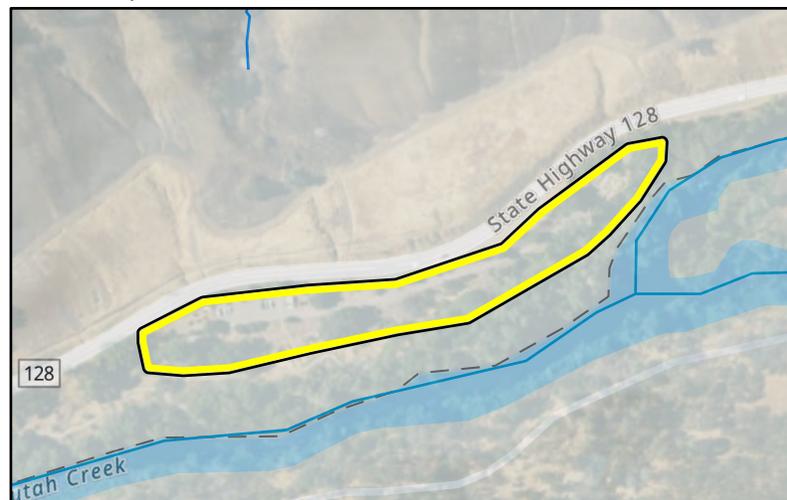
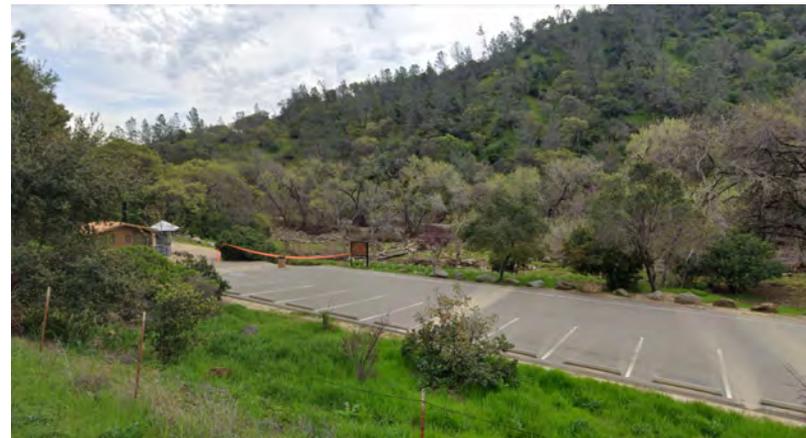
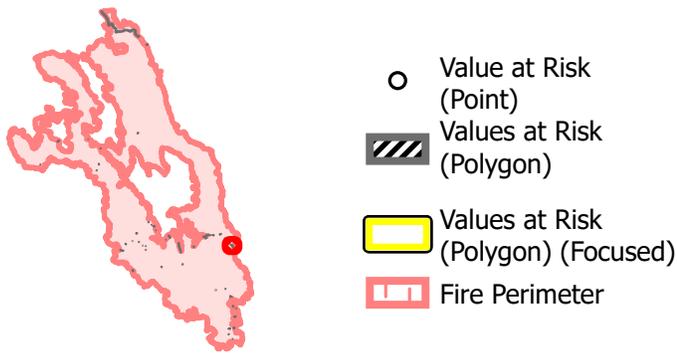
Field Observation Campground low on banks of Putah Creek. Potential for flooding due to runoff
Potential Hazard: from drainages downstream of Monticello Dam.

Potential Hazard to Life: moderate

Potential Hazard to Property: low

Description: close facility prior to and during large storm events

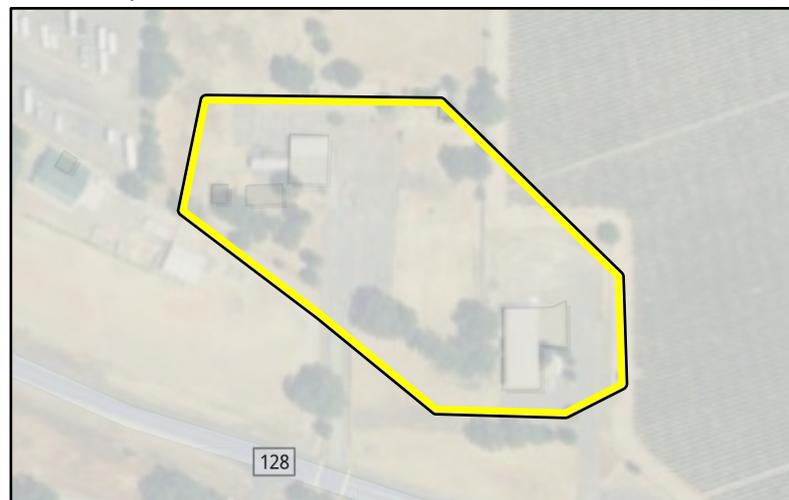
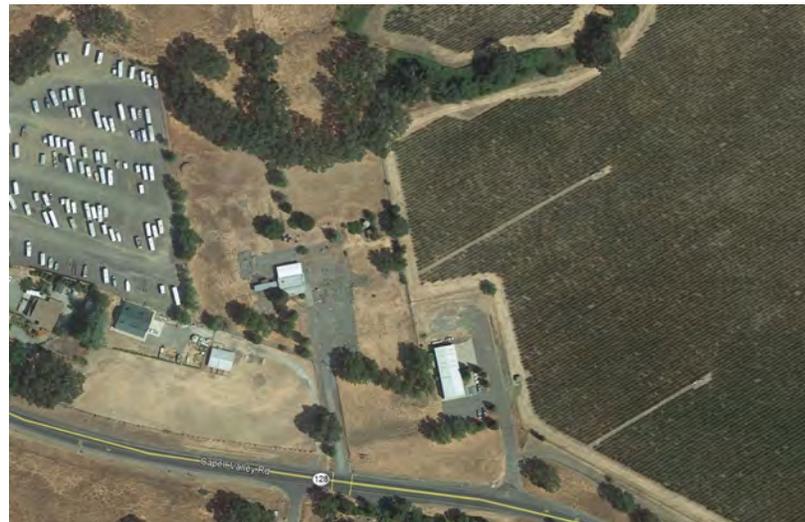
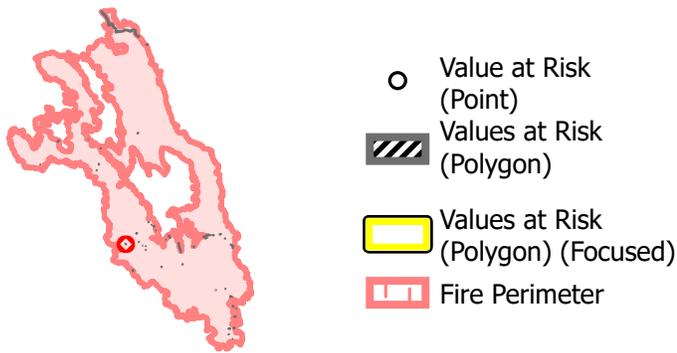
Field Observation Winery, parking area and terraced picnic area below mouth of debris flow
or Potential Hazard: catchment

Potential Hazard to Life: **moderate**

Potential Hazard to Property: **moderate**

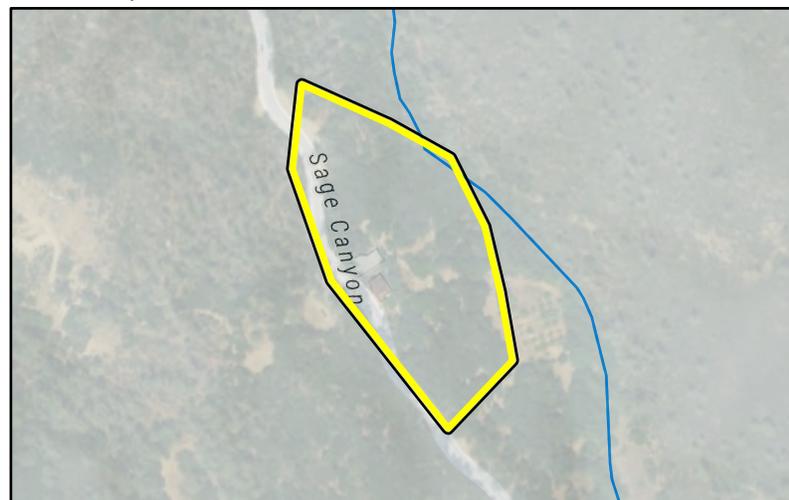
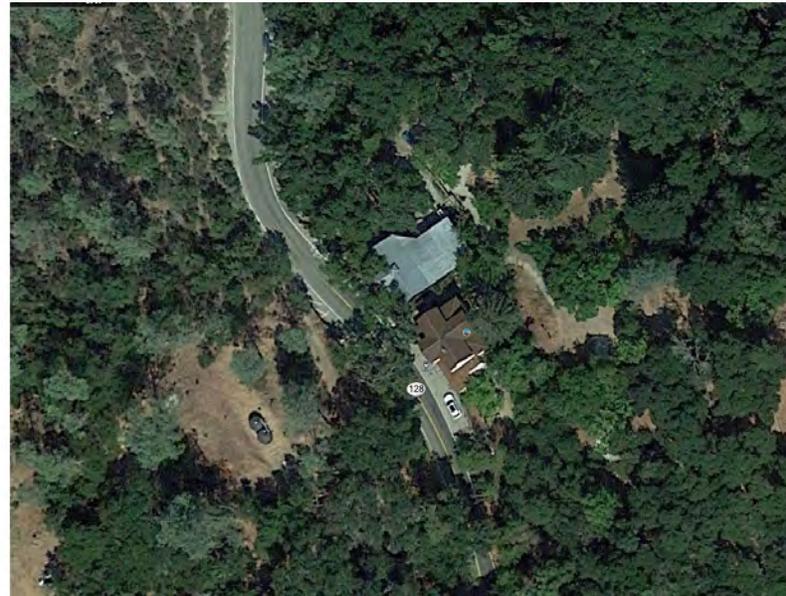
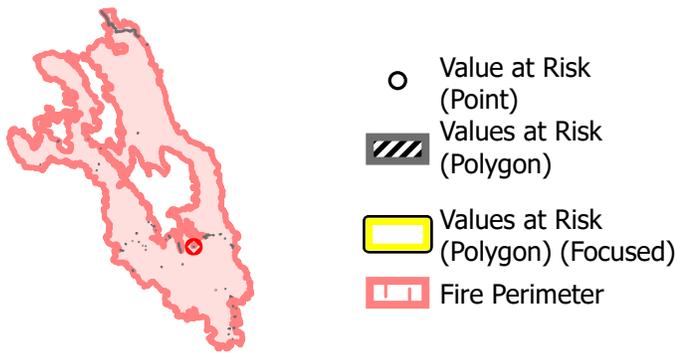
Field Observation Resort at mouth of two potential debris flow drainages
or Potential Hazard:

Potential Hazard to Life: high

Potential Hazard to Property: high

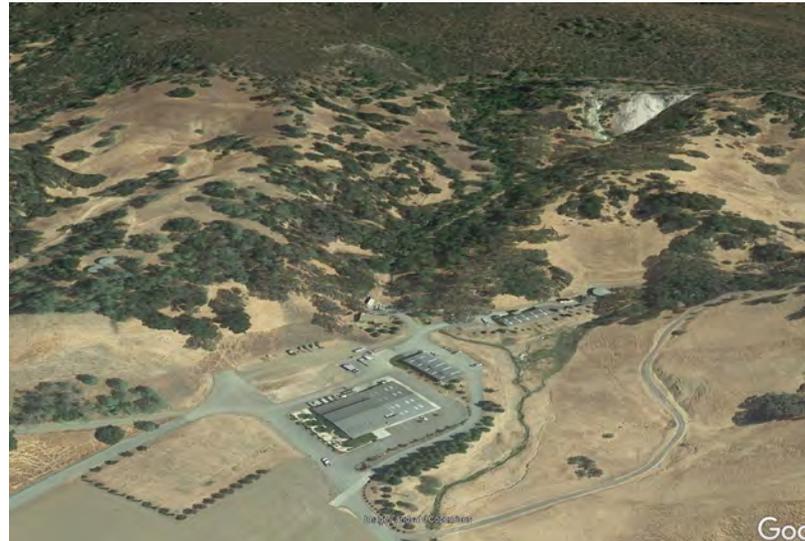
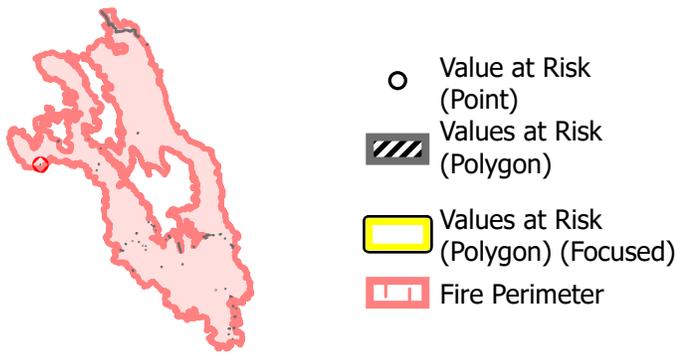
Field Observation Houses located within and below the mouth of potential debris flow drainage
or Potential Hazard:

Potential Hazard to Life: **high**

Potential Hazard to Property: **high**

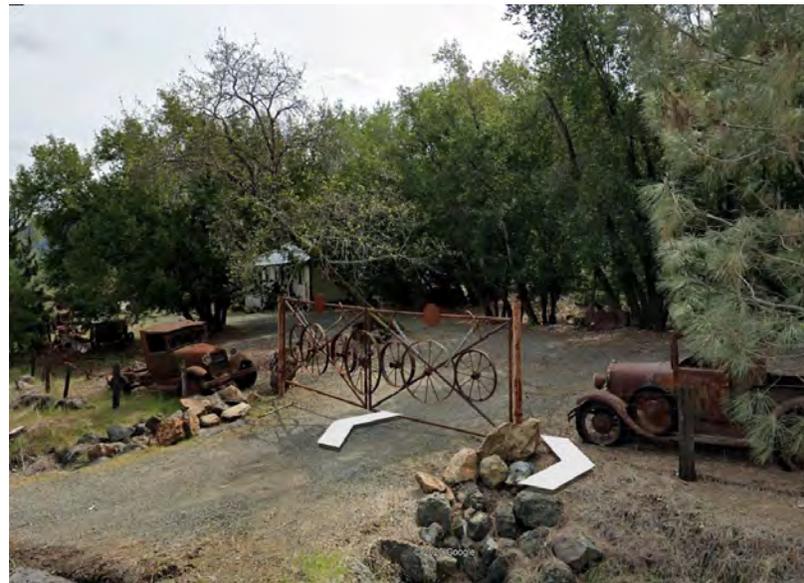
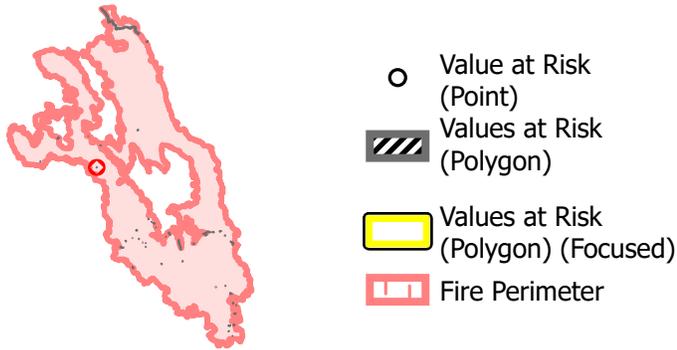
Field Observation Houses and commercial building below mouth of potential debris flow drainage
or Potential Hazard:

Potential Hazard to Life: moderate

Potential Hazard to Property: moderate
