January 6, 2011

To: Chris Lee, SCWA  
Rich Marovich, LPCCC

Subject: General Update - Solano  
System

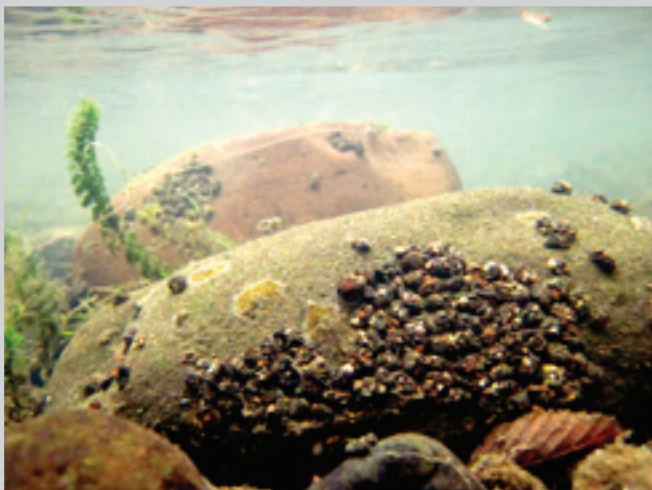
*Subsurface Image: Glossosoma pupae*

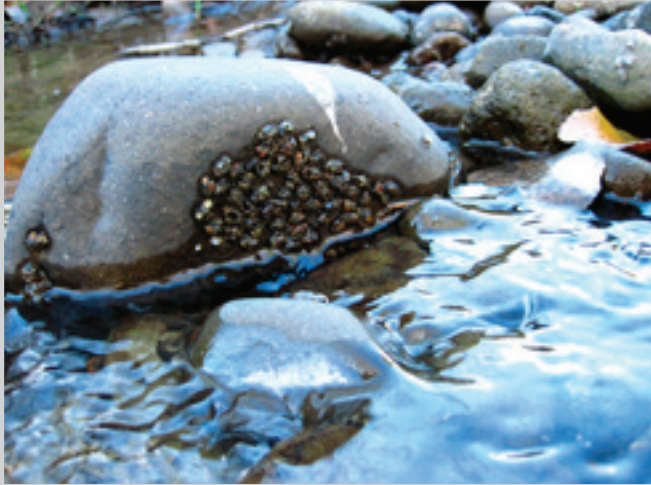
In addition, some anglers express concern about stranded *Glossosoma* pupae in the Interdam Reach.

*Glossosoma* - Stranded (most emerged) pupae

Studies over the last few years continue to determine that the vast majority (80-90%) of the pupae emerge before the water level is lowered and the subsurface nymph population is rather significant.

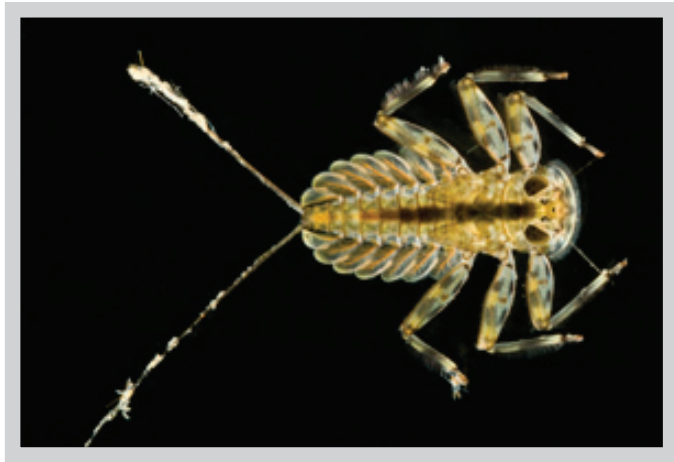
*Epeorus albertae*: Clean water species - dorsal view

The *Epeorus* mayflies are highly intolerant of organic pollution and are generally considered indicators of clean water. The population of *Epeorus* in the Interdam Reach has increased dramatically over the past few years. I've already found a few small specimens in early 2011. The main population will grow though early spring and hatch by late April.

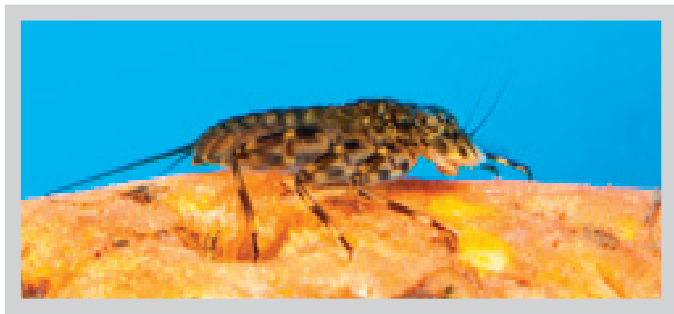
*Epeorus albertae*: lateral view - shows hydrodynamic structure as nymphs prefer clean, rapid flowing water.

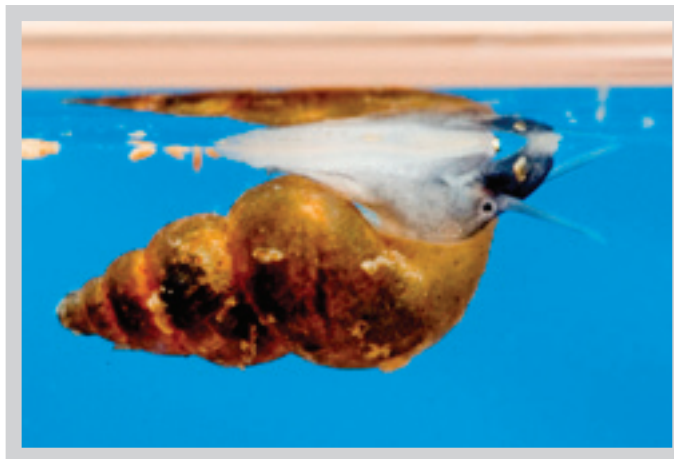
New Zealand Mudsnail translocating under water surface

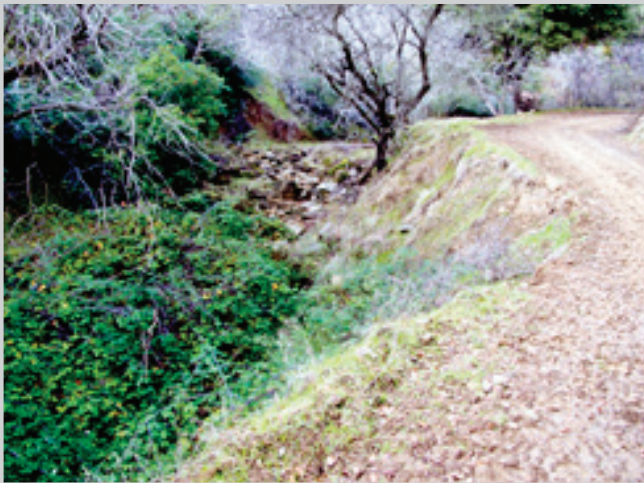
*Thompson Creek - Road: Matt Straw property - 1/6/11.  
Note blackberry cover in creekbed.*

Recent discussions with Matt Straw, the owner of a significant section of Thompson Creek, continue to be constructive. He supports my unfunded invertebrate work in Thompson Creek and property access by SCWA staff and consultants to determine potential sediment-reduction ideas.

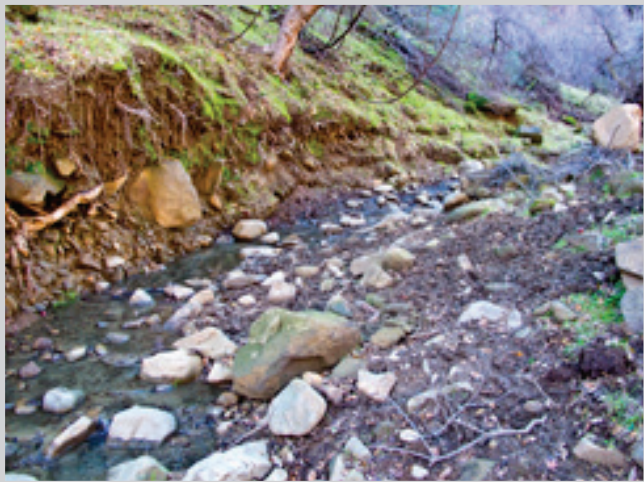
*Thompson Creek - 1/6/11*
