Subject: Salmon Fry in Lower Putah Creek

### Report

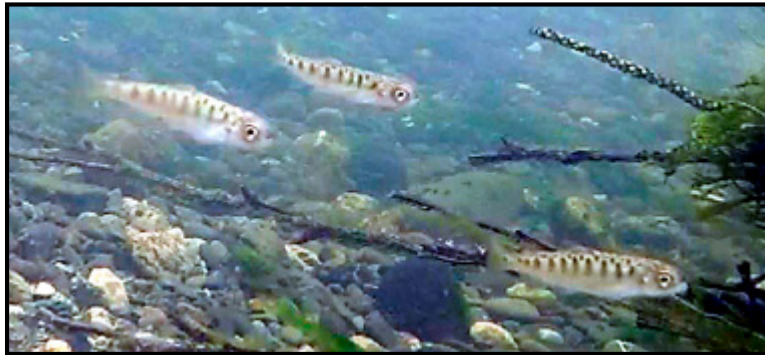
Several salmon fry / juveniles. Image 2/11/2018

taken yesterday clearly shows the salmon fry are exceptionally healthy and that they effectively use the branches for safe harbor and foraging.

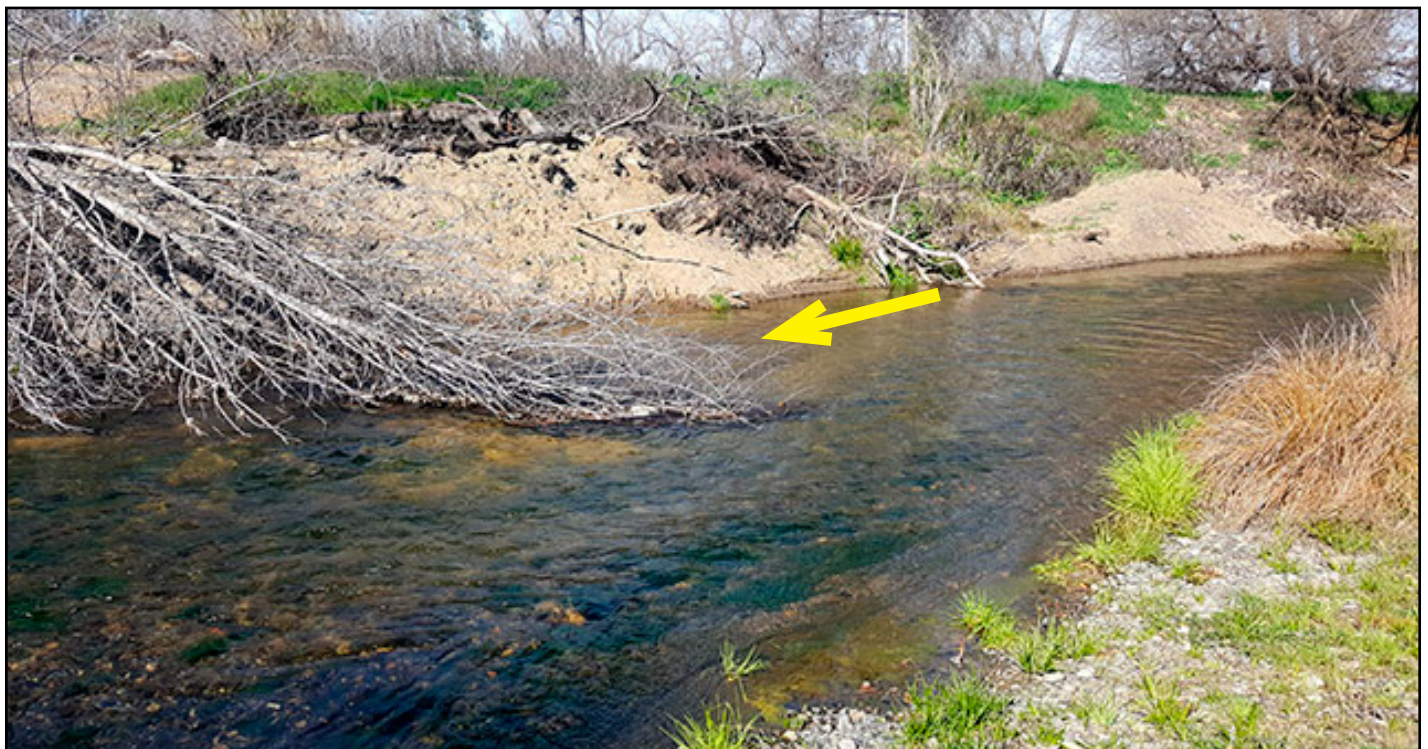
Downed tree that is being used by a significant number of salmon fry / juveniles. Several salmon redds are located in the shallow area directly upstream from the tree.

where naturally-downed trees are providing exceptional habitat for salmon fry. The branches provide effective harbor and foraging sites as many limbs are covered with Black Fly larvae, a common prey source for small salmonids. The branches also provide lower-velocity water flow.

1. I plan on continuing to monitor the known salmon refugia and documenting their presence, health, and use of the sites. Video footage will be available.
2. I recommend that we determine if we can introduce Tree Material (LWD), such as shown on Page 1, into sites such as the scarification (spawning) area shown below at Morales. That of course, might have to wait until next year if permits are required.
3. It appears that salmon fry readily use refugia that are immediately downstream from the redds.
4. Because I documented salmon spawning in late December, I believe we still have alevin that have not emerged from some redds. I will document that situation by video monitoring.
